INDEX TO GAZETTEER

<p>GAZETTEER NUMBER 1</p> <p>Zone: West</p> <p>Feature Name: Section of Town Wall on the boundary between St Mary's Churchyard and car park</p> <p>Phase/Construction Date(s):</p> <p>Phase 2: 14th century Phase 6: 19th century Phase 7: 20th century</p>	<p>Location:</p>

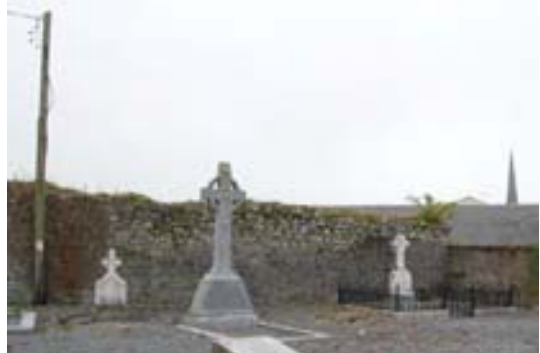
<p><i>External face of wall from the churchyard showing repaired section, looking south-east</i></p>

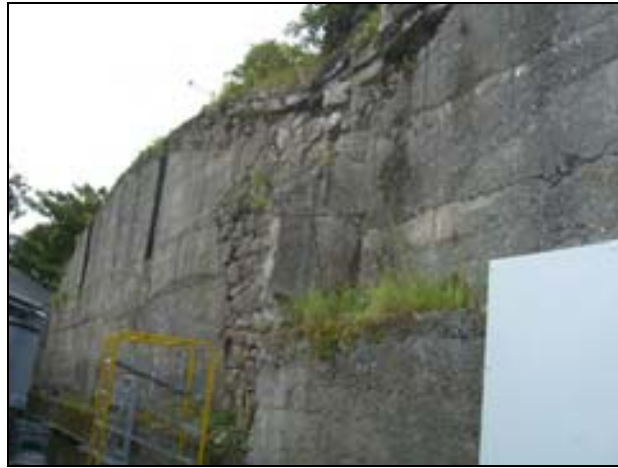
Wall tops	See above.	
Vegetation	<p><u>North-West section:</u> Rebuilt section has no vegetation growth.</p> <p><u>South-East section:</u> Significant vegetation growth to wall top and upper part.</p>	
Openings	As external face.	
Previous repairs / modifications	<u>South-East section:</u> The scars/disturbance left by the construction/removal of the previous building have not been made good. It is not clear whether the areas of concrete are superficial or whether they penetrate into the wall. There are

several slots into the wall, around which the stonework is becoming loose.

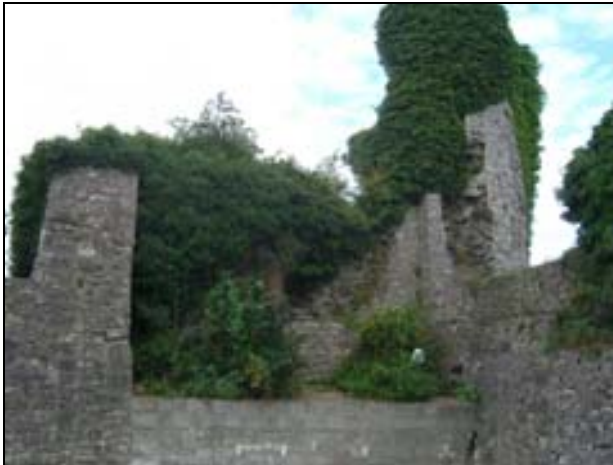
Zone: North	Gazetteer no. 2 – Condition record Feature Name: North-West Tower	Face: Internal
Item:	Comments:	
Description	As external face.	
Access	Access at car park level only; no access at higher levels.	
Completeness	As external face.	
Verticality	As external face.	
Stability	As external face. Loss of face work to West wall of guard house has reduced thickness of wall.	
Stonework/mortar	<p><u>Tower:</u> Stonework to the tower appears in reasonable condition where visible externally. Where the former wall and parapet to the east is no longer present, core work is visible, which needs consolidating.</p> <p><u>Guard house:</u> Remains of south wall in good condition; end appears to have been rebuilt flush with adjacent wall. West wall is in poor condition; core-work exposed over most of internal face, requiring some consolidation. North wall is in reasonable condition, but areas of loose stone visible at base of wall above revetment.</p>

Wall tops		
Vegetation		
Openings	<p><u>Tower:</u> Large opening (door?) to south-east above top of adjacent wall (Gazetteer no. 1), with dressed quoins. Stone below the opening is in poor condition and requires consolidation.</p> <p><u>Guard house:</u> Remains of arch above arrow slit opening to west wall is in poor condition, with ivy growing through it, and needs consolidation. Side faces of opening in good condition.</p>	
Previous repairs / modifications	<p>The internal ground level has reportedly been lowered by approximately 1.5-2m, and a blockwork wall built across the guard house to retain the ground. The surface of the retained ground has been covered with gravel and has shrubs growing in it. The end of the blockwork wall is crudely finished at the junction with the north wall.</p> <p>The current end of the south wall has been refaced probably during the rebuilding of the adjacent wall.</p>

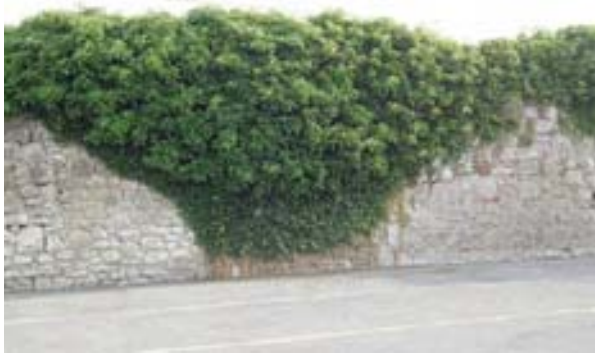
<i>External face of wall, looking south-west</i>

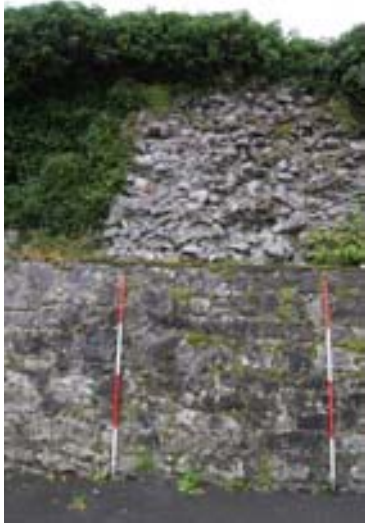
<i>Internal face of wall, looking north</i>

<ul style="list-style-type: none"> • The lower terraced section of the internal face adds protection to the walls, however the re-pointing of concrete-based mortar may trap water inside, weakening the wall structure. • The vegetation has taken a firm hold on the wall and is intrusive to the structure, especially the exposed rubble core areas. • The exterior of the wall may be affected by the future usage of the Convent school grounds, now closed.
Policies / Recommendations	<ul style="list-style-type: none"> • Treatment and removal of the ivy and other vegetation is necessary to consolidate the outer section of the tower, internally and externally and regular pruning would aid the stability and appreciation of the structure. • Appropriate signage should be placed close to the supermarket entrance to inform visitors of their location within the Town Walls and the particular features visible. • The base of the openings appear to have a number of dressed stones that may have been added as conservation work of recent times, however, further work is needed, while taking care to preserve the scars of the adjoining walls. • Re-pointing of sympathetic mortars is required in places, particularly around the base on the external side. • As the location of the tower is the only publicly accessible part of the Walls in addition to the North Gate and the Castle, an intellectual link needs to be made between the three sites to encourage a fuller appreciation of the Walls. • Careful treatment and pruning is required in order to consolidate the tower and control of re-growth is required. • A scheme should be implemented to ensure repair, checks on vegetation and any new collapses, etc are addressed in a consistent and appropriate manner. • Planning conditions for archaeological mitigation of any surviving below-ground remains should be applied to any future development works in the vicinity of the wall.

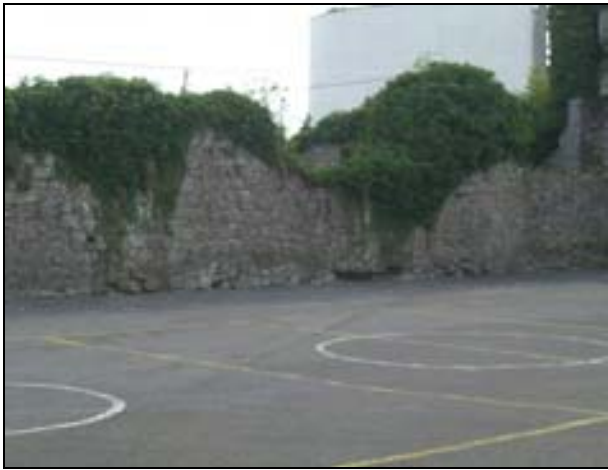
Wall tops	Very irregular, and obscured by ivy for much of its length.	
Vegetation	Heavy ivy growth on the wall. To the east end there are climbing plants covering areas of the wall.	
Openings	-	
Previous repairs / modifications	-	
Other	-

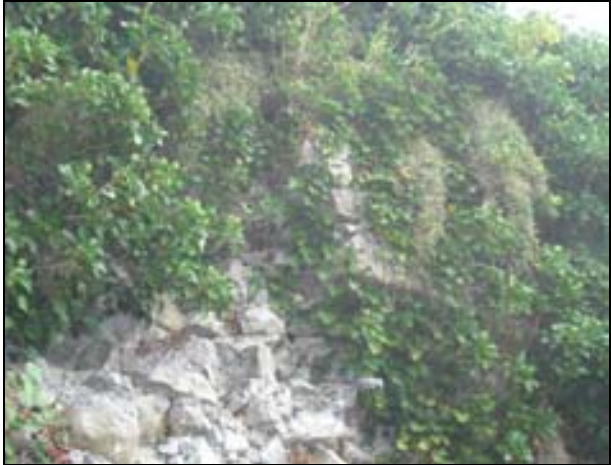
Stonework/mortar	<p>Where visible, the corework to the wall is exposed and is in poor condition. One area of facework is visible. The lower modern wall / revetment is in reasonable condition.</p>

Wall tops	Irregular, obscured by ivy.
Vegetation	Very significant ivy growth.
Openings	-
Previous repairs / modifications	Modern wall/revetment at base is in similar stonework and presents a misleading impression of the form of the wall.
Other	-

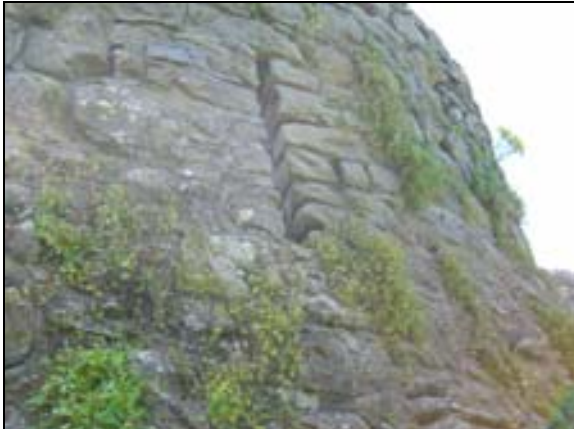
<p><u>South-East quarter:</u></p> <p>A straight section of solid masonry vertical wall on a sloping base. It formed the external elevation of a large hall inside the walls. The thickness of the wall varies from 0.5m to 1m. Maximum height above base approximately 8m. Approximately height of base 3m. Condition of stonework and mortar generally reasonable. Some runs of lime/salts on face, particularly adjacent to the window openings. The base is</p>

<p>in good condition and well pointed. The wall above is in poorer condition with mortar weathered back in joints. Regular series of holes at high level.</p> <p><u>South Tower:</u> A high circular tower on a sloping base protruding from the curtain wall to the south-east but continuous with the wall to the south-west. The thickness of the walls is approximately 1.1m Maximum height above base approximately 9m. Approximately height of base 3m. Condition of stonework and mortar generally reasonable. The joint between the south-east curtain wall and the tower is very irregular and open; possibly difficult to repoint (large joint, thermal movement?). The south-east face of the tower has mortar weathered back in the joints. To the south the base bears the scar of a previous low concrete wall which had been cut into the stonework. Occasional missing stones to the south-west. Large crack emanating from south-west opening, and continuing diagonally to the top of the wall; may require stitching to prevent loss of fabric. Edge of tower ragged at west (adjacent wall is lower).</p>

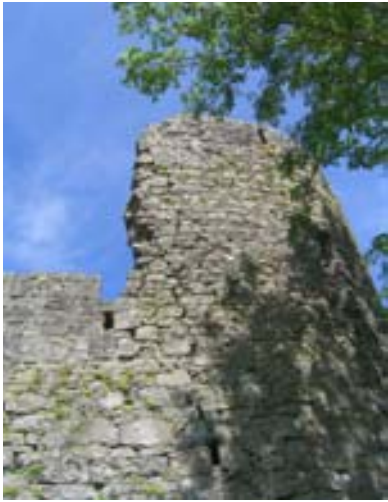
<p><u>South-West quarter:</u> A lower section of wall, running between the tower and the entrance. The batter is in reasonable condition; it has previously been repaired in patches, and other areas now need some repointing. The upper part of the wall has some open joints, some missing stones and has lost some packing stones.</p> <p><u>Entrance:</u> Modern square stone piers with metal gates. Some runs of lime/salts on inside faces of piers, otherwise in good condition.</p> <p><u>North-West quarter:</u> To the end adjacent to the entrance, a modern section of vertical wall, curved on plan, with no visible batter, but an earth rampart. Darker stone and different style of stonework. Generally good condition. Slight crack (2mm) through joints on lower part of wall to visitor building. Many runs of lime on face. Possible previous cracking - repointed? To the end adjacent to the toilet block, a section of wall more like rest of the curtain wall, with a vertical wall on top of a batter. The upper part of the wall is modern. Many runs of lime/salts on face. Vegetation has been stripped off previously. All well pointed. Generally good condition. Buttress to the wall in good condition. A short section to the north of the buttress could not be inspected, but appeared to have greater vegetation growth.</p>

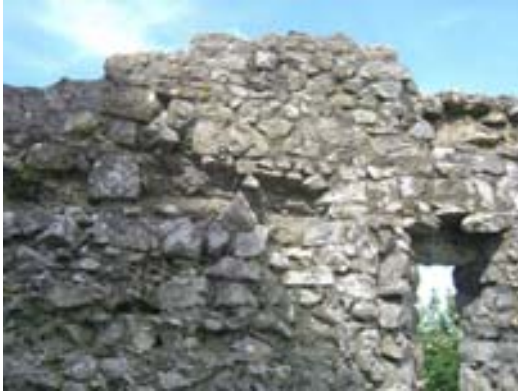
<p><u>East Tower:</u></p> <p>The majority of the wall to this circular tower stands approximately 1.4m above internal ground level, and is approximately 1.4m wide. It is in reasonable condition. A small section upstanding above the general level is well consolidated. Adjacent to the Hall the wall is thinner (approximately 450mm) above 0.5m.</p> <p><u>South-East quarter:</u></p> <p>This constitutes the external wall of the Hall and is continuous with the tower wall. The wall is generally approximately 9m high, 1.05m wide. A section of parapet remains at high level. Approximately 1m below parapet level there is a narrow ledge/wall-walk. A further ledge exists at approximately 1m below the wall-walk. The wall is in good condition.</p> <p>Pointing is variable in colour, with lighter (newer) pointing at low level.</p>

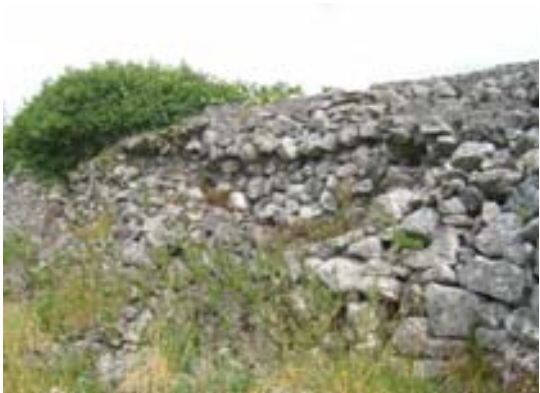
Wall tops	Where visible, the wall top appears to be very irregular but has been previously capped with mortar in places. Elsewhere it appears very loose. However, much of the wall top is obscured by ivy.	
Vegetation	Large areas of the wall are completely obscured with ivy and shrubs/nettles growing close to the wall. Where visible, there is minor vegetation growth in the wall face.

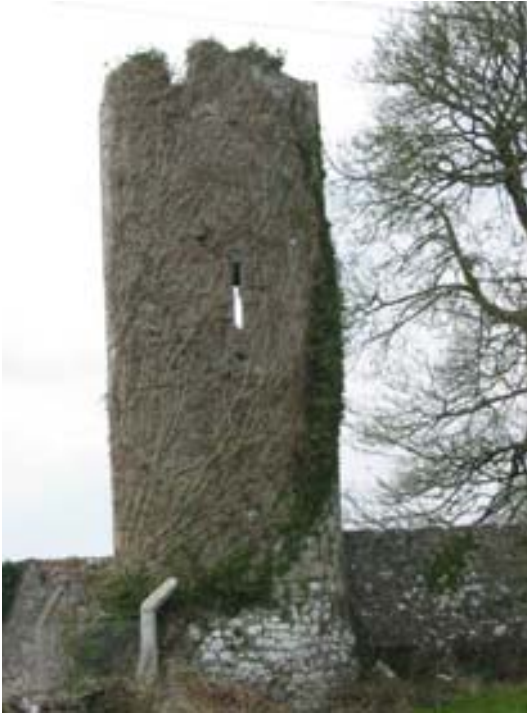
Access	Good access at ground level.	
Completeness	Appears reasonably complete to current height where visible, except to south-west where wall previously abutted tower. Some tumbled stone visible around the base of the tower.	
Verticality	Appears reasonably plumb where visible.	
Stability	No signs of overall instability where visible.	
Stonework/mortar	<p>Random limestone rubble (slightly squared stones) with some coursing. The stone size is larger than generally used for the walls, and some of the galleting is present in joints. Condition appears reasonable where visible. Remains of wet dash.</p> <p>Dressed stone quoins around door opening. Core work (to scar where wall has previously abutted) has vegetation growing from it and requires some consolidation. The upper surface of the roof is of rough stonework, with vegetation growing in the joints.</p>

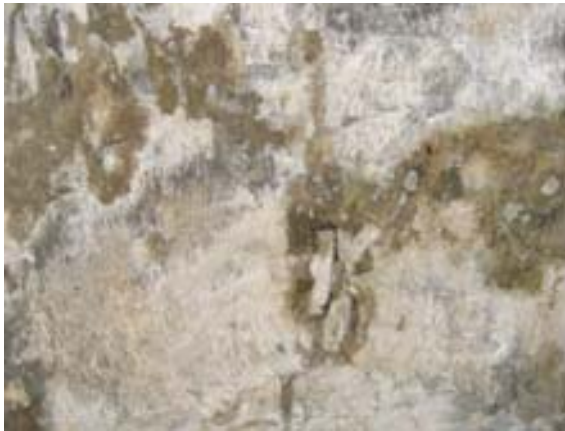
<p>The walls appear to be reasonably flat, of roughly squared stone in variable sizes, coursed, and may have been rendered previously. A number of pockets are present in the internal masonry, which may be original, but are more likely to have been created by removal of stones, and should be made good to prevent climbing.</p> <p>The floor is covered with debris.</p> <p>Roughly dressed stones occur around the door and window openings, and to the treads of the circular stairs</p> <p>The treads to the spiral stair are small in plan and generally worn. Some have broken corners. There is some ivy growth in joints. The wall to the staircase is in reasonable condition.</p>

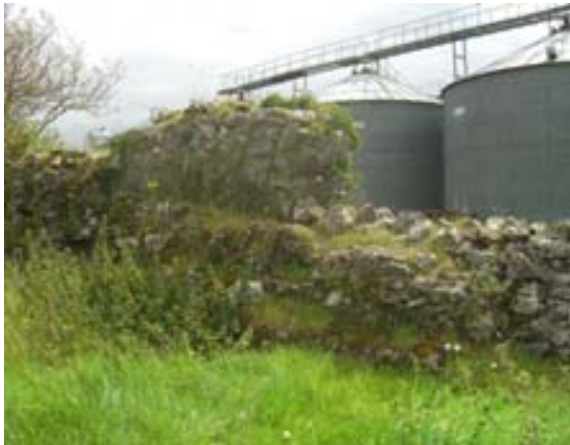
Access	Good access at ground level.
Completeness	The wall is incomplete.
Verticality	Reasonable, slight outward lean in places.
Stability	The newer wall appears reasonably stable, as do the remains of the old wall. It is not thought that the 2 walls are tied together where they run in parallel, but probably gain some mutual support from each other.
Stonework/mortar	<p><u>North-East section:</u> Several different types of wall style visible, with random coursing present in some areas. Size of stones varies considerably. Some areas of render to the face. Generally the pointing is in poor condition, with packing stones missing in some areas. There are significant numbers of tumbled stone at ground level, particularly near the Co-op boundary.</p> <p><u>South-West section:</u> The corework is in reasonable condition where visible, but will require consolidation in the medium term. There are significant numbers of tumbled stone at ground level.</p>

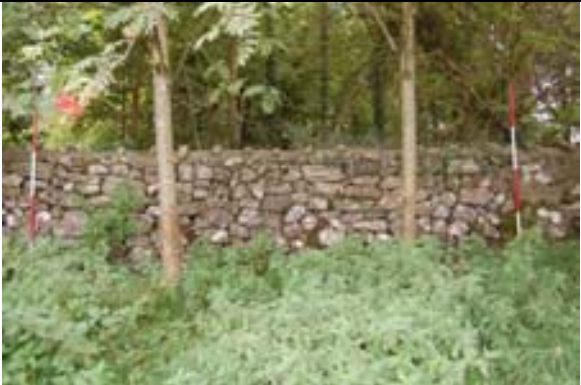
<p><i>Concrete capping and stones set in as crenelations, internal face of wall, east of the gateway, looking south</i></p>
Statutory Protection	National Monument; RMP GA-084-001; RPS 132
Condition	Not accessible at external face due to undergrowth. For internal face see condition survey record
Significance	National: forms part of the Town Walls circuit.
Vulnerability / Issues	<ul style="list-style-type: none"> • The wall is very overgrown in places, with ivy prominent around and within the wall structure. Careful removal and monitoring of growth is required, to avoid future collapse. • The land east and west of the river is in possession of a housing and mixed use development which at present has limited its land use to the west area of the river. The 30m buffer zone applies to the interior face of the wall. • The land to the east of the river may be vulnerable as a site for future development. • Archaeological investigations are addressing certain sections west of the River Clarin, but little is known about the overall archaeological potential of the east area.

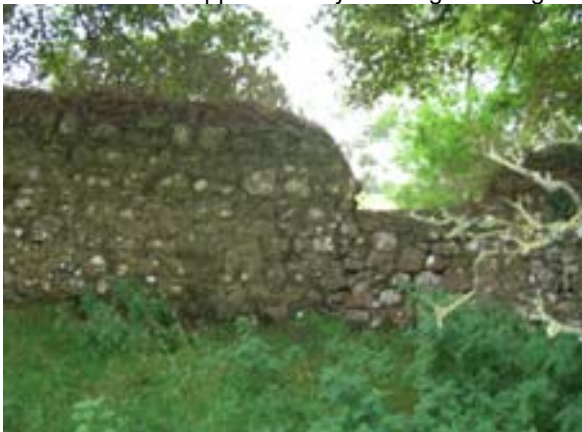
Stonework/mortar	<p>Where visible the wall has random coursing in small sized stone. There are some areas of rebuild and significant numbers of tumbled stone adjacent to the wall.</p>

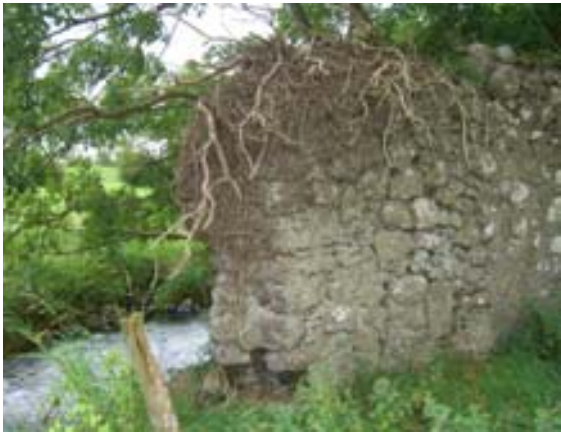
<p>The east section has some evidence of render to this face. Generally the wall requires repointing.</p>	
Wall tops	The wall top is very uneven for most of its length It has been previously capped with mortar, with stones set in, but now appears loose.	
Vegetation	The wall top is obscured by ivy for the majority of the wall. There are some large trees growing very close to the wall.	
Openings	-	
Previous repairs / modifications	Some rebuilt areas with no coursing and little mortar in joints.	
Other	-

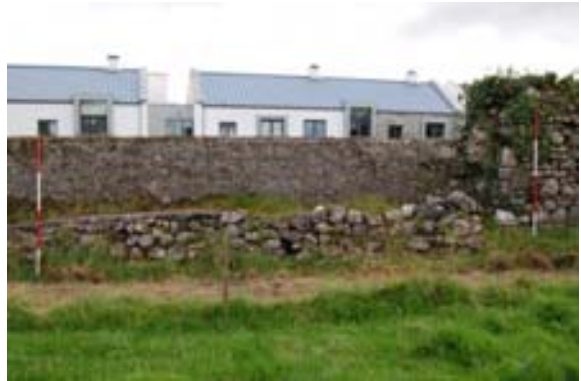
<p><i>Degraded section of interior face of wall, with concrete wall to the exterior, looking south</i></p>

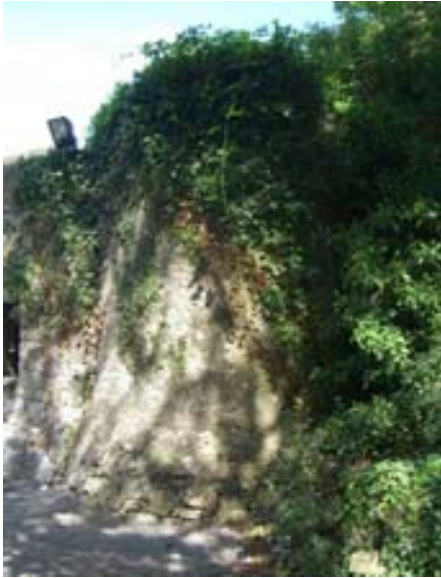
Access	Access to parts of the tower only at ground level due to adjacent building.	
Completeness	Appears complete to current height	
Verticality	Appears reasonably plumb where visible	
Stability	No signs of overall instability	
Stonework/mortar	The tower has the remains of render to the visible areas. There is an isolated hole to the north-east. The lower part of the tower requires repointing.

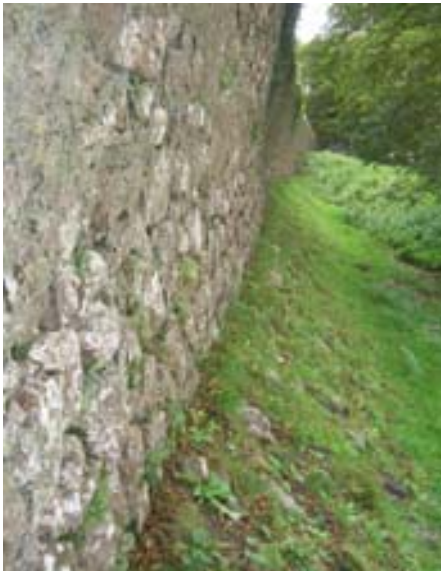
Stability	Potentially unstable in places.	
Stonework/mortar	<p>Coursing random, some areas rendered. Some areas good condition, but generally quite poor condition. Some open joints and cracking in joints. Some loose/ missing stone particularly at the base of the wall. Significant amount of tumbled stone at base of wall and in ditch.</p>

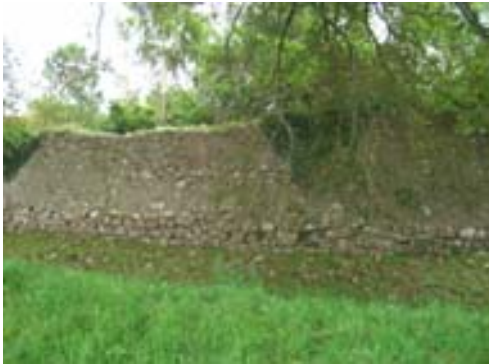
<p>One area of collapsed face at low level towards the north-east end requires support to loose stones above and consolidation/repair. Other areas of collapse of facing adjacent to and behind buildings at the north-east end.</p>

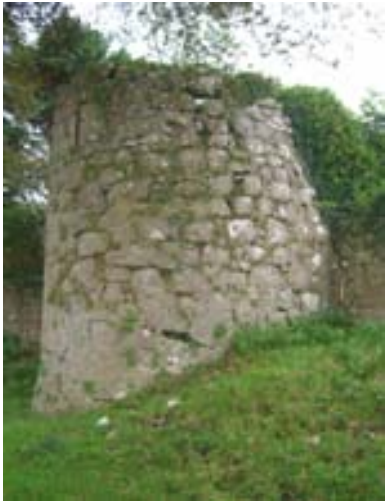
Wall tops	The wall tops are in poor condition, with loose stones visible. There appears to have been a protective mortar capping applied previously.		
Vegetation	Minor vegetation growth in joints. Some ivy to wall tops particularly adjacent town walls.		
Openings	Thin rectangular (blocked?) openings are visible to the west and north faces, and possibly also to the south face (although this is difficult to distinguish).		
Previous repairs / modifications	-		
Other	-
