Killora Church & Graveyard

Conservation Management Plan

October 2021

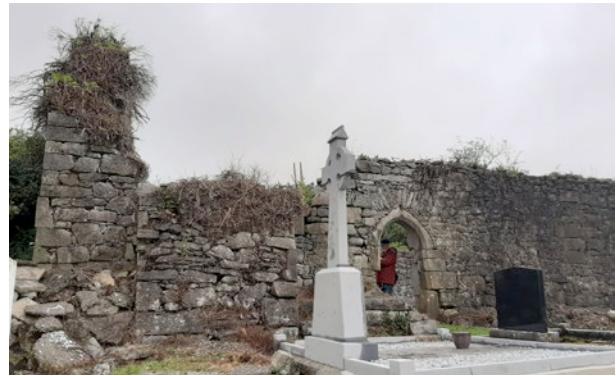
A large masonry buttress (H 2.35m; Wth 1.3m at base narrowing to 0.55m at top) has been added to the south at the west end, indicating previous structural instability in this area, and this wall does appear to have been rebuilt at some stage, now consisting of rubble masonry, with thirteenth century inserts. The buttress no longer appears to be functioning in a structural capacity, and is now detached from the wall and starting to collapse.

Viewing looking towards South wall, with West gable on the left

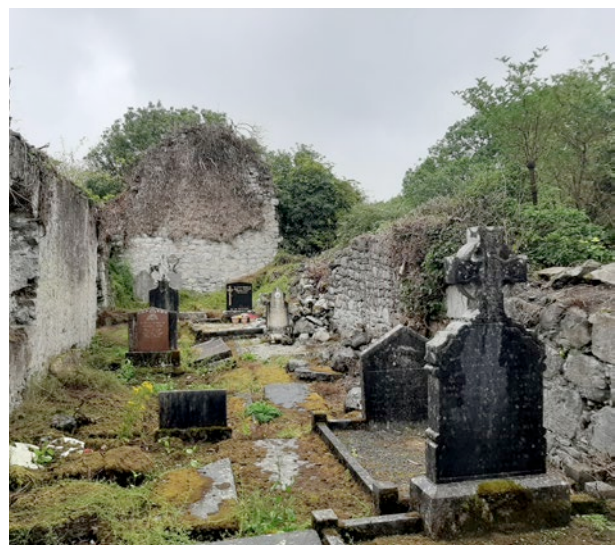
The north wall measures 19.3m long internally and is on average 800mm thick. The upper five or six courses of the north wall were removed circa 1988, and much of the masonry from these coursing is likely contained on the north side of this wall, which is currently inaccessible. It is recorded in the Ordnance Survey Letters that the west extent of the north wall (length of circa 6.5-7m) was taken down some time prior to 1839 and roughly rebuilt in drystone masonry. A portion of this rebuilt wall has since collapsed inwards, and now partly covers one of the burial plots within the church. The upstanding east portion of the wall contains earlier medieval church stones while the central section of the wall is of late medieval date. This late medieval wall is well-built of roughly-coursed irregular limestone blocks. Unlike the south wall and the east gable there is no evidence for the reuse of stone from the earlier church in the construction of this wall. There is no access to the north side of the north wall due to the presence of scrubland.

General interior view looking West, showing condition of North wall on the right

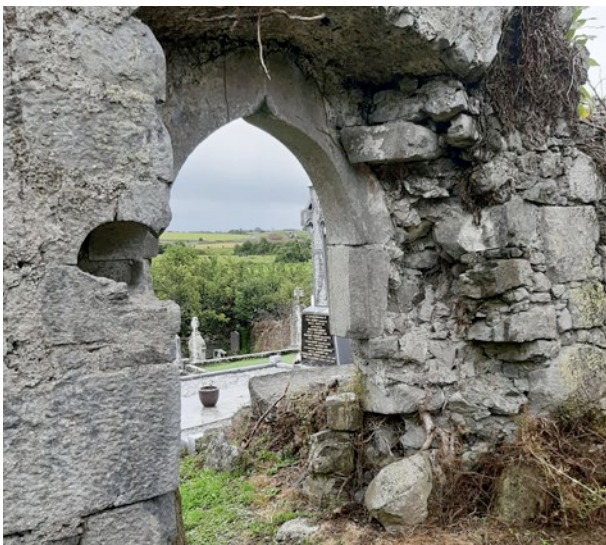
Features include a 'hanging-eye' upon which the door was hung, and draw-bar holes to accommodate the draw-bar used to secure the door. Internally the doorway has a segmental-arched head, the mortar bed of which preserves the imprint of the wickerwork used in the construction of the arch. The east jamb of the embrasure is formed of roughly-dressed limestone blocks and incorporates a partly-broken stoup/font, very similar to one at Kilboght Church approximately 15km to the east. The west jamb of the embrasure is completely missing.

Internal view of entrance doorway

Reinstatement of support stones to the west jamb of the entrance should be considered, as although these are missing since 1838, the wall embrasure on the internal side of the door is now collapsing and the integrity of this wall has become compromised.

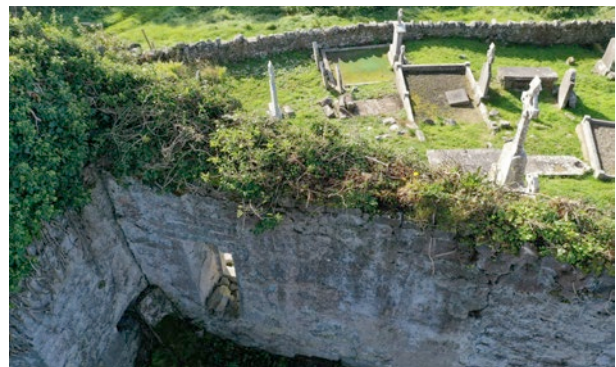
Aerial view of top of South wall

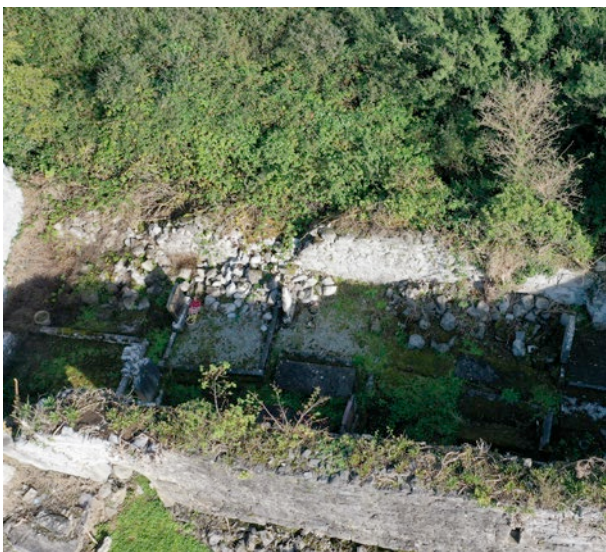
The collapse of the north wall appears to be on-going, due to the increasing presence of vegetation to the north of it, and this will result in on-going loss of historic fabric unless the vegetation is carefully managed.

The internal ground within the church is very unstable, due to the presence of burials throughout and this movement appears to be on-going. Previous disturbance to the graveslabs is evident, and a limited amount of maintenance has been employed to attempt to keep the graves visible and legible. Loose rubble from the north wall and elsewhere is piling up inside the church and this should be sorted and removed.

Aerial viewing looking down into church interior, with the collapse of the North wall and ground conditions visible

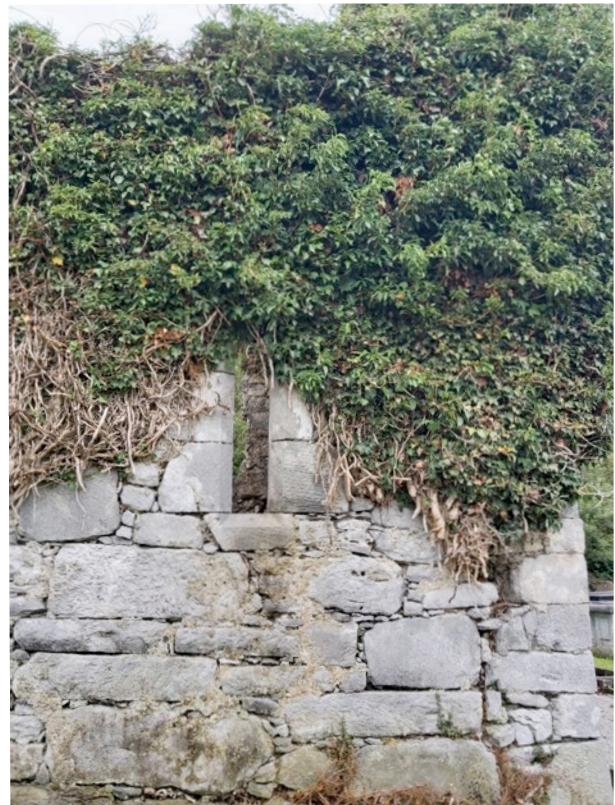
There are a number of architectural openings – two of which, the west gable window and the most easterly south window, are fully or partially shrouded with ivy and cannot be fully inspected. The east gable window appears relatively sound but the entrance opening in the south wall is in danger of further collapse and requires structural intervention.

View of window on Eastern end of South wall, showing ivy growth

If left unchecked the plant will regenerate vigorously increasing the size of the embedded roots that will eventually split the masonry and cause collapse. To remove this risk all of the ivy should be killed back using an approved biocide, with no cutting of the lead stems, so that the biocide will enter the embedded roots that will in time die and rot. These can then be removed relatively easily and the masonry pinned and pointed in lime and sand mortar.

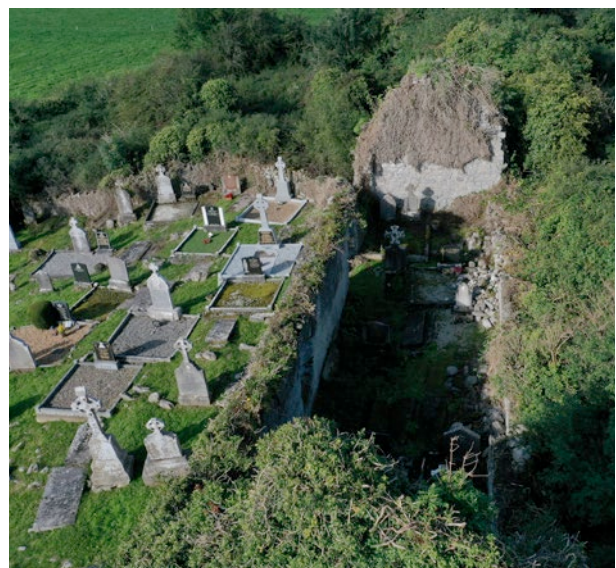
The amount of ivy growing on the ruin is significant, with more than 50% of both gables covered with thick growth, though the west gable ivy has been killed and now needs to be removed. Thick mature stems can be seen at ground level, and from the thickness of the secondary stems it is almost certain that the ivy has developed adventitious roots that have penetrated into the masonry.

Aerial view looking West, showing ivy growth at West gable

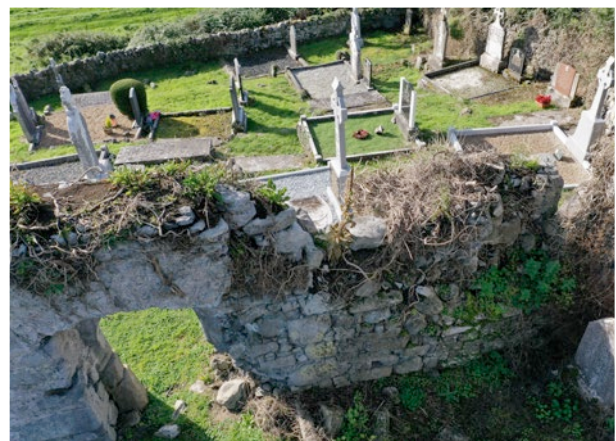
The abundant ivy on the church walls is indeed a remarkable phenomenon, the more so in view of the fact that it has not been rooted in the ground for some years. While its berries provide some food for pigeons and other birds in winter, these are far from being essential to the survival of any species. Small birds might possibly nest in the large ivy clump on the church but in the proximity of a rich variety of bushes, farms and gardens, no species of bird could be considered dependent on its presence.

Aerial view of church entrance and walls, showing ivy growth on top
