# Issertkelly Church and Graveyard

Conservation Management Plan (CMF22-2-GA001)

November 2022

This conservation management plan was commissioned by Galway County Council to assess the current condition and make recommendations for any necessary repairs to the ruin of the Church of Iisert Kelly, also known as Iisertkelly, near Loughrea, Co Galway. It is grant funded by the Community Monuments Fund, from the Department of Housing, Local Government and Heritage. It has been prepared by Howley Hayes Cooney Architecture in association with Rory Sherlock Archaeology; Bernie O'Doherty Archaeologist, John Britton Engineering; and MKO ecology. The surveys and enabling works on which this report is based were carried out in August and September of 2022.

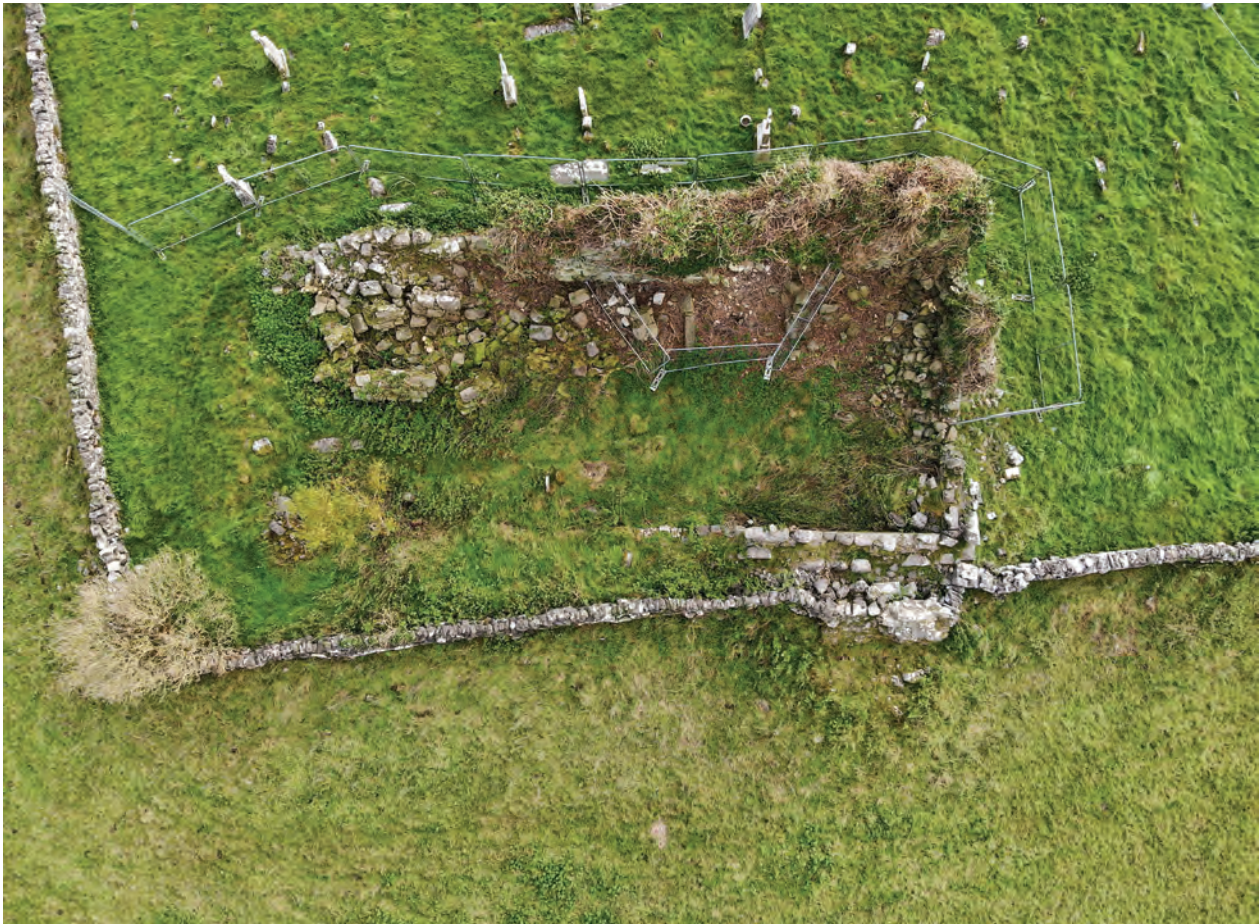
Figure 3 - Aerial view of the church, a single cell structure - the east wall (on left of photo) is entirely collapsed

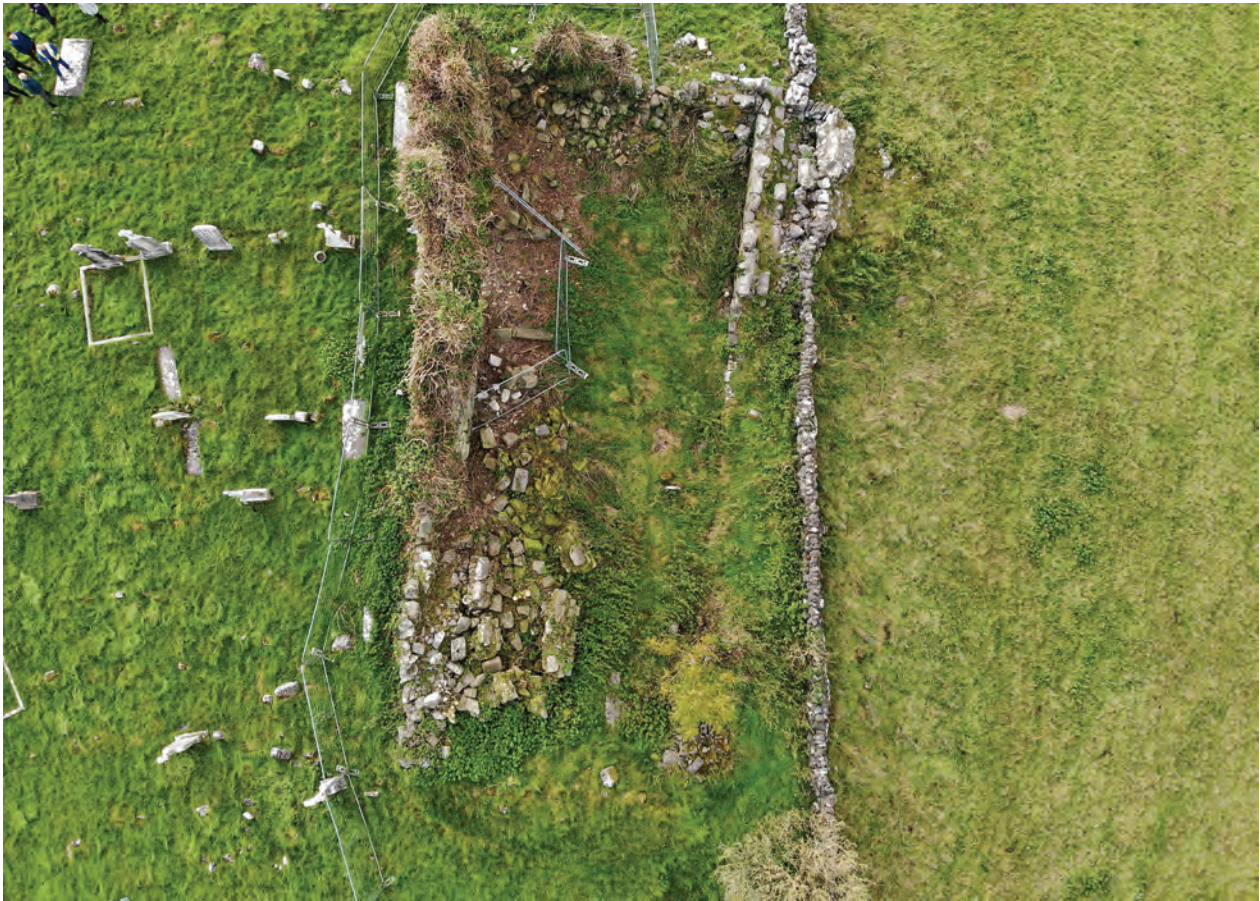
Figure 12 - The north wall (on right in photo) has collapsed in part onto the boundary wall

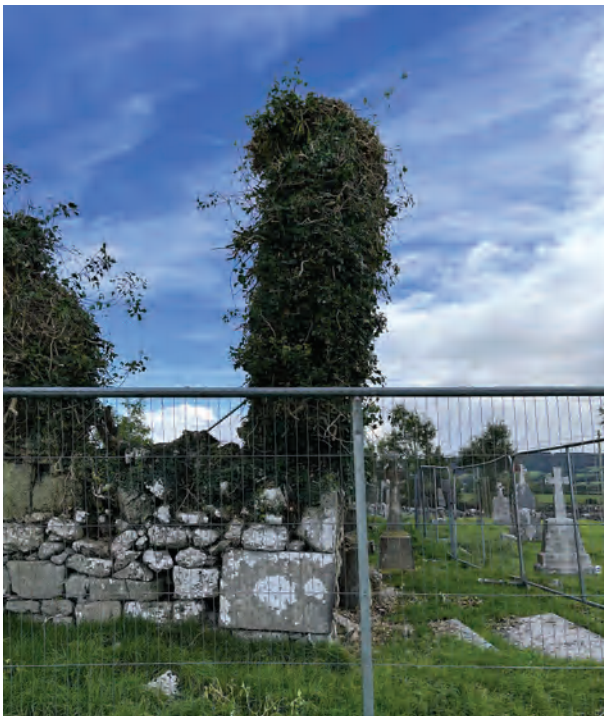
Figure 15 - Lean of the south wall is evident when viewed from the side

The lean in the wall is a cause of major concern and has been assessed by John Britton Consulting Engineers (see Appendix A) and was found to be 300mm out of alignment over a height of approximately 4m. The structural assessment determined that this wall is in danger of imminent collapse.

- Immediate support of the south wall to prevent collapse – propping as outlined in the proposals in Appendix A. Longer terms methods to take down the top portion of this wall and rebuild should be undertaken once propping is in place.
- Removal of vegetation to prevent ongoing damage to the ruined walls.
- Repairs to the arched entrance way with reinstatement of masonry to the entrance reveals and lost arch voisseurs overhead.

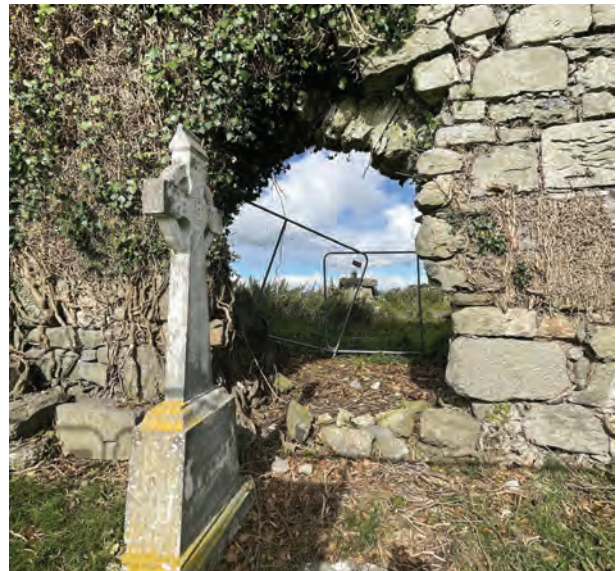
Figure 16 - Arched opening in the south wall

The arched entrance in the south wall is in very poor condition (fig 16). Missing the cut stones to both reveals, which has resulted in deep pockets of unstable masonry, it is also missing all of its outer voisseurs stones to the arch (figs 17). Although the inner face appears to retain its voisseurs, the joints have lost all mortar, and the arch needs to be repointed (fig 18).

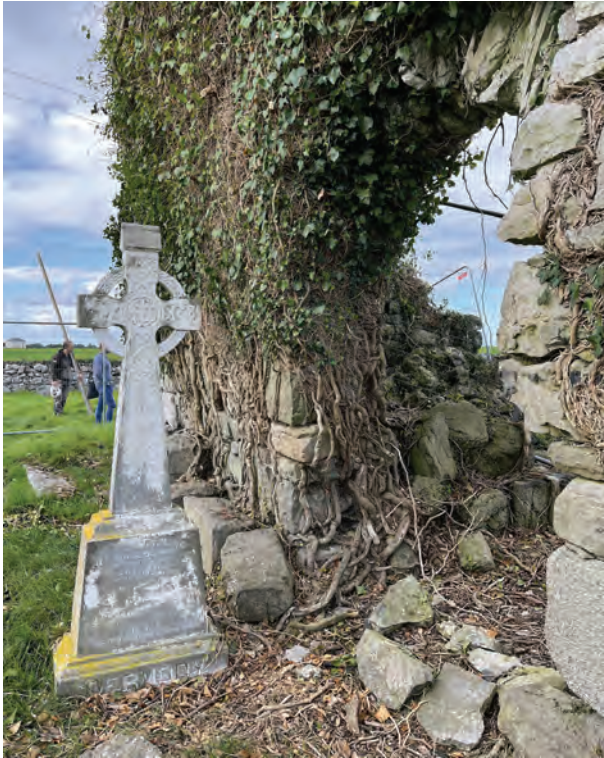
Figure 17 - The masonry entrance reveal

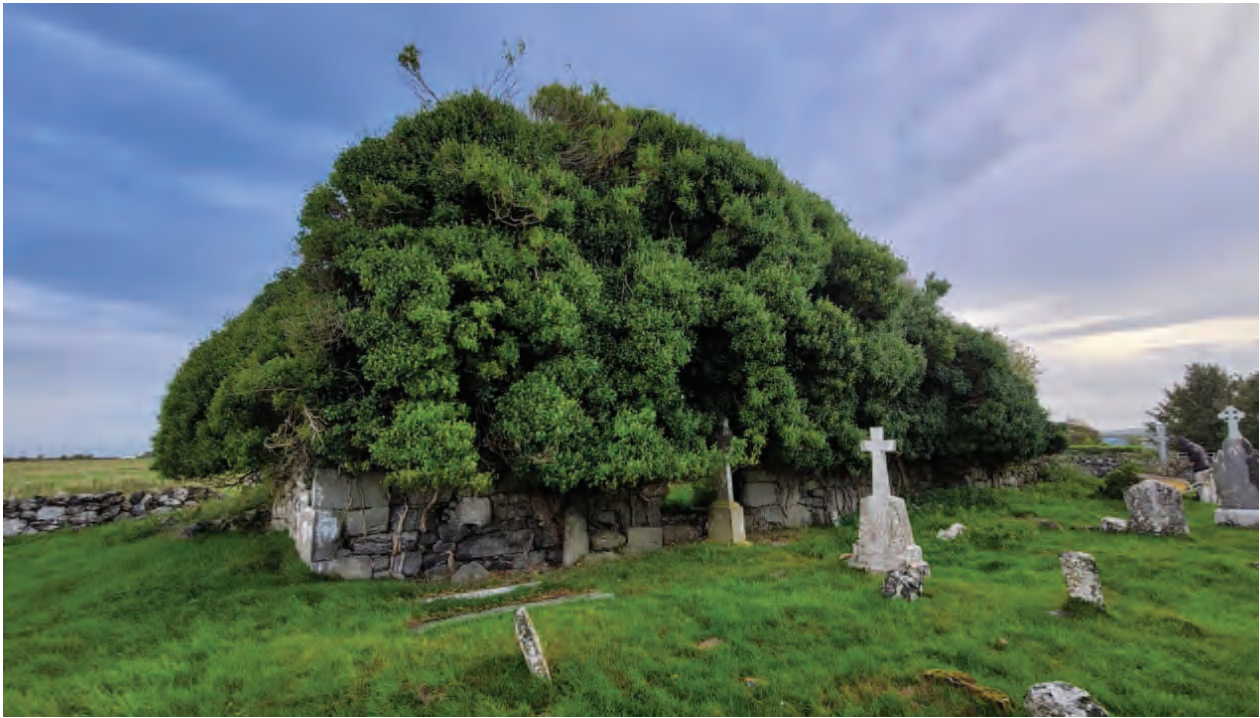
Ivy was trimmed back across the whole structure in September 2022 to within an inch or two of the wall faces, though due to the precarious nature of the structure, it was not trimmed back to this degree in all locations (fig 19). This work was undertaken after a bat survey in August 2022 confirmed there were no active bat or bird roosts in the structure. Roots within the walls were not disturbed, as this could result in the loosening and potential loss of masonry and ministerial notification is not in place at this time to allow for the repair of masonry (see Appendix C for notification documents). This process allowed the team to inspect the ruin and determine how much of the historic structure remains in tact beneath the vegetation. Prior to this work it was not possible to inspect the upstanding ruins. The vegetation removal works were notified to the National Monuments Service and monitored on site by Archaeologist Rory Sherlock.

Figure 19 - The ruin prior to the trimming back of ivy

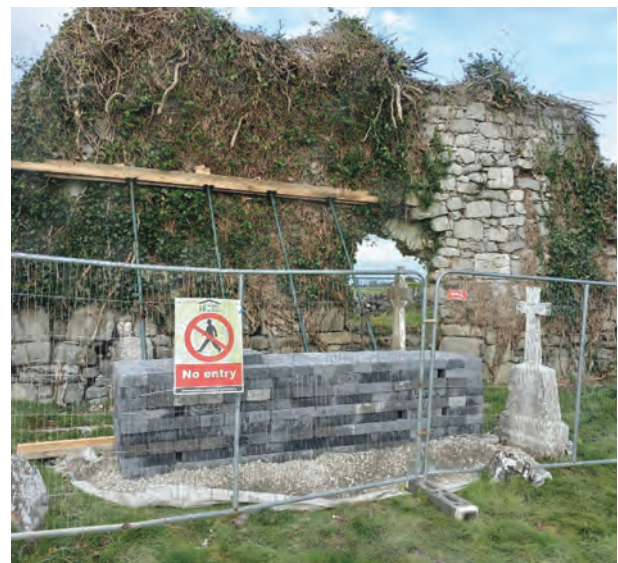
Figure 20 - Installation of propping underway at Issertkelly

Due to the immediate structural concerns with the south wall, the decision was made to install temporary props to the wall, designed by John Britton Consulting Engineers and constructed by Mathieu Mitchell contractors. Galvanised props, supported by heavy ballasts were put in place in October 2022 (fig 20). The ballasts were placed on the existing ground, in suitable locations between the graves, due to the archaeological nature of the site, it was not considered appropriate to excavate for the insertion of foundations for props. This measure is considered to be temporary in nature, and is required to prevent the imminent collapse of the south wall, however it is not a long-term solution for the Due to the presence of graves, and the fact that this is an archaeological site, This work was notified to the National Monuments Service and monitored on site by archaeologist Bernie Doherty.

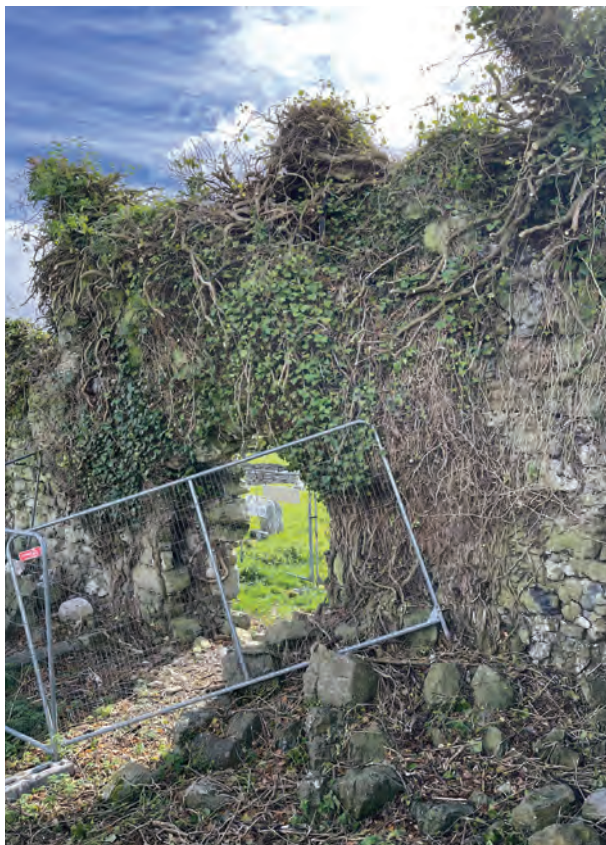
Figure 24 - Large vegetation still rooted into the top of the wall

Though vegetation has been trimmed from the structure, there is still a considerable amount of growth along the wall tops which should be addressed in order to prevent further loss of masonry (fig 24). A strategy for access to the ruin should be devised with a suitable contractor which will establish a means to erect scaffold or platforms in order to carry out work at high level from the wall tops, in order to treat and remove the heavy roots along the top of the walls. The ivy should be removed from all upstanding masonry to facilitate local repairs to be carried out where required. The contractor should ensure that all significant root systems are targeted and in particular the roots which have now been plugged with eco-plugs.

Large vegetative root structures should be removed from the top of the south wall, and repairs carried out to the entrance arch.

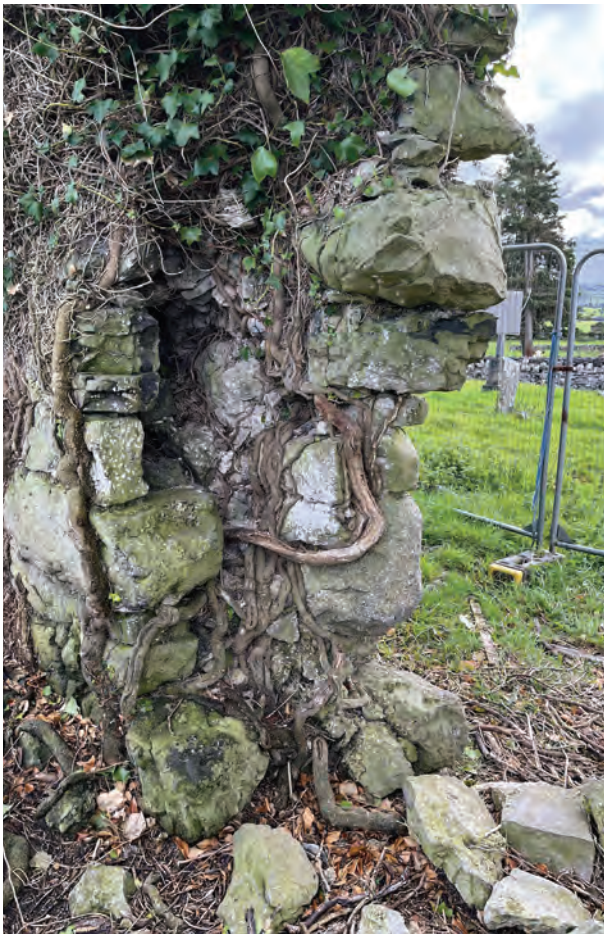
Figure 25 - Masonry reveal to the south entrance

- Full removal of remaining ivy from the south and west wall.
- The larger roots should be removed from the top of the south wall, and masonry repairs and consolidation carried to the wall.
- The wall top of the south and west walls should be rough-racked to protect it from on-going water ingress.
- Mortar samples should be taken from the structure to determine the composition of the original mortars and to inform repair mixes.
- Repairs and consolidation to the reveals and head of the entrance within the south wall, along with repairs to any remnants of a window in the south wall.
- Repointing of the entrance arch (fig 25)
- Localised repointing, pinning and repair to the lower south and west wall.

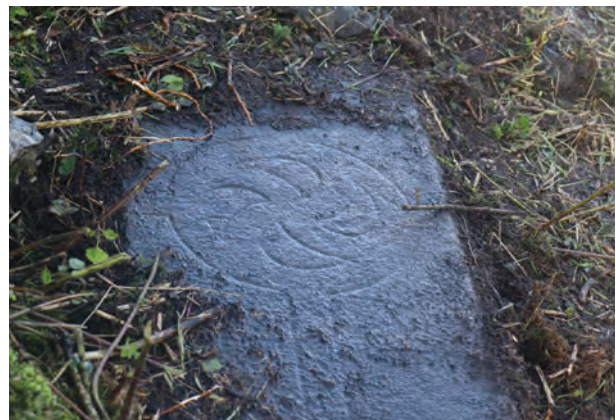
Figure 26 - Graveslab uncovered in the nave

Special care must be taken on site to protect the gravestones on site during any conservation works (fig 26). Fallen masonry may have already damaged gravestones within and around the church, so any works to consolidate, move, or sort masonry should be fully recorded to ensure that graveslabs underneath are documented in their found condition. Detailed method statements will be required for work of this nature.

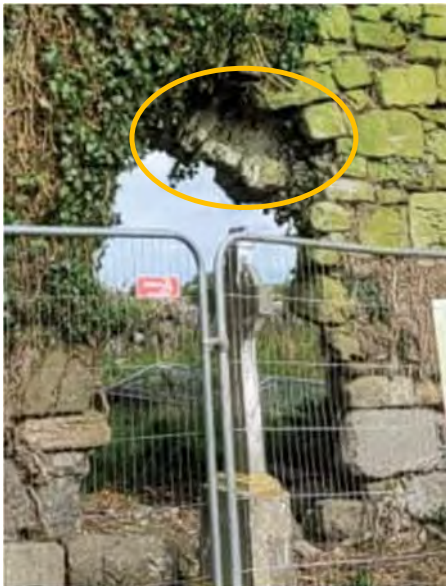
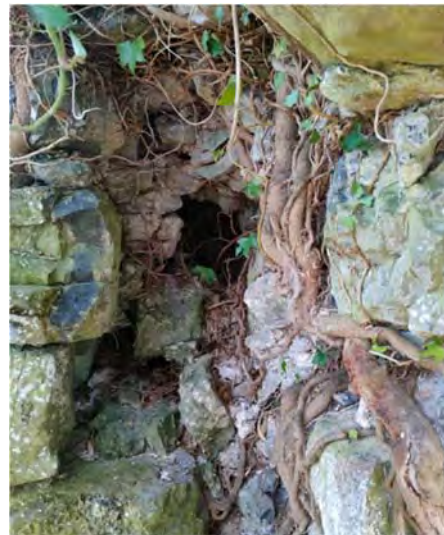
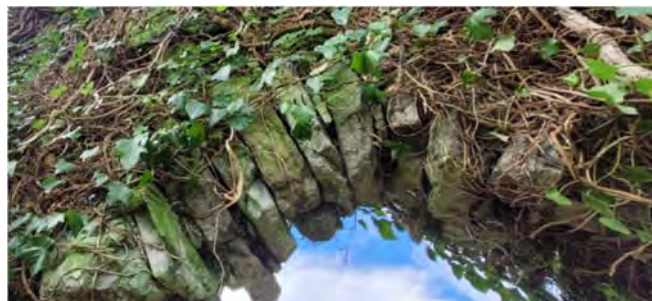
The arched doorway appears to be in very poor condition: the jambs are missing cut stones, likely for some time; the outer voussoir stones are missing, circled below left. Although the inner face of the arch appears to have voussoir stones these are lacking in pointing as shown below centre; and the core of the wall is missing for some depth on one side of the arch, as shown below right.

The arched entrance here is in danger of collapse if left to deteriorate. It is recommended that the door jambs are consolidated by rebuilding these with suitable reclaimed stones, filling the core also. Whilst, structurally speaking, these could be re-built with suitable facing stone, there may be a preference to have these built using commissioned cut stone, subject to budget constraints and Archaeologist/Conservation Architect advice. This work should be only carried out by a specialist stone mason. Along with rebuilding the jambs, the outer voussoir stones should also be rebuilt using suitably reclaimed stone.

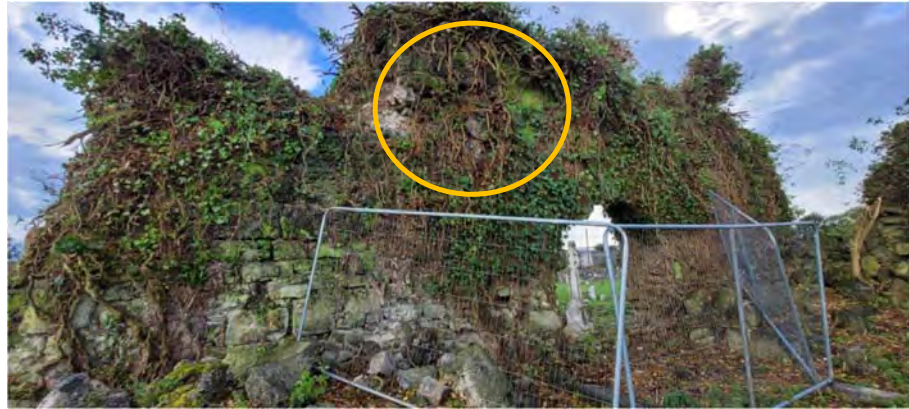
Although at the time of the inspections the vegetation growth had been cut back, there was evidence of significant vegetation to the full extent of the South Wall. The extensive vegetation has led to significant loss of mortar and pinning stones from the joints, and this loss has likely been increased through erosion as a result of water ingress. This wall also shows several apparently loose facing stones, likely having been dislodged due to vegetation growing deep into the core of the wall. The area circled right is of particular concern in relation to loose facing stones.

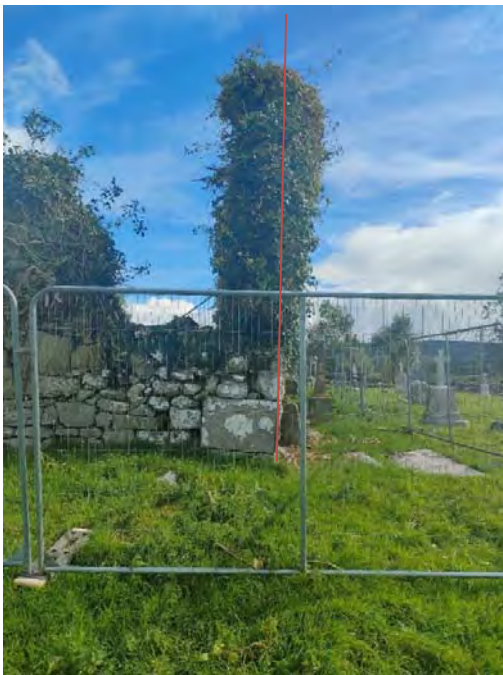
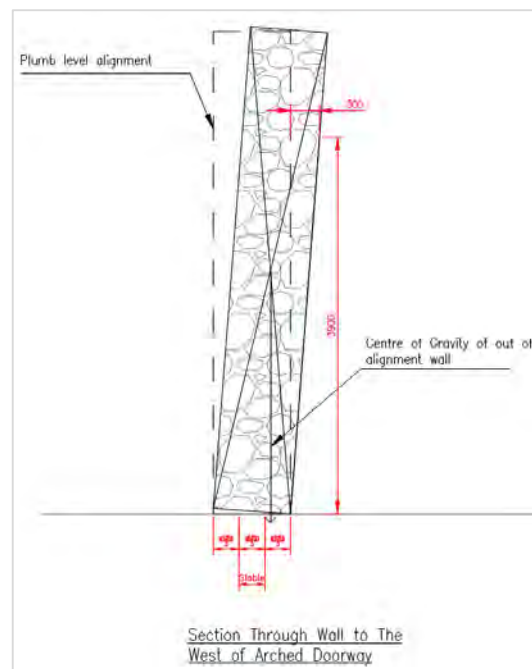
The most concerning aspect of this elevation is the significant lean to the southwest corner, as shown in the photo below. This is most likely a result of settlement due to nearby grave excavations and/or damage by vegetation: either past ivy growth moving the stones out of position or the weight of the ivy hanging onto the wall. The lean in the southwest corner was measured to be approximately 300mm out of alignment over 3.9m in height, and for stone walls to remain stable under self-weight, the centre of gravity should lie within the middle third of the base of the wall. Based on measurements taken onsite, it would appear that the centre of gravity for this wall is outside the middle third, as shown below, and is in imminent danger of collapse.

The leaning wall to the southwest should, in the interim, be propped to prevent collapsing of the structure under self-weight; separate correspondence regarding this has already been communicated. In order to remove the props, the wall will need to be partially taken down and rebuilt. The reduction will be dependent on the amount of lean and the height of the wall, so will vary along the length. From preliminary onsite measurement, the wall will need to be reduced to approximately 2m above existing ground level. The height to which the walls are rebuilt is subject to Archaeologist/Conservation Architect advice and the availability of salvaged stone. The image below highlights (in yellow) the estimated area of wall to be carefully taken down and rebuilt.

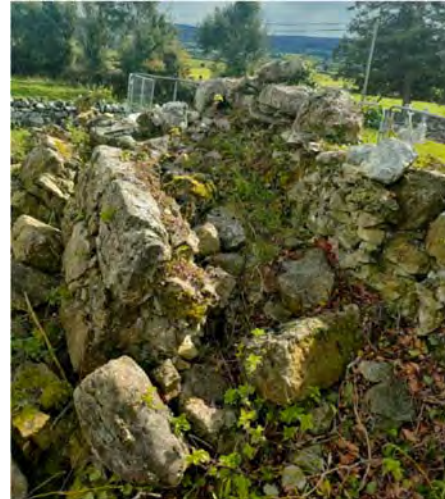
The southeast section of the South Wall is significantly lower than the remainder of this wall. There are also significant amounts of stone to the inside of this wall, indicating significant collapse in the past, as shown in the photo right.

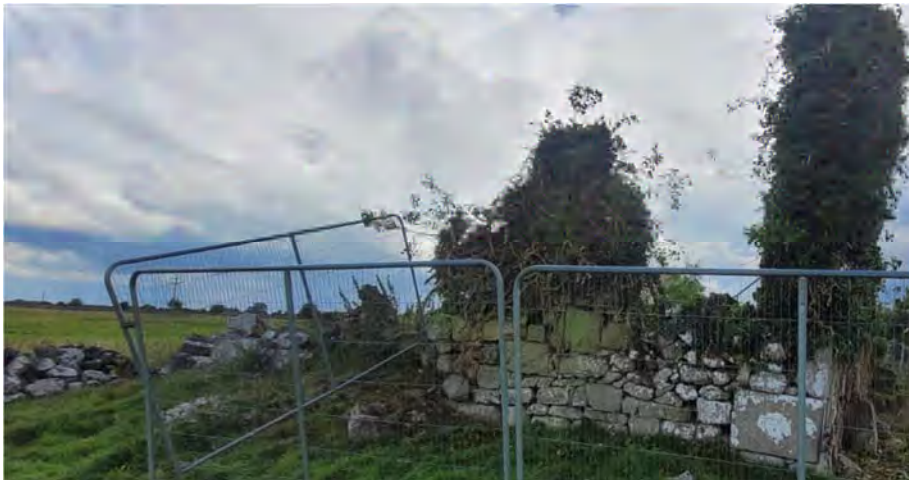
The West Wall of the ruin is approximately 900mm in width and ranges from 0.5m to 2.5m in height. Settlement is evident to the southwest corner and connection to the South Wall in this corner is significantly reduced, as shown in the photo below, weakening both the West and South Walls. As with the South Wall, the West Wall is missing lime mortar and pinning stones throughout, most likely from erosion due to water ingress or ivy growth.

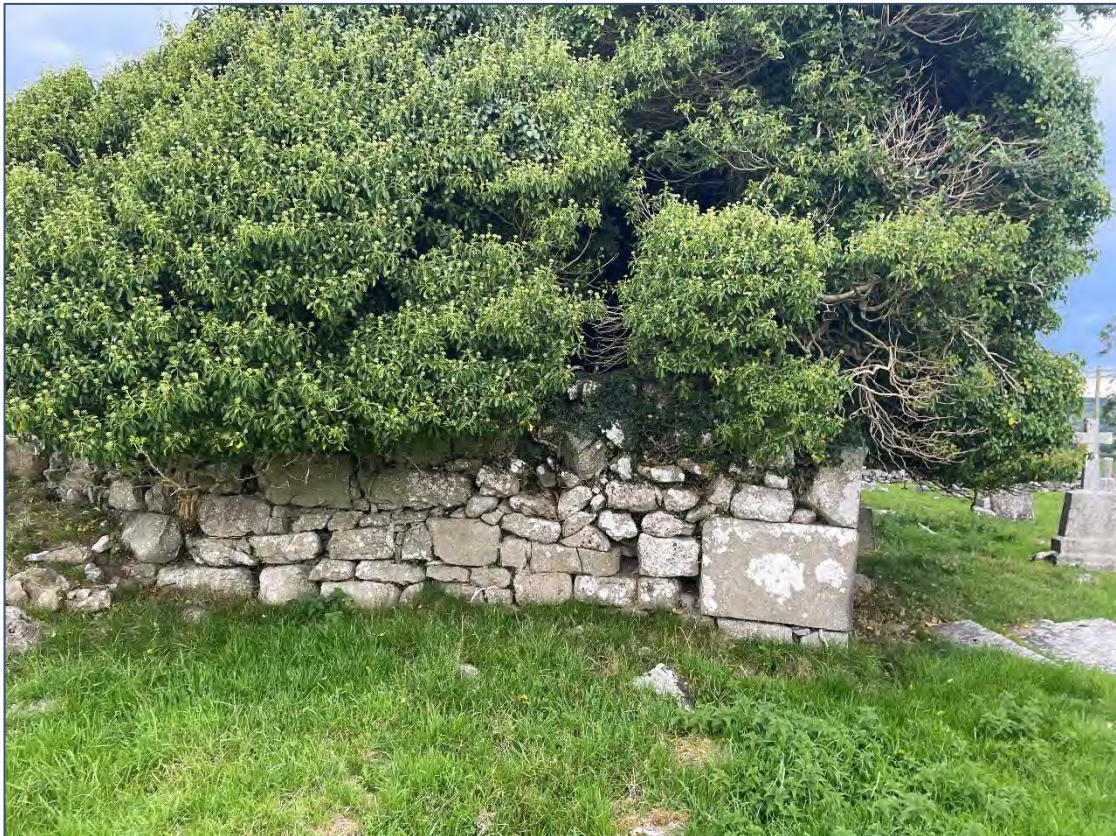
Plate 3.1. Ruined walls at Issertkelly Church with dense ivy.

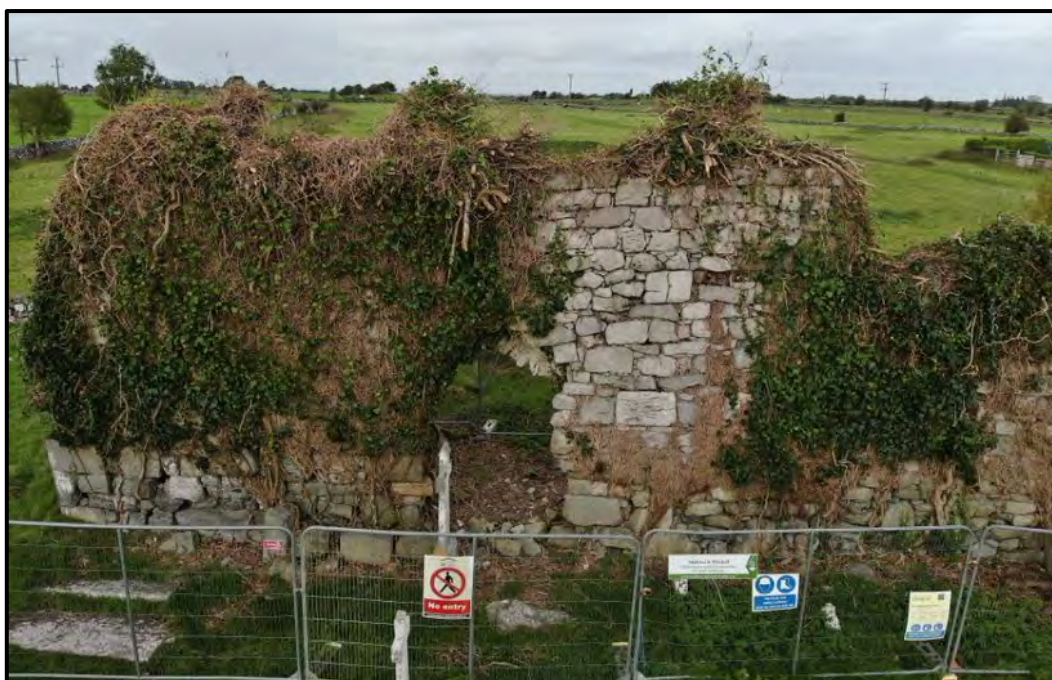
*Plate 3: Aerial photograph showing detail of south wall freshly exposed after the trimming of ivy*

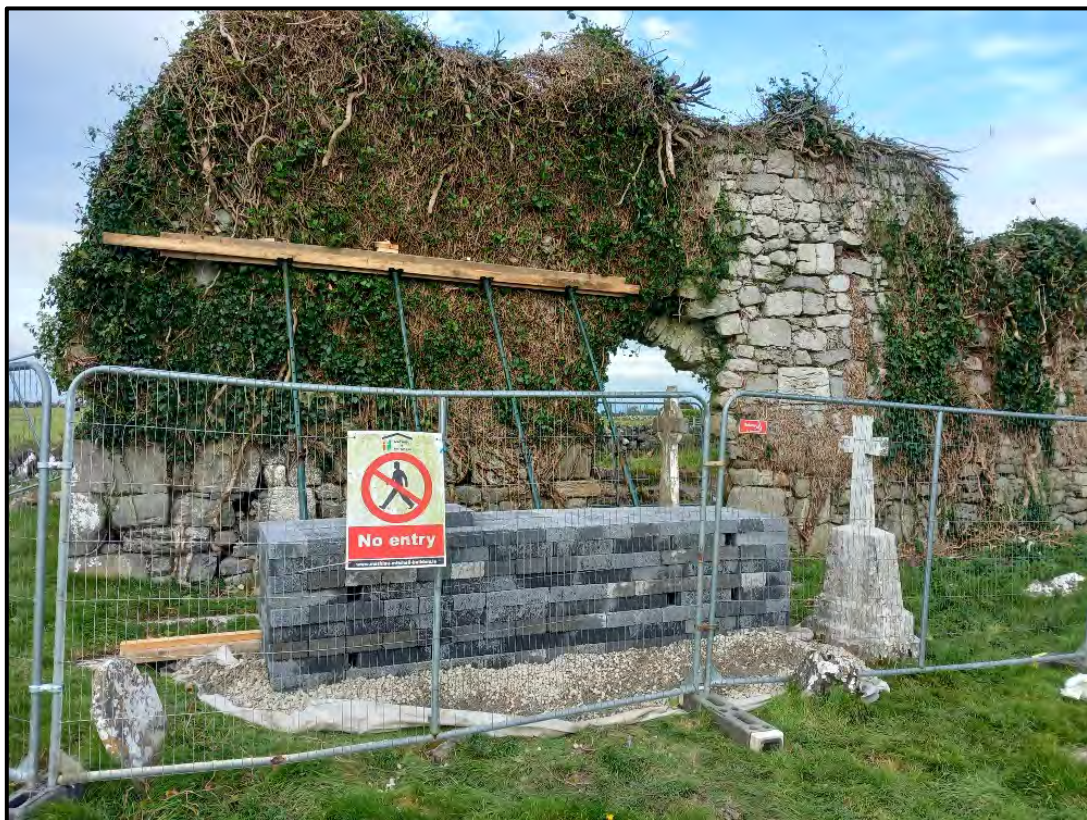
*Plate 19: Looking North showing south wall propped as per specifications from John Britton, Structural Engineer, approved by NMS, Department of Housing, Local Government & Heritage*

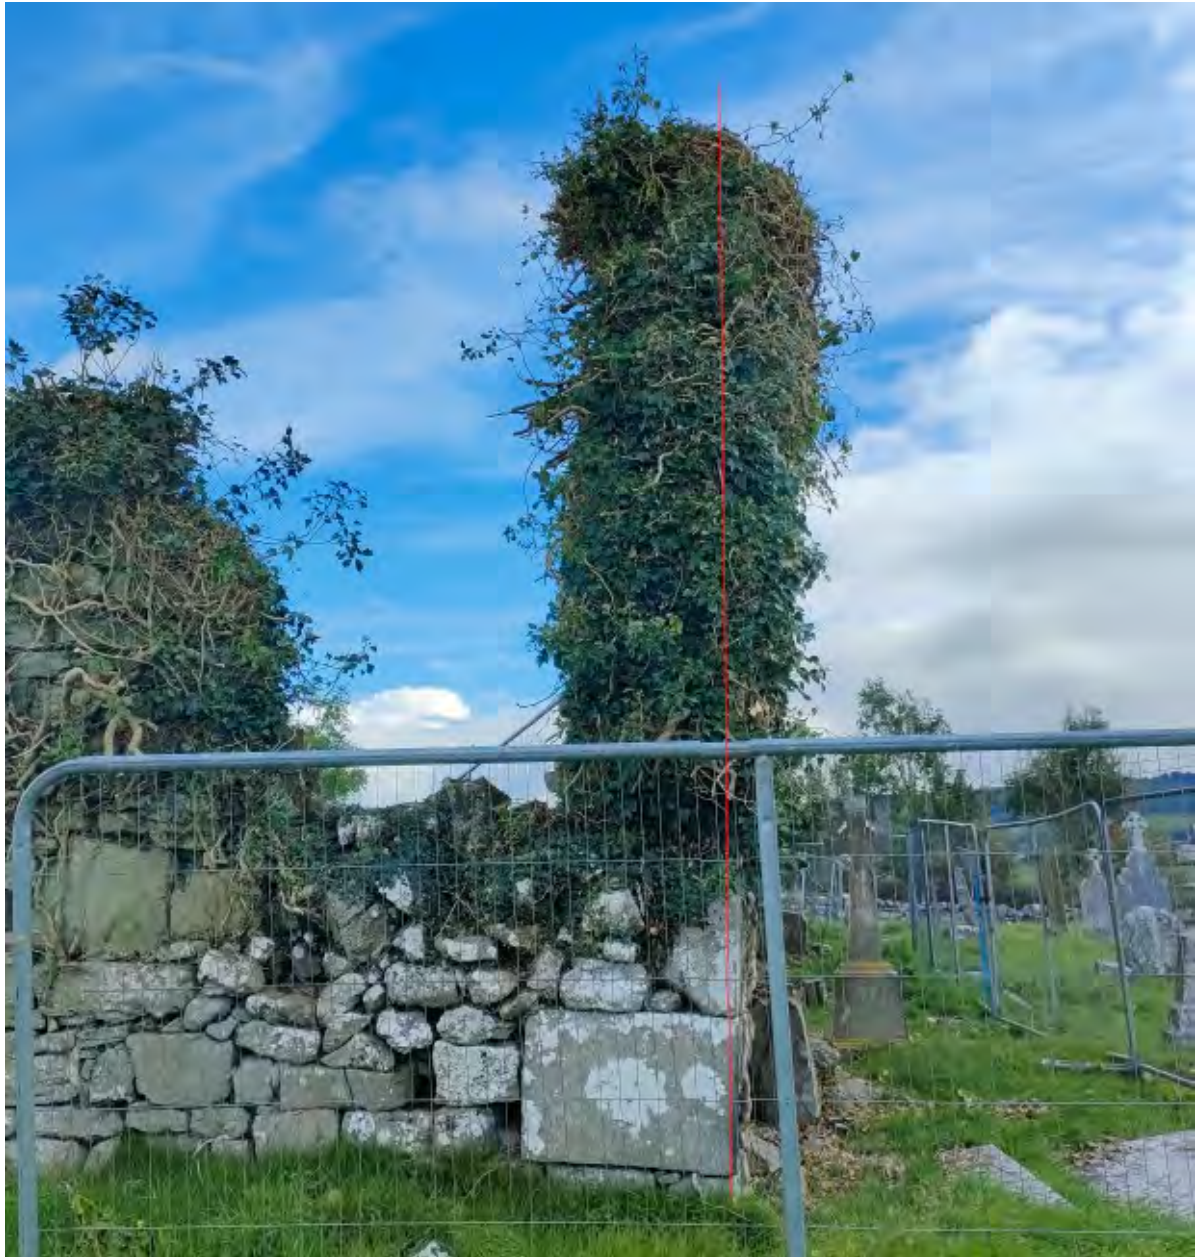
Figure 1 Lean on the wall is evident

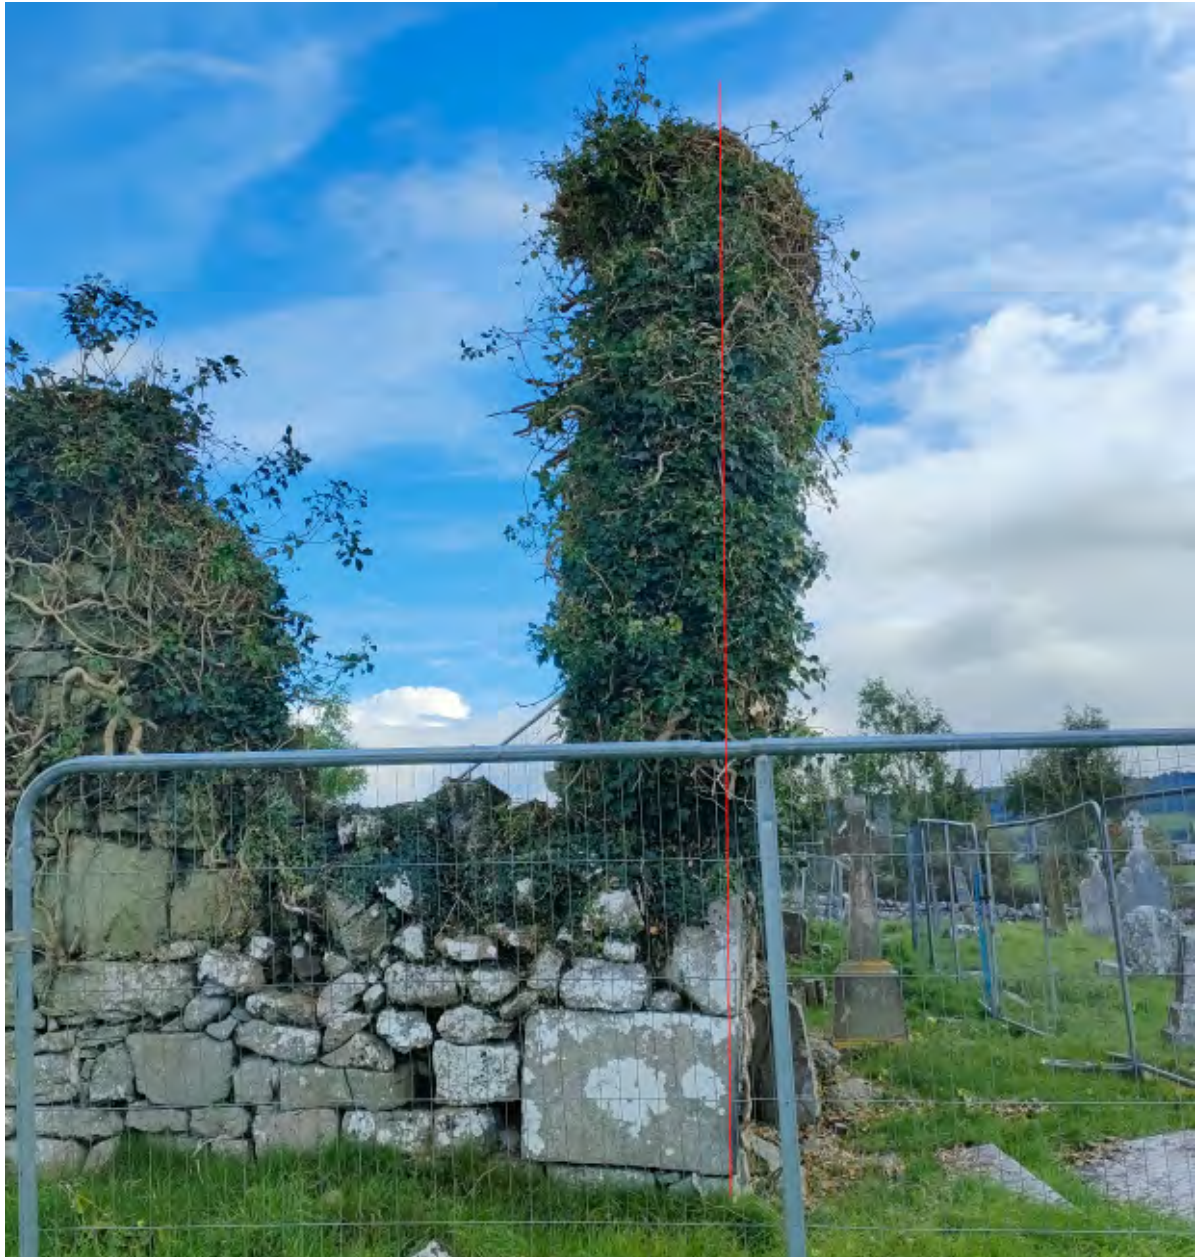
Figure 1 Lean on the wall is evident
