Conservation of Traditional Stone Barn

Annagh, Ballymacward, Ballinasloe, Co Galway.

Locational Information

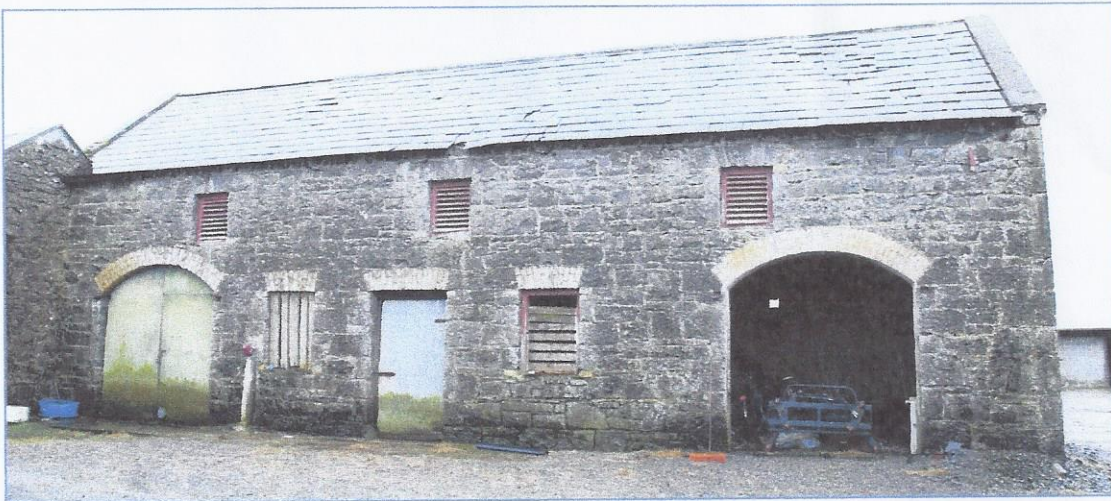
Plate 1 Barn building, prior to the conservation works commencing.

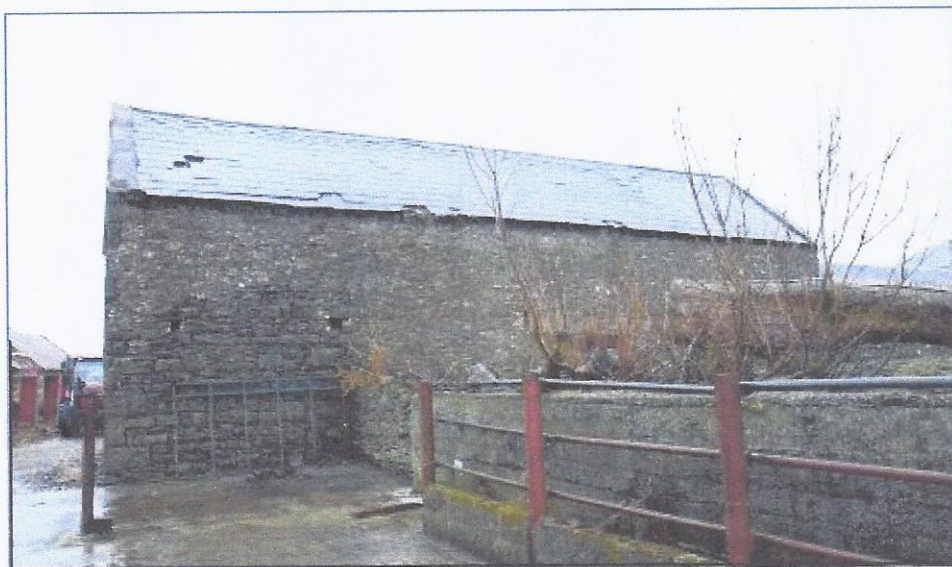
Plate 2 Stable building, from south, prior to works commencing.

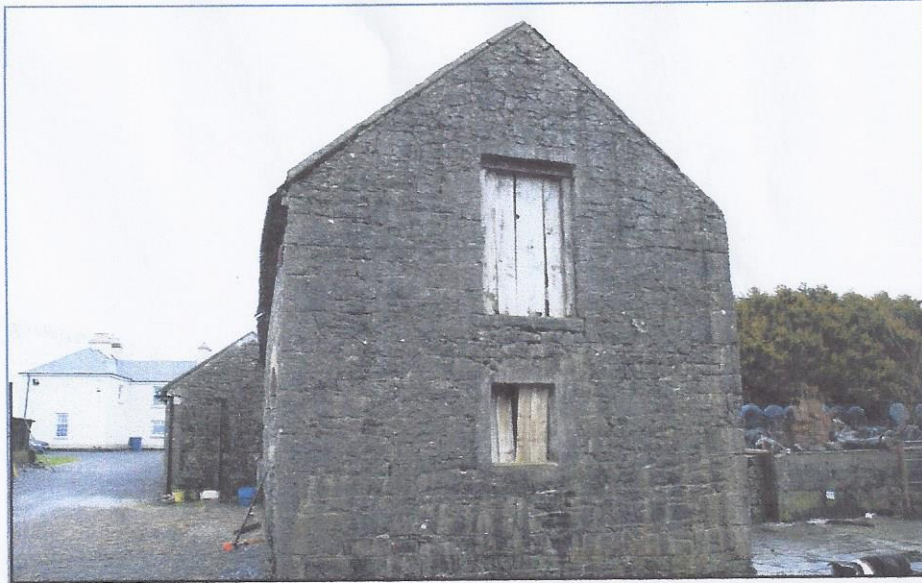
Plate 3 West gable of stable building, prior to works commencing.

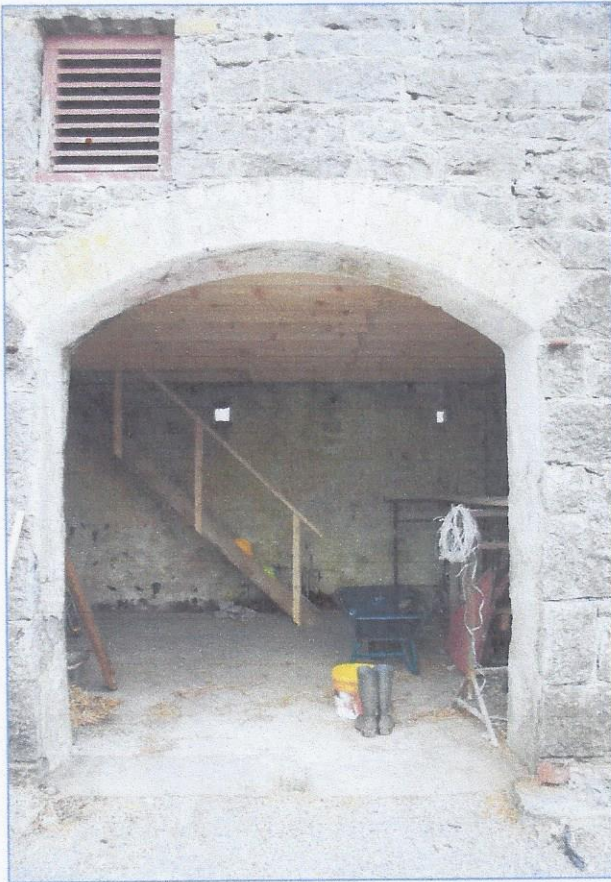
Plate 4 Stairs and ceiling joists, viewed from front of barn.

Prior to the works commencing there was no floor to the loft in the main barn. New ceiling joists were erected and marine grade plywood was fixed to them to form the new loft floor (Plates 6-7). A timber stairs was added to the western end of the building, giving access from the interior of the ground floor (Plates 4-5). In the small barn to the east, the existing 9" x 1" timber floor boards were removed due to their poor condition and the loft was re-floored with like in new treated timber boards. The timber planks to the first floor doorway in the western gable were replaced with a hinged timber plank door, which was fitted with a galvanised pad bolt to ensure it can be locked for safety. A new louvered timber window was fitted to the ope in this western gable on the ground floor.

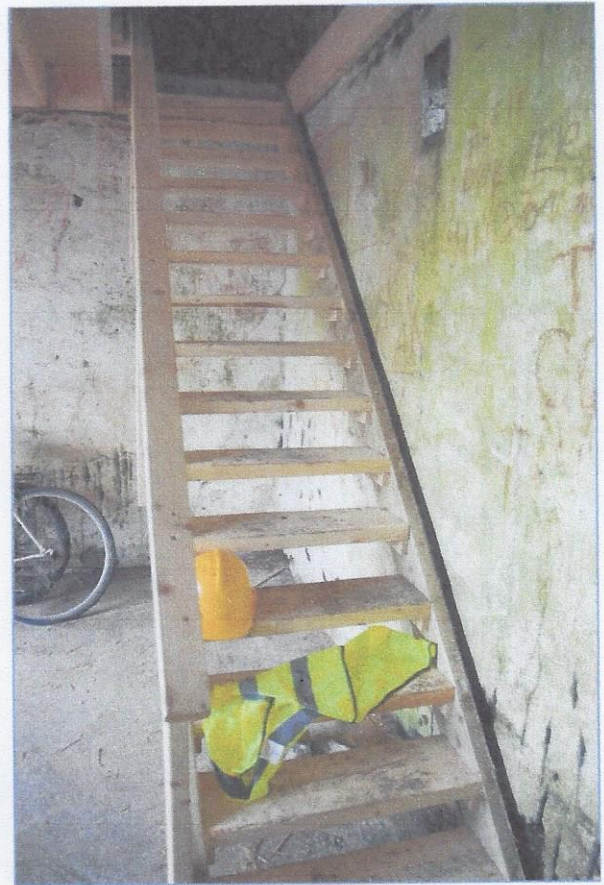
Plate 5 New Stairs to first floor.

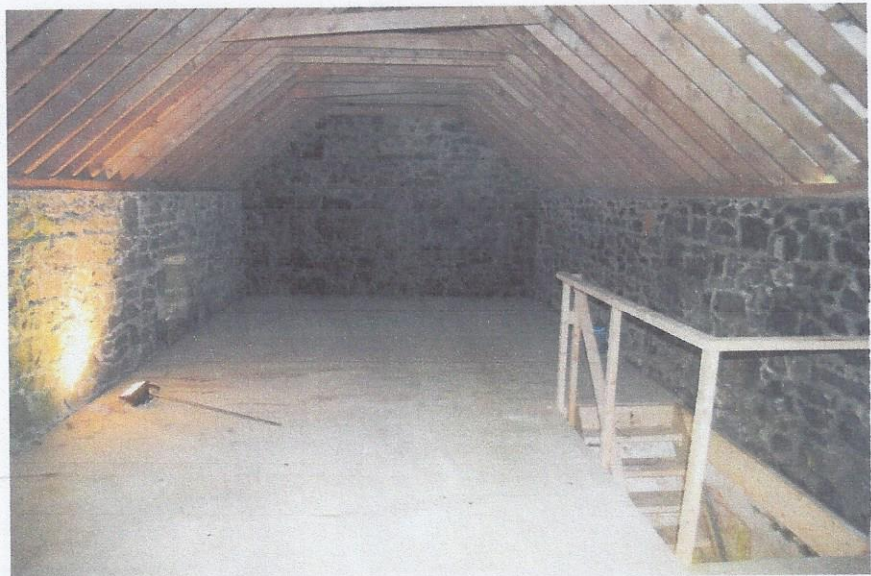
Plate 6 First floor, looking east, prior to re-roofing.

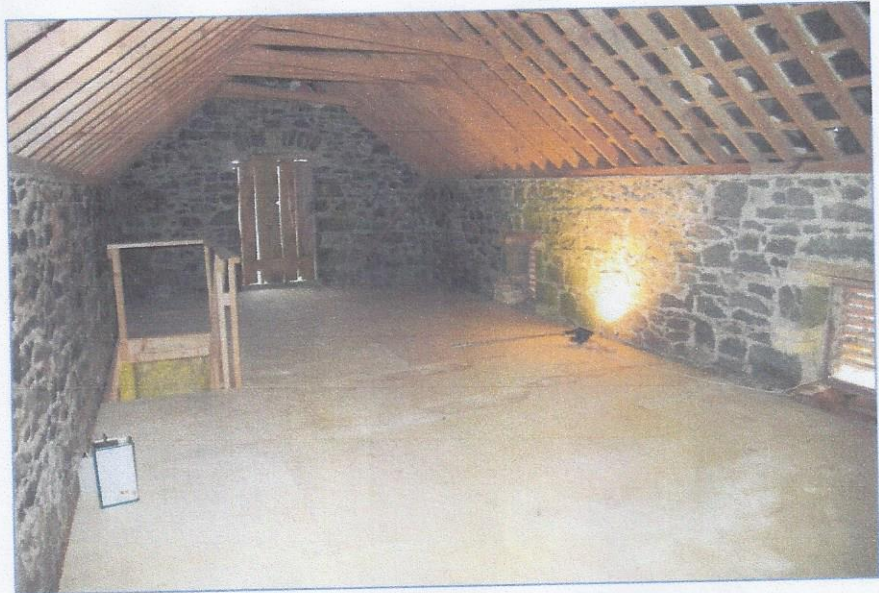
**Plate 7 First floor,
looking west, prior to
re-roofing.**

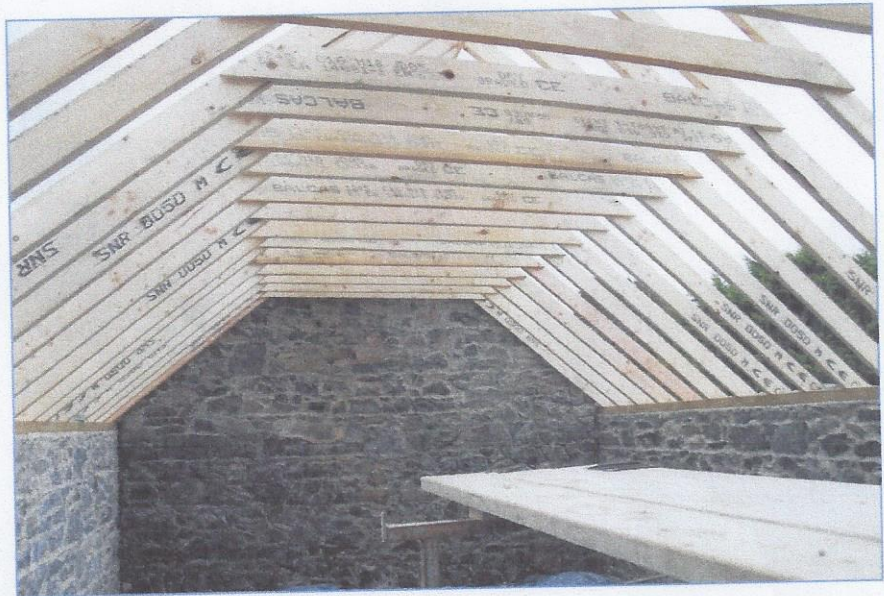
**Plate 8 New rafters
and cross ties.**

Slates were first stripped from the roof of the main barn on both the front and rear pitches and the timbers were examined by the building contractor. They were seen to be in an advanced state of decay. The existing rafters were removed and replaced with rafters, 125 x 44mm, which was treated (Plates 8-12). Battens of 3" x 1" were used, cut down from 6" x 1" pressure-treated timber. The roof was then re-slatted using existing slates and slates from salvage elsewhere. Slates were not removed from the small barn and no roof timbers were replaced there during the works.

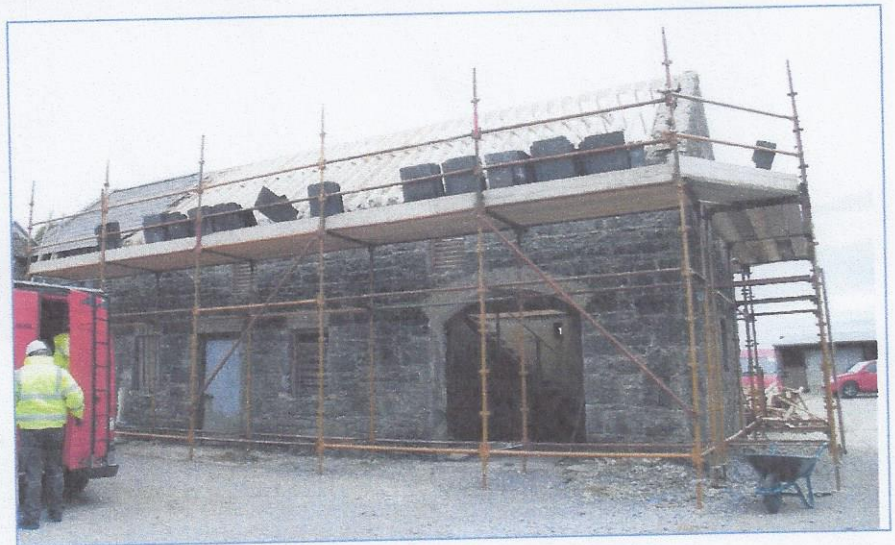
**Plate 9 New rafters to building,
from front.**

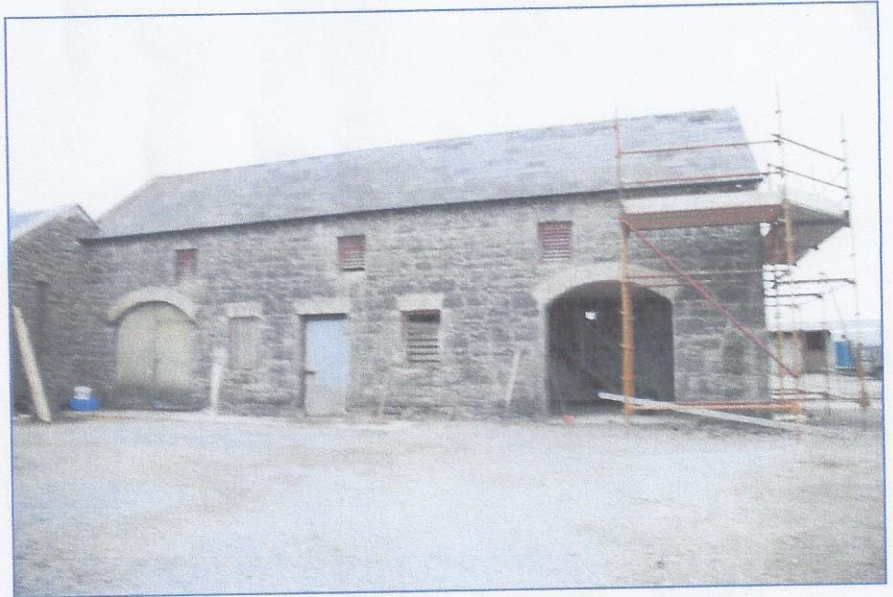
**Plate 10 Re-slating complete,
from front.**

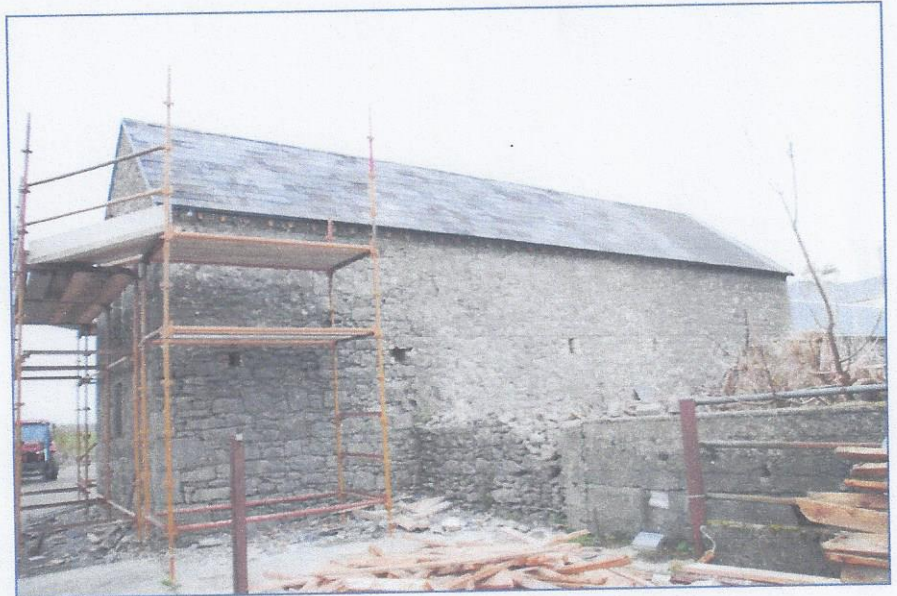
**Plate 11 Re-slating complete,
from rear.**

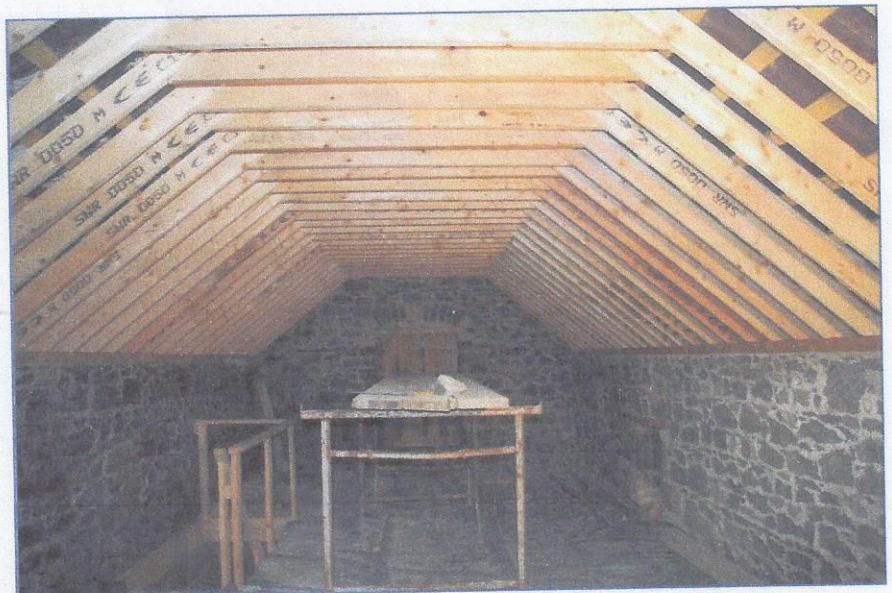
**Plate 12 Interior, main barn,
following completion of
slating.**

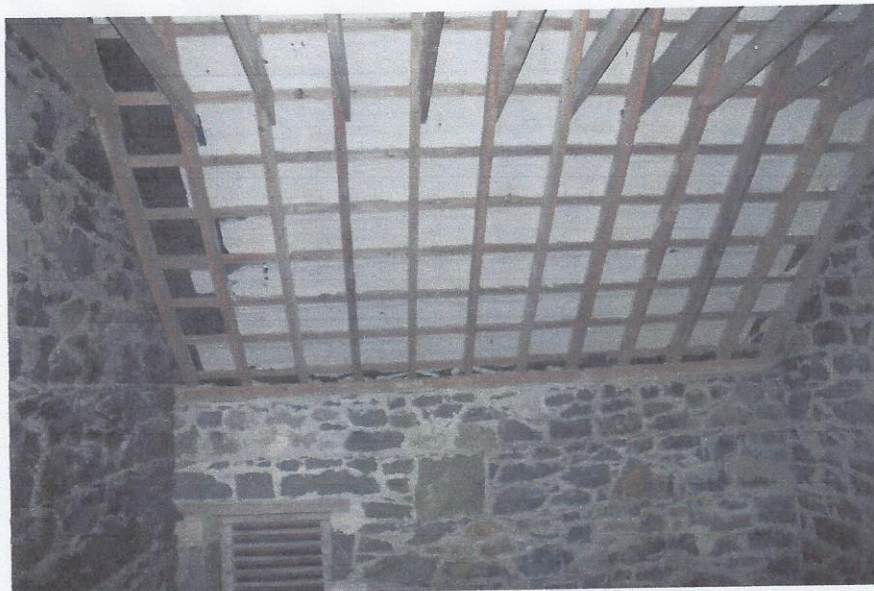
**Plate 13 Interior, small barn,
showing no alteration.**

Lime parging was applied to the underside of all the slates in the main barn (Plates 14-17). A small amount of parging was added to areas where earlier parging had fallen away in the small barn (Plates 13 and 18), mainly on slates abutting the internal dividing wall between the barns, on the western side of the small barn. A lime mix of 1:2½ was used, comprising NHL 2 lime and sharp sand, with a 3mm grit. The lime mix also included some animal hair (tail clippings) and commercially-sourced synthetic fibre. The parging mortar was well mixed and applied in ideal conditions (10°C-12°C, in soft misty weather). As a result the lime went off without needing any additional protective coverings.

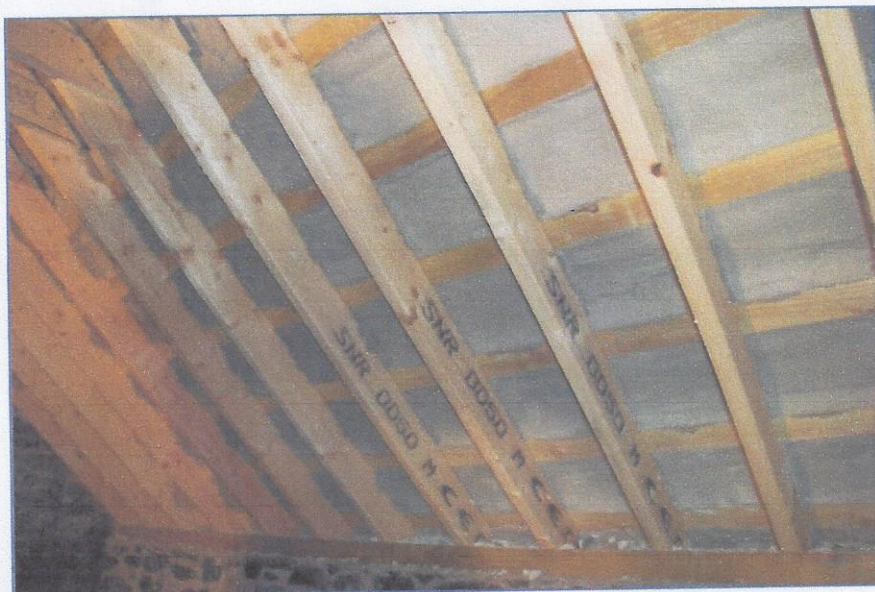
**Plate 14 Freshly applied
parging, main barn.**

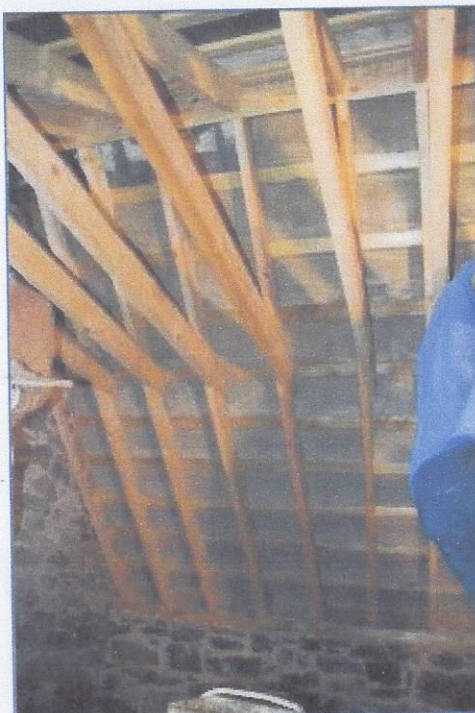
Plate 15 Parging, during application.

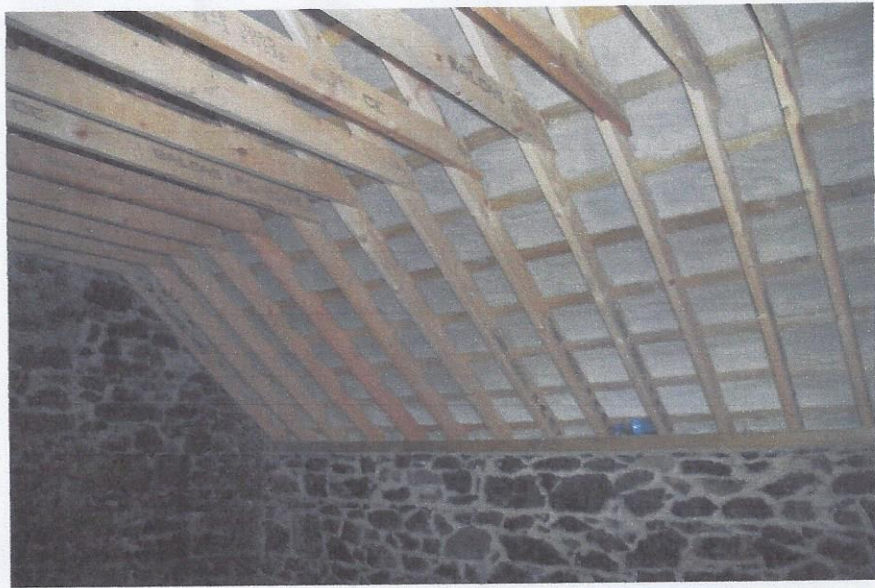
Plate 16 Parging, rear pitch, main barn, following completion.

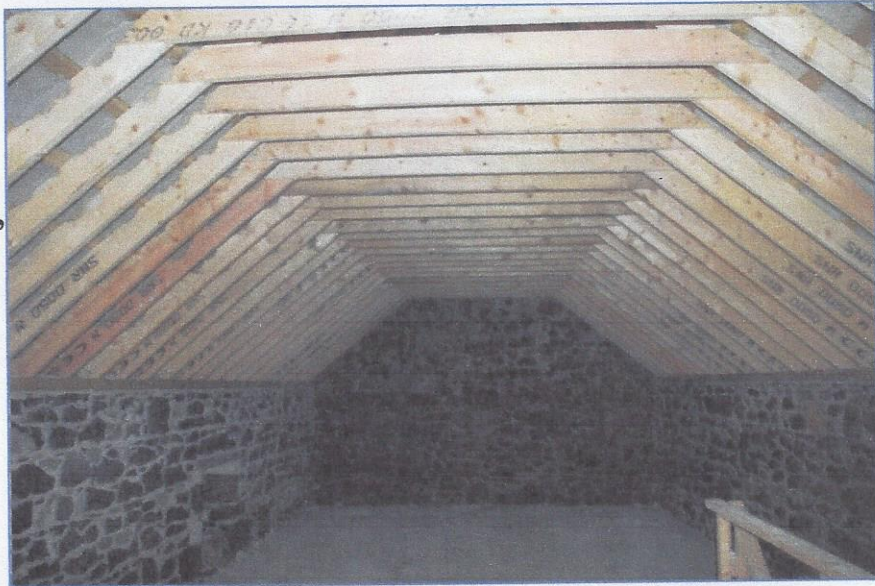
Plate 17 Interior of main barn, looking east, following completion.

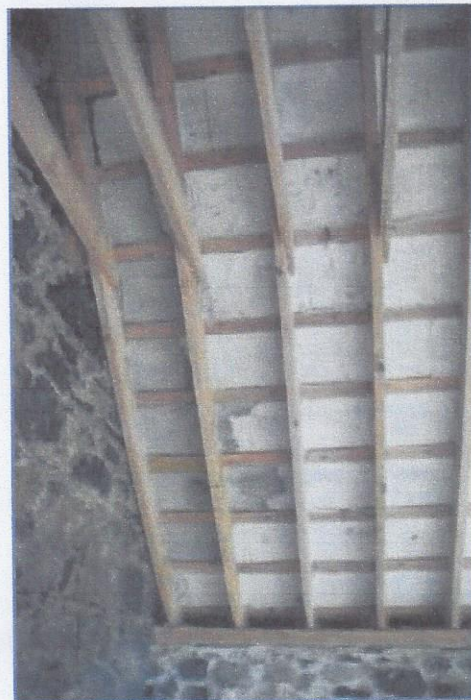
Plate 18 Interior of small barn, showing patching to parging, following completion.

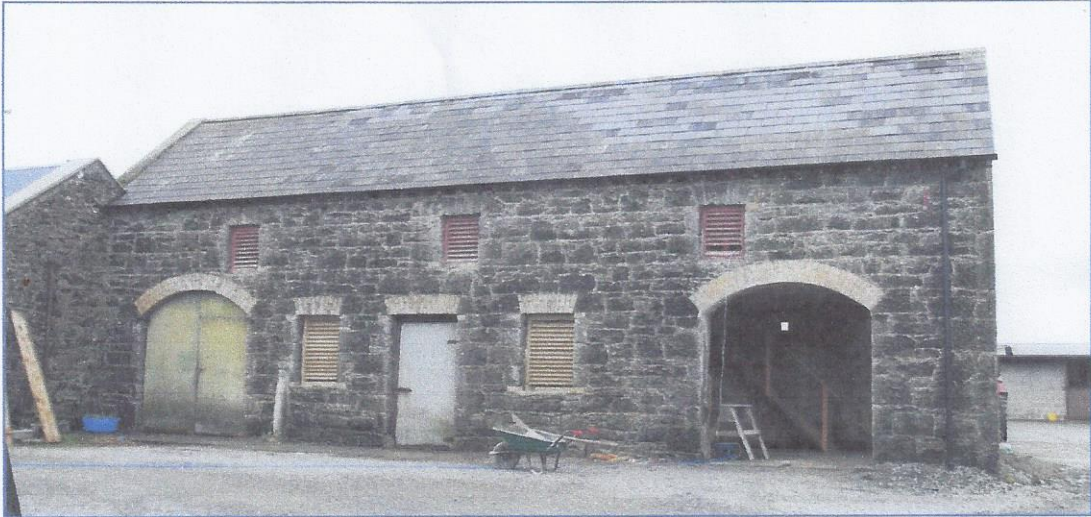
Plate 19 Front elevation of barn, following completion.

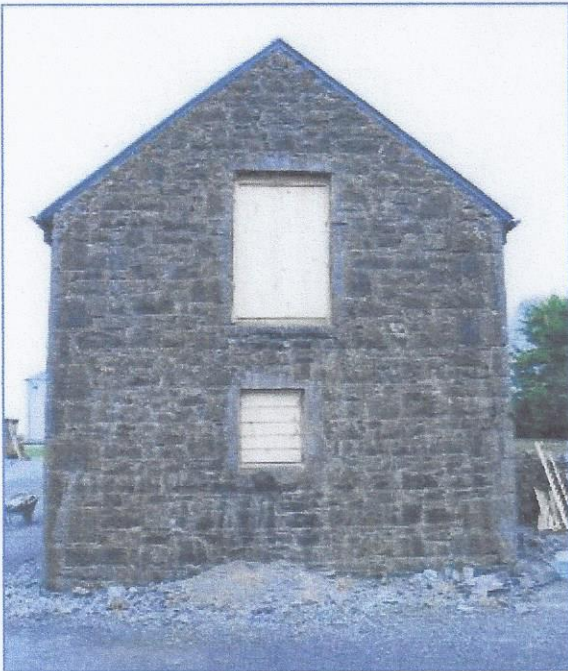
Plate 20 West gable, following completion.

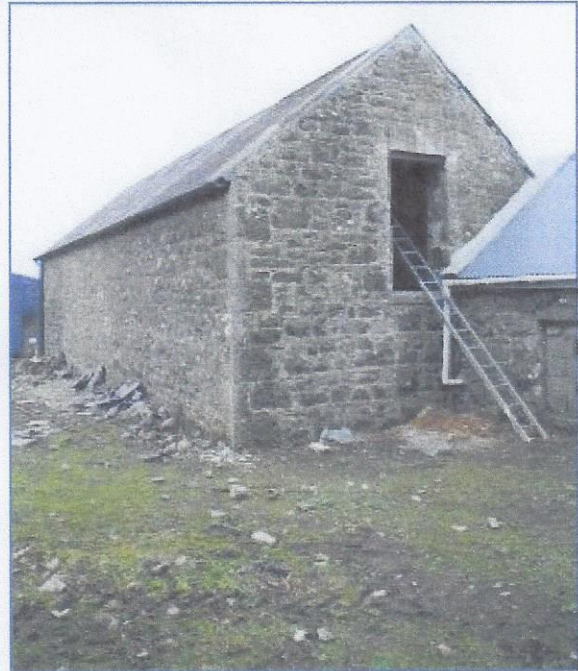
Plate 21 East gable, following completion.

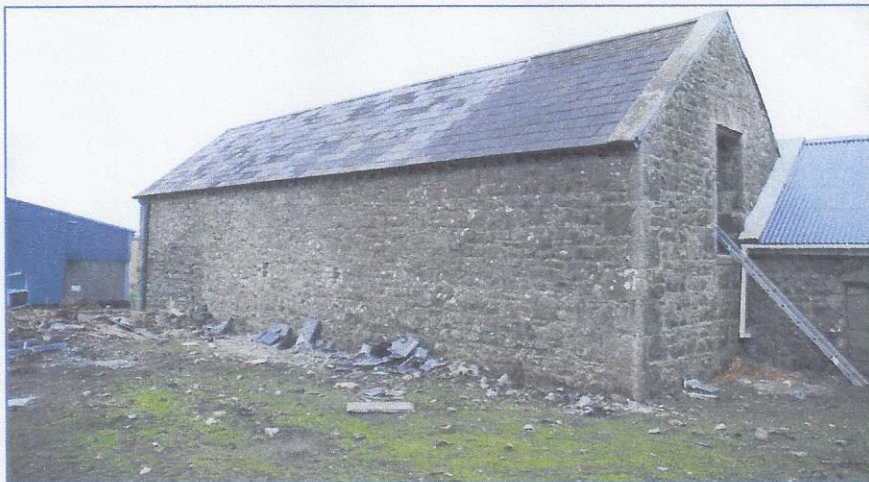
Plate 22 Rear of building, following completion of works.
