ÆGIS Ref.: 825-1

Conservation Management Plan for Moylough Castle, Moylough townland, Co. Galway.

Report Status: Final

Date: 15 November 2024

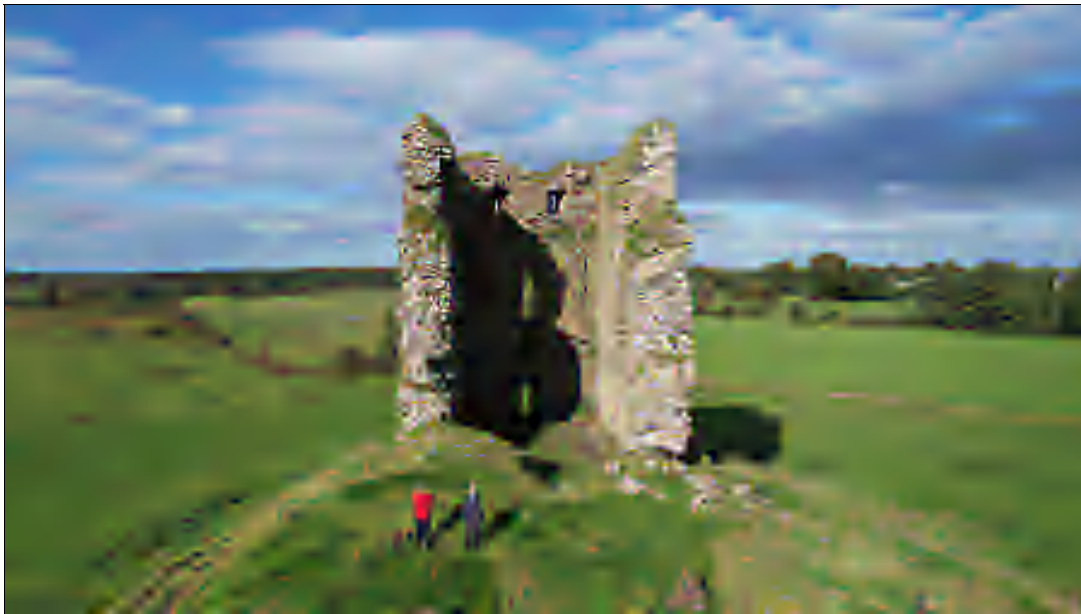
The west wall has collapsed, with only the lower courses standing to a height of approximately 1.5m at the NW and SW corners. The castle has a base batter, which has been robbed out along the length of the N and W walls, and part of the S wall. However the original base batter remains partly along the length of the wall on this side.

Figure 2.28. Collapsed SW wall, from SW (F. Coyne).

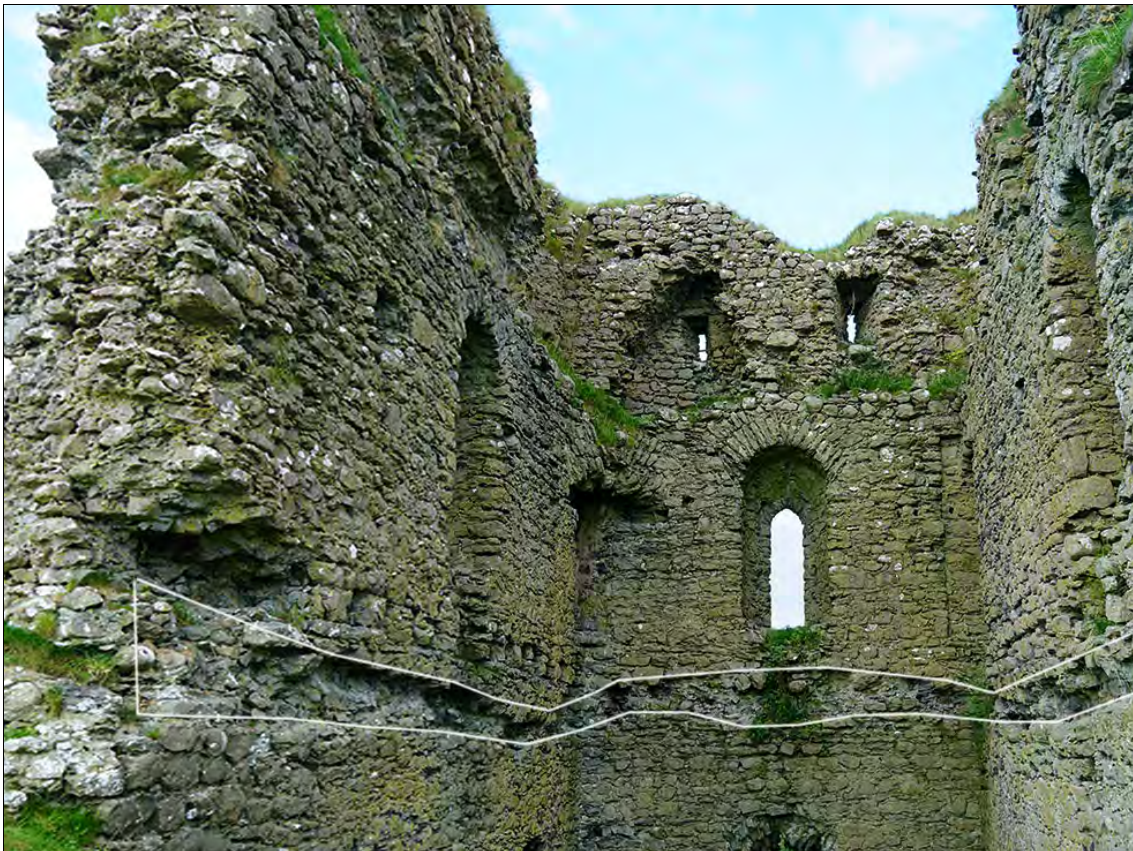
On first glance, the castle appears to have only a single phase of use. However, a scar which stretches around the three remaining walls may suggest a collapsed vault, which replaced the earlier timber floor. It is possible that the timbers which spanned the castle rotted where they were inserted into the wall. Later building utilized a series of corbel, on which rested oak beams.

Figure 2.34. Scar for possible vault indicated, from SW (F. Coyne).

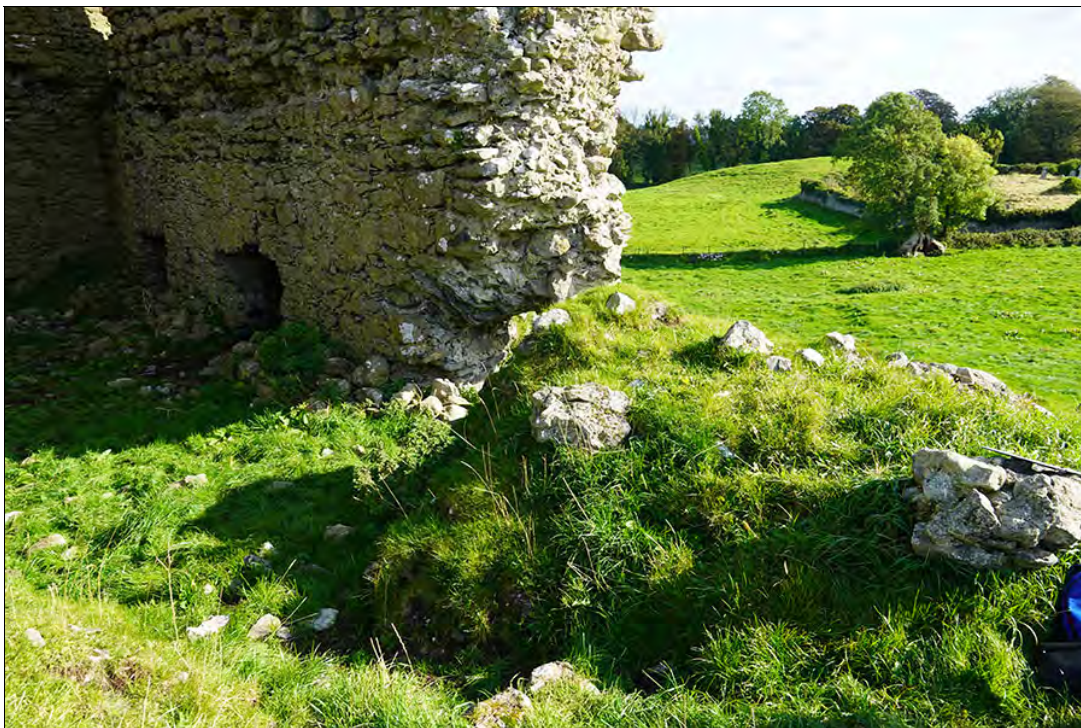
The building has structural issues, which need to be addressed immediately. Masonry is falling from the walls, particularly in the E corner, and also in the Scornor. A large chunk of masonry has fallen in here in the last five years (see architect and engineers reports).

Figure 2.72. fallen masonry, from W (F. Coyne).

This is considered to be the most critical conservation work on the site, and essential to the long term survival of the castle remains. The S corner of the SE wall is in urgent need of propping to prevent further collapse of masonry. Similarly E corner of the SE gable at the upper floors is in need of repair. A structural crack is evident, and masonry has fallen from this area.

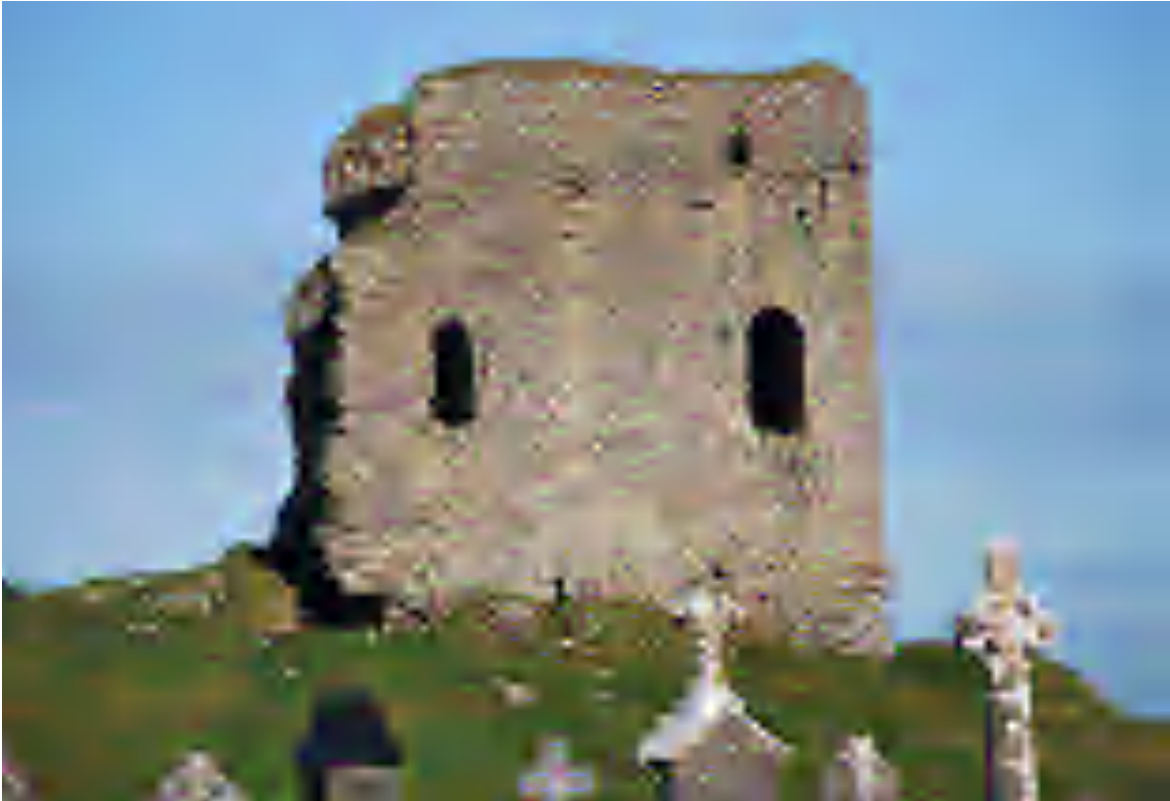
Photo no. 1 (0134)

Looking at photo no. 1 (0134), it is noted that the ground level outside the Castle is lower on the rear or North-East side and sloping up to the higher ground level at the collapsed South-West side. Presumably, this is due to the substantial amount of fallen stone outside the South-West wall. There is reference in John Deaton's Report to stolen or robbed stones. Really this is only speculation in relation to below ground levels, outside and inside the Castle until site investigation and /or slit trenches are carried out by Archaeologist's investigation.

In relation to the likelihood of future partial collapse of parts of the wall, I refer to photo no. 1 (0134) above and no. 2 (2020) taken in 2020 below, which were presented as evidence that there was a partial collapse of the hatched area in 2020. This reaffirms the view that collapse or falling of loose or partly supported masonry can fall at any time and consequently the advice re; fencing of the site and placing notices warning the public of the hazards should be erected.

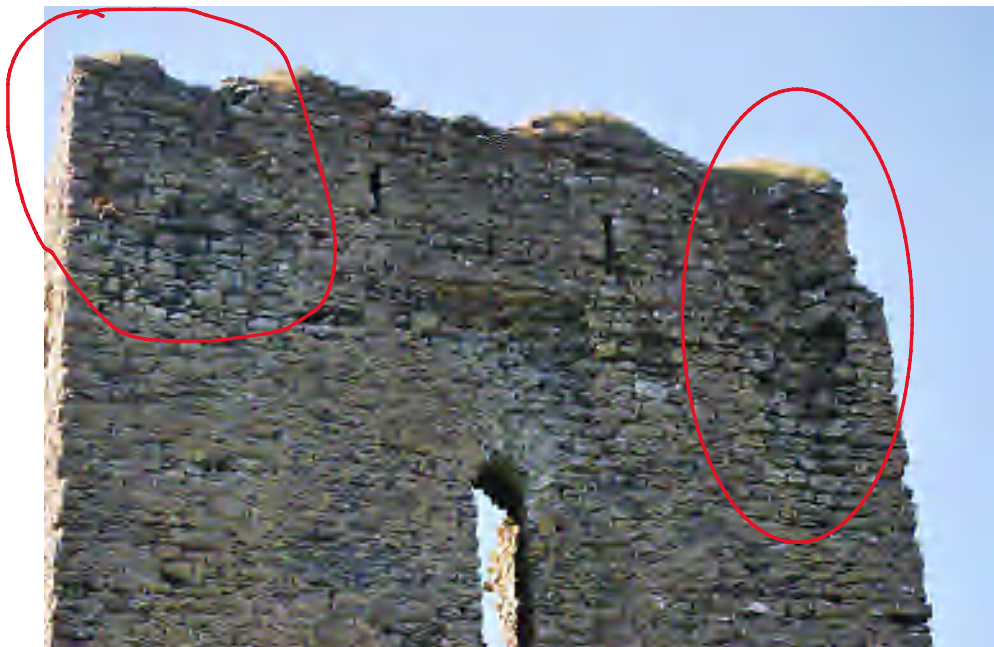
Photo No. 20 (0202)

8. Referring to the outside face of the rear or North-East wall, it is seen that rain water flowing off the soft top grass capping at two points has contributed to or caused the damaging of the stone masonry below these locations and this has caused these patches of external stone face to fall out – see photo no.'s 20 (0202), 21 (0200), 22 (0197) and 23 (0195).

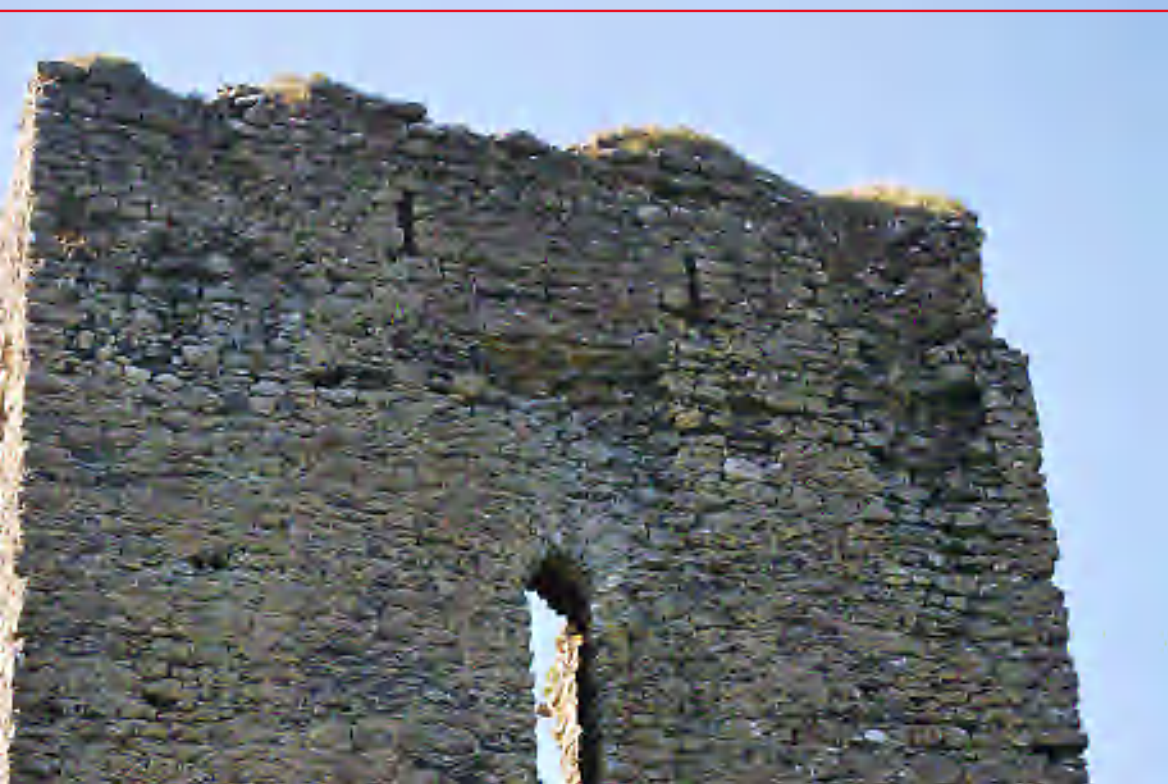
Photo No. 24 (0202)

9. There is no formal or level capping to the top of the walls – see photo no.'s 24 (0202) and 25 (1042).

Wall tops, ledges, loose masonry – The wall tops are exposed to the elements and will continue to deteriorate over time. It is recommended that the wall tops be consolidated by rough racking in lime mortar. It is acknowledged that the cost of this would be prohibitive funding it may not be feasible. Any loose stones such as those around opes should be stabilised with lime mortar and pinnings, if accessible. Minor shrub and vegetative growth should be carefully treated and removed.

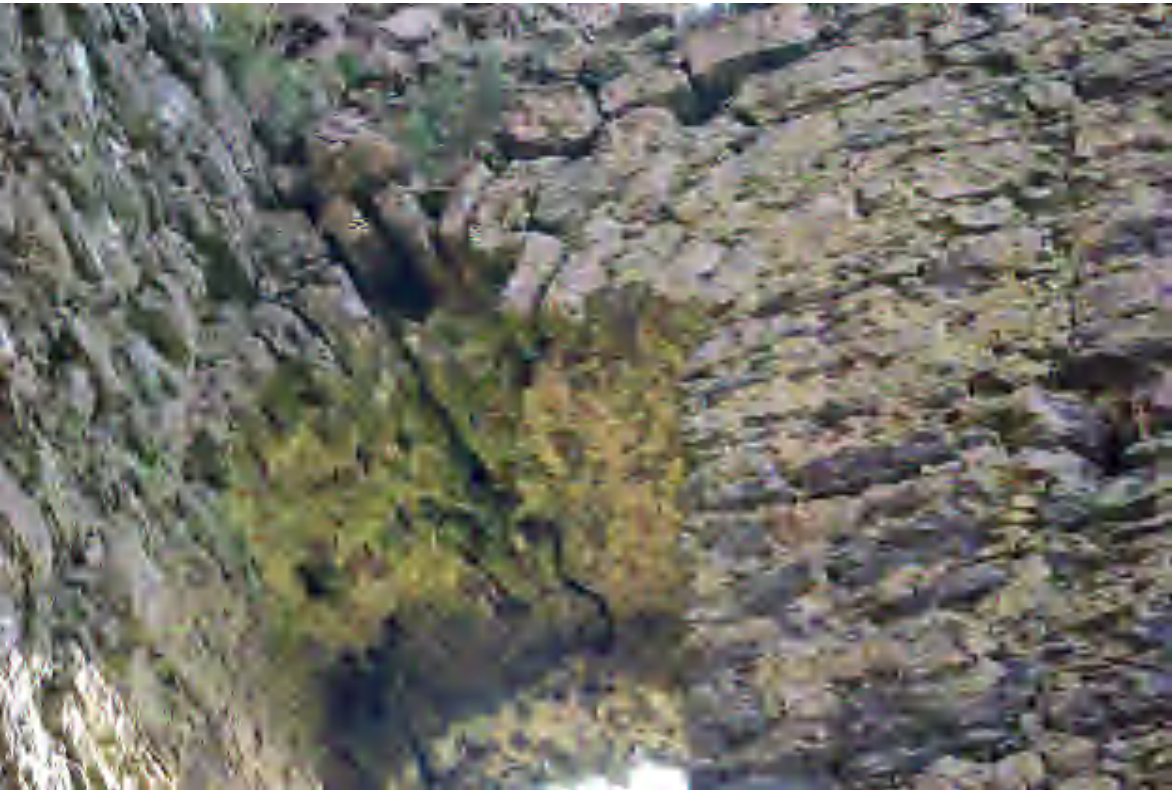
Photo No. 27 (0154)

The crack over the main door at first floor level extends into the head of the door and is the full depth of the wall – see photo no. 27 (0154)

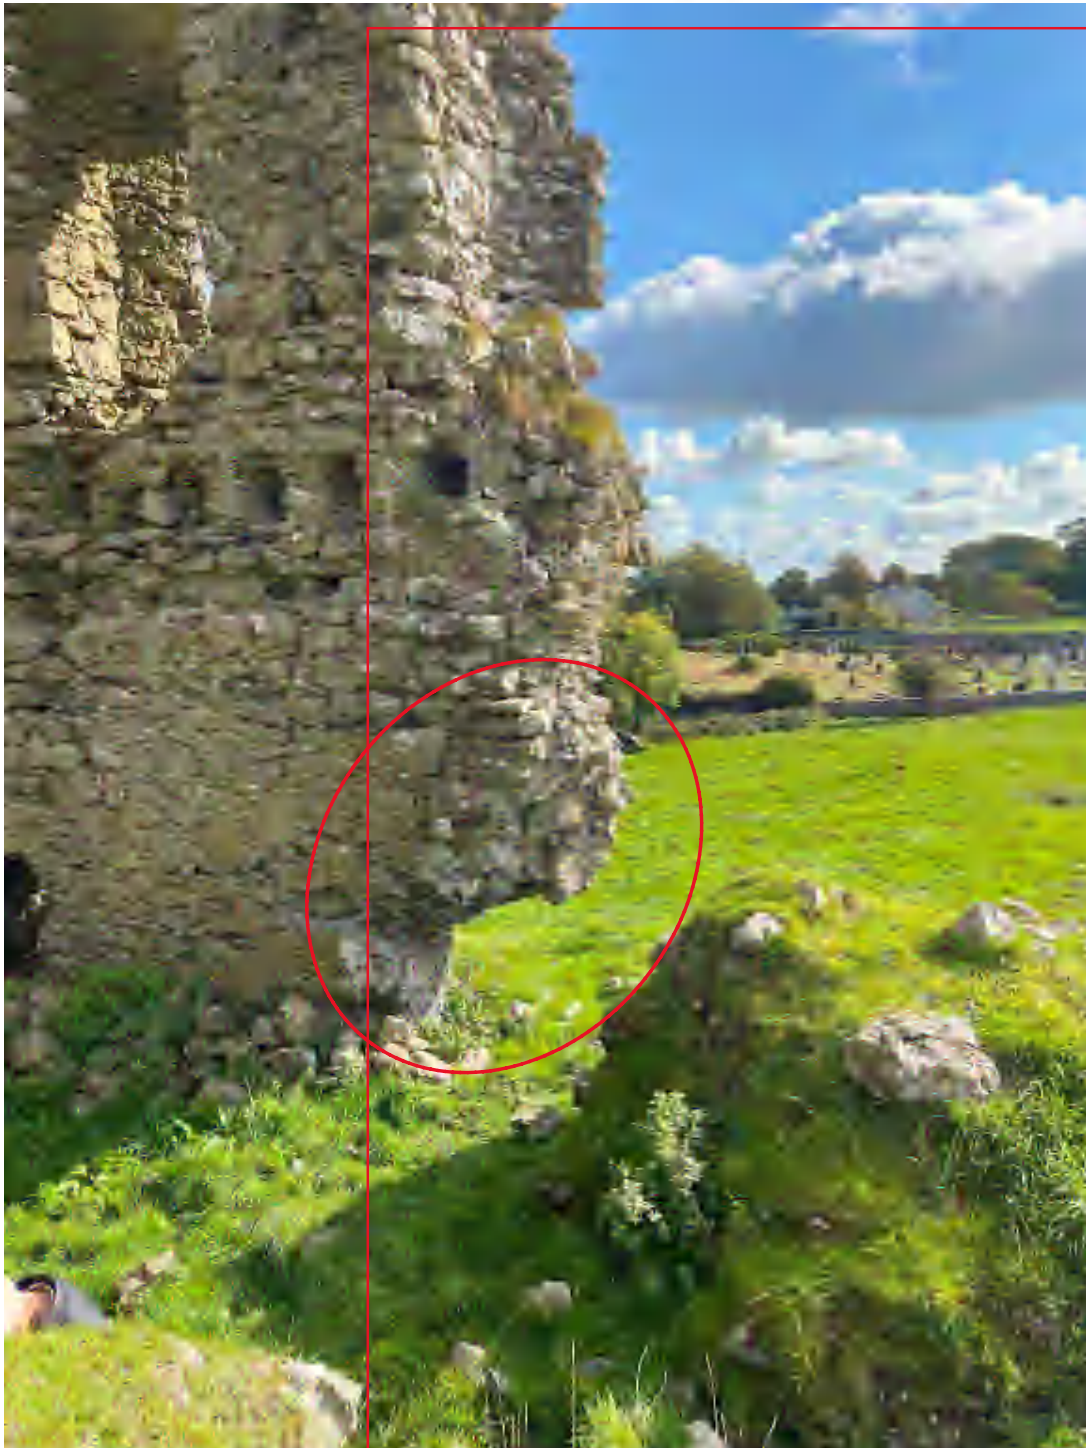
Photo No. 45 (1040)

5. One of the major areas of concern structurally is at the front face of a corner of the right-hand wall at the South-East corner at ground floor level where the collapsed front wall pulled part of the side wall with it. It appears as though there was an arched opening at ground floor level and a window almost directly over it at first floor level. These would form a weak point or line in the side wall and it is along this line that the masonry attached to the front wall that fell separately from the side wall – see photo no. 45 (1040).

Masonry collapse at south end of the south-eastern wall. It is anticipated that the wall should be built up underneath the cantilevered section. I assume that it would be built off the existing base wall without the need for the digging of foundations. The question therefore is "How can the works be designed to accord with best conservation practice?"

I recommend Option 2 therefore.

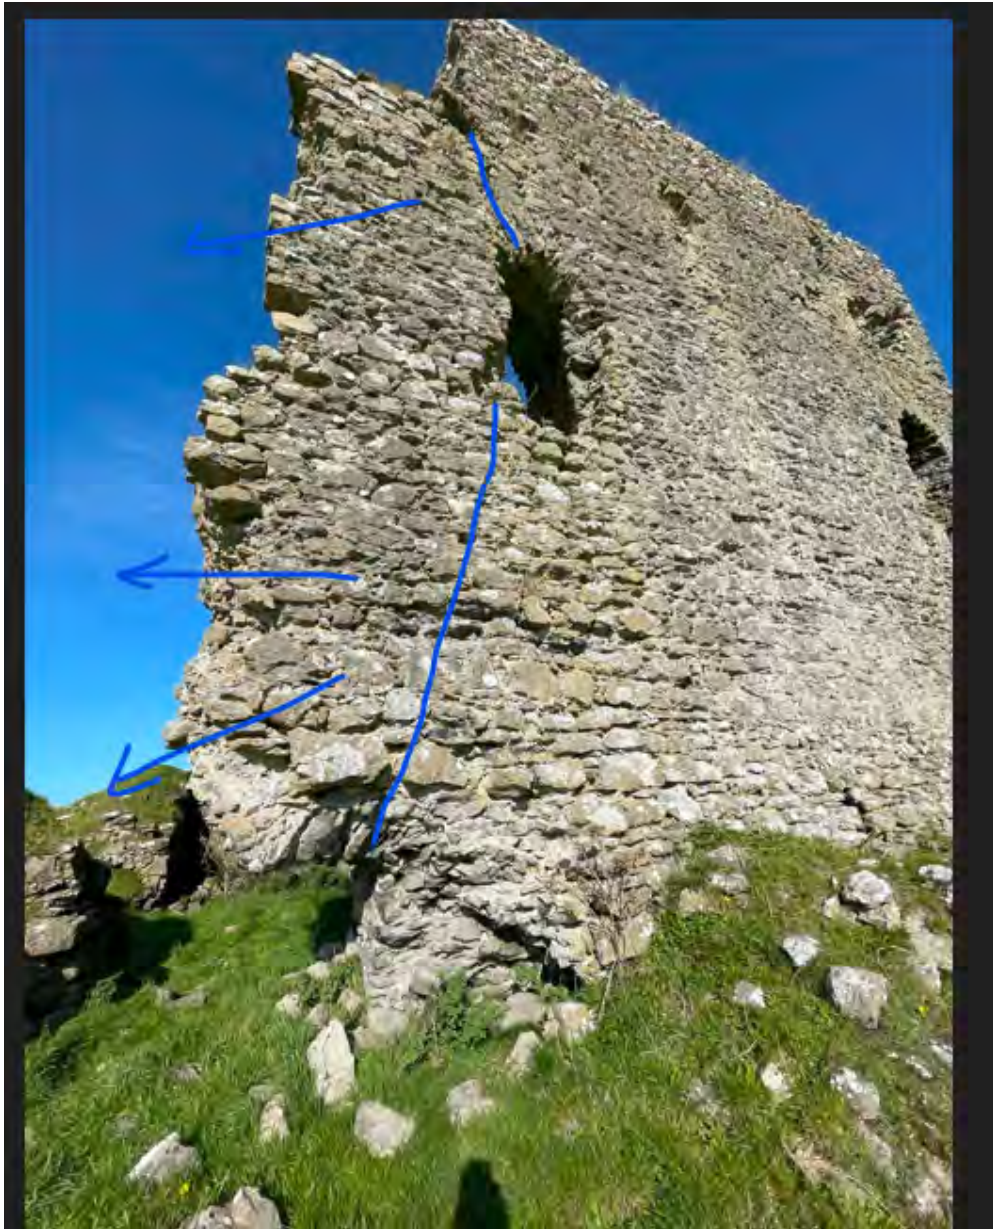
Photo of 'Likely Failure Mode – South-East Elevation'

Because of the shape and configuration of the masonry over the partial remaining arch, a crack will develop from the top of the arch, through the putlog holes to the cill of the window overhead. This combined with the existing crack over the arch of the window will result in the eventual collapse of a large section of this wall – see marked up photo ‘Likely Failure Mode – South-East Elevation’
