Undated – Mesolithic/Neolithic/Bronze Age/Iron Age

The Devinish Boat

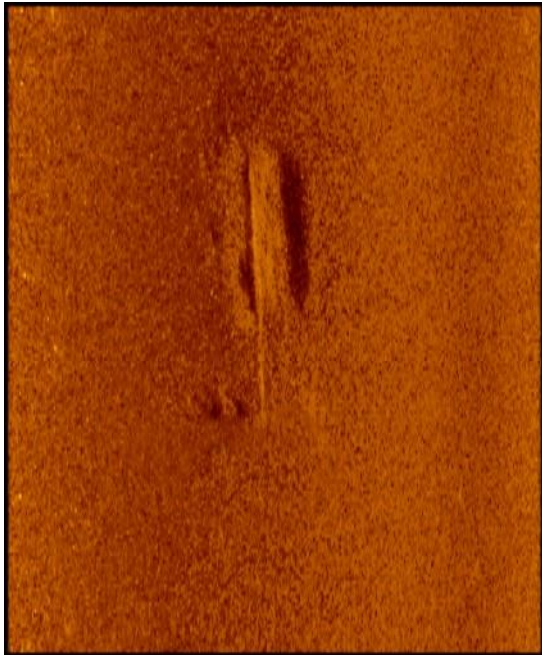
The side scan sonar image was created in 2013, the sub-surface currents in this part of the lake are substantial, and the bottom is very mobile. When I last looked at this it was almost completely covered again.

Figure 1 Side scan sonar of the Devinish Boat (T Northage)

In June 2013 while we were surveying at the southern end of the main lake we detected an anomaly in just over 5m of water. We had already found several trees in the area, but it was difficult to pin this anomaly down.

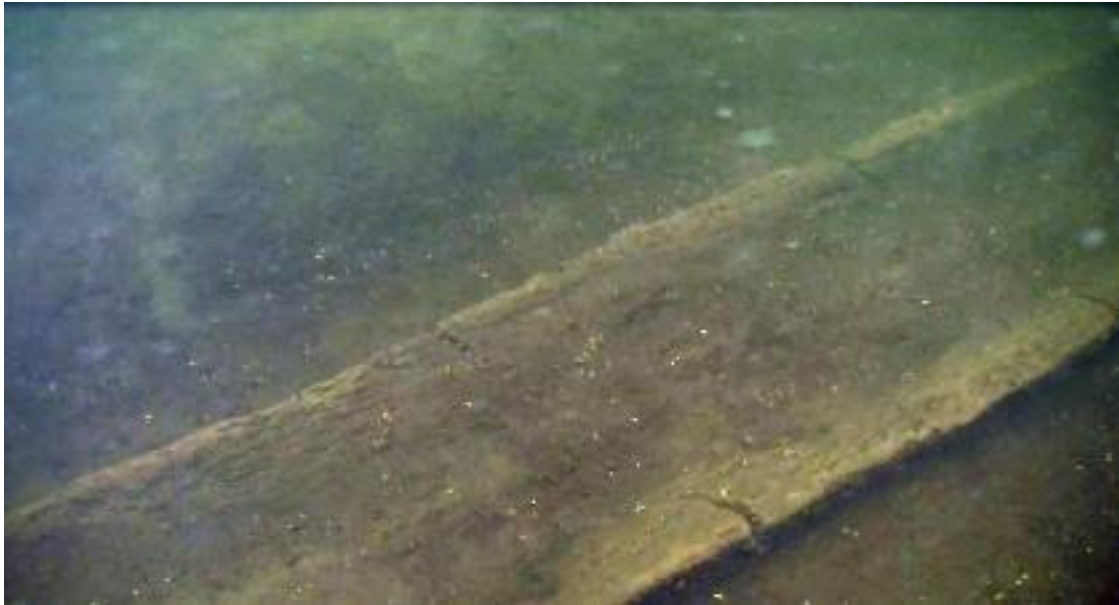
We looked at the movies and stills from all angles, and there was no denying it, this boat had been attacked with a large saw.

Figure 2 *Devinish Boat* with saw cuts. Photo T Northage

The vessel at first appeared to be eroded by time and nature until only the bottom of the hull remained, but the saw cuts seem to indicate the boat's sides were deliberately removed, making the age of the boat more difficult to determine by eye, she may not be quite as old as she looks. The boat is approximately 26ft long and is partially buried in silt. There is a very clearly defined area of *scouring* around the boat. This has been caused by the variable deep currents that flow in this part of the lake. These currents are caused by water returning after it has been blown downwind. A strong westerly wind will pile water onto the eastern side of the lake, the water returns to the west side as a subsurface current.

Saws have been around for thousands of years in one form or another, but Bronze Age saws were small and apparently were only had filed teeth, not *set teeth* (the teeth set out from the line of the saw), so it appears unlikely these

wide cuts were made in the Bronze age. During the Iron Age however, from 800 BCE onwards some really useful saws were developed, which would have been capable of making these cuts. These saws had *raked and set* teeth, and they cut on the pull stroke. Today's saws cut on the push stroke, something only possible with the hard tough steels of the modern day. It may be possible to look at this vessel's cuts and determine how they were made. A radiocarbon 14 date from the vessel's wood would give us a reasonable date for the boat. This would be a good start to helping us date one of Lough Corrib's prehistoric shorelines and develop a picture of the landscape of our ancestors.

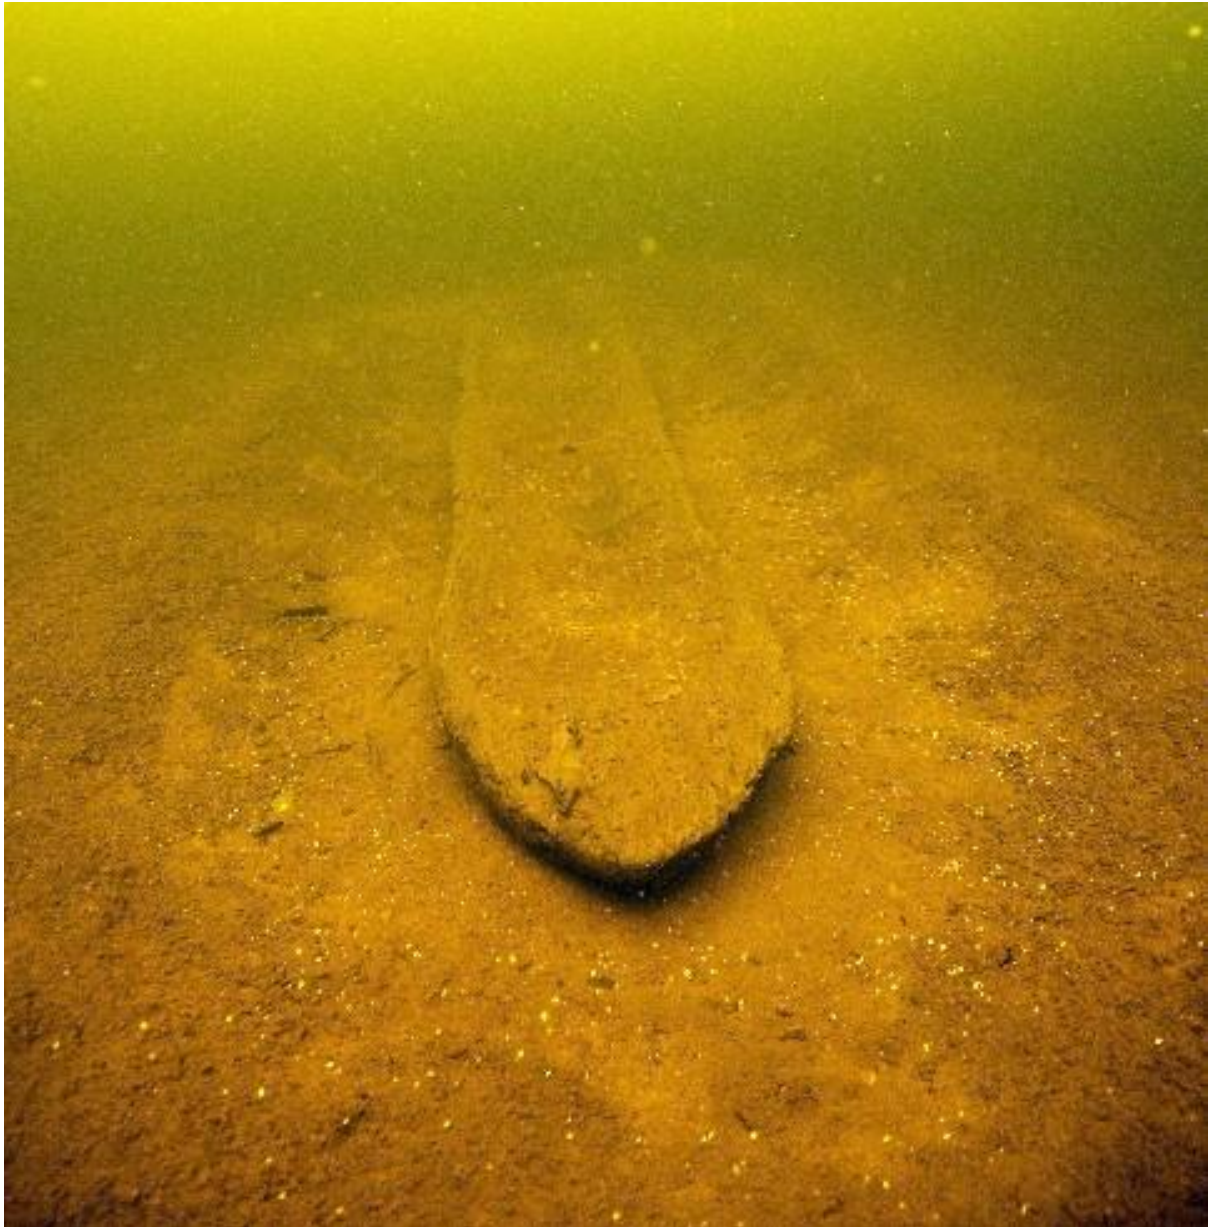
Figure 3 *Devinish Boat* showing prominent scouring around exposed parts of the wreck. Photo T Northage
