# A Settlement of the Uí hUiginn Poets and its Landscape Setting

Kilcloony, County Galway

A report by Elizabeth FitzPatrick, School of Geography, Archaeology and Irish Studies, NUI Galway, for the Milltown Heritage Group, with plans by Noel McCarthy.

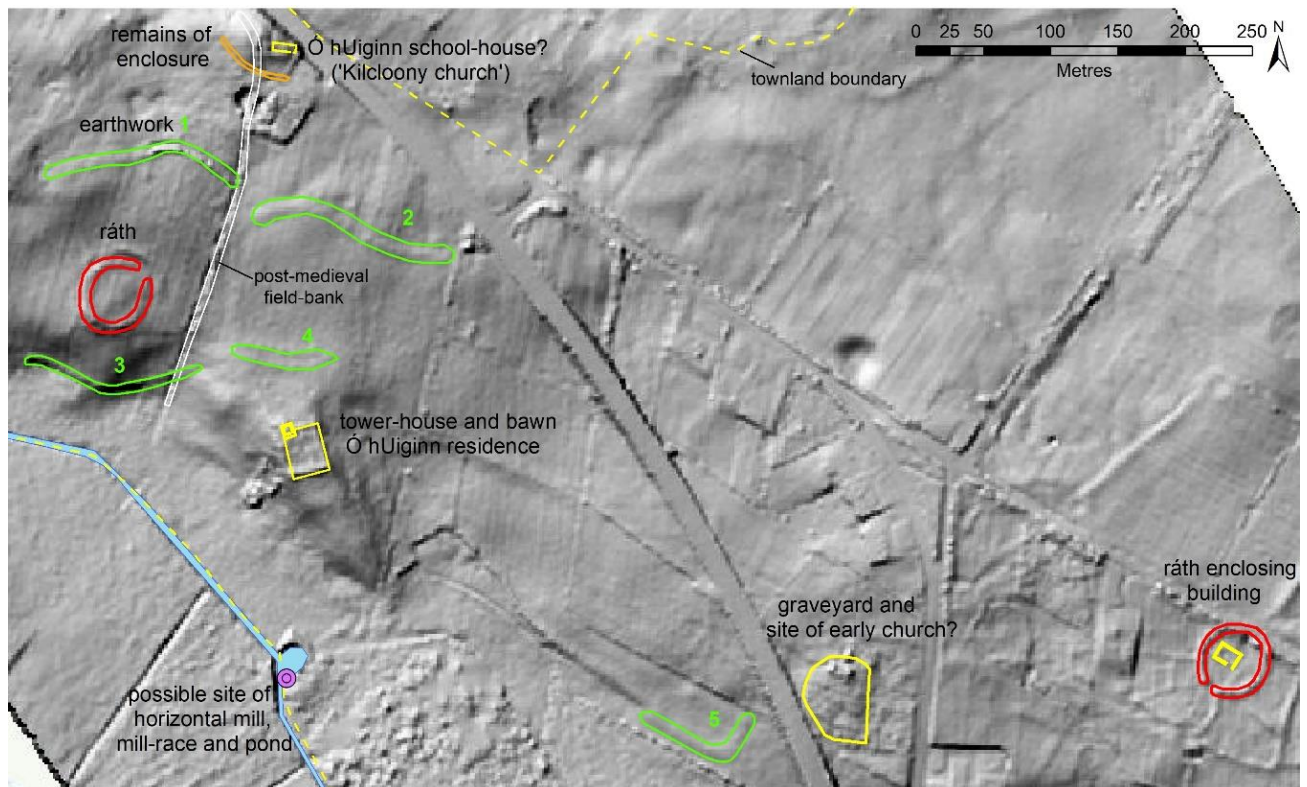
Fig. 2. LiDAR image showing some of the key settlement features of the Kilcloony landscape. The ráth (GA016-060) and an associated souterrain (GA016-060001) are outside this image, to the northwest (map: N. McCarthy based on LiDAR courtesy of TII).

The settlement at Kilcloony is a complex of buildings and earthworks extending over the greater part of the townland (Fig. 2). The central focus of that settlement is a tower house with an accompanying bawn wall and courtyard building (Fig. 3).<sup>10</sup> It looks out towards the great expanse of flat land that runs southwest to the prominent hill of Knockmaa or Cnoc Meádha Siúil,<sup>11</sup> the most important landmark of the early medieval kingdom of Mag Seola, which lay immediately west of Conmaicne Cenél Dubáin (Fig. 4).

What may be the site of a horizontal mill, mill-pond and mill-race, upon which there is a modern pump-house, lies 200m to the south, on the townland boundary (Fig. 2). A small rectangular building situated 275m north of the tower house was recorded by the Ordnance Survey as 'Kilcloony Church',<sup>12</sup> a burial ground lies 450m to the southeast of the tower house<sup>13</sup> and there are three ringforts in the north-western and north-eastern areas of the townland.

LiDAR imagery of the area (Fig. 2) immediately to the north and south of the tower house shows four lengths of substantial linear earthworks that are new to the archaeological record for the townland.<sup>14</sup>

In the wet grassland and marsh to the south of the tower house there is a natural spring with a pond and canalised stream (Fig. 2) that collectively indicate the possible site of a former horizontal mill, mill-stream and mill-pond. At the very least, this site must have been the

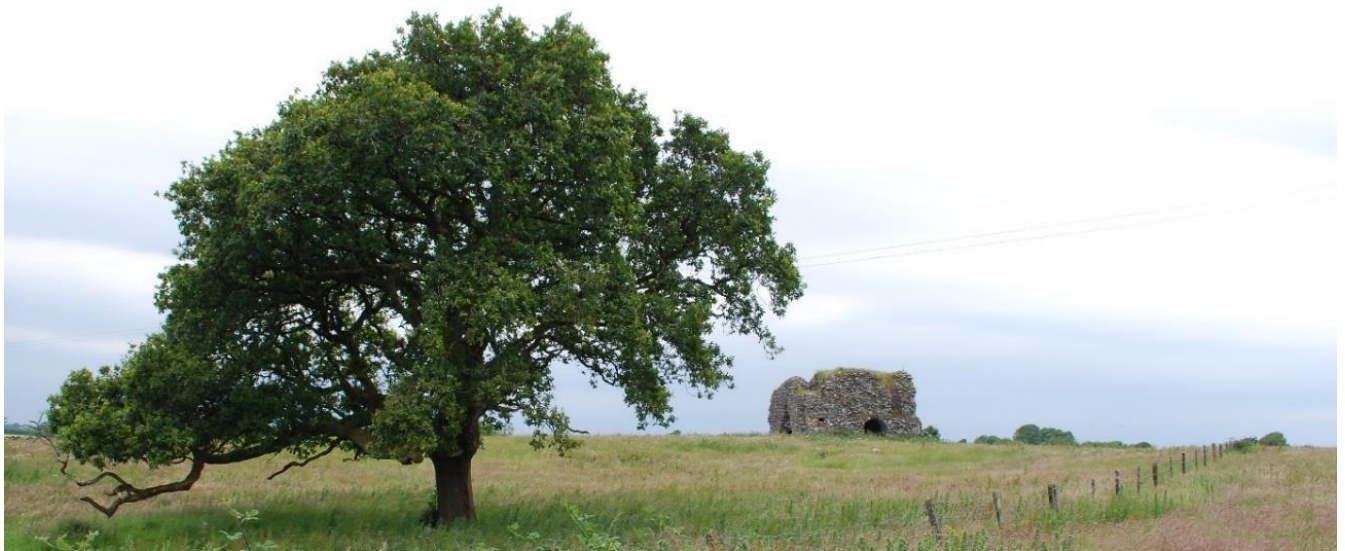
*Fig. 3. Kilcloony Castle viewed from the east.*

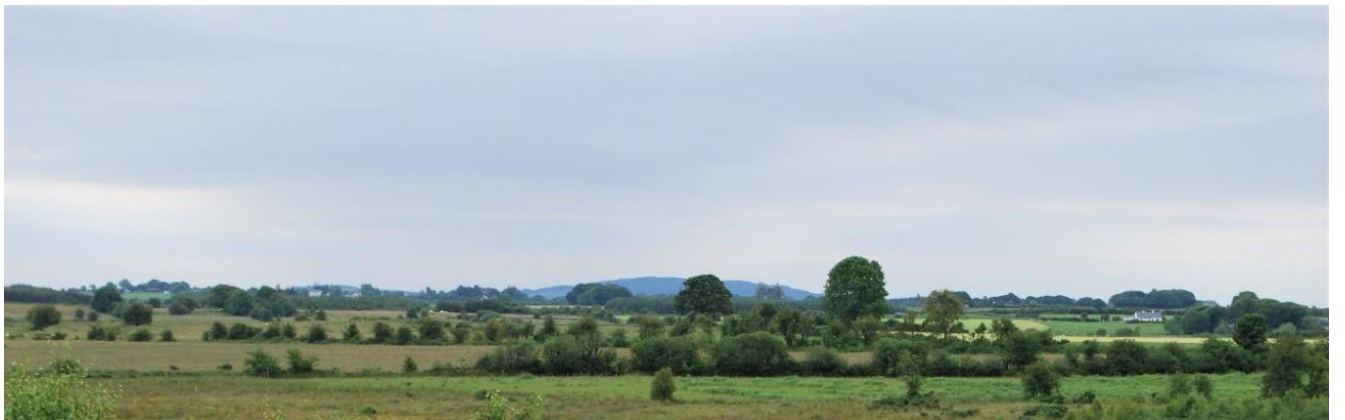
*Fig.4. View looking south to Knockmaa from Kilcloony Castle.*

The tower house had uninterrupted views southwest across the old kingdom of Mag Seola to its iconic landmark – Knockmaa (Fig. 4). The setting of the tower house on a spur of land with precipitous drops on the west and south flanks was perhaps intended to impede approaches to the building from those sides. The architecture of the tower house expresses a concern with controlling access to the building too, with security features at the main entrance in the south wall and at the entrance to the eastern chamber that led into the main ground floor chamber and to the staircase. Despite the security consciousness of the south façade, the surviving windows and opes, including the gun-loop, facing into the bawn, were finished with very fine cut-stone details. The level of protection suggests that during the time it was built in the fifteenth century there was a threat to life and property. For the sixteenth-century learned occupants of Kilcloony Castle, the security devices including door-bars, a gun loop and yett-holes would have made their residence a secure place for keeping important items, such as manuscripts, for instance.

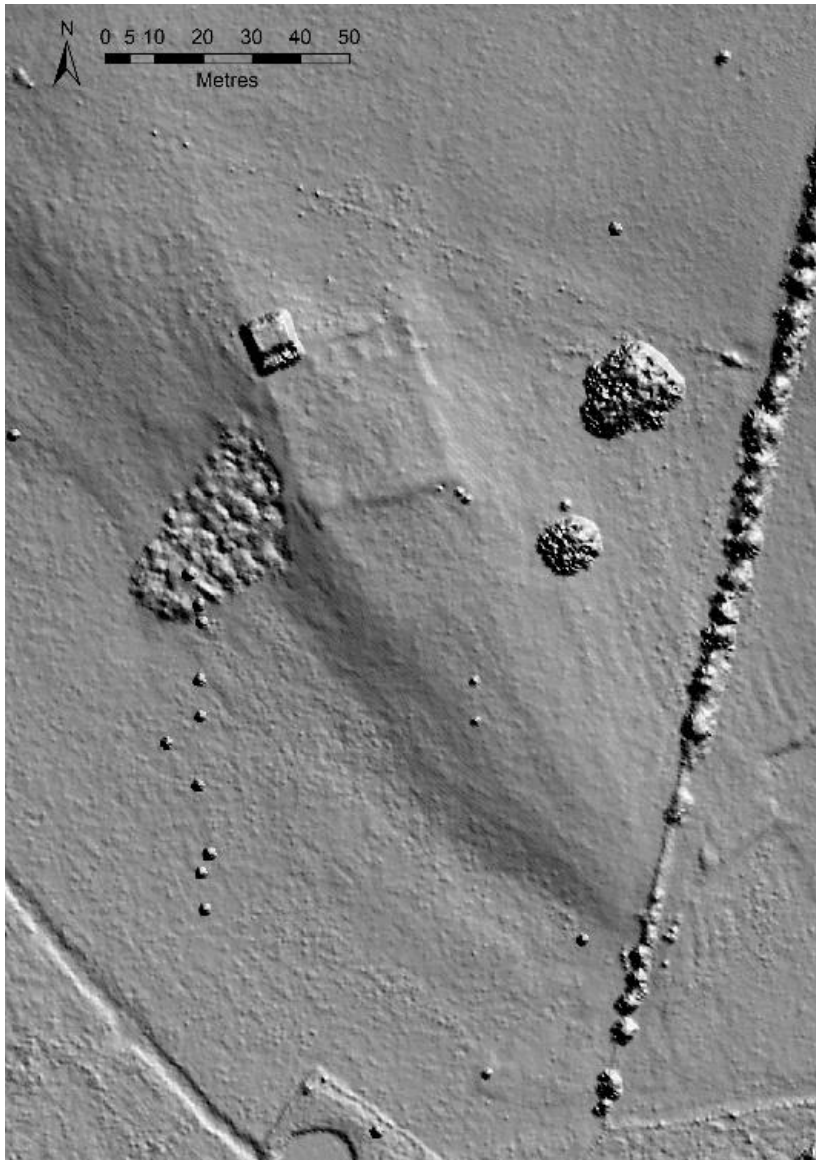
*Fig. 5. The tower house and bawn situated on the flat summit of a spur of land projecting into wet grassland (LiDAR courtesy of TII).*

The tower house and bawn at Kilcloony stand on a prominent spur of land (Fig. 5), a natural promontory (c. 60m OD) that descends southwards into the marshy ground of the south of the townland. The west side of the promontory is particularly straight-sided and steep, with a deep quarry below. The tower house was perhaps purposely situated there to take advantage of the steep slope.

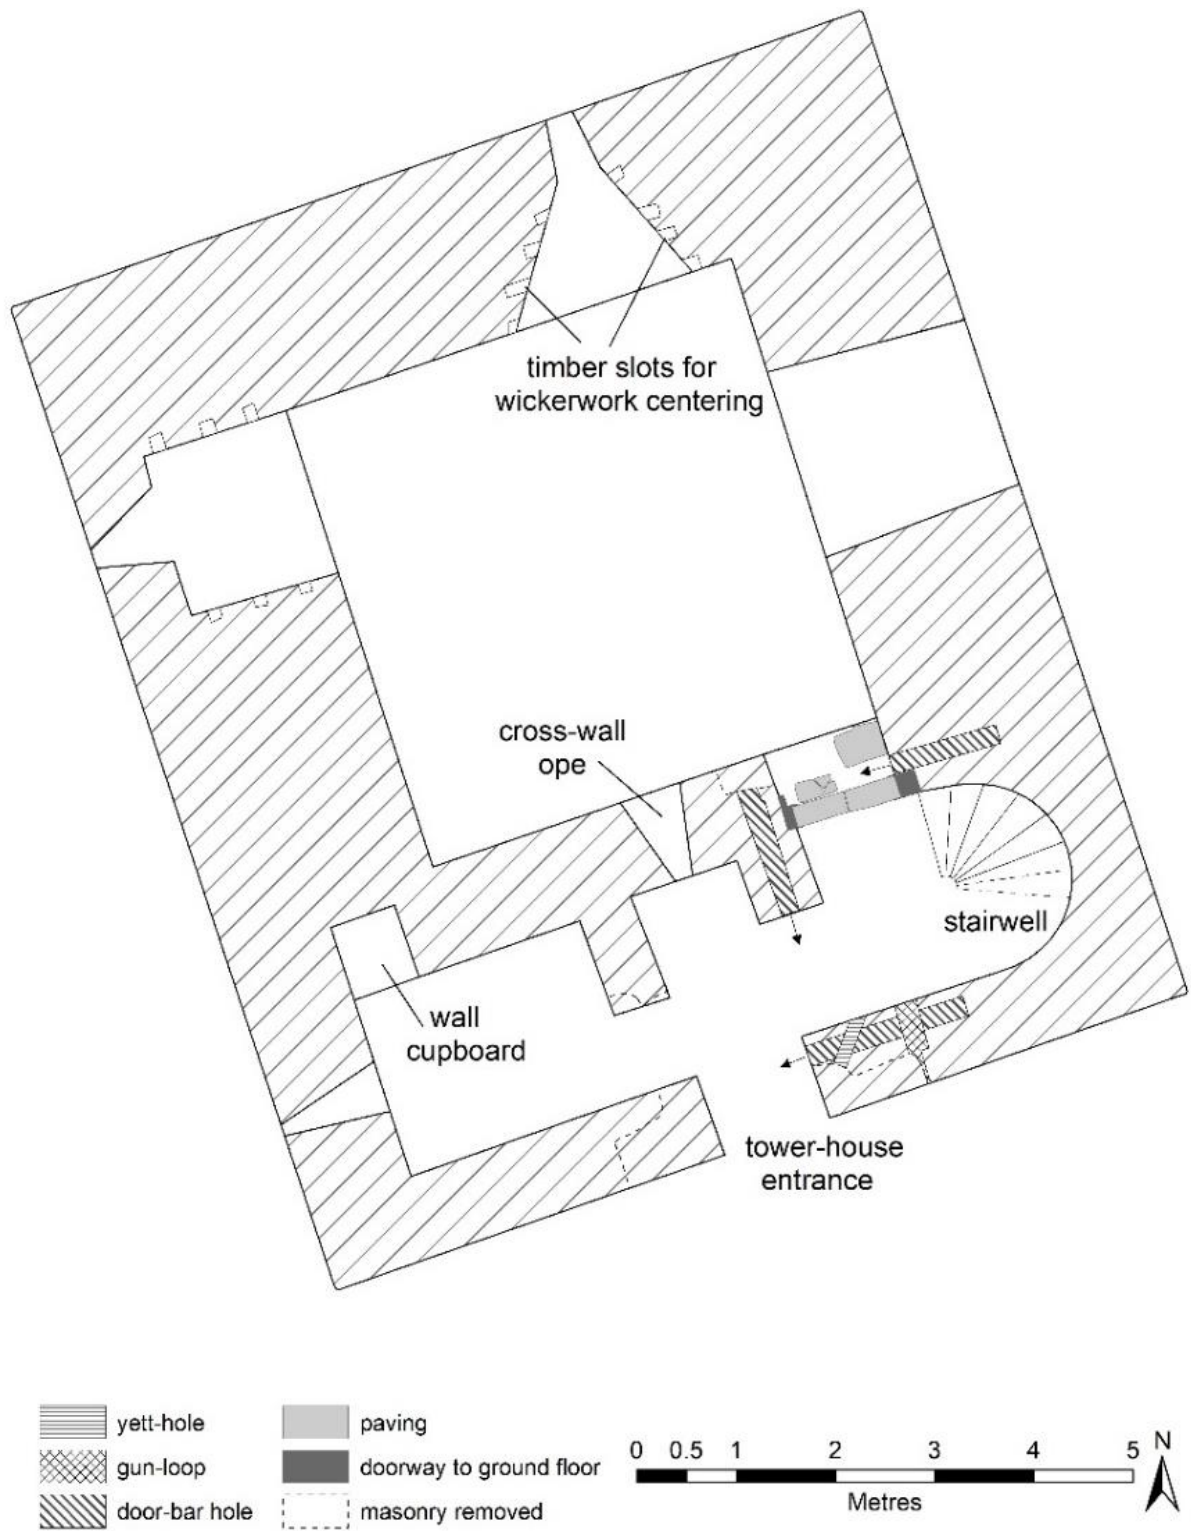
Fig. 6. Ground floor plan of Kilcloony tower house (drawing: N. McCarthy; © E.FitzPatrick).

The ground floor of the tower house is divided on its east–west axis by a cross-wall c. 1m thick (Fig. 6). The area south of the cross-wall is quite narrow at 7m x 2m internally and it is further subdivided into three discrete spaces – an entrance lobby, a western chamber and an eastern chamber that contains the fragmentary remains of a spiral staircase in the southeast corner. The tower house was entered from the south wall (Fig. 10). The doorway has been removed

The main ground floor (4.87m N-S by 4.80m E-W) room of the tower house lies on the north side of the cross-wall (Fig. 6).

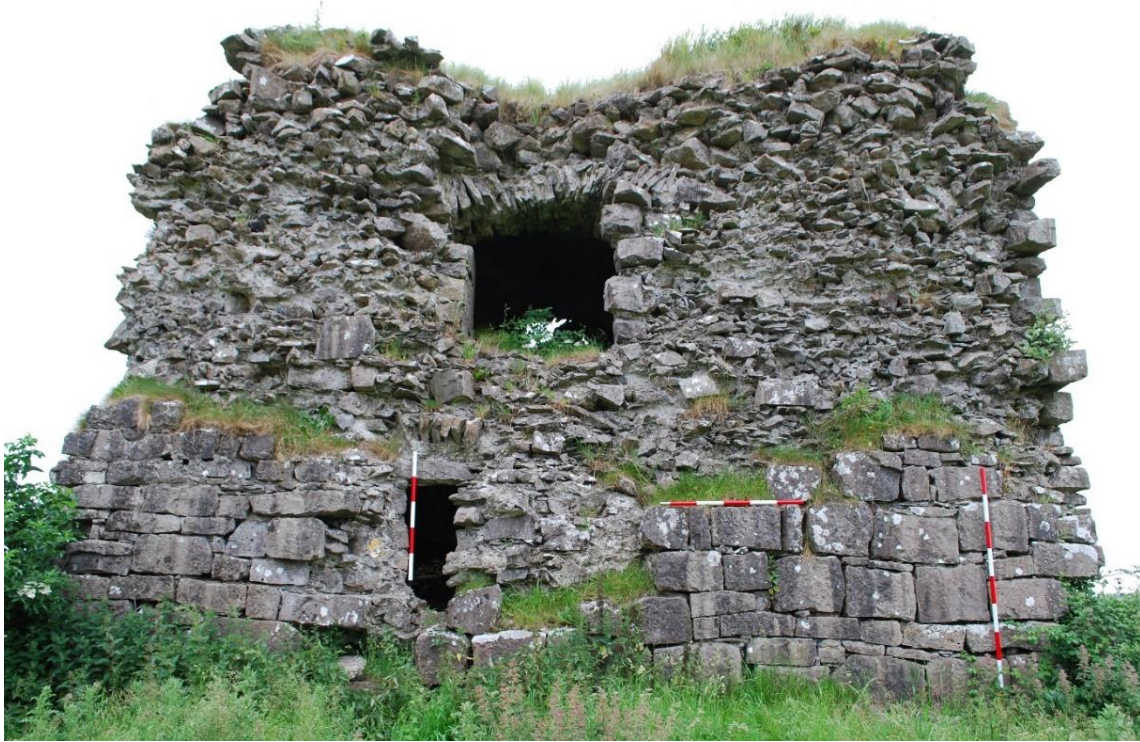
*Fig. 7. North wall with extensively robbed out masonry above ground floor level.*

Kilcloony Castle is a highly vulnerable late medieval building. Above the line of the base batter on the north wall, all of the facing stones have been removed, as well as the cut stones of the ground floor window. The east wall has suffered the worst of the vandalism, with most of the façade ripped out, leaving just a few quoin-stones in place on the northeast and southeast corners. Most of the facing stones up to the level of the vault have survived on the south wall, but the entrance to the tower house was broken out and most of the quoins at southeast and southwest have been removed. Masonry at the centre of the vault that supported the first floor has become loose and threatens to collapse the entire structure. The bawn wall has been reduced to its footings, which are discernible on the ground along the north end of its eastern route only.

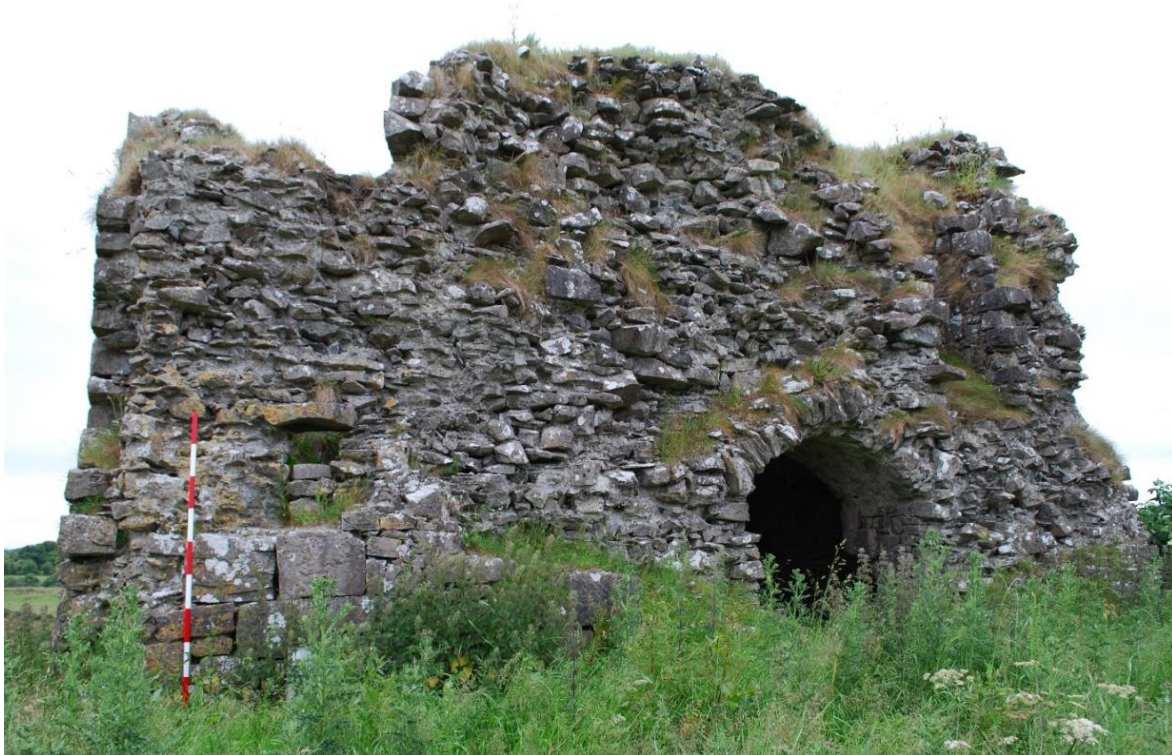
*Fig. 8. East wall showing robbed-out masonry, window embrasure and garderobe chute.*

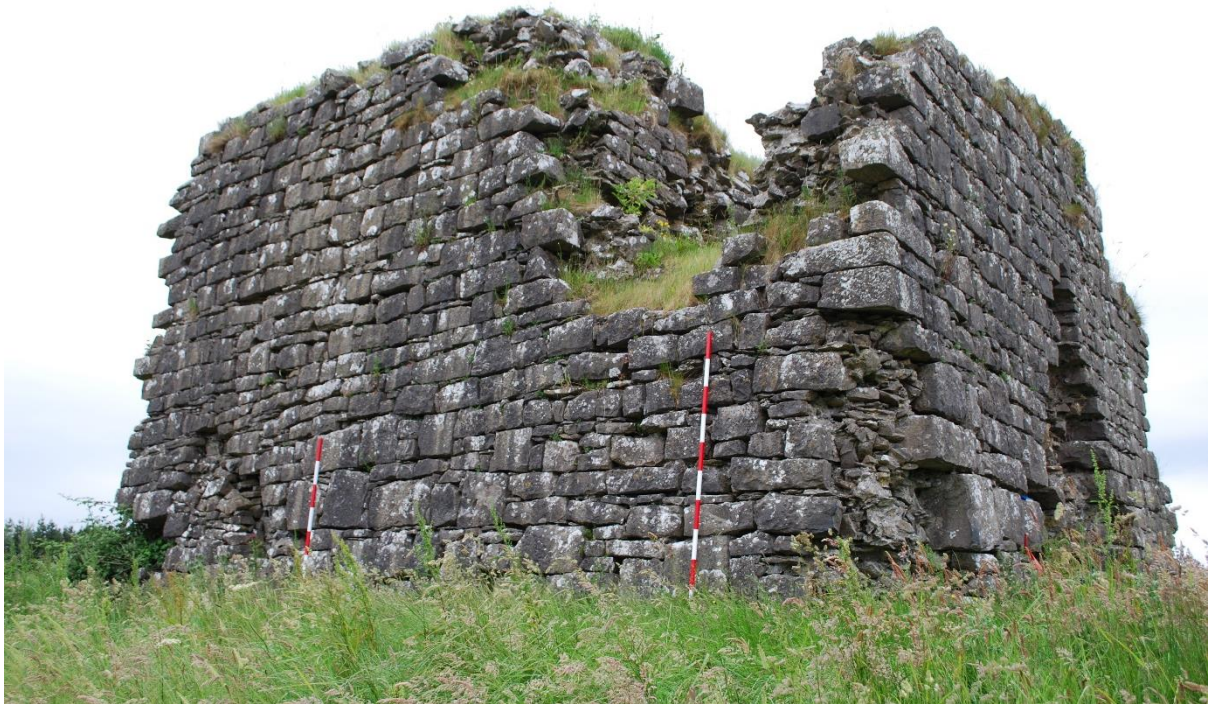
*Fig. 9. The west wall of the tower house with breach indicating position of former window embrasure on first floor above the vault.*

Little of the wall fabric of the tower house survives above the vault at first-floor level. A breach at the south end of the west wall indicates the former position of a first-floor window and its embrasure. The first-floor room was provided with a garderobe that was positioned in a mural chamber at the north end of the east wall. Remains of the garderobe chute are now visible as a result of its exposure through the robbing out of the facing stones from the entire façade of the wall (Fig. 30).

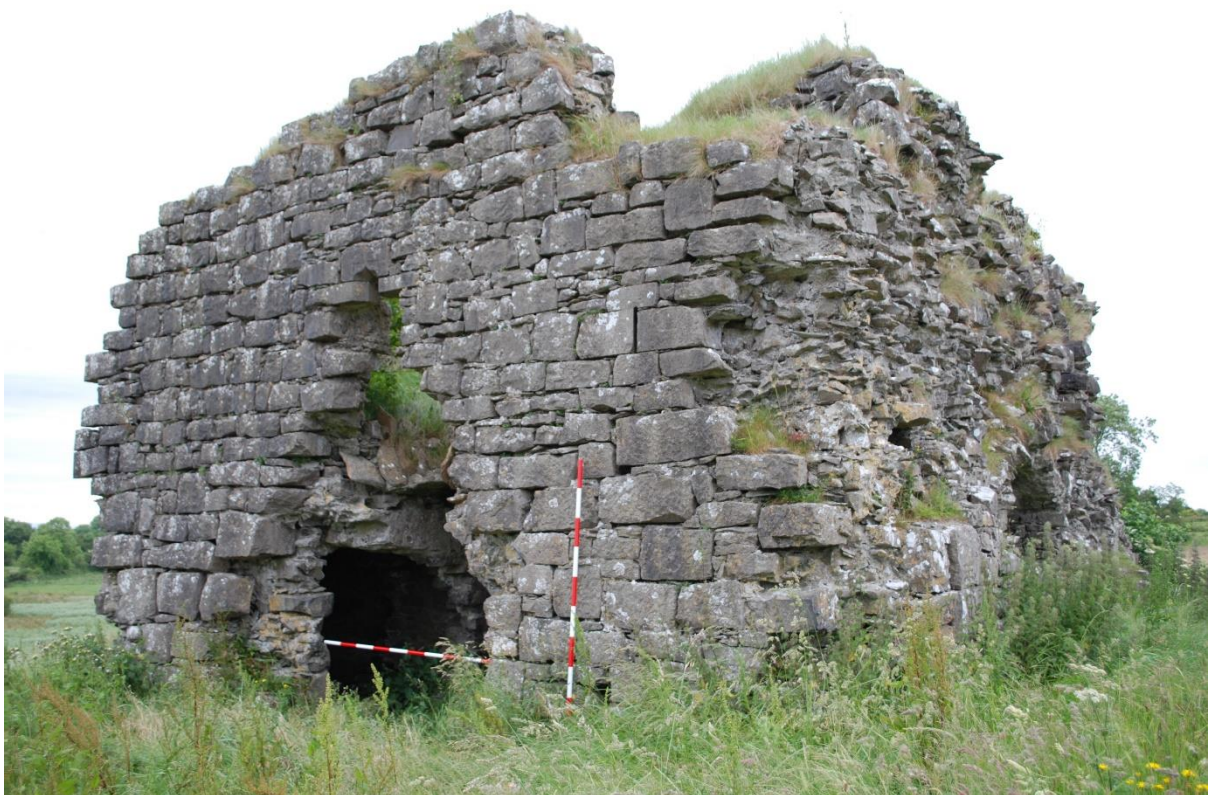
*Fig. 10. South wall showing breached entrance, mezzanine chamber window and tiny loop on stairwell in southeast corner.*

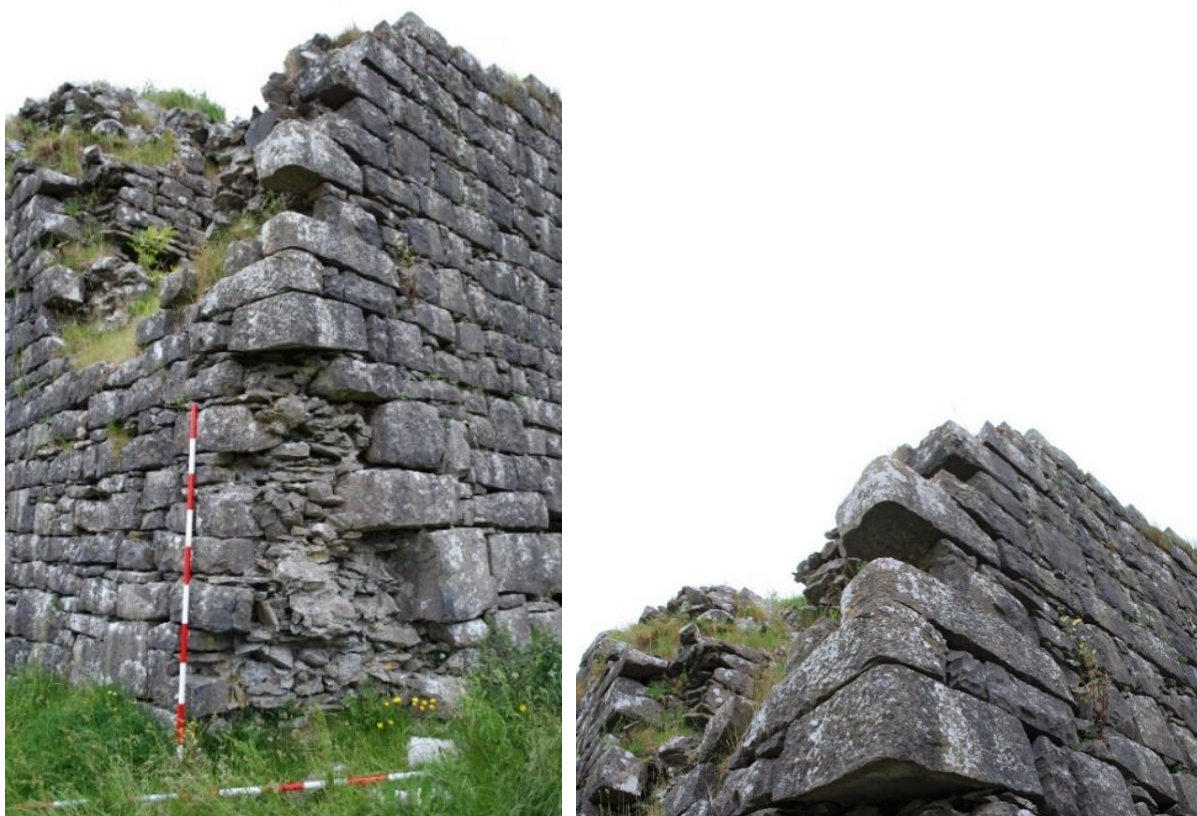
*Fig. 11. Rounded quoin-stones on the southwest corner of Kilcloony tower house.*

The construction of the tower house may be attributed to the fifteenth century, based on features such as the rounded quoins (Fig. 11) that are found in other tower houses securely dated to that period. Four alternating long and short, punch-dressed quoin-stones survive on the southwest corner of the building and two towards the base of the southwest corner. All those on the corresponding northeast and northwest corners have been robbed out. This style of quoin, with a half-round section, is found elsewhere in Co. Galway tower houses, such as Claregalway Castle of the Clanrickard Burke family, which has been assigned to the first half of the fifteenth century through radiocarbon dating of hazel twigs used as wickerwork centering during the construction of the vault of the tower house.<sup>15</sup>

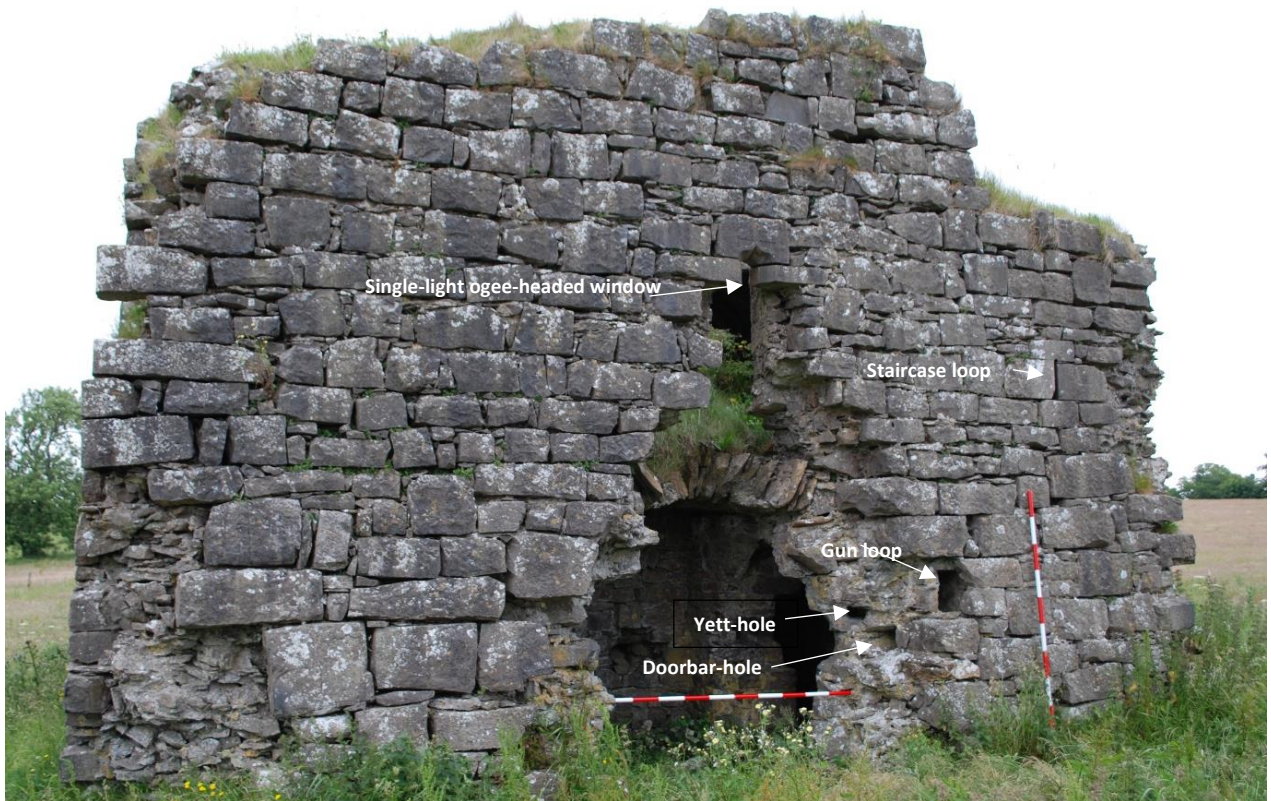
*Fig. 12. The south wall showing the breached entrance, gun-loop to the right, a single-light ogee-headed window on the first floor above the doorway and a narrow round-headed loop lighting the staircase.*

Typical of late medieval tower house entrances, it probably had a semi-pointed arch. What does survive, however, are security fixtures flanking the east side of the former doorway (Fig. 12-14). These include – a yett-hole (Fig. 14a) angled northeast-southwest and running 0.33m deep into the wall on the east side of the doorway. This hole was for a chain attached to a yett or iron grid, which could be pulled against the tower house doorway, from the inside, for protection. There would have been a corresponding yett-hole on the west side of the doorway. Beneath it there is a square (0.20m x 0.20m) aperture (Fig. 14a) for a door-bar running 1.10m deep into the wall. This held a stout timber bar that could be shot across the inside of the doorway for additional protection.

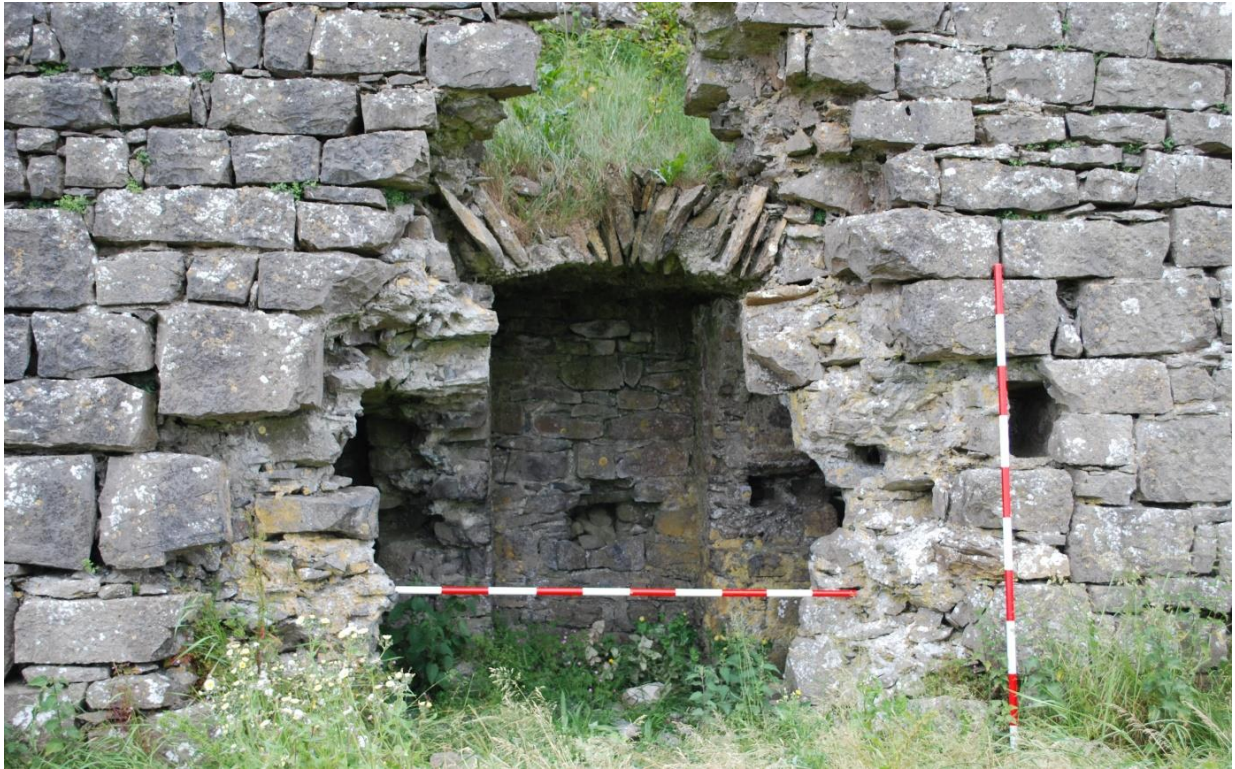
Fig. 13. The breached entrance in the south wall showing the lobby with its vaulted roof.

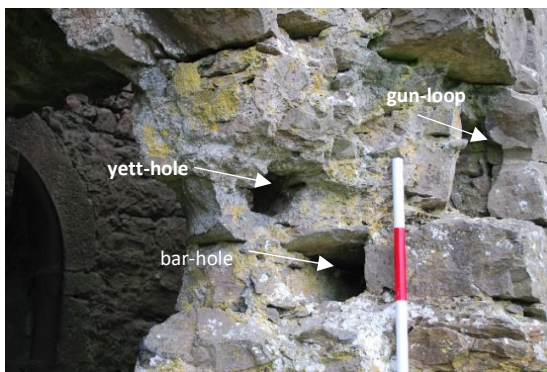
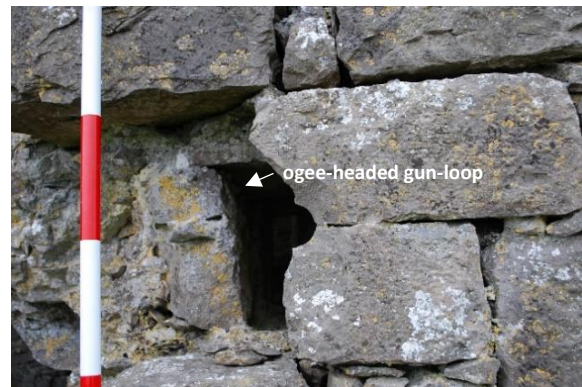
Fig. 14a and 14b. Security fixtures, south doorway.

A third security feature is positioned east of the yett-hole. It is a circular gun loop (Fig. 14b; diameter 0.06m), its lethal purpose masked externally by a neatly cut and dressed ogee-headed ope (the western half is missing). It is set into a rectangular aperture 0.3m x 0.25m angled south-southwest towards the entrance and running 0.85m deep through the wall. This was where a shooter placed a weapon to fire on intruders at the doorway of the tower house.

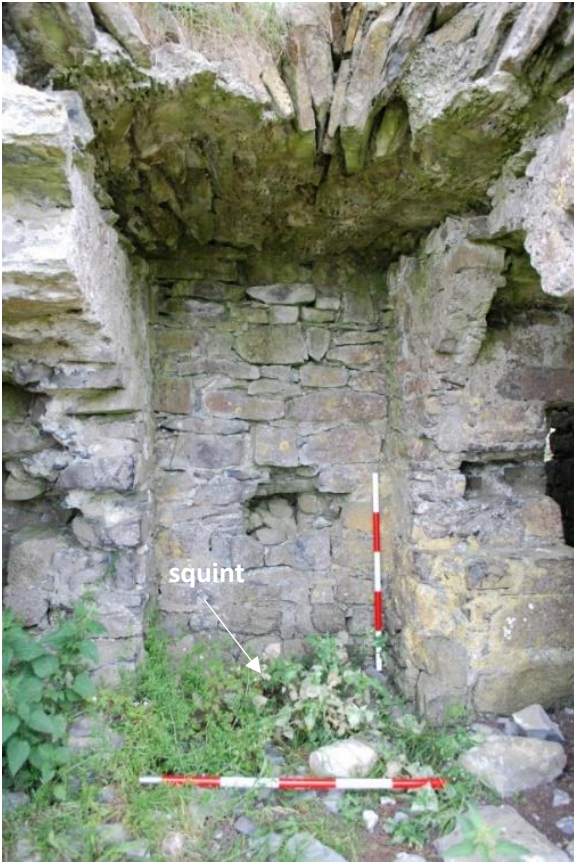
*Fig. 15. Lobby with vaulted roof looking north towards partially block-up squint in cross-wall.*

The main doorway leads into a small lobby (2.25m N-S x 2m E-W) in the north wall of which there is a rectangular squint, now partly blocked up (Fig. 15). The embrasure (0.54m x 0.42m) of the squint has a neatly lintelled head and splays outward into the interior of the main ground floor room. This would have allowed some light into the lobby and would have enabled a view of anyone entering through the tower house entrance. This squint is quite low

down in the wall notwithstanding the build-up of the floor with rubble. It is oddly low and may alternatively have been used for passing something through to, or out of, the ground floor from the lobby. The roof of the lobby is vaulted and carries traces of wickerwork centering.

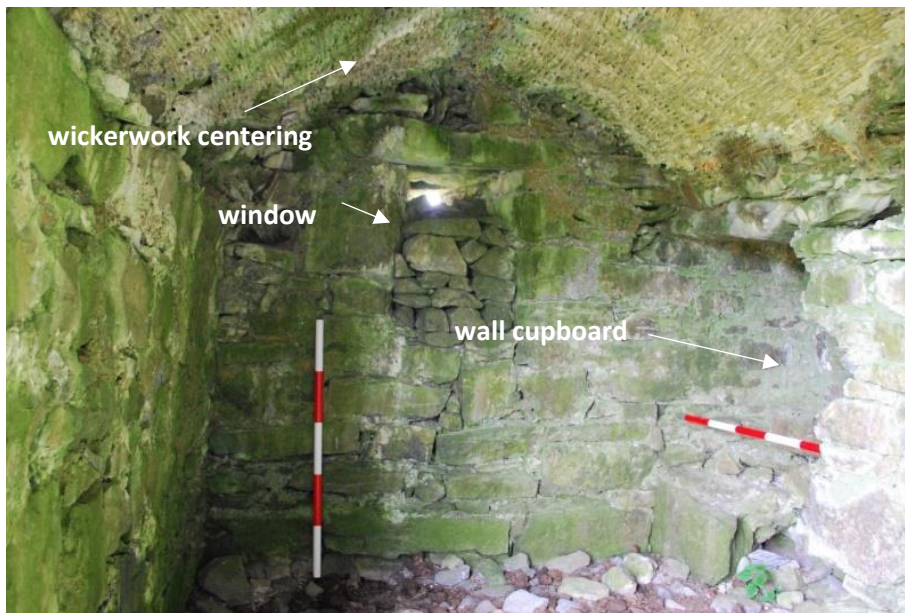
*Fig. 16. Barrel-vaulted west chamber with wicker-work centering, partially blocked window and wall cupboard.*

Turning west, the lobby yields to a small barrel-vaulted space (c. 2.3m E-W x 1.9m N-S) formerly entered through a cut-stone doorway which has been robbed out (Fig. 16). It is lit from the west wall by a crude, single-light rectangular ope (0.28 x 0.12m) set into a splayed embrasure with a lintelled head.

There are substantial remains of wickerwork centering on the soffit of the vault. A wall cupboard (0.67m<sup>2</sup>; 0.7m deep) is positioned at the west end of the north wall. Much of the masonry, with the exception of the two lintel stones of the head of the cupboard, is broken away.

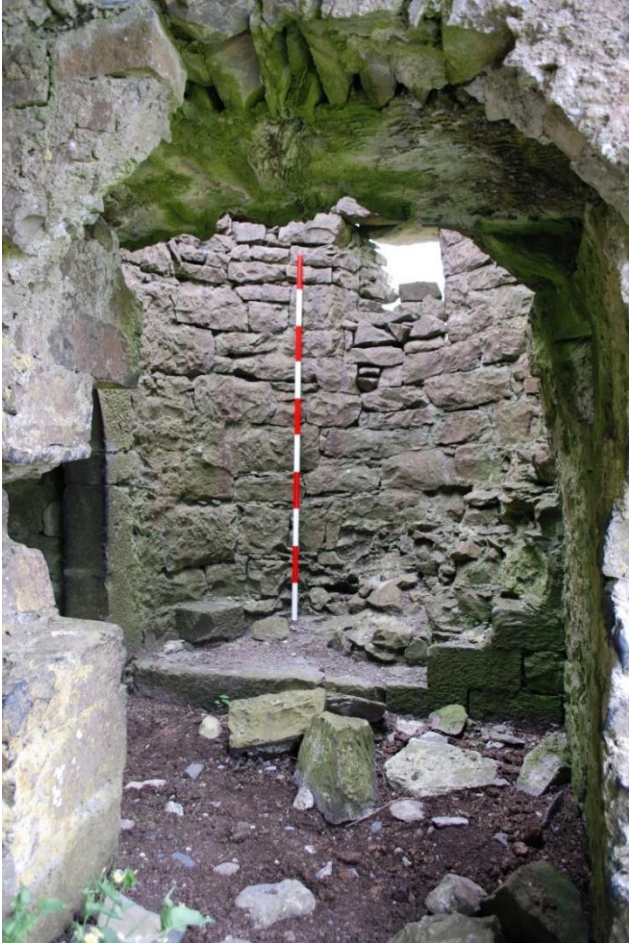
*Fig. 17. Looking through the embrasure of the west doorway to the stairwell space at southeast.*

Turning east from the lobby, one enters the space (c. 2.20m E-W x 2m N-S) in which the stairwell is housed and from which the main ground floor room of the tower house was reached (Fig. 17). It is also in this space that security features of the main doorway in the south wall were accessed. The doorway in the west wall of the stairwell space has been robbed. Just the embrasure with wickerwork centering overhead, and a deep bar-hole that once held a stout timber bar that ran 1.15m deep into the north side of the embrasure of the doorway, remain in place.

The spiral staircase (c. 2m in diameter) was situated in the southeast corner of the tower house and its steps have been hacked out from ground to first-floor level (Fig. 17, 18, 19).

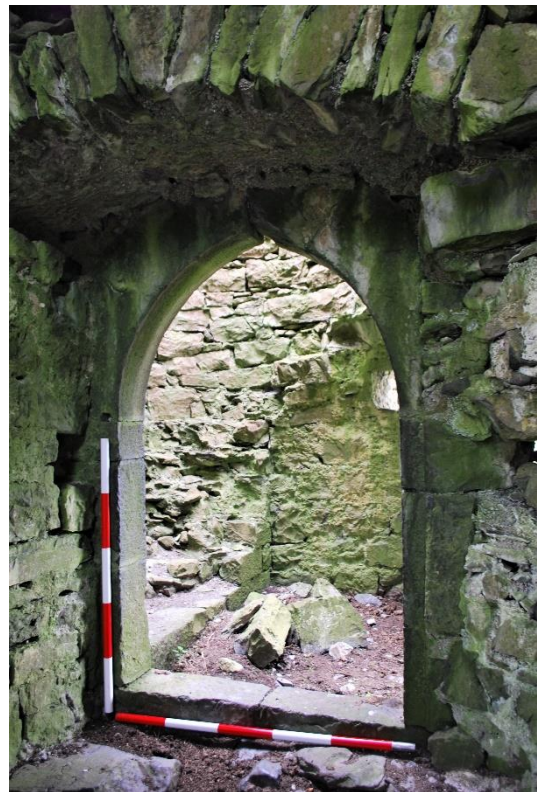
*Fig. 18 View of the robbed-out staircase through the doorway of the main ground floor room.*

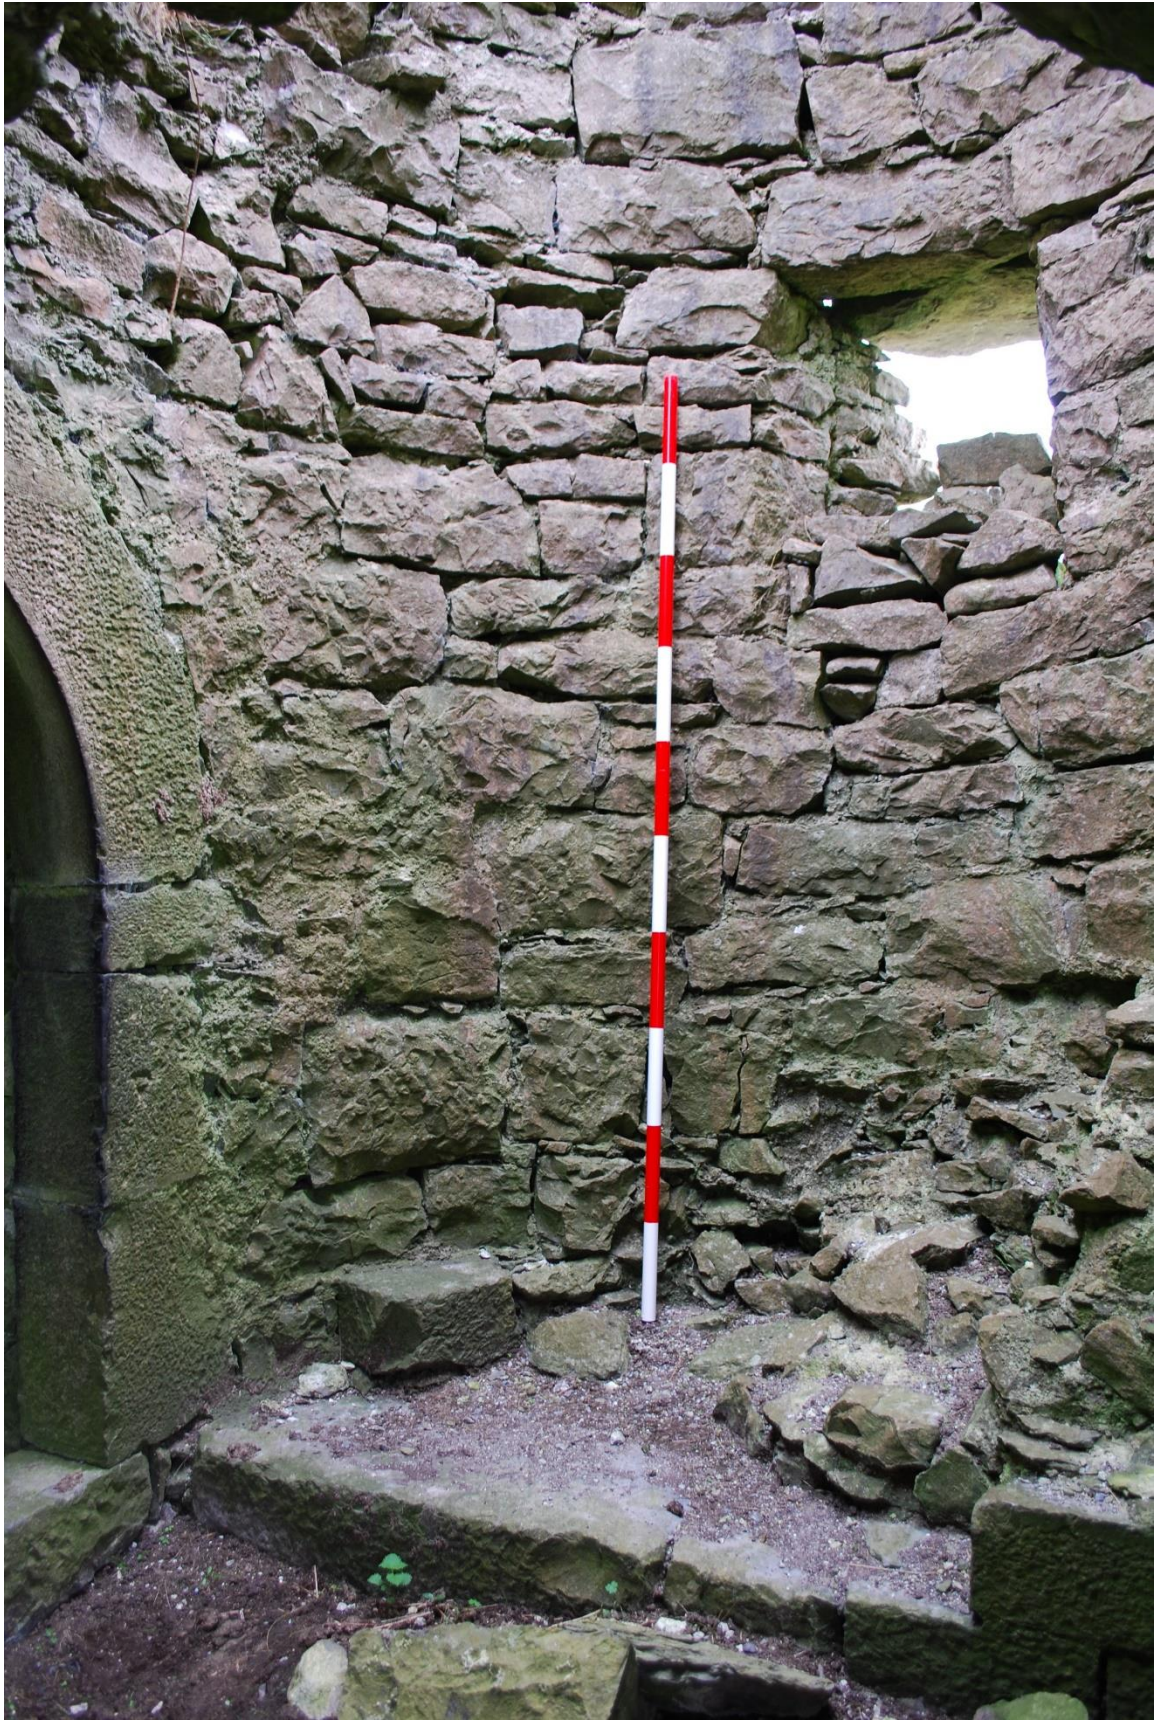
*Fig. 19. Stairwell in southeast corner of the tower house.*

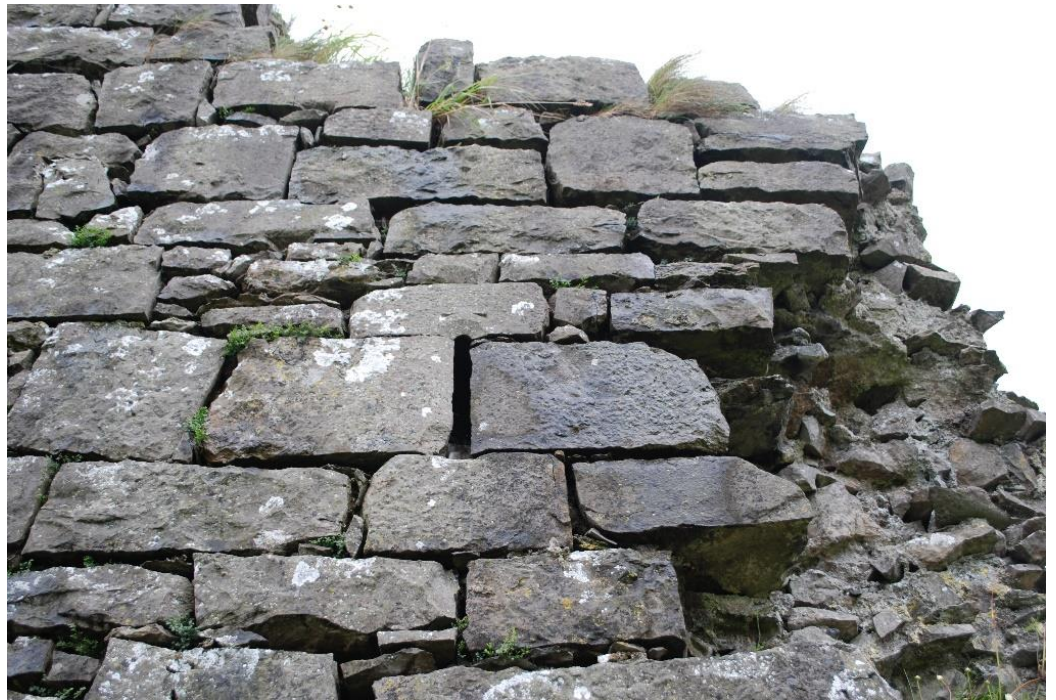
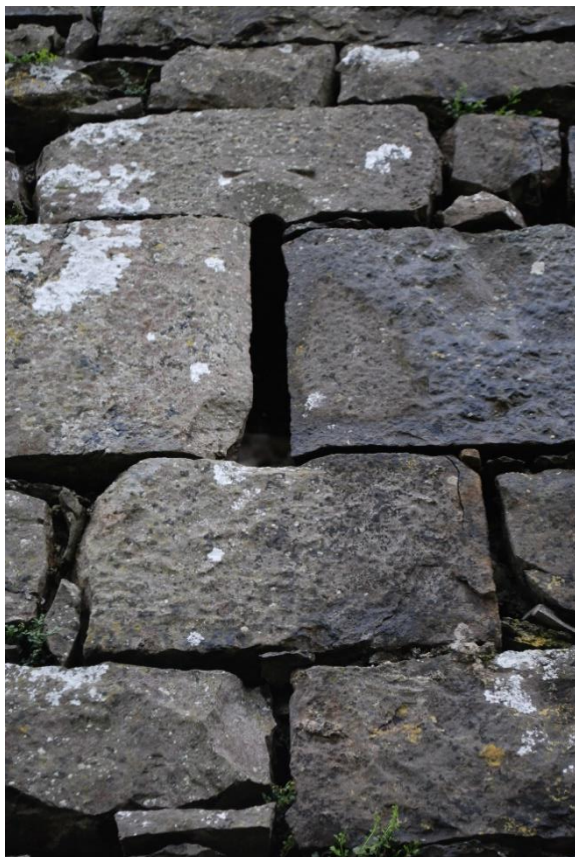
*Fig. 20a (above) and 20b (left). Cut and dressed round-headed ope lighting the route of the tower house staircase at southeast.*

The stairwell was lit between ground and first floor by small rectangular opes at east and southeast. Externally, the southeast-facing ope has a neatly cut and dressed round head (Fig. 20).

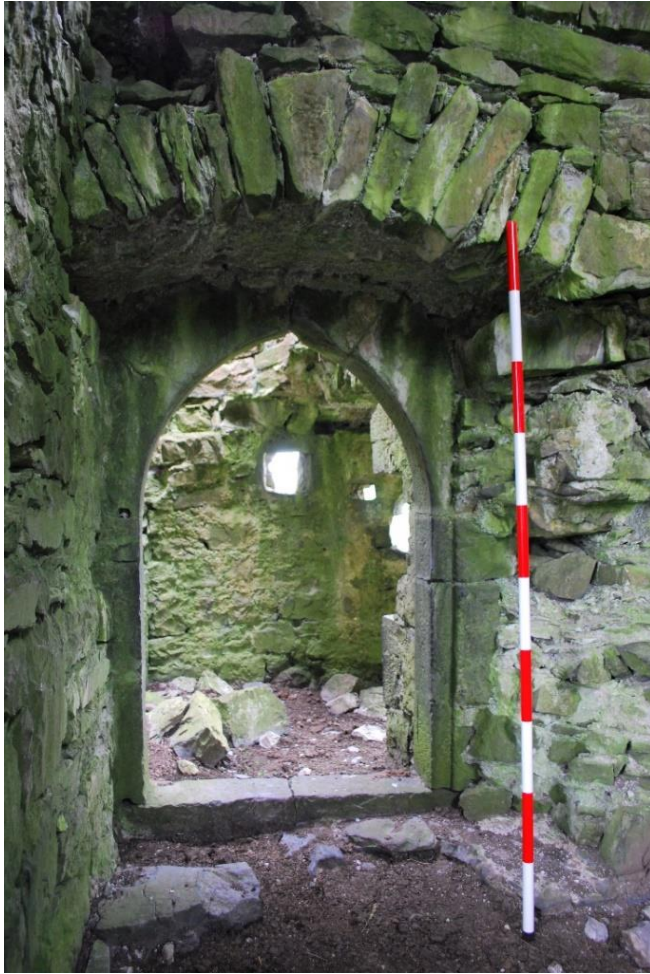
*Fig. 21 Cut-stone, semi-pointed doorway leading from the stairwell space into the ground floor room.*

The main ground floor of the tower house is entered through a semi-pointed cut-stone doorway at the east end of the cross-wall (Fig. 21). The doorway, which is nicely punch dressed, is the only cut-stone feature of the tower house that is fully intact. It is 1.65m in height from soffit to threshold and 1.02m wide. The doorway embrasure on the east side contains a door-bar hole that runs 1.23m deep into the wall. The head of the embrasure carries remains of wickerwork centering. The floor immediately north of the threshold and within the embrasure retains parts of flat paving stones.

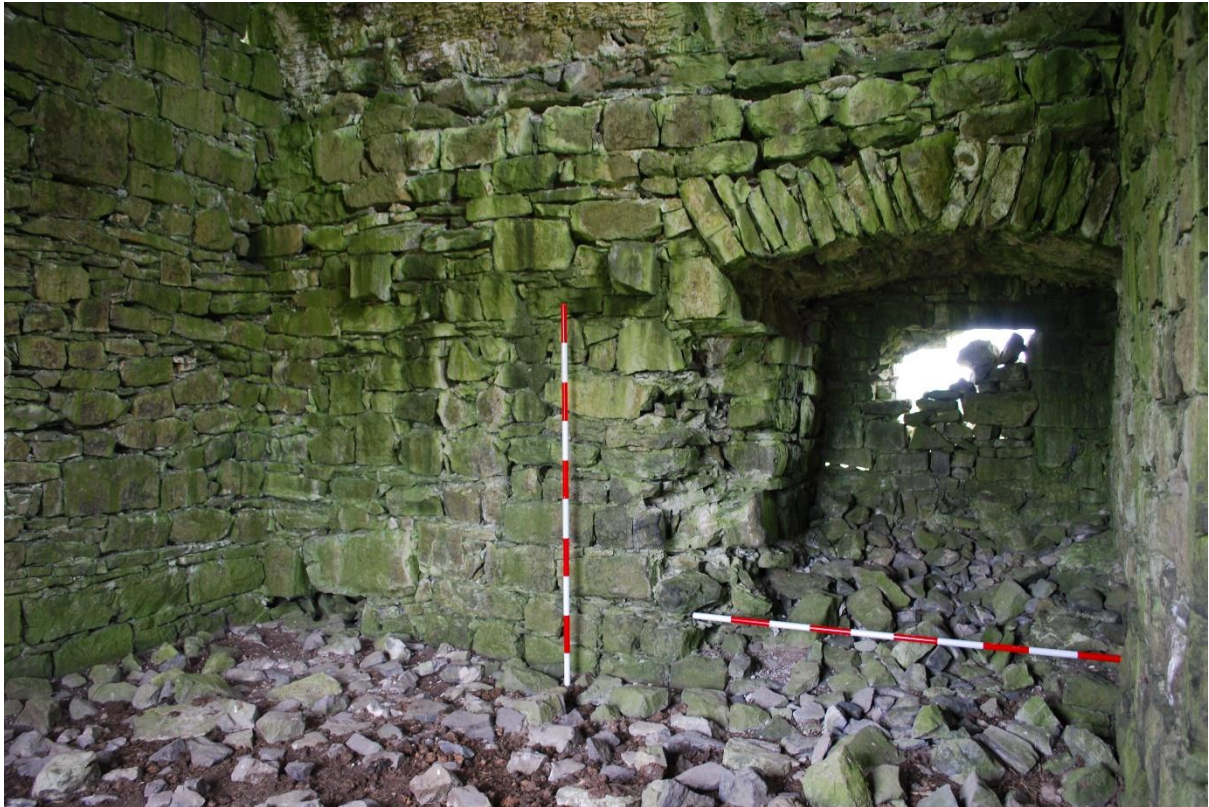
*Fig. 22 Ground floor west wall with window embrasure.*

It was lit by windows in the west, north and east walls, with the squint in the south wall admitting some light too. The west wall (Fig. 22) retains the cut and punch-dressed head and northern side-stones of a narrow rectangular loop. It sits in a straight-sided deep embrasure, 1.65m wide, which has a depressed arch retaining substantial traces of wickerwork centering on its soffit. The top of the sides of the embrasure, at their junction with the soffit, contain small rectangular holes that carried flat timbers for supporting wickerwork frames when the heads of the embrasures were being constructed. These are present in all of the surviving window embrasures of the ground floor.
