# A Settlement of the Uí hUiginn Poets and its Landscape Setting

Kilcloony, County Galway

A report by Elizabeth FitzPatrick, School of Geography, Archaeology and Irish Studies, NUI Galway, for the Milltown Heritage Group, with plans by Noel McCarthy.

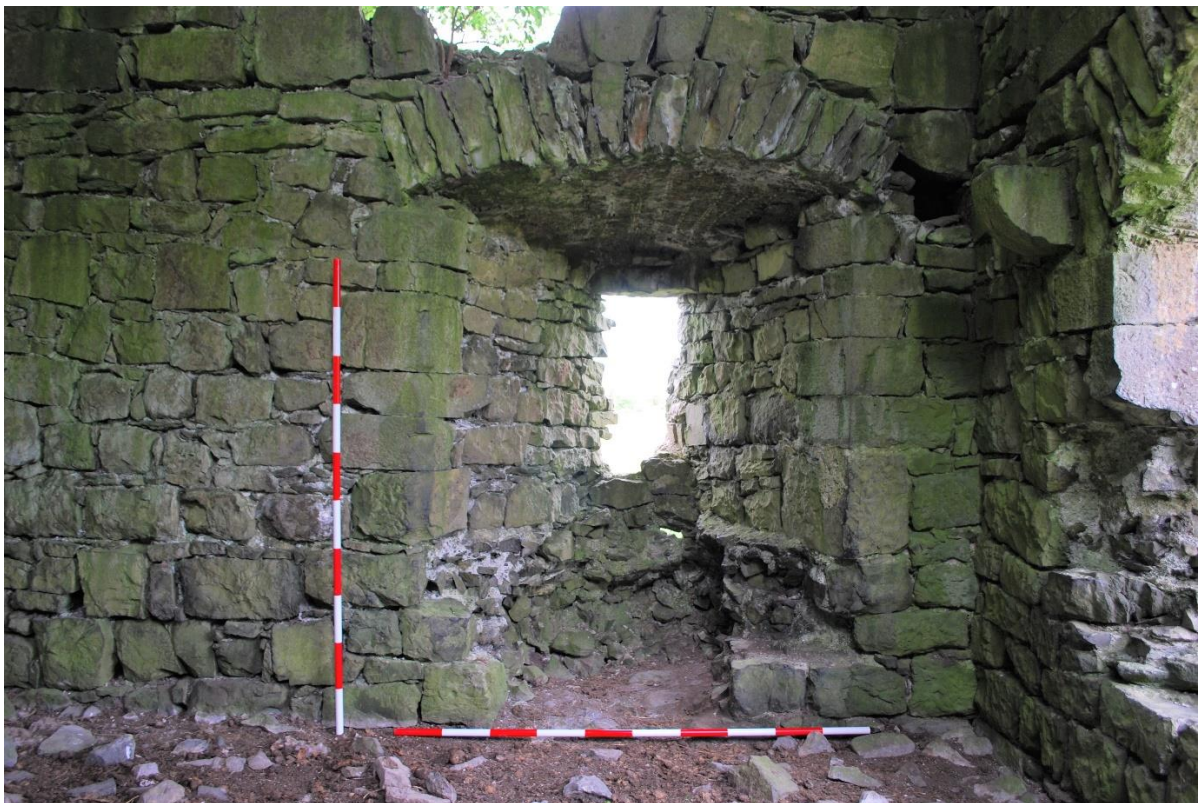
*Fig. 23 Ground floor north wall with remains of single-light window and embrasure.*

The window positioned at the east end of the north wall (Fig. 23) has a more widely splayed embrasure, 1.83m wide internally and 2.35m in height from soffit to base. It has neatly dressed quoins and a depressed arch of rough wedge-shaped voussoirs set on edge, the soffit of which also carries remains of wickerwork centering. With the exception of the window head, the rest of the window has been broken out.

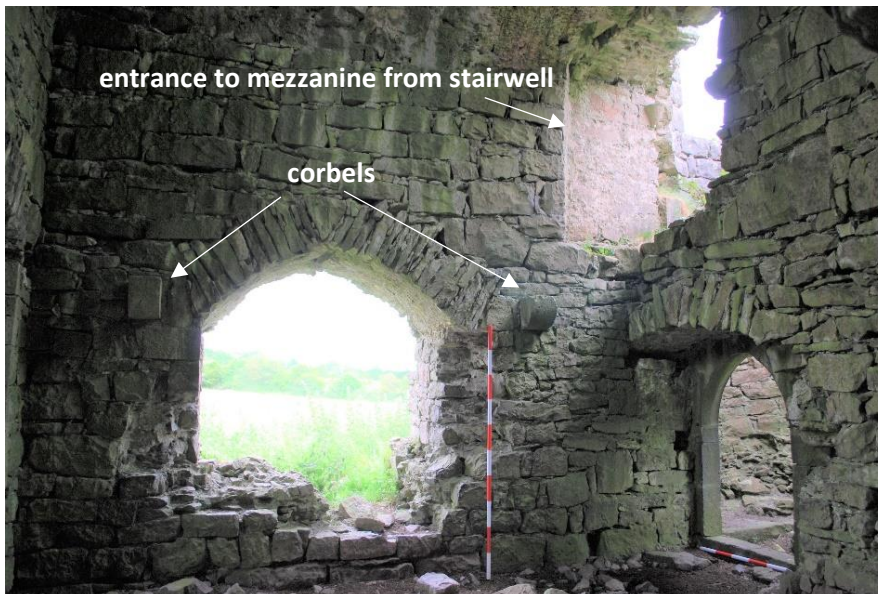
*Fig. 24 Mezzanine beneath the vault reached from stairwell in southeast corner. Corbels for mezzanine floor beams can be seen in the east wall.*

Some of the corbels that carried the beams for the mezzanine floor remain in place c. 2m above ground level (Fig. 24). Fragments of two corbels can be seen on the west wall (Fig. 26). Holes positioned at the extreme east and west ends of the north wall once carried two corbels. Two well-preserved cut and punch-dressed corbels flank either side of the window embrasure in the east wall and another survives in the south or cross-wall.

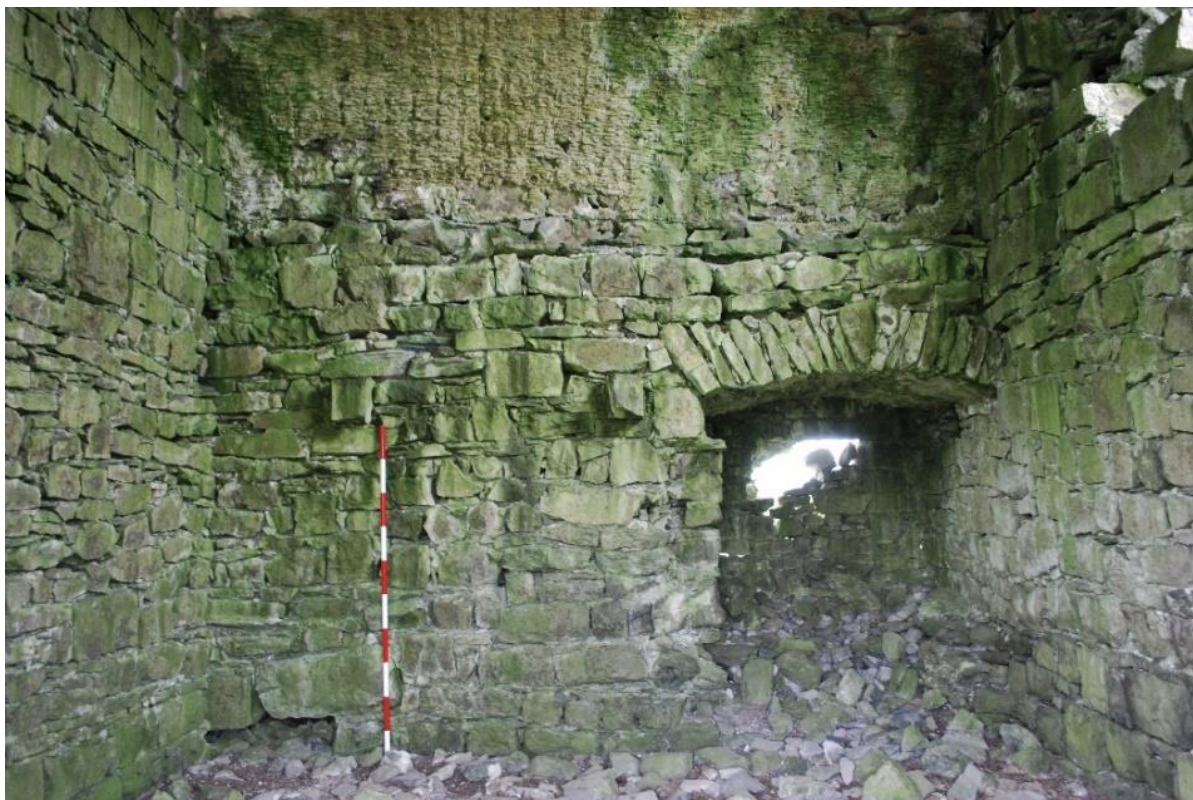
*Fig. 26 West wall with blocked window and fragmentary corbels for mezzanine floor beams.*

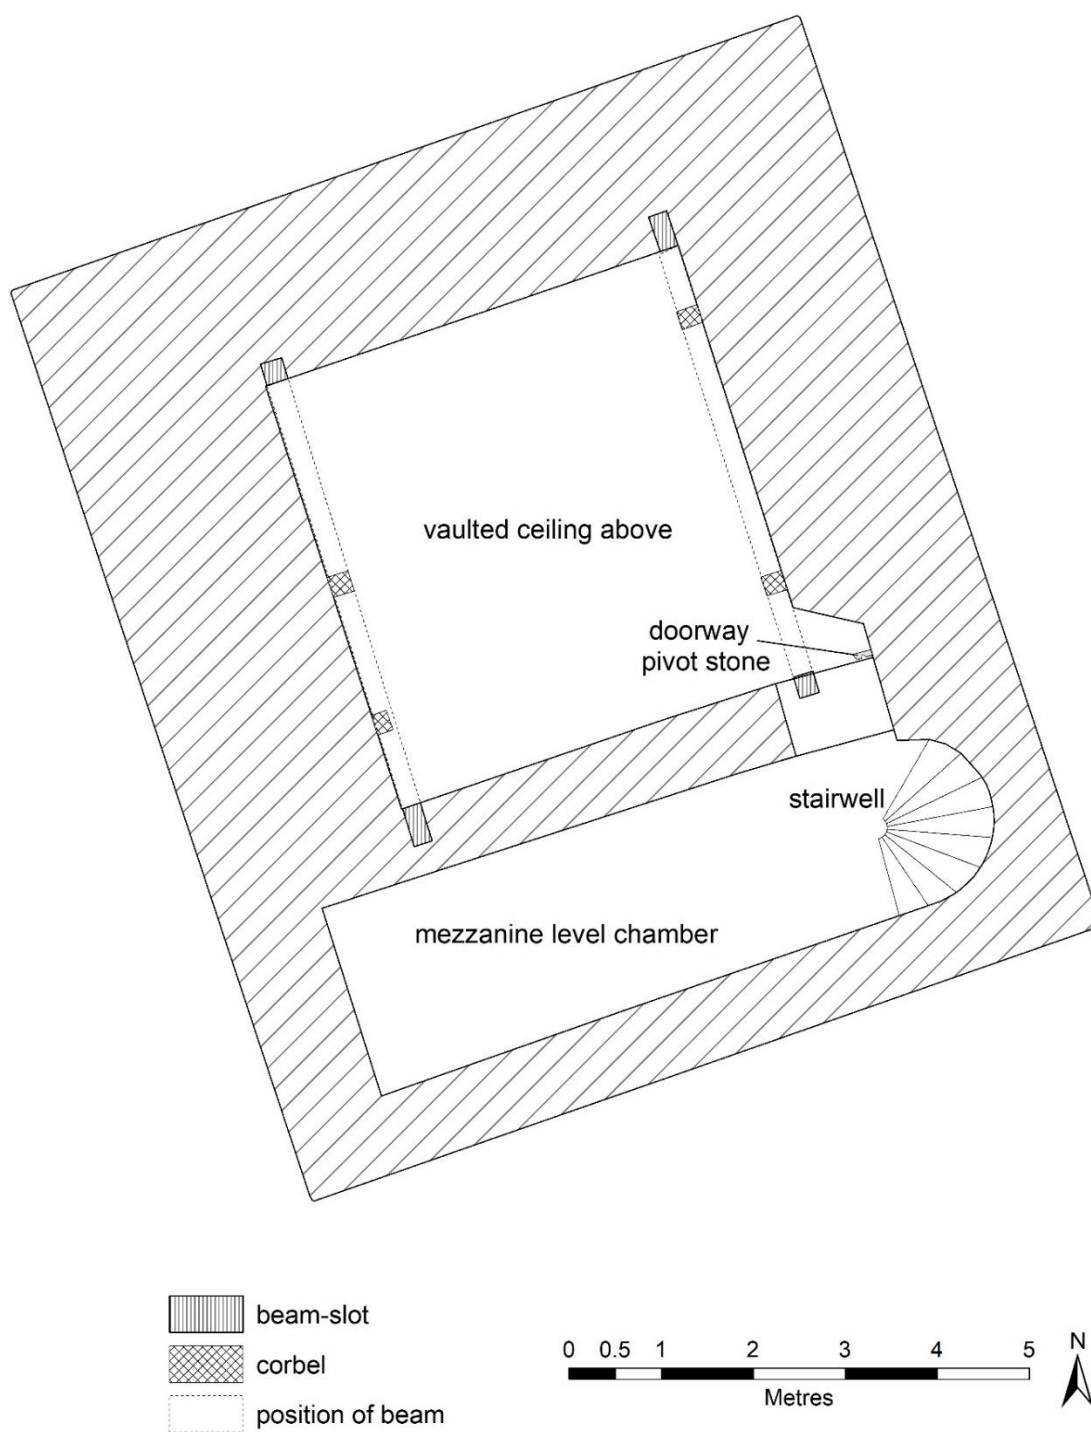
Fig. 25 The mezzanine level of the tower house beneath the first-floor vault (drawing: N. McCarthy; © E. FitzPatrick).

There was a mezzanine beneath the barrel vault of the tower house (Fig. 25) reached from the stairwell in the southeast corner through a cut-stone doorway in a deep embrasure. Just

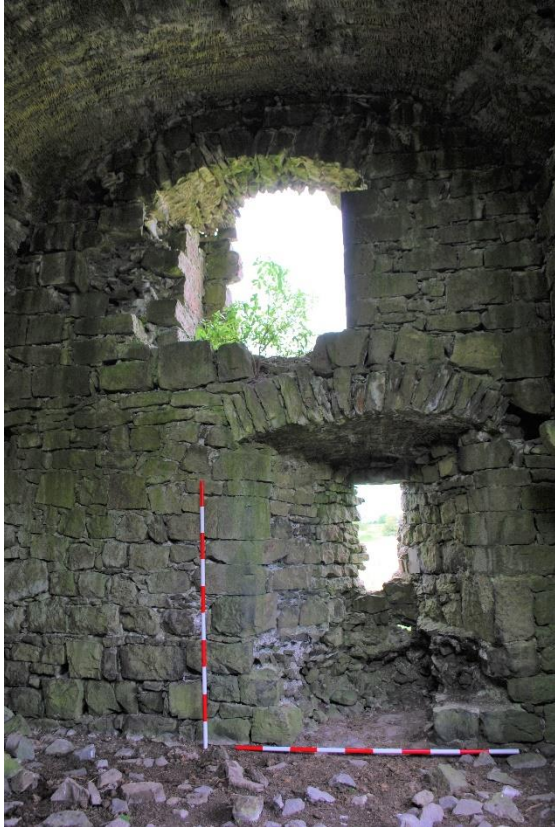
*Fig. 27 The centrally placed mezzanine window and eccentrically positioned ground floor window in the north wall of the tower house.*

The large breach in the masonry of the north wall (Fig. 27), just beneath the vault suggests that the mezzanine was lit by what must have been a centrally placed two-light window. This was the only window at mezzanine level. It has been robbed out. The window embrasure is straight-sided with a depressed arch which carries patches of wickerwork centering. The sides of the embrasure were finished with alternating long and short, cut and punch-dressed, quoins that survive on the east side. The depth of the embrasure suggests that it may have contained a window-seat.

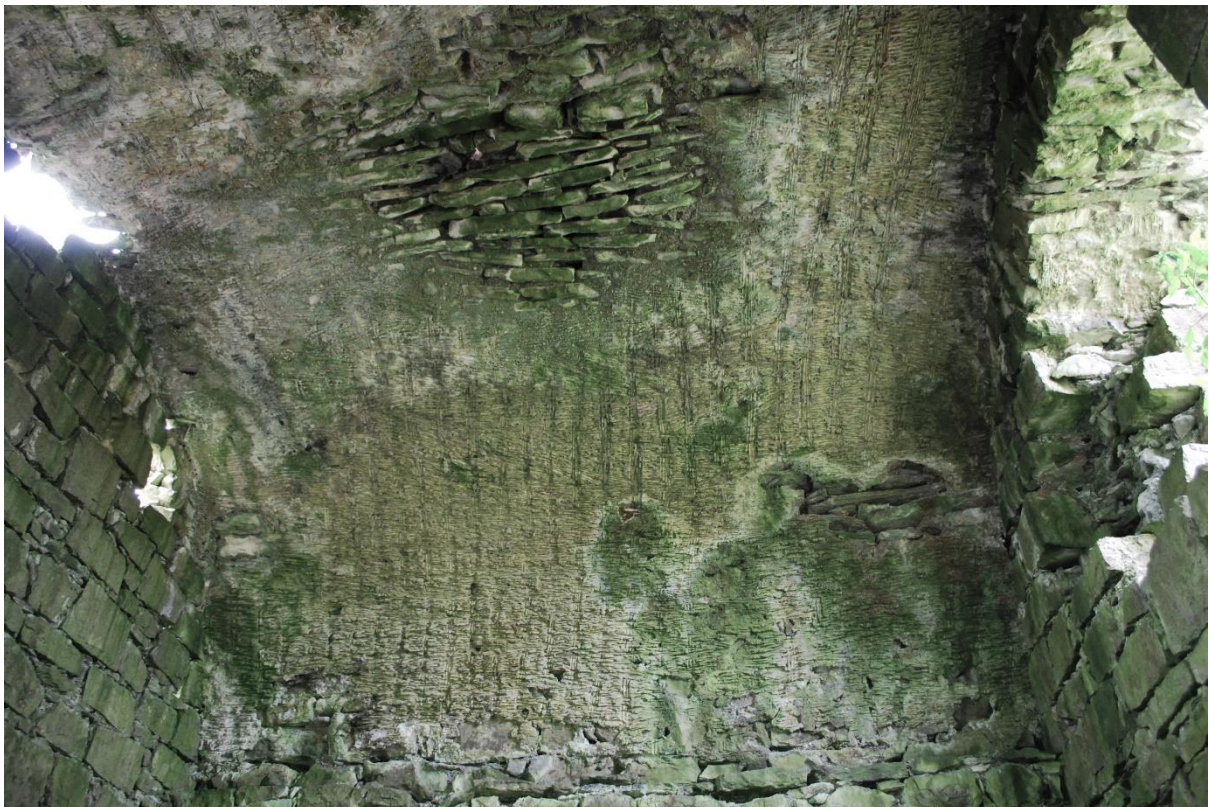
*Fig. 28 Some stonework at the centre of the vault has become loose and is in danger of collapsing the structure.*

The striking feature above the mezzanine is the well-preserved barrel vault (Fig. 28) that supported the first floor of the tower house. It carries extensive remains of wickerwork centering.

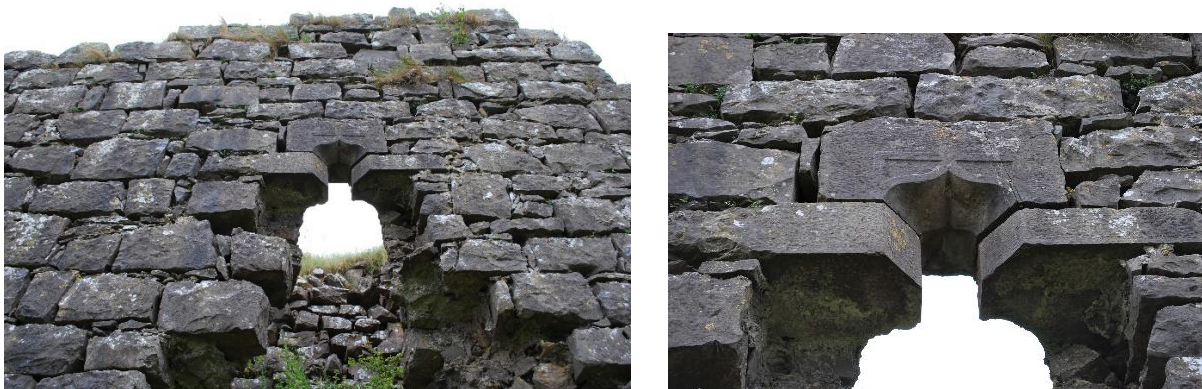
*Fig. 29 Remains of ogee-headed window in south wall lighting the mezzanine chamber on the south side of the cross-wall.*

On the south side of the cross-wall, on the same level as the mezzanine, there is a narrow chamber lit from the south wall by a single-light ogee-headed cut- and punch-dressed window with cusped spandrels (Fig. 29). Just the head and the chamfered upper side-stones of the frame remain in place. Internally, what survives of the window embrasure indicates that it had a wide splay and a lintelled head. Much of the masonry on the west side and all of that at the base of the window has been robbed out. This chamber was reached from the spiral staircase in the southeast corner of the tower house.

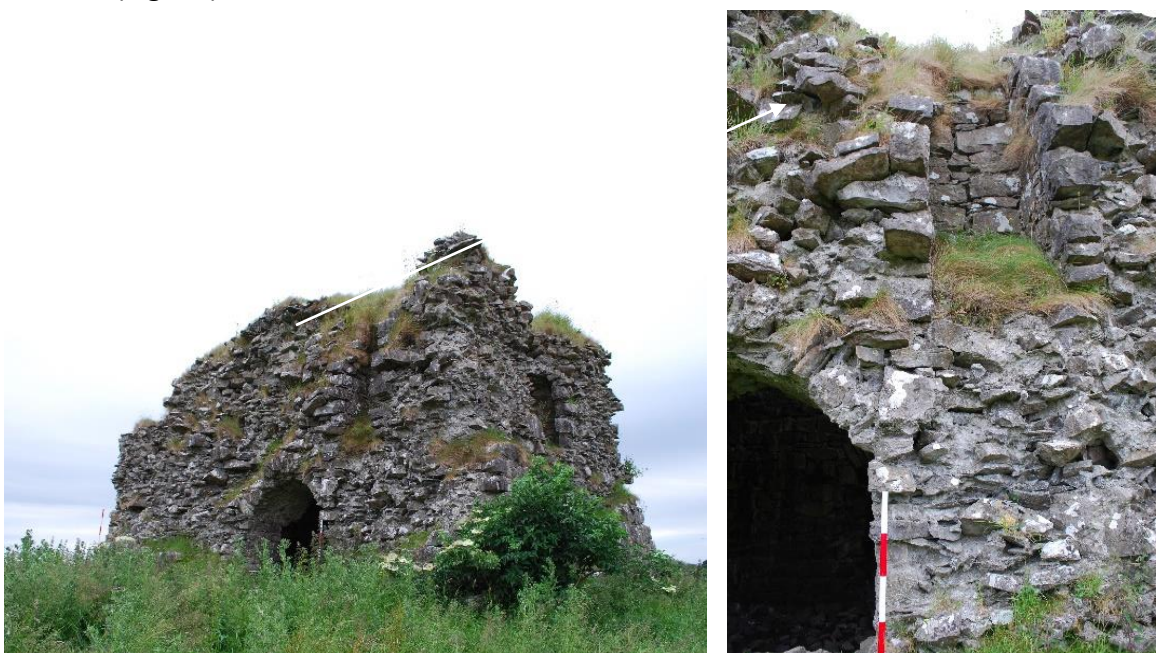
*Fig. 30 The exposed garderobe chute at the north end of the east wall.*

Little of the wall fabric of the tower house survives above the vault at first-floor level. A breach at the south end of the west wall indicates the former position of a first-floor window and its embrasure. The first-floor room was provided with a garderobe that was positioned in a mural chamber at the north end of the east wall. Remains of the garderobe chute are now visible as a result of its exposure through the robbing out of the facing stones from the entire façade of the wall (Fig. 30).

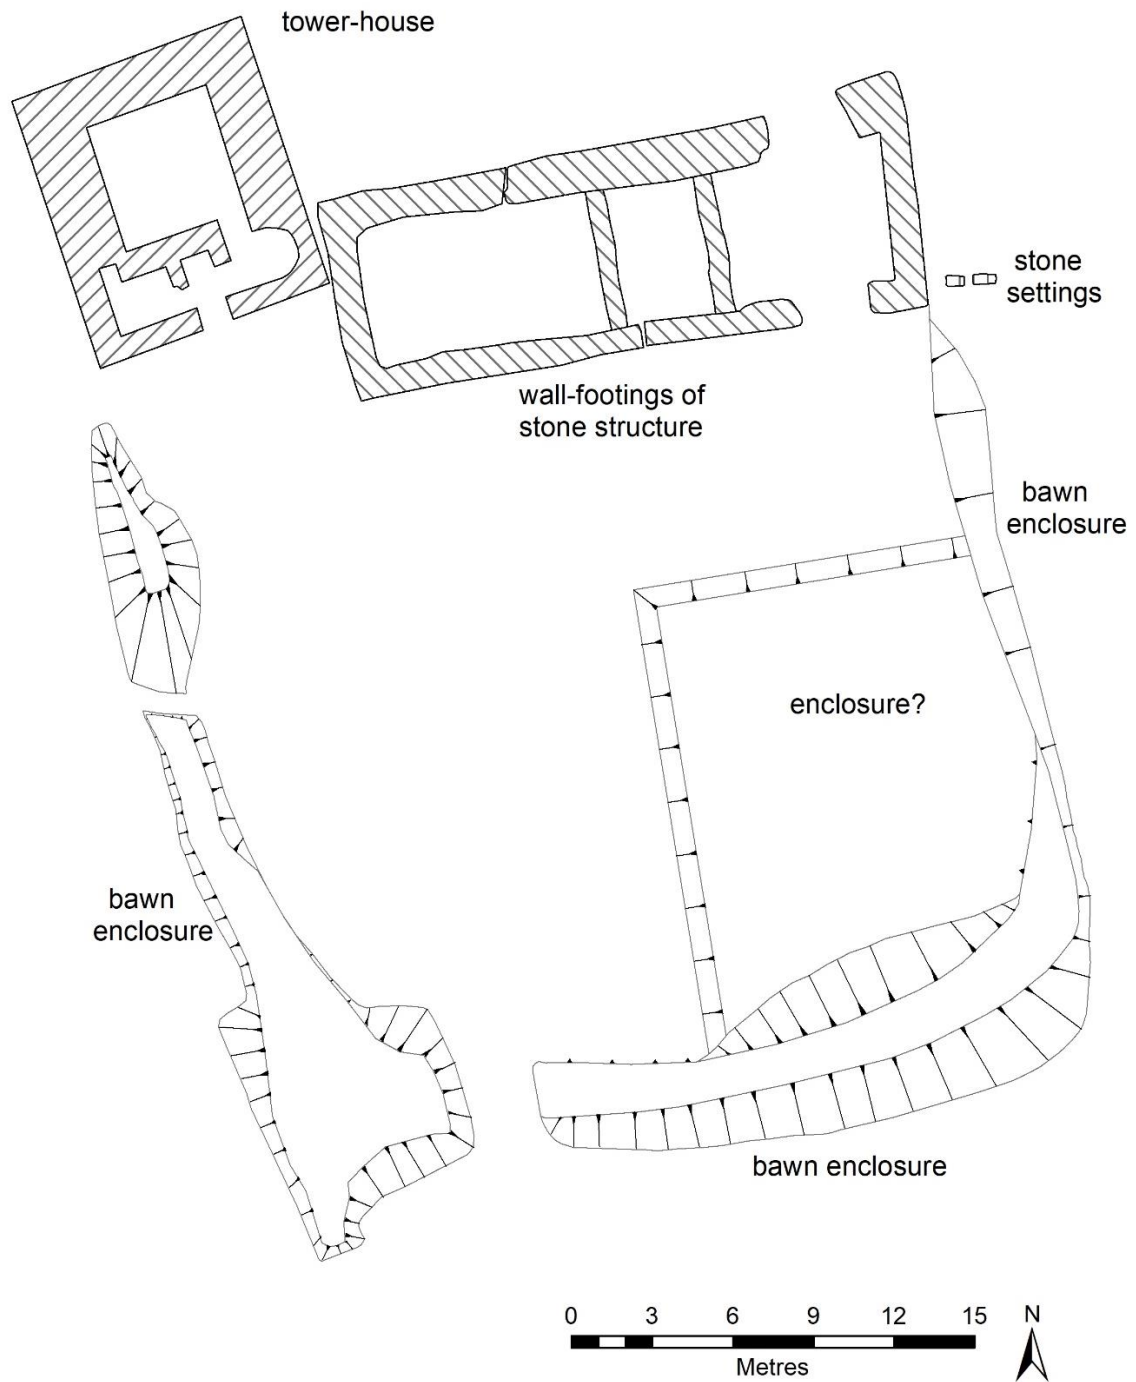
Fig. 31 The tower house, bawn and associated structures at Kilcloony (drawing: N. McCarthy; © E.FitzPatrick).

On the ground, the bawn and its relationship with the tower house is not well defined (Fig. 31). The bawn consists of fragmentary and grassed-over wall-footings and, in some places, banks, of a rectangular enclosure that sits on the level summit of a spur of land (Fig. 5). However, a LiDAR image of the tower house and bawn (Fig. 32) reveals its true extent (37m N-S x 32m E-W). The south façade of the tower house projects into the northwest corner of the bawn, with the entrance facing into and protected by the bawn. The bawn wall is c. 1m thick, where visible, and a possible entrance to it is suggested by a break towards the west end of the south wall. A building with two internal partitions appears to have been built up against the internal face of the bawn wall and immediately east of the tower house. There are also traces of a square enclosure occupying the southeast corner (Fig. 31). Without excavation it is not possible to say whether these features are contemporary with the tower house or post-date it.

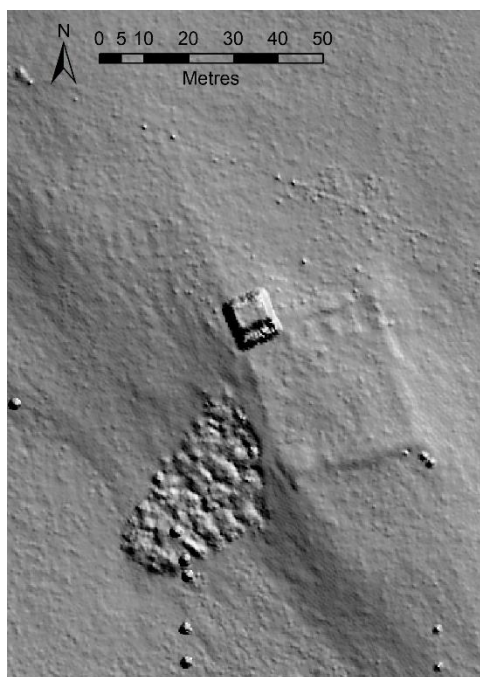
*Fig. 32 Kilcloony tower house and bawn (LiDAR courtesy of TII).*

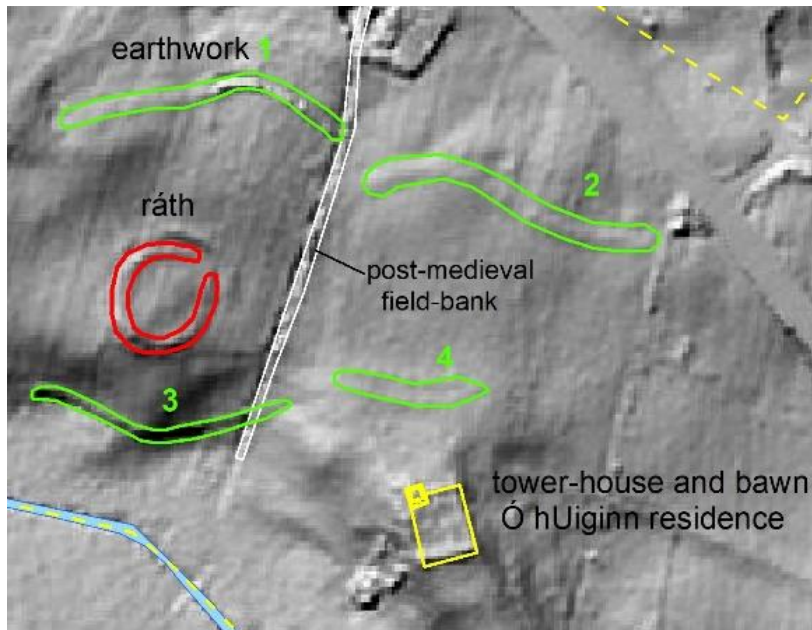
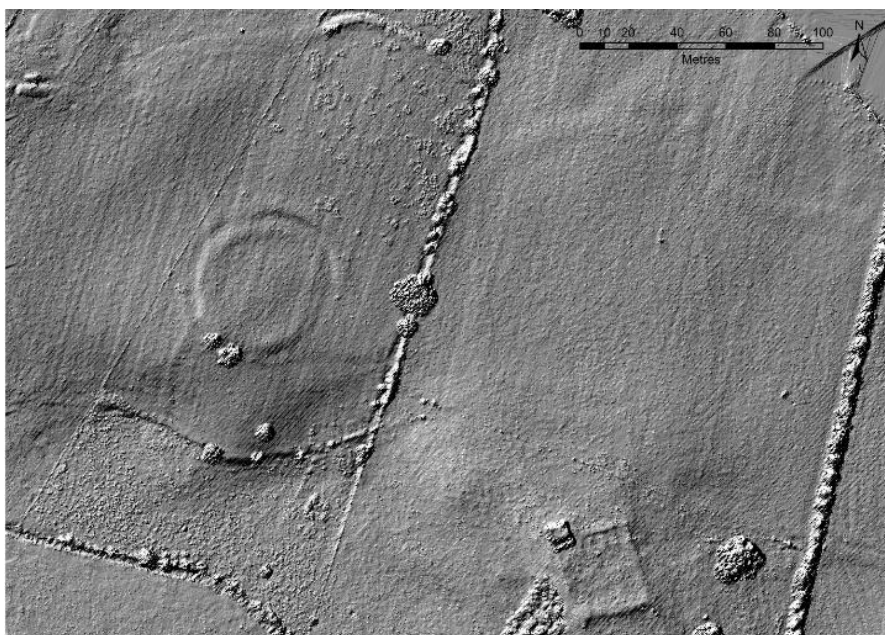
*Fig. 33a (above) and 33b (left). A large ráth and segments of embankments visible on the LiDAR image of Kilcloony townland (LiDAR courtesy of TII).*

The degraded remains of a bivallate *ráth* (GA016-064) lie c. 150m west-northwest of the tower house (Fig. 33a & b). The *ráth* is large at c.57m in diameter and enclosed by two banks

separated by a fosse. On the ground, there are just partial remains of both of the banks and the fosse which, combined, are c.8m wide. The full extent of the monument is visible on the LiDAR imagery that covers part of the townland. There are four segments of broad earthen field banks to the north and south of the *ráth* (labelled 1-4 on Fig. 33a). Portions of embankments 1 and 3 are visible at ground level, but embankments 2 and 4 are visible only on the LiDAR.

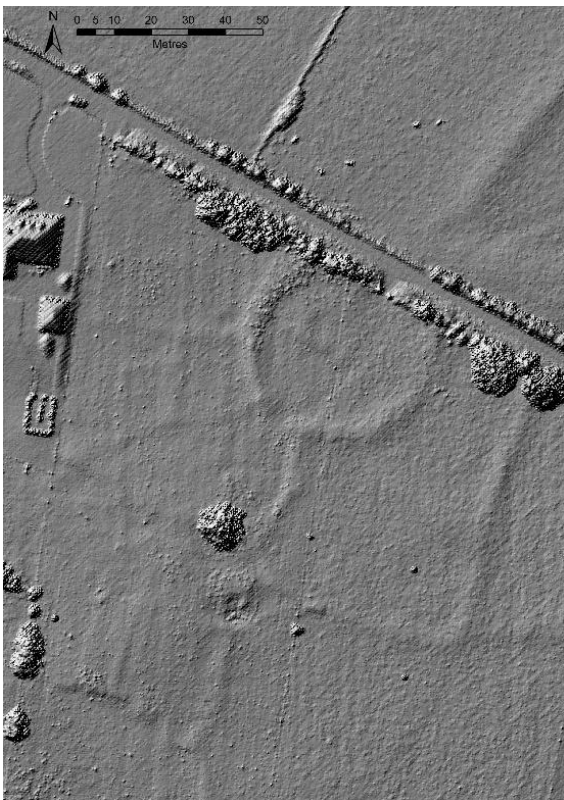
Fig. 34 The remains of a *caiseal* enclosure containing a house, with associated fields and plots. (LiDAR courtesy of TII).

A third settlement enclosure, which is new to the archaeological record for Kilcloony townland, is situated 670m east-southeast of the tower house and 200m east of Kilcloony

burial ground (Fig. 34). An arc of the enclosing bank in the northwest quadrant contains a high content of stone and what survives of the monument on the ground suggests that it is best classified as a *caiseal*. The full extent of the enclosure is visible only on the LiDAR imagery for the townland. It is c. 30m in diameter internally. The northern arc of the enclosure was truncated by a minor road aligned west-northwest–east-southeast. The LiDAR image shows the remains of a small rectangular building in the western half of the interior and what appears to be an internal wall dividing the interior of the *caiseal* on its north–south axis.

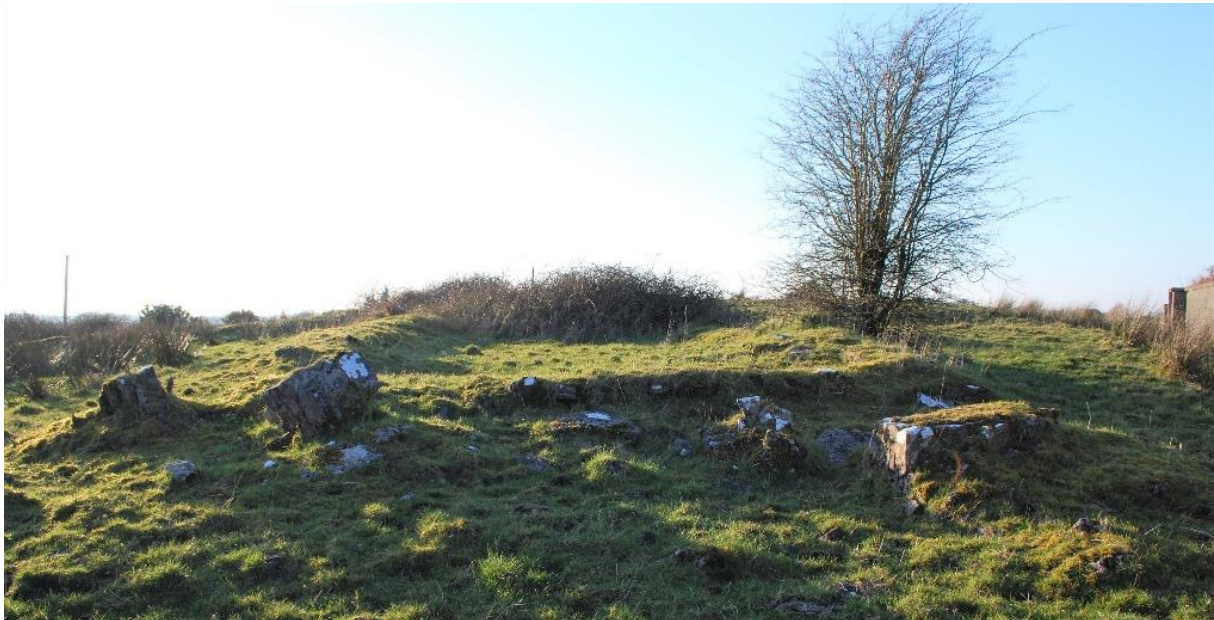
*Fig. 35 Wall-footings of the building known as 'Kilcloony Church' viewed from east end.*

A building recorded by the first Ordnance Survey as 'Kilcloony Church in ruins' (GA016-061) lies immediately south of the N17 and c. 250m north of the tower house (Fig. 35, 36). It is a rectangular structure (c. 15m x 4.7m internally), the long axis of which is aligned east-west. The walls have been reduced to grassed-over wall-footings, c. 0.80m thick. A break at the east end of the north wall may indicate the position of a doorway. It is enclosed to the south by an earthen bank, while a broader linear bank marching south, which cuts through the enclosed area of the building, can probably be attributed to agricultural improvement on the Kilcloony Estate during the late eighteenth or the nineteenth century (Fig. 36).

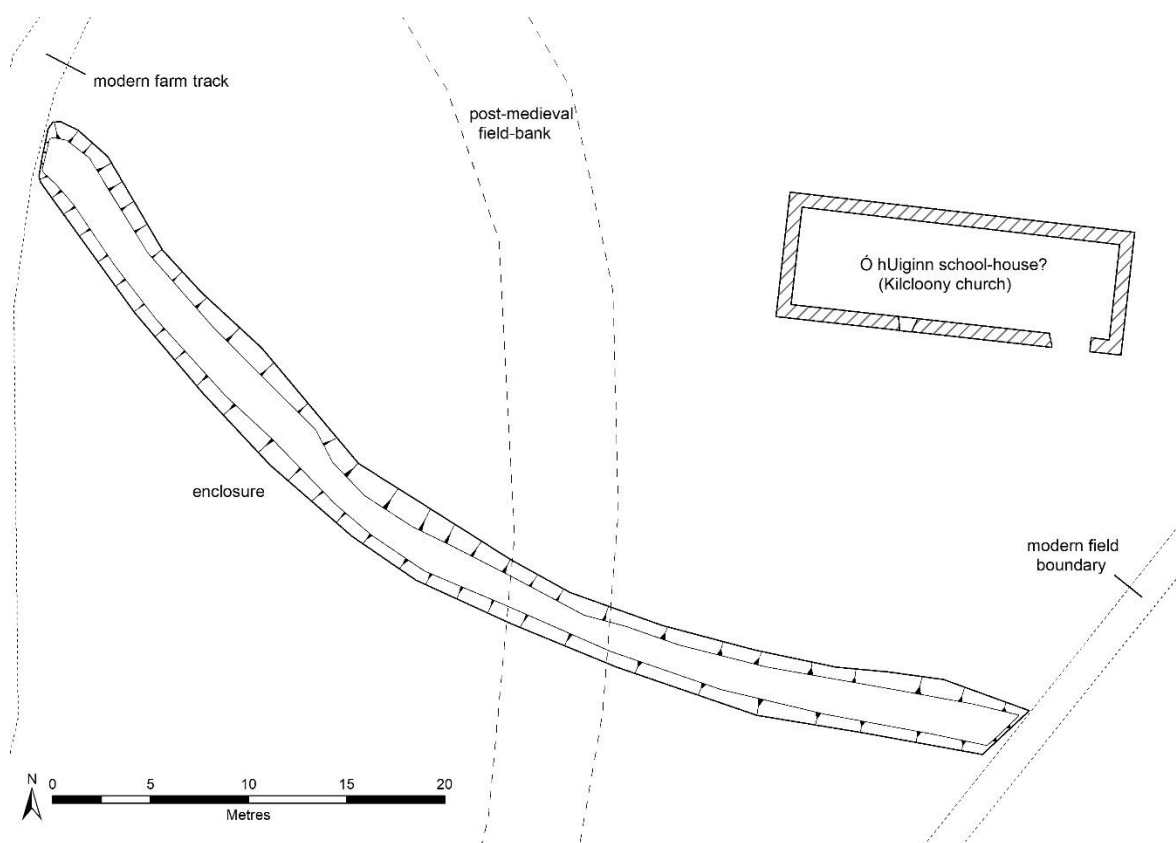
Fig. 36 'Kilcloony Church' and embankments (drawing: N. McCarthy; © E.FitzPatrick).

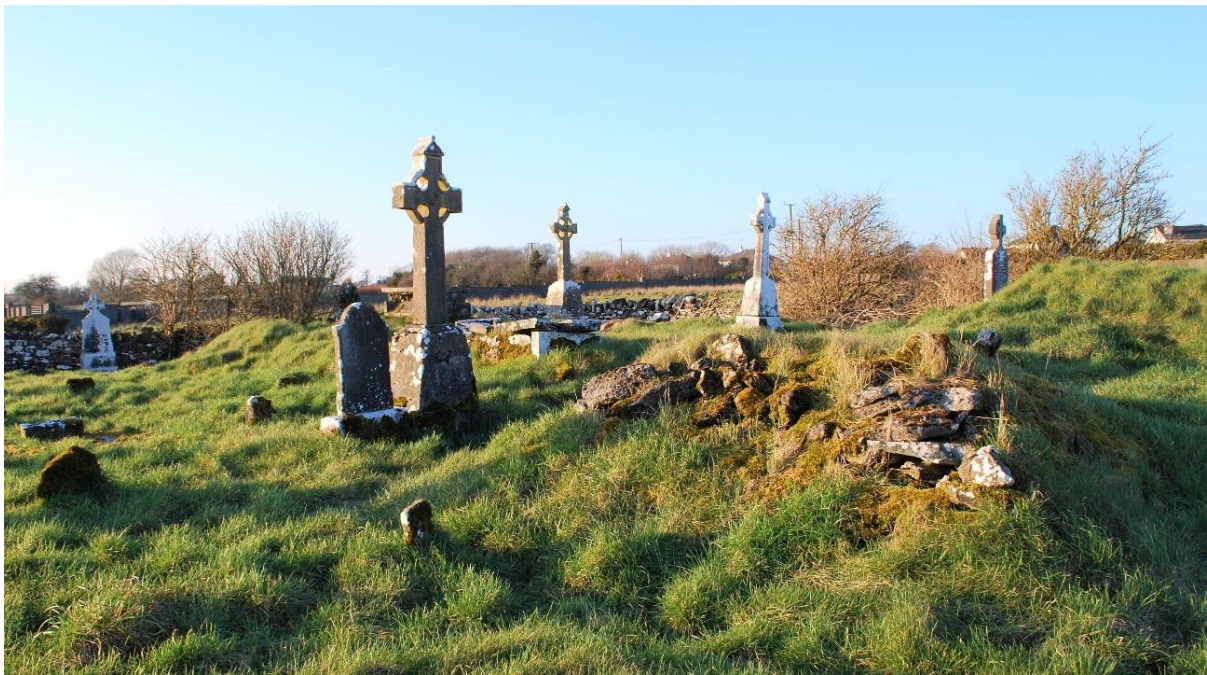
*Fig. 37 The higher western area of Kilcloony burial ground showing remains of a stone structure and grave-markers.*

A graveyard (GA016-063001) designated as a 'Burial Ground' (c. 45m x 40m) on the first edition Ordnance Survey six-inch map is situated on a southwest-facing slope 425m southeast of the tower house (Fig. 2). It has been extended eastward over time. Wall footings of a possible building were noted in the higher and older western area of the graveyard during walkover survey for this report in 2019 (Fig. 37). In the same area, two crosses (GA016-063003; GA016-063004), both interpreted as early medieval and described as crudely cut, were recorded in 1984, but they were not found when the graveyard was inspected in 2019 for this report. The first of the crosses (GA016-063003) was recorded as being 0.56m high and 0.05m thick, 0.21m wide across the arms, narrowing to 0.23m at the base and set loosely in the ground in a secondary position.<sup>21</sup> It has been described as 'a thin plain cruciform-shaped stone with an almost semi-circular top, short stubby arms and a narrow shaft which splays outwards near the bottom'.<sup>22</sup> The second cross (GA016-063004) was recorded as being 0.8m high and 0.4m wide. The record of two early crosses on the higher ground of the western area of Kilcloony graveyard intimates that this, and not the building south of the tower house, which the nineteenth-century Ordnance Survey designated 'Kilcloony Church', could be the site of a medieval church at Kilcloony and specifically a pre-Norman monastic church.
