Heritage Council Reference Code: CH17958 Reilig na bhFilí
ITM: 546704/719794
SMR Nos: Church (GA096-121----) and Graveyard (GA096-121001-).
ÆGIS Ref.: 814-1

Conservation and Management Plan for Killeeneen Medieval Parish Church, Killeeneen More townland, Co. Galway.

Report lead author: Frank Coyne MA MIAI

Date: 9 October 2023

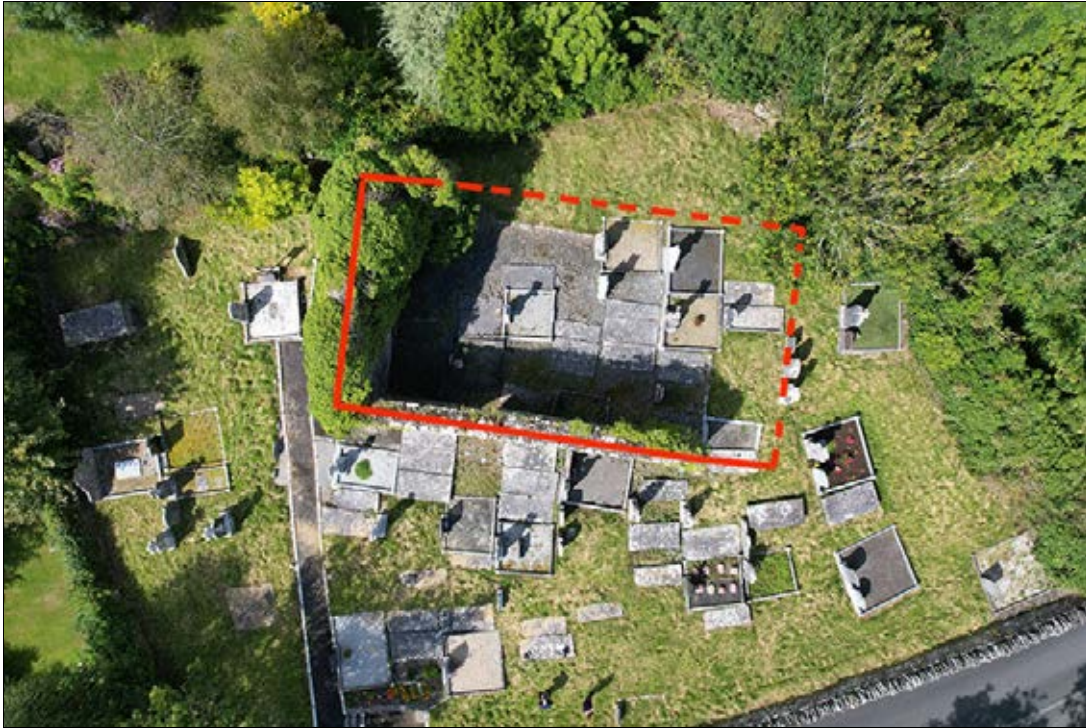
Figure 2.13. Aerial view of church (annotated by writer).

The remains of church now comprise the western and southern wall. There is no trace of a font, although portion of one is recorded in the ground close to the door by the Archaeological Survey of Ireland. It was not located during field work . The door is located in the south wall. It consists of a fifteenth century pointed arched doorway, which is a later insertion.

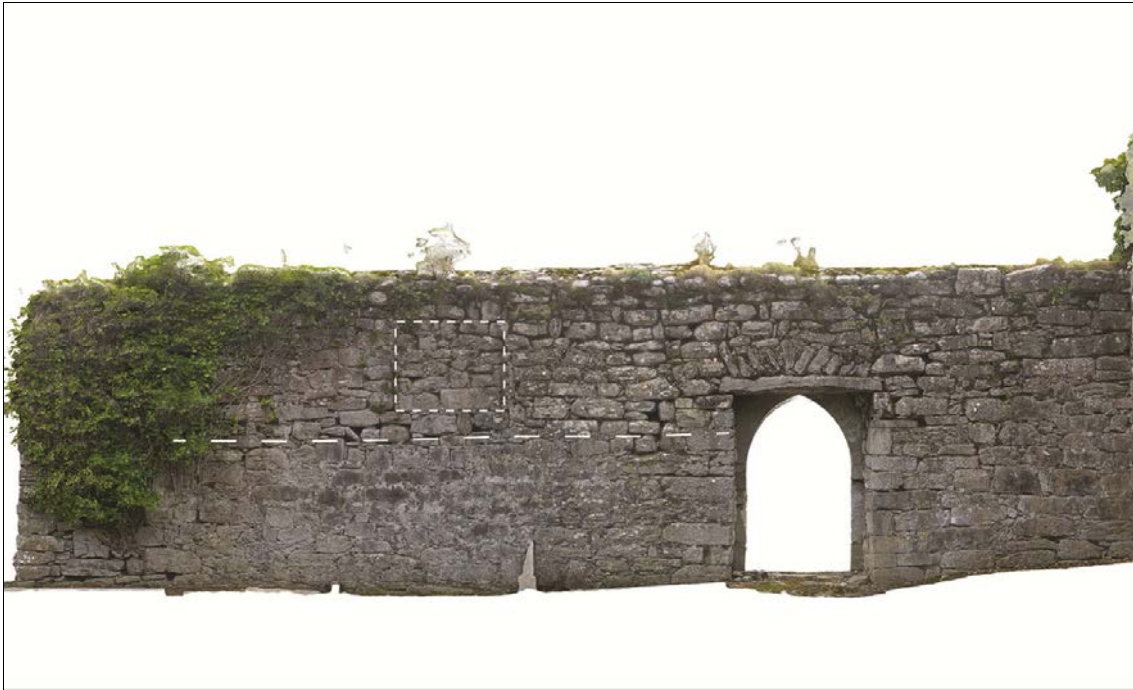
Figure 2.14. Elevation of interior of church wall (after KGSS, annotated by writer)

A possible blocked up wall niche was also note, which belongs the to the 15th century phase, and was subsequently filled in.

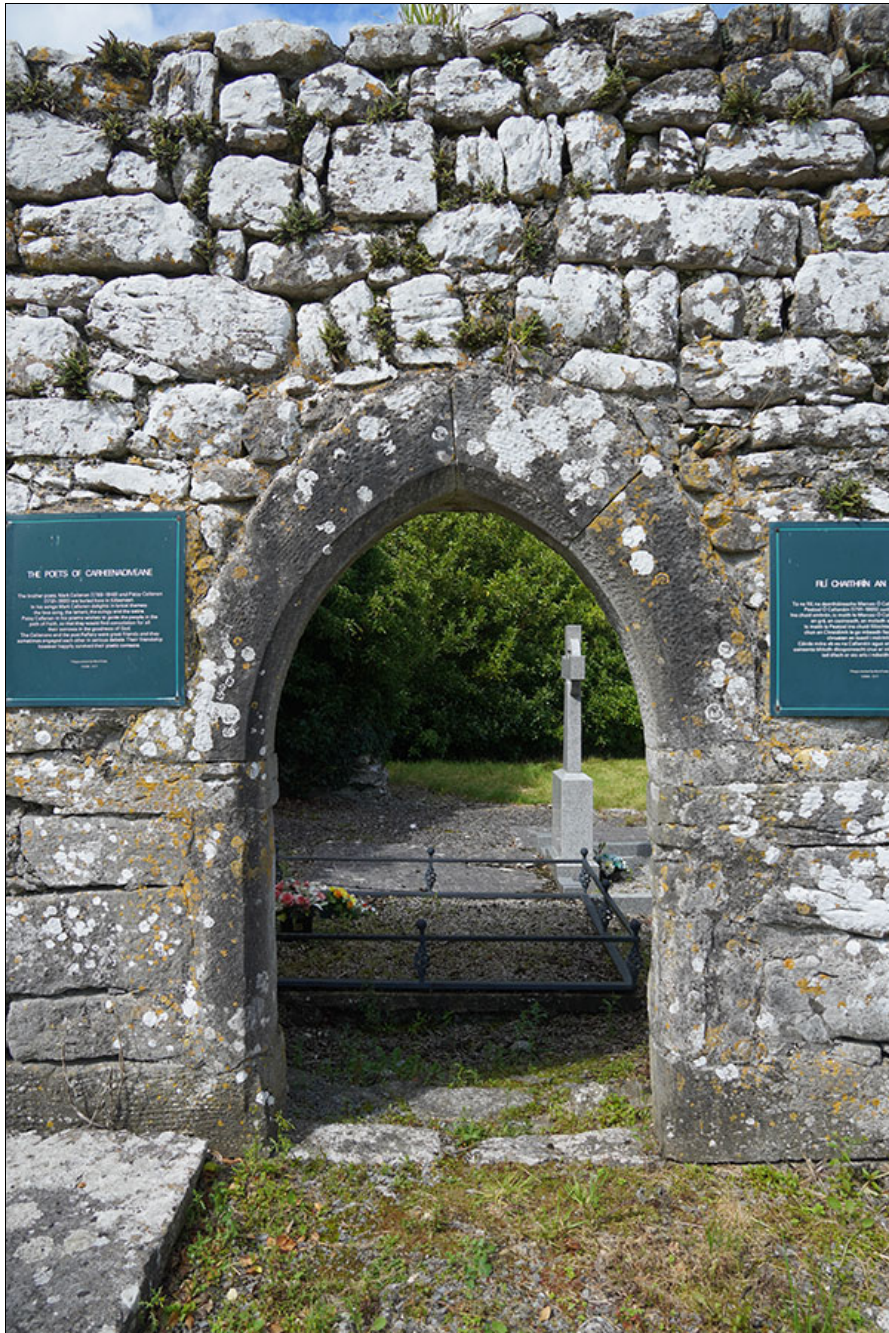
Figure 2.15. Door in the southern wall, from S.

Portions of the original twelfth/thirteenth century door jambs are visible, and in places have been re-dressed with fifteenth century punch dressing. The recess for a drawbar hole is visible in the interior, extending in the interior of the wall for approximately 1m towards the east, with the receiving hole located in the western side of the door. This would have served to lock the door from the inside.

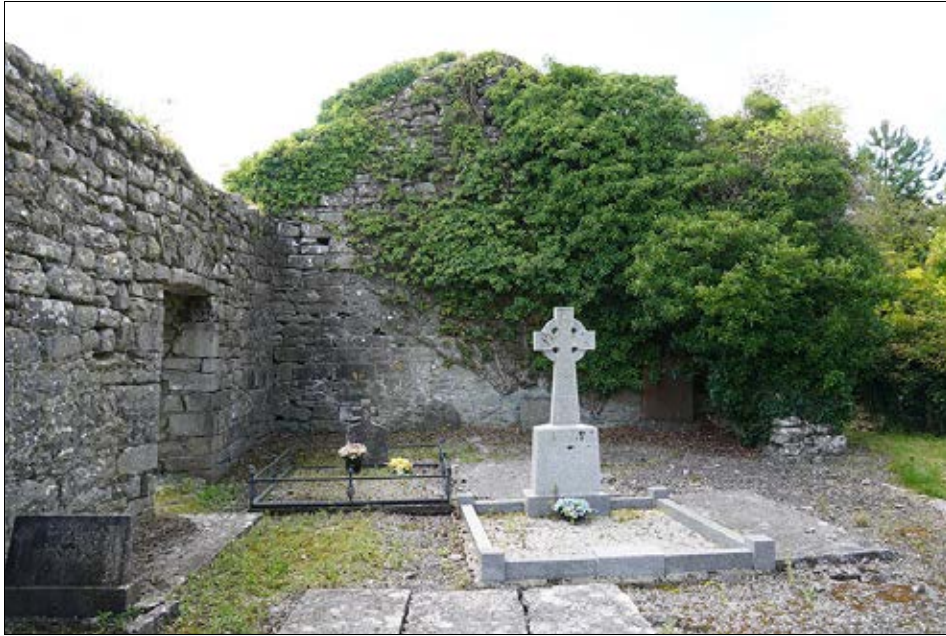
The northern and eastern walls of the church are no longer extant, and are visible as a low, grass-covered ridge. The interior now contains a variety of burials, comprising late medieval tapered grave slabs, nineteenth century ledger slabs and nineteenth and twentieth century headstones and grave surrounds. There is no trace on any internal divisions, and no indication of a priest's residence at the western side of the nave.

Figure 2.17. Interior of church, from E.

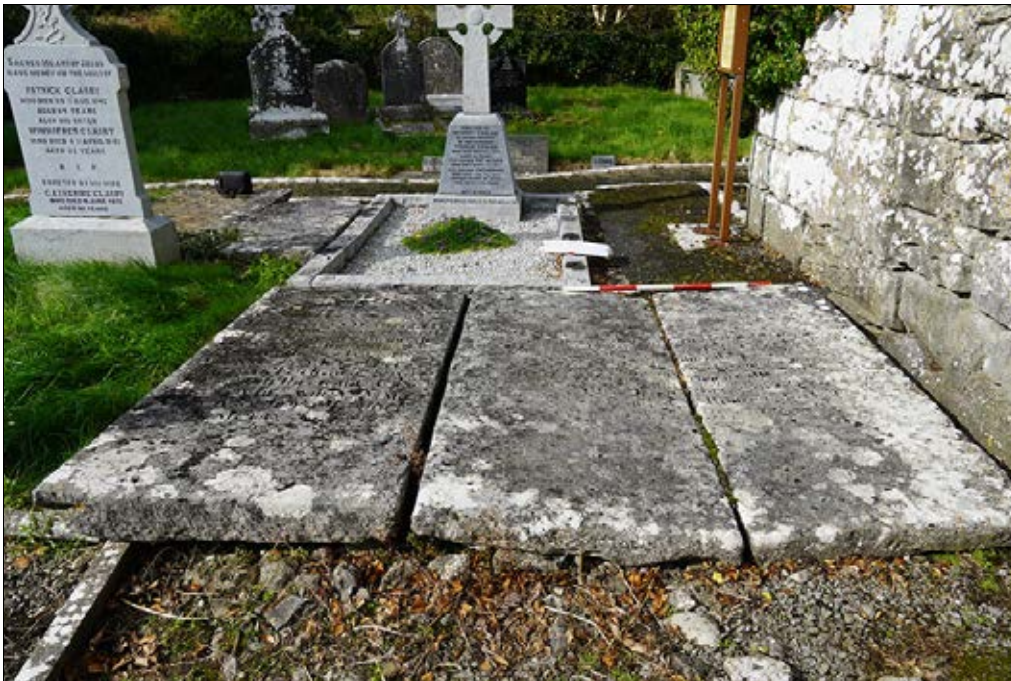
A variety of burial markers are visible in the interior of the church and the graveyard. There does not appear to be any early, undecorated simple grave markers. In all, there are approximately 80 graves in the graveyard. The majority of these are nineteenth century in date, and comprise highly decorated ledger slabs and headstones.

Figure 2.18. Nineteenth century ledger slabs, from E.

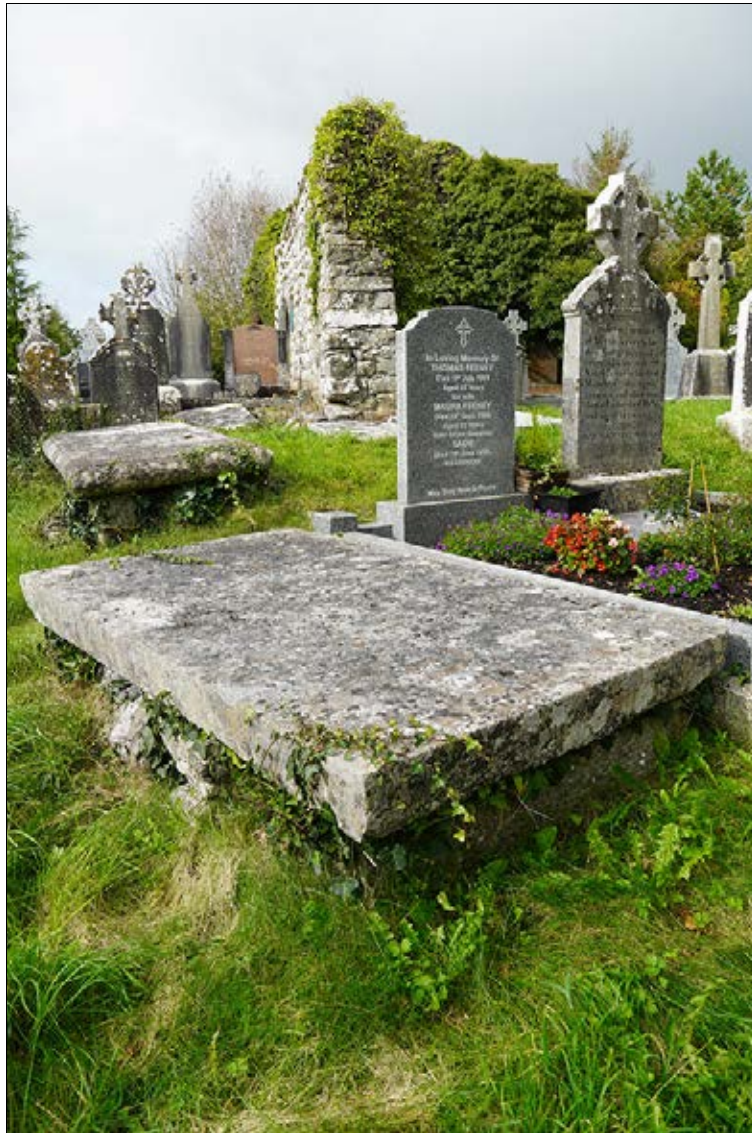
There are also a number of table tombs, and one box tomb, all apparently of nineteenth century date.

Figure 2.19. Nineteenth century table tomb, from SE.

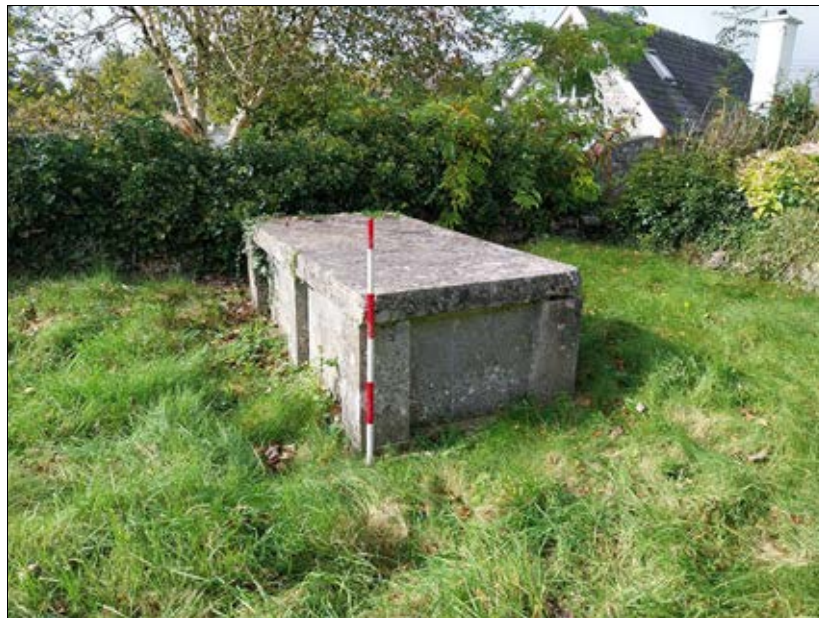
Figure 2.21. Box tomb, located in the NW side of the graveyard.

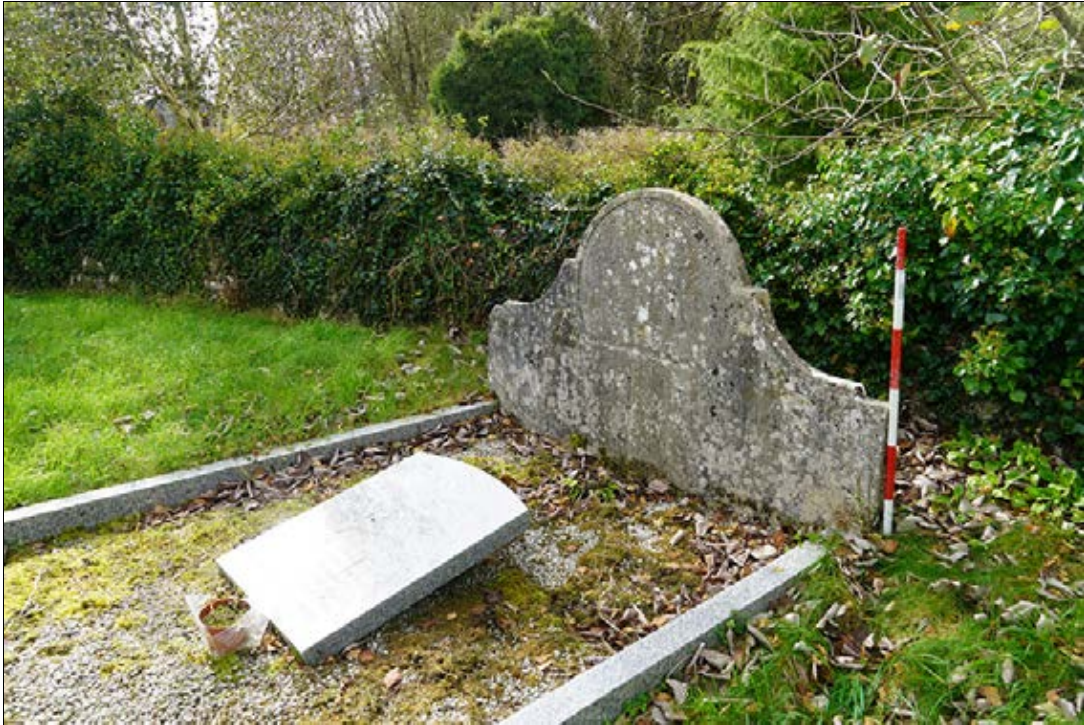
Figure 2.22. large shouldered headstone, nineteenth century, from NE.

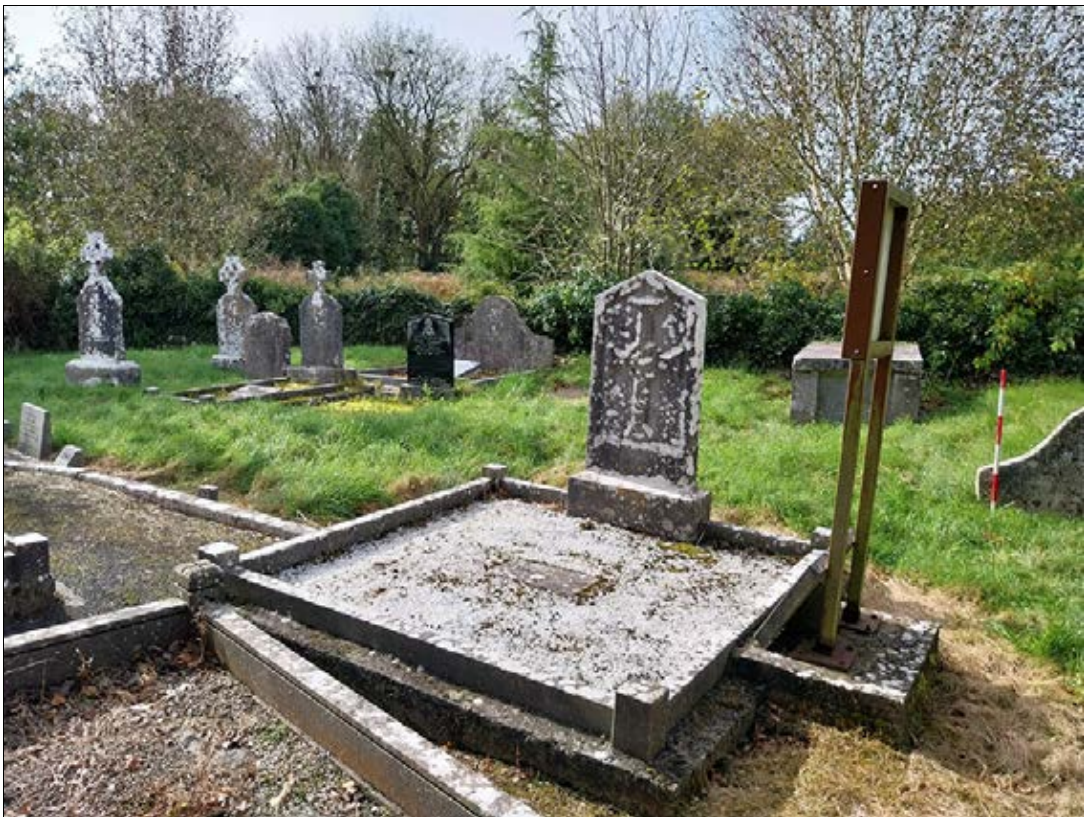
Figure 2.23. The most well-known plot at Killeeneen More, the grave of Anthony Raftery the Poet.

The grave is in good condition. It has a concrete surround, and a memorial plaque donated by lady Gregory. To the north are two other memorials, one in stone, and another on a steel frame, erected in the early 1970s.

The Raftery and Callanan graves are in reasonable good condition, but would benefit from some maintenance.

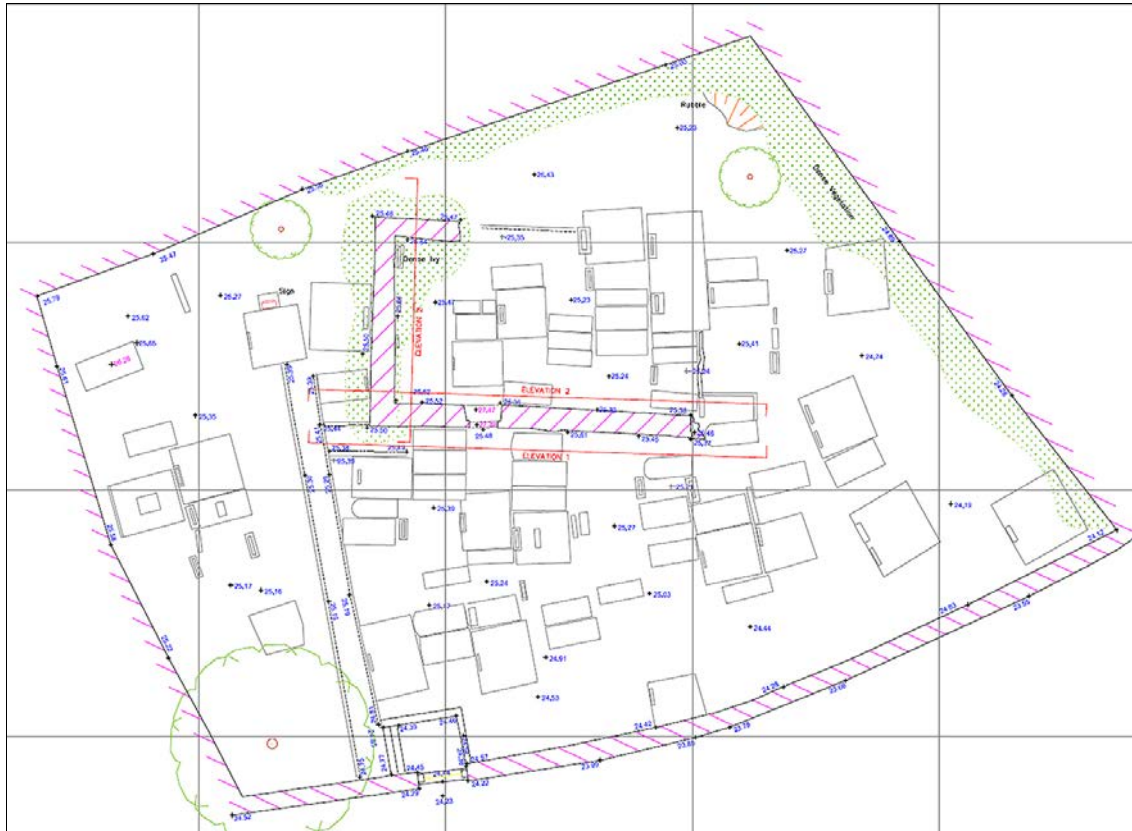
Fig. 2.26. Plan of Killeeneen More (after KGSS Surveys).

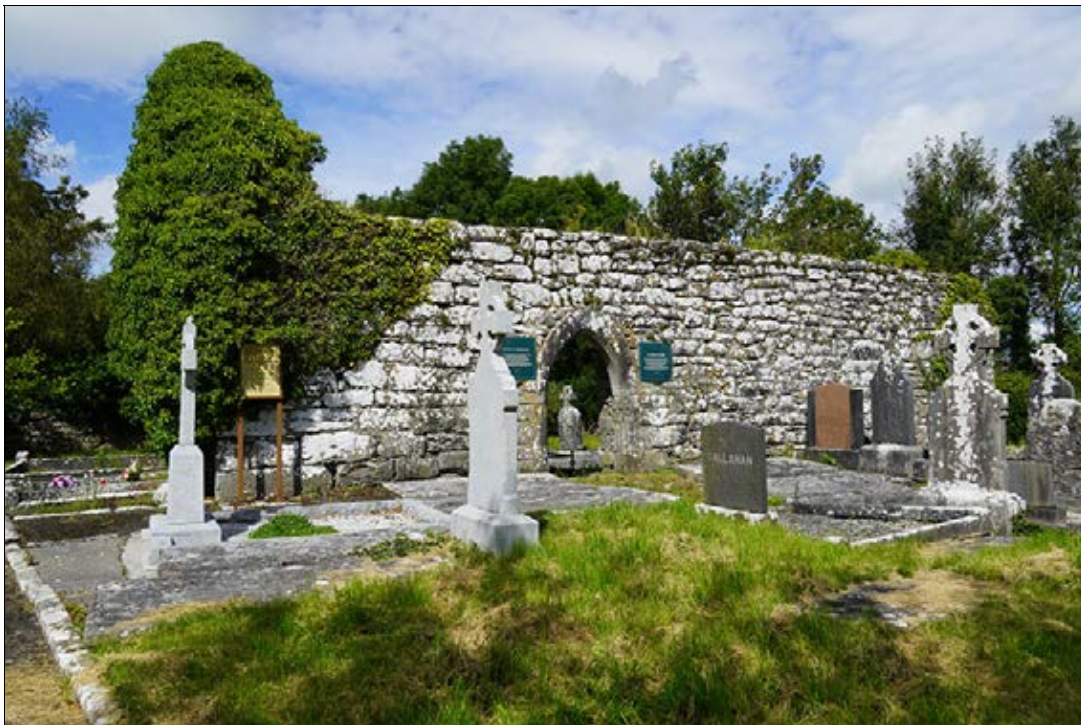
Figure 2.29. South wall and west gable, from SW.

The western gable of the church is now almost completely overgrown with ivy. This has been cut at the base before, particularly on the interior face of the wall. However, the ivy continues to thrive. Otherwise the interior is in good condition.

9	Complete removal of ivy and a programme of consolidation and repair of the church.	2	Long

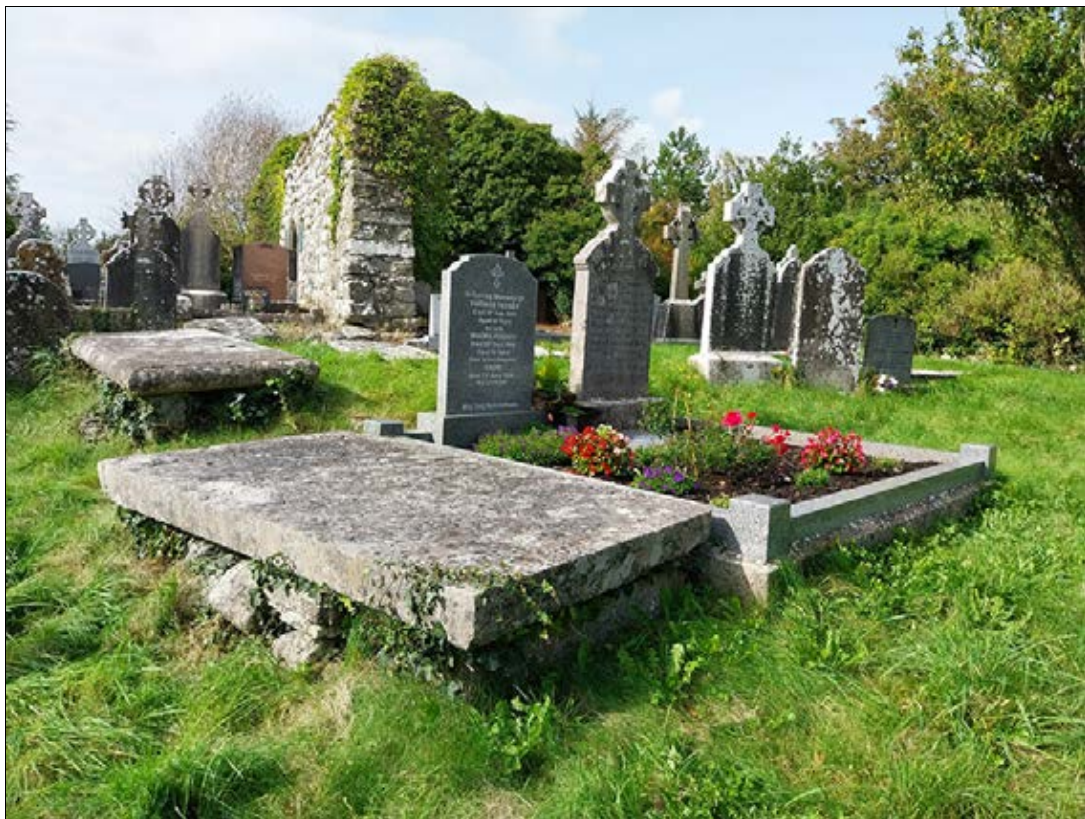
The graveyard is in good condition. The graves are accessible, although there are no dedicated footpaths around the graveyard.

Figure 2.30. Graveyard, from SE.

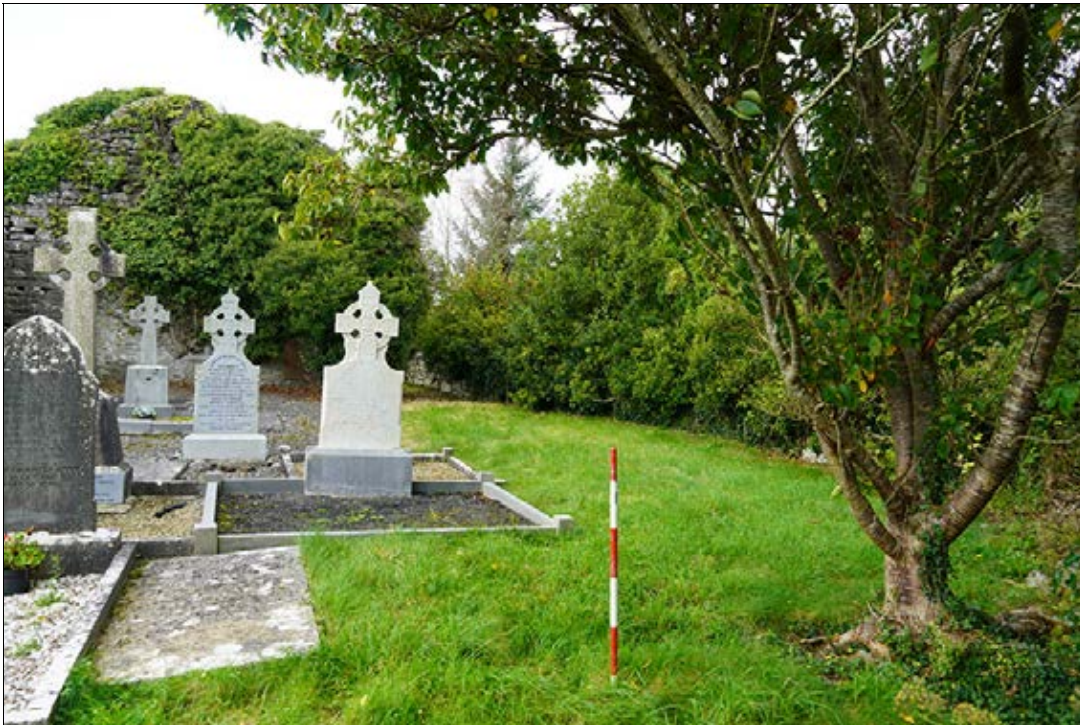
Figure 2.31. Line of north and east wall of church, note tree on right, from E.

The northern and eastern walls of the church are no longer extant. The remains are visible as a grass covered raised area, approximately 1m high and 0.3m high. The roots of an ornamental cherry tree growing at the northeast corner will ultimately impact on the sub-surface remains of the walls.

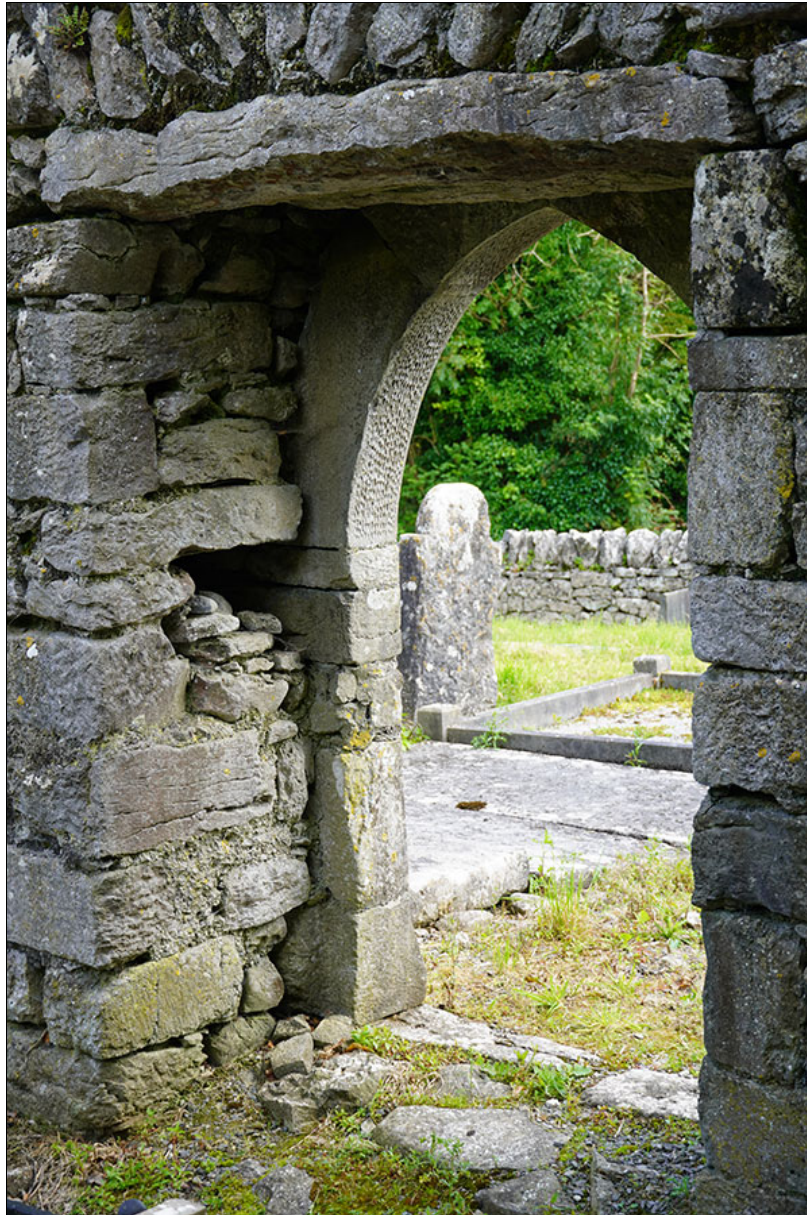
Figure 2.32. Church door, note drawbar hole, and 15th century pointed archway with punch dressing, from interior of church, from NW

The door in the south wall is in good condition. However, minor repairs may be necessary, as some of the masonry has become loose in the drawbar socket.

The door exhibits two phases of construction-an earlier 12th/13th century original stonework, and later 15th century pointed arch and replacement jambs.

3. Repair	Maintaining complex for future generations to enjoy. Improve access for visitors	Cost implications; Schedule of future maintenance required to keep building sound; Future cost implications	Minor repairs to structure around door. Footpath levelled and re-dressed. Improved disability access at the gate.

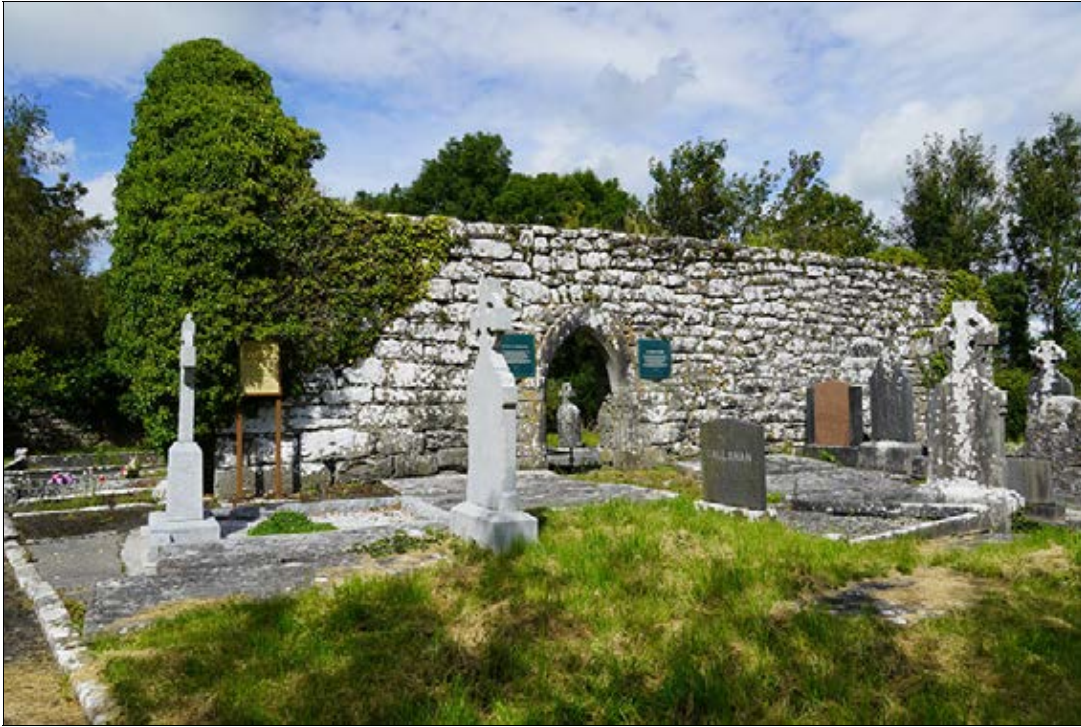
Figure 2.34. Callanan family plot with memorial plaques, from SW.

The grave is in reasonably good condition. It has a concrete surround, and a modern headstone. Two memorial plaques commemoration mark and Patsy Callanan are screwed to the wall, and held in place with cement on either side of the church door.

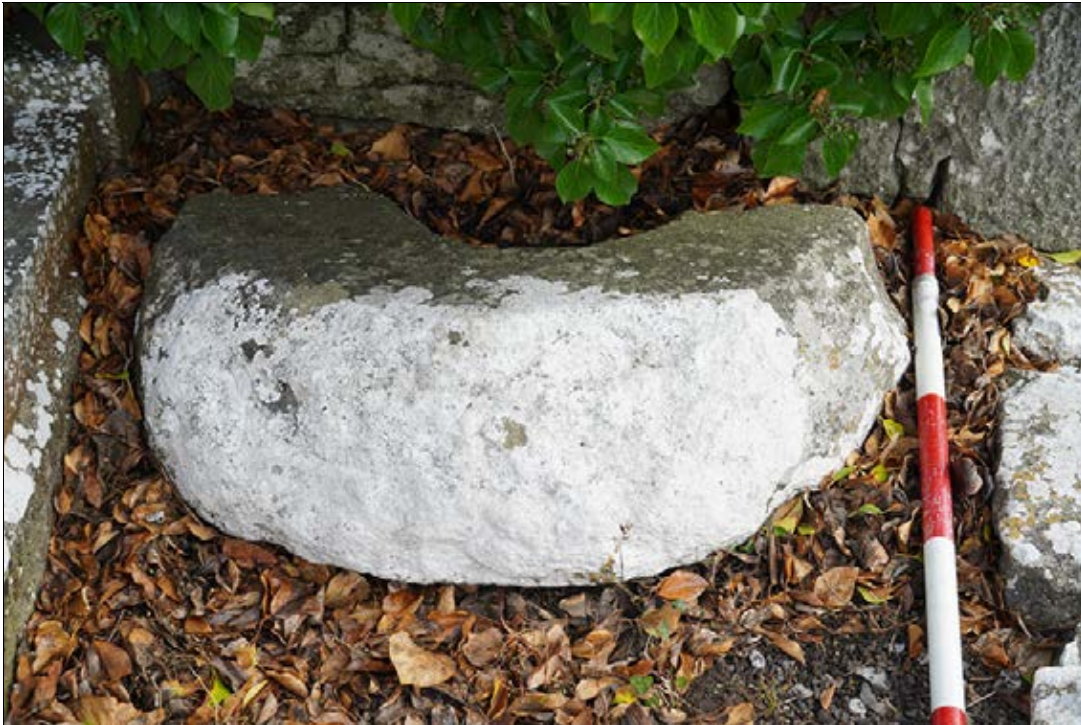
Figure 2.35. 12th/13th century window head fragment at W gable of church, from W

The round head of a 12th/13th century window, probably part of the original east window of the church lies on the ground externally at the western gable. It is in good condition, but it is in a vulnerable position.

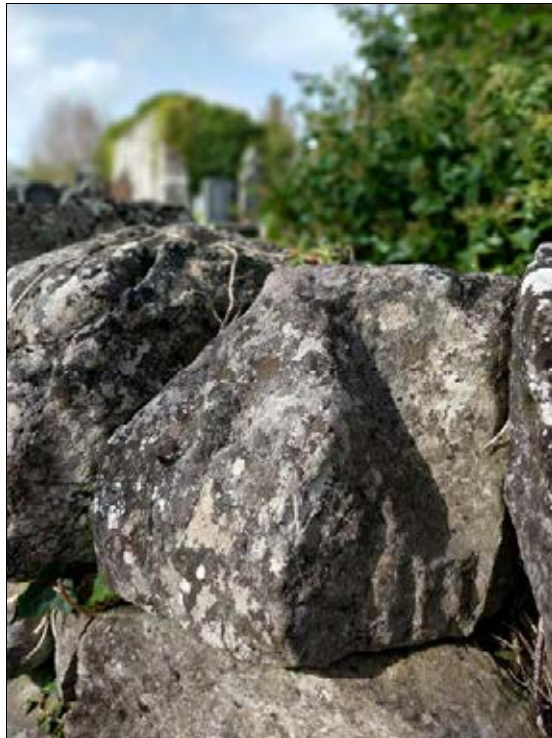
Figure 2.36. Carved stone head on corbel, from SE.

There are several ex situ fragments in the graveyard wall, some visible as dressed stone, and other recognisable fragments, such as a decorated stone corbel, and part of a twelfth century window. They are in good condition. The location of the carved stone head makes it vulnerable to being stolen.

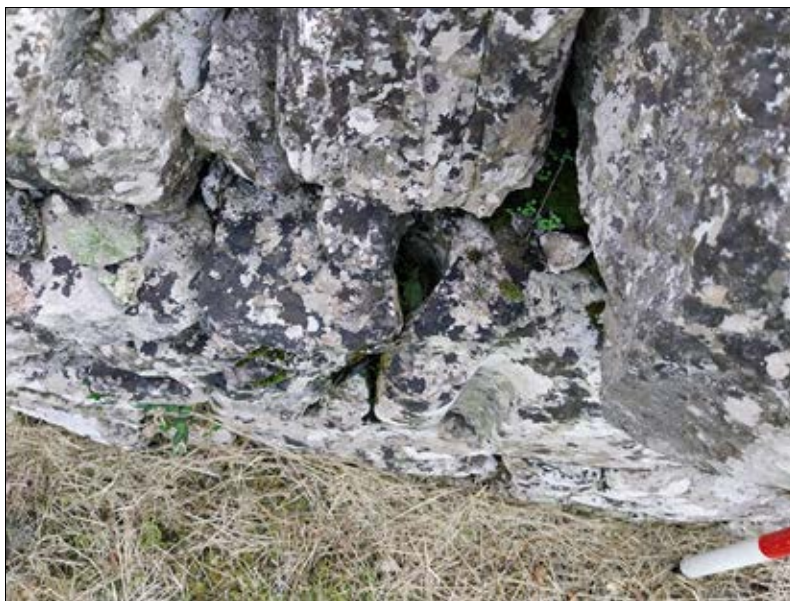
Figure 2.37. 12th/13th century window fragment in wall, from N.

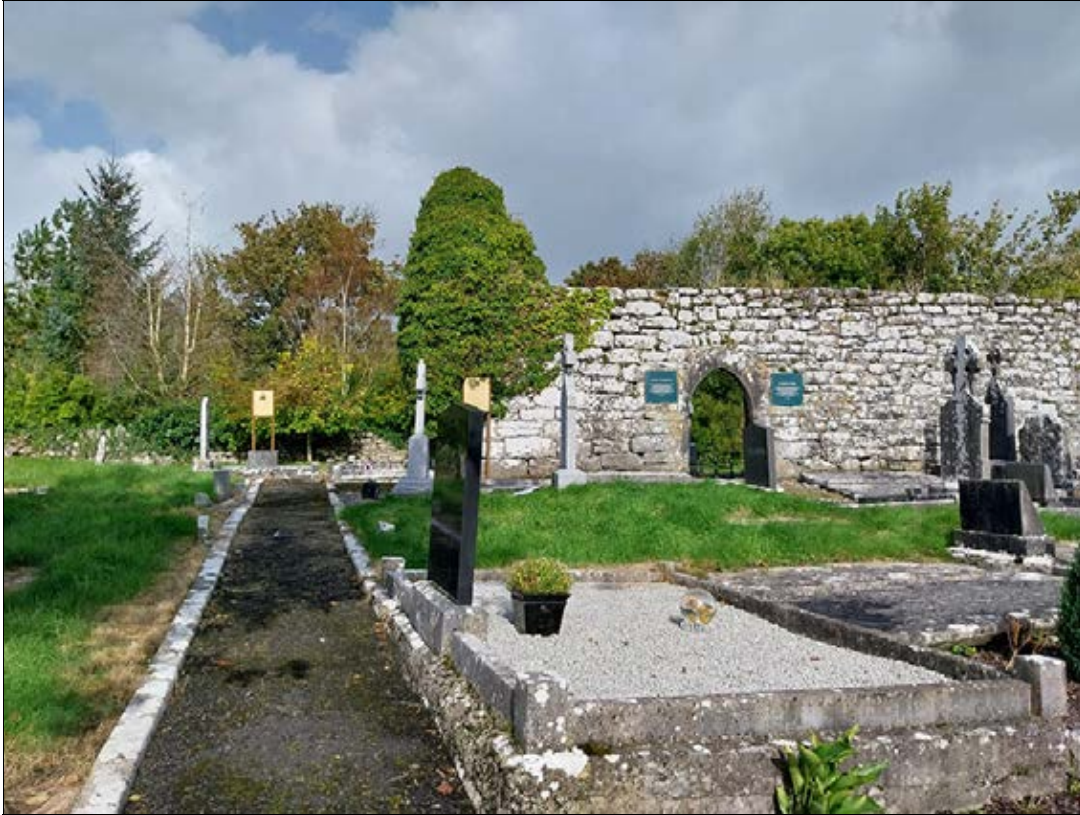
Figure 2.38. Uneven footpath, from S.

Raftery's grave is accessed by means of a narrow tarmac footpath. It is uneven, and not suitable for access for elderly visitors.

The main access route to Raftery's grave is via a narrow tarmac footpath. This is undulating and uneven, and is increasingly becoming a trip hazard, particularly for elderly visitors to the site.

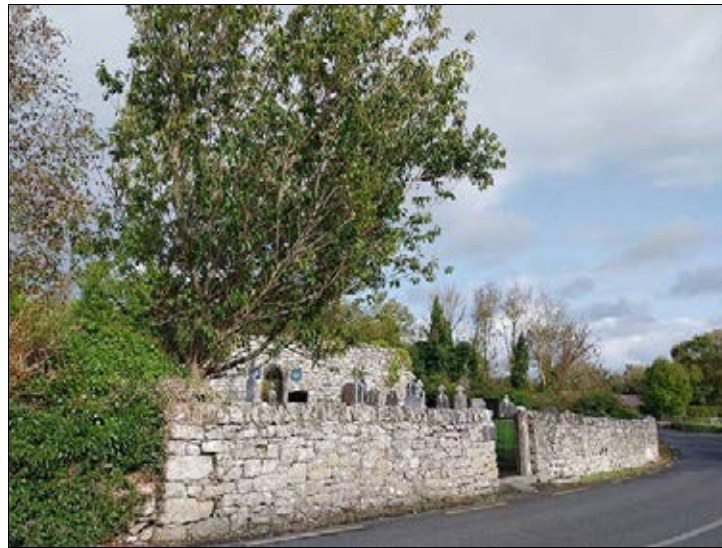
The graveyard is surrounded by a stone wall, bonded with mortar. It is substantial along the curving southern side of the graveyard where it meets the public road.

Elsewhere, the boundary is formed of an overgrown wall, with an area of collapse at north. The boundary is in need of maintenance, and the vegetation need to be controlled. A pile of stone here may be from collapse, and should be sorted and checked for architectural fragments.

Figure 2.39. Graveyard wall, from SW.

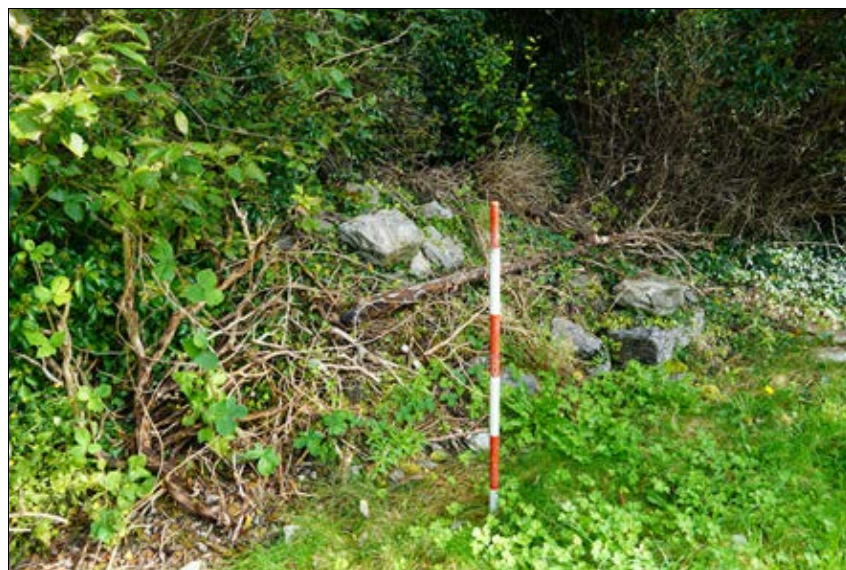
Figure 2.40. Stone pile, collapsed wall of graveyard at N, from SW.

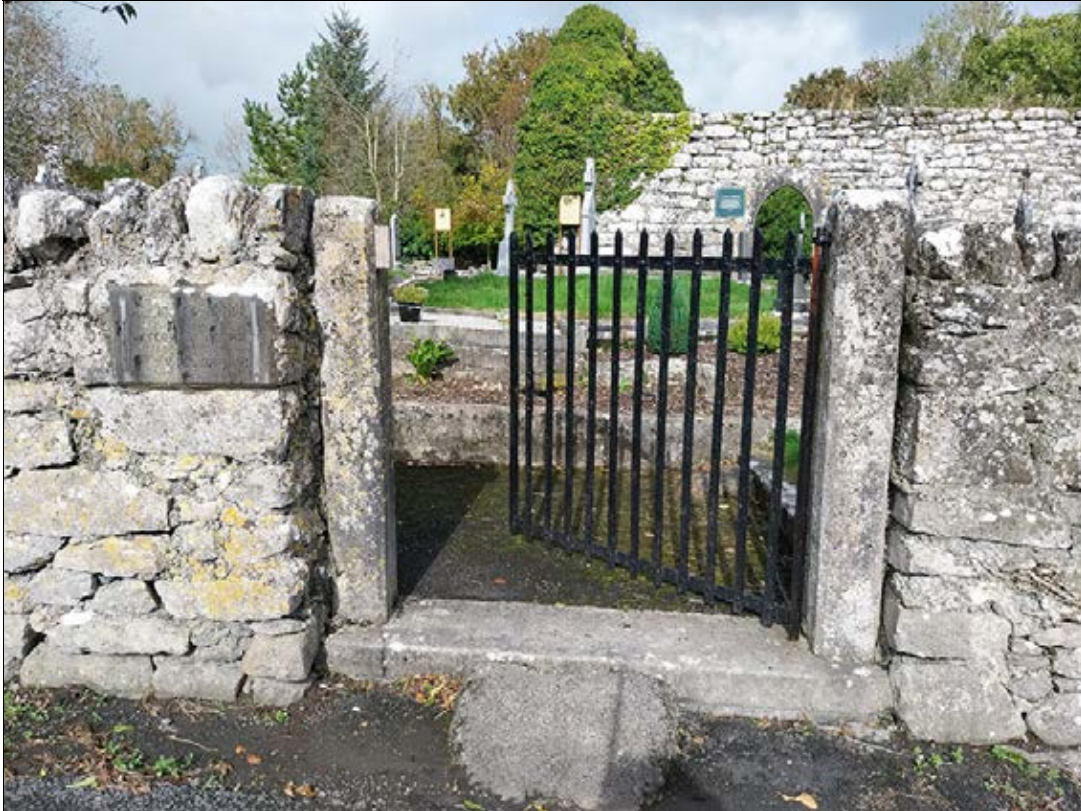
The graveyard is access through a wrought iron gate and two cut stone piers. It appears to be of nineteenth century date. The piers have been set in concrete, and a small access ramp made for tarmacadam has been constructed externally.

It is in good condition.

Figure 2.41. Graveyard entrance, from S.

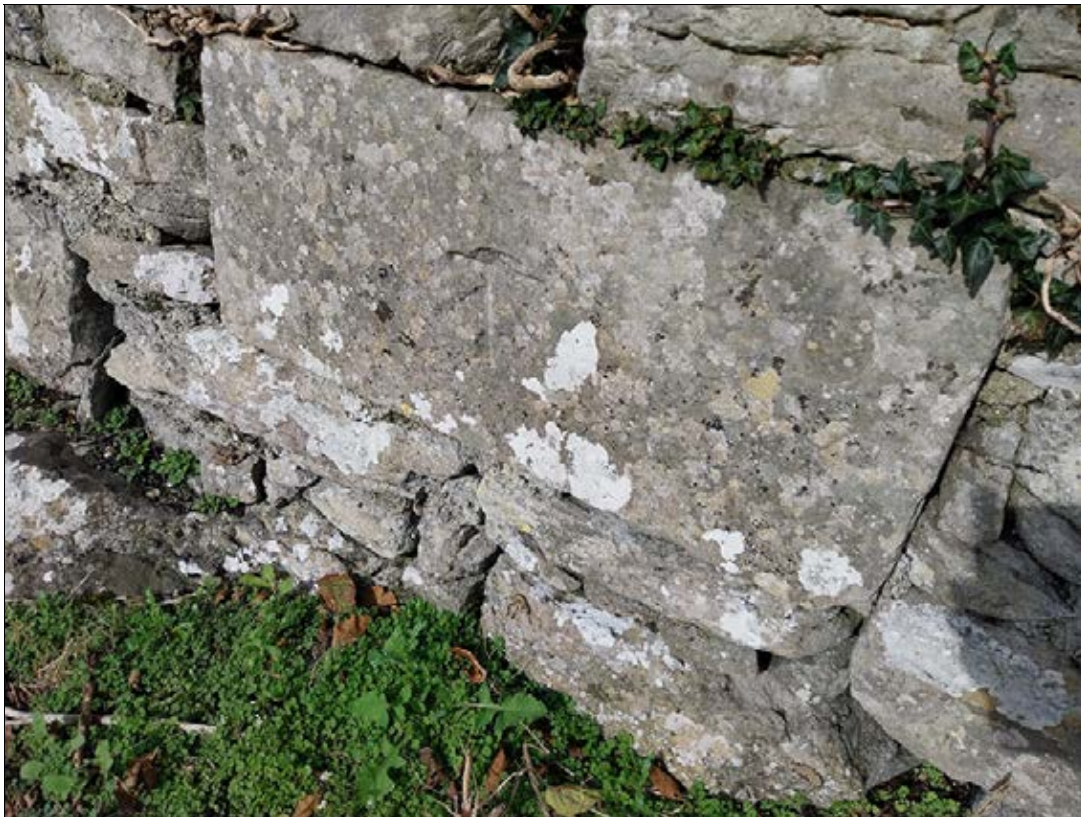
Figure 2.42. Ordnance Survey benchmark, from S.

It is in good condition. It has been inscribed on an earlier architectural stone, possibly 12th/13th century. Its setting as the lower courses of the wall give it a good degree of protection from being stolen.

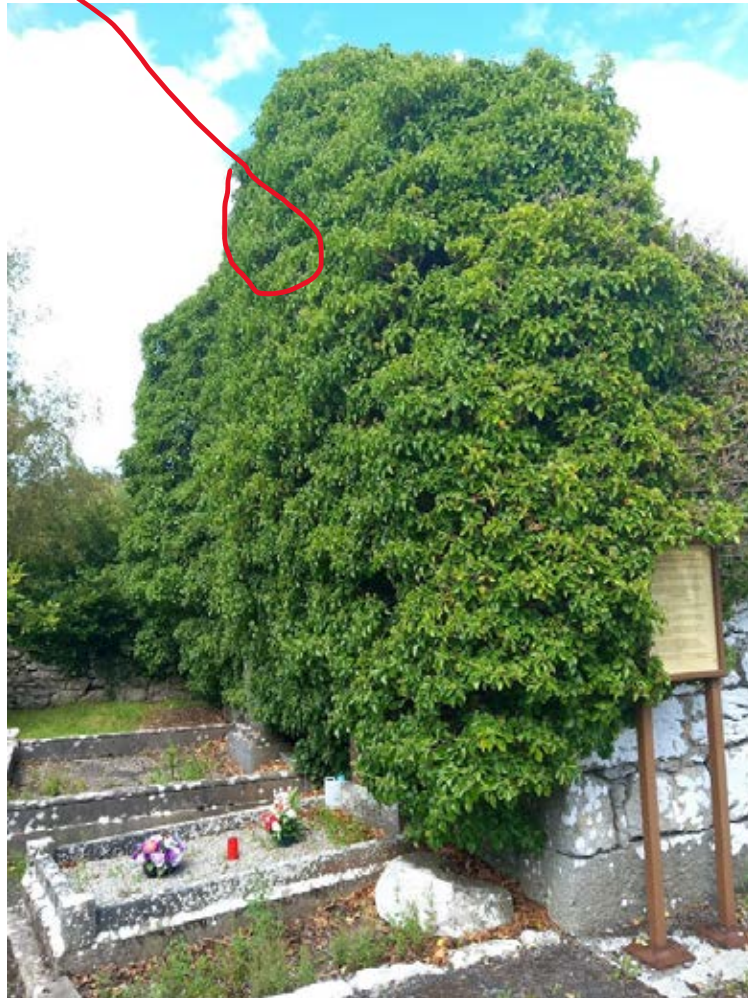
PLATE 1 GABLE WALL - SOPRANO PIPISTRELLE ROOST APPROXIMATE.

The ivy clad church ruins do support potential roosting features given its age, construction, location and dense ivy growth. The recording of three individual soprano pipistrelles suggests it functions as a minor roost and possibly a temporary roost. See Plate 1 for location of dense ivy growth on surviving gable wall and approximate exit of soprano pipistrelles.

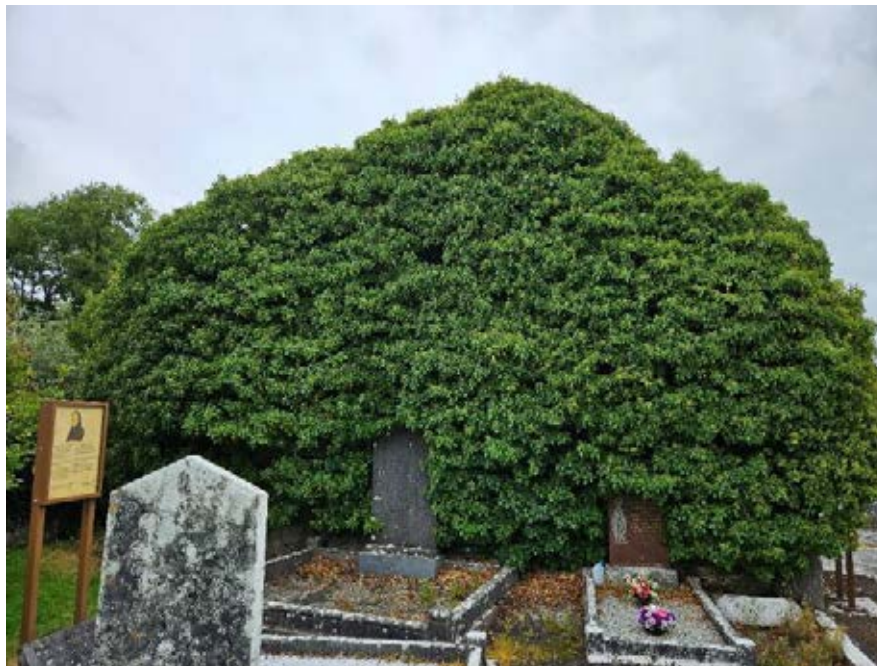
The western gable is noted to be heavily overgrown with ivy, which has not been attended to in some time (evident by the thickness of the growth). An accurate assessment of the condition of this wall is not possible due to the presence of the afore-mentioned ivy growth. It is noted however that when viewed in plane from inside the building footprint, the upper section of the gable appears to be listing westwards.

Photograph 1 Exterior western façade of Killeeneen Church Ruin.

In order to arrive at an informed assessment of the gable end, it is recommended that the ivy is cut back to the wall face (not killed off or fully removed at this point). An outline scope of possible works is included in section “4.0 Outline Scope of Works”.

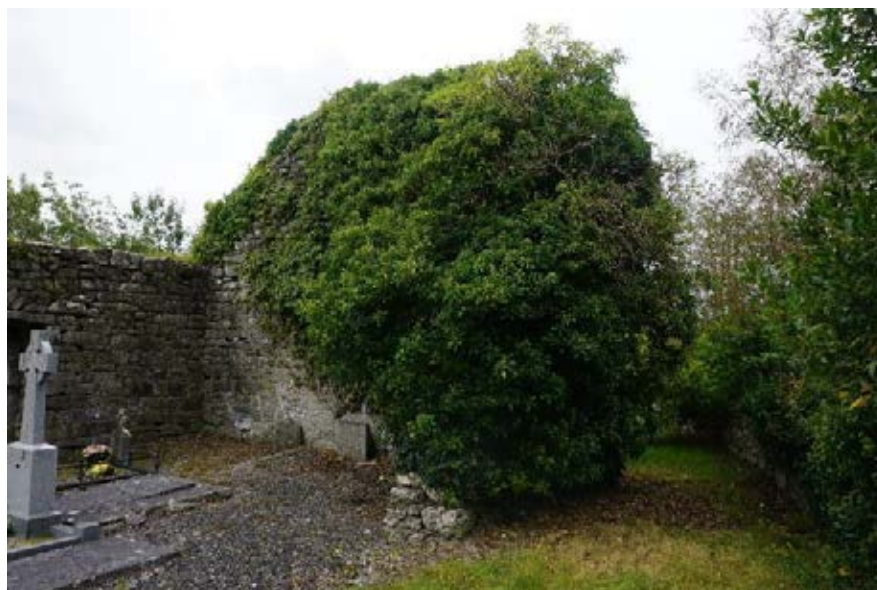
Photograph 2 Interior façade of the western gable.

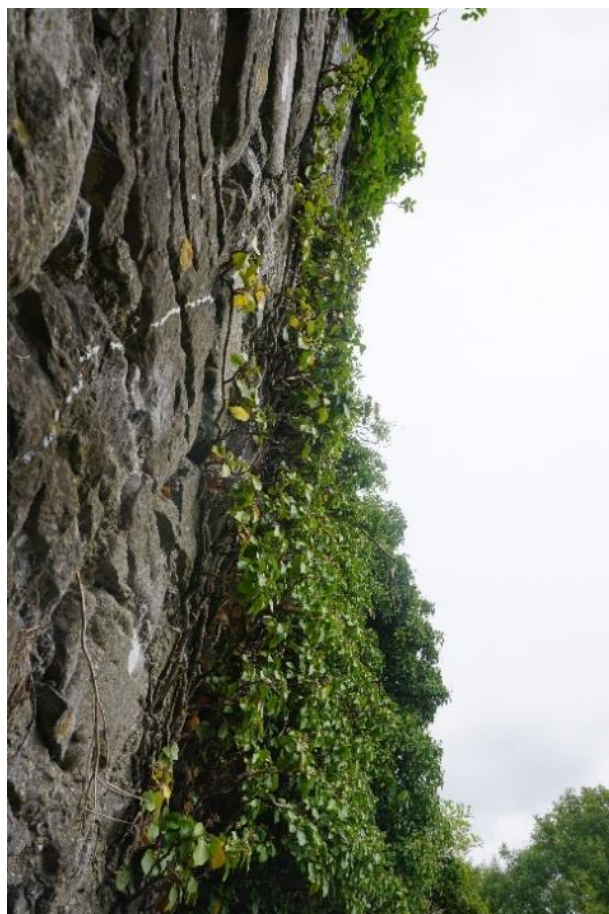
Photograph 3 View of the upper western gable end from inside the footprint of the building ruin.
