Heritage Council Reference Code: CH17958 Reilig na bhFilí
ITM: 546704/719794
SMR Nos: Church (GA096-121----) and Graveyard (GA096-121001-).
ÆGIS Ref.: 814-1

Conservation and Management Plan for Killeeneen Medieval Parish Church, Killeeneen More townland, Co. Galway.

Report lead author: Frank Coyne MA MIAI

Date: 9 October 2023

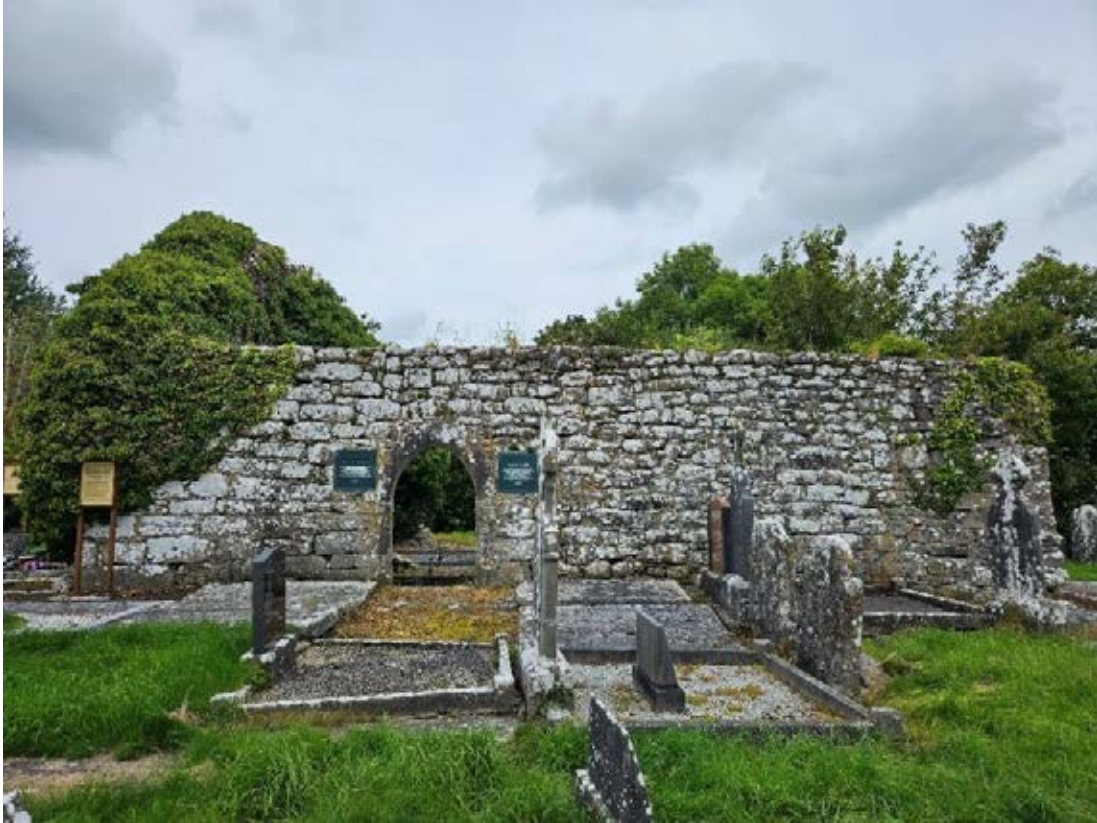
The southern wall appears largely intact with a gothic arched opening present. There is light vegetation growth noted to this section of the ruin. There is a heavy presence of lichen growth to the wall. The wall is also noted to not be true in plane (straight), with a slight batter noted to the exterior façade. However, it is also noted that there are no visible (patent) defects of a structural nature.

Photograph 4 Southern wall external façade.

The southern section of the ruin will require full removal of the vegetation, with localised repointing and grouting works using a Natural Hydraulic Lime based mortar and growth. A soft capping is recommended to the wall top (a limecrete rounded top is optional, but will eventually give way to vegetation growth, in an area difficult to access for maintenance works). An outline scope of possible works is included in section 4.0.

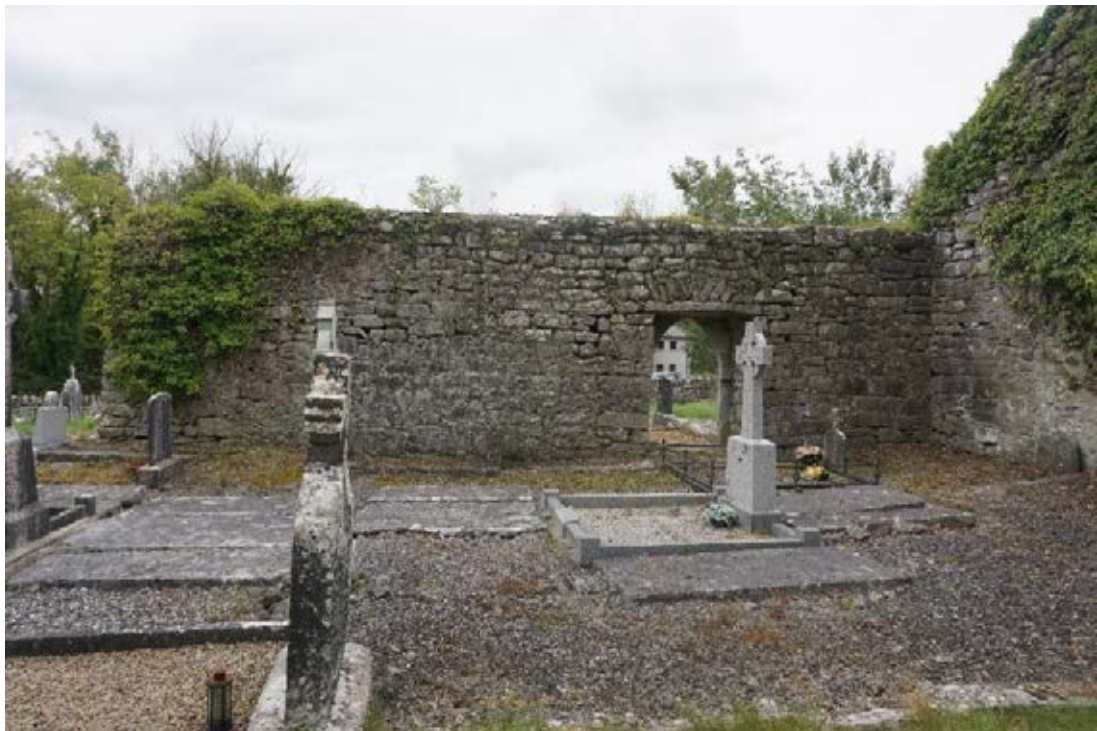
Photograph 5 Southern Wall internal façade.

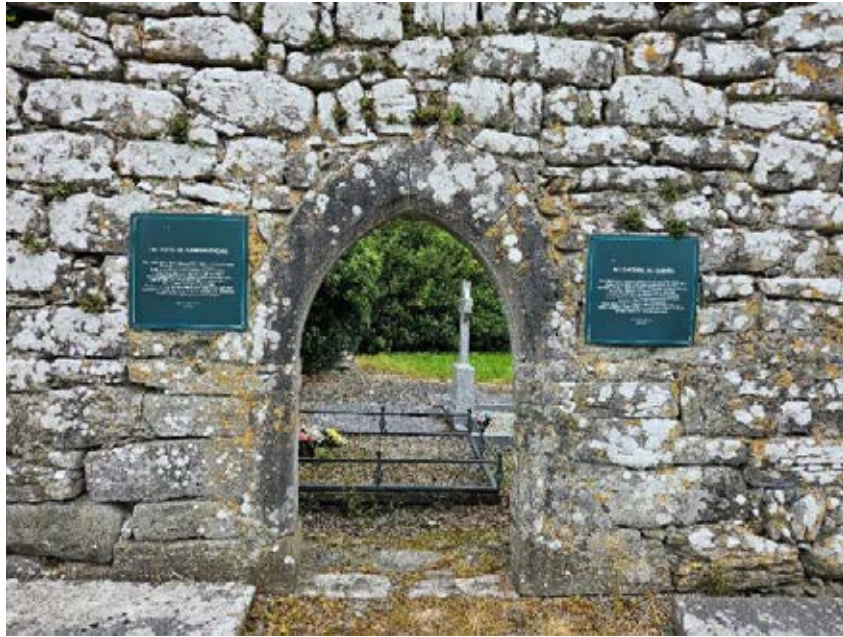
Photograph 6 Detail of the surviving door opening.

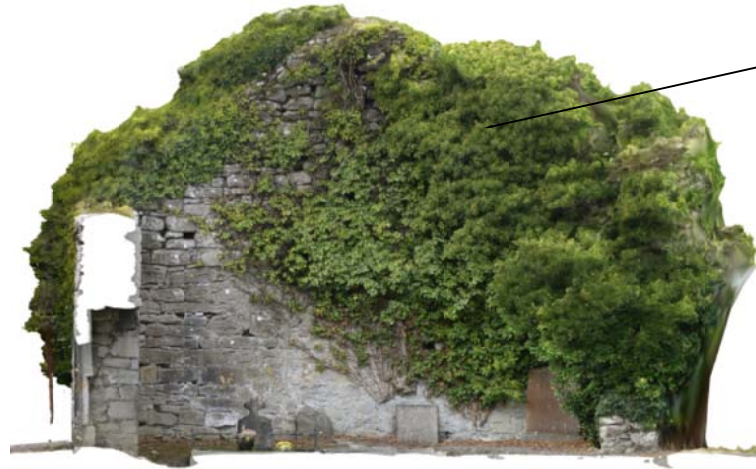
Removal of vegetation, followed by an inspection of the underlying masonry which will inform the definite scope of works required.

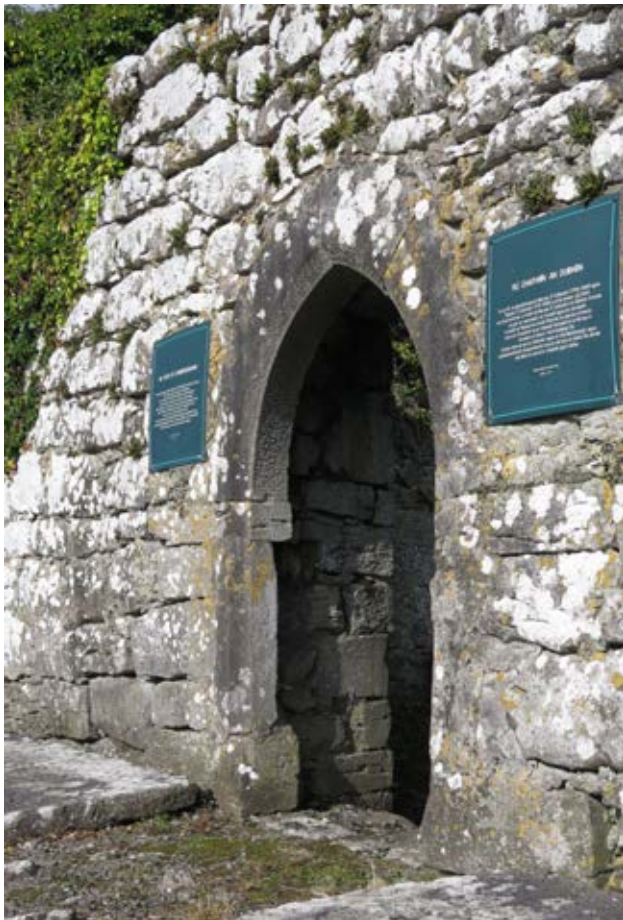
Fig 4: Signage Dominates the South Wall & Doorway.

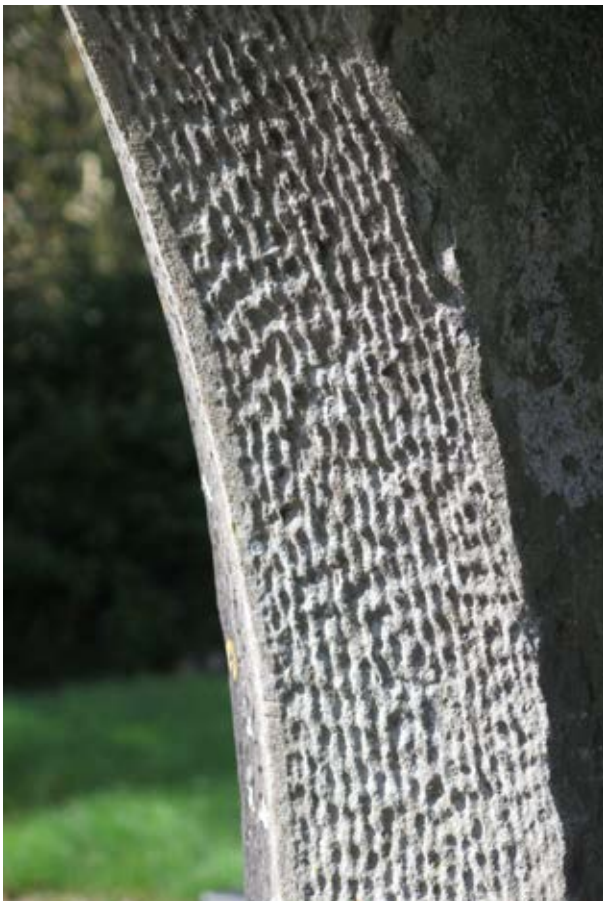
*Fig. 5 - Southern Doorway Arch,
Sparrow Pecked Surface Detail.*
