CMF Reference Code: CMF24-2-GA001

## Conservation Management Plan for St Grellan's Church and Graveyard, Kilcloony townland, Co. Galway.

**Report lead author:** Frank Coyne MA MIAI

**Date:** 18 October 2024

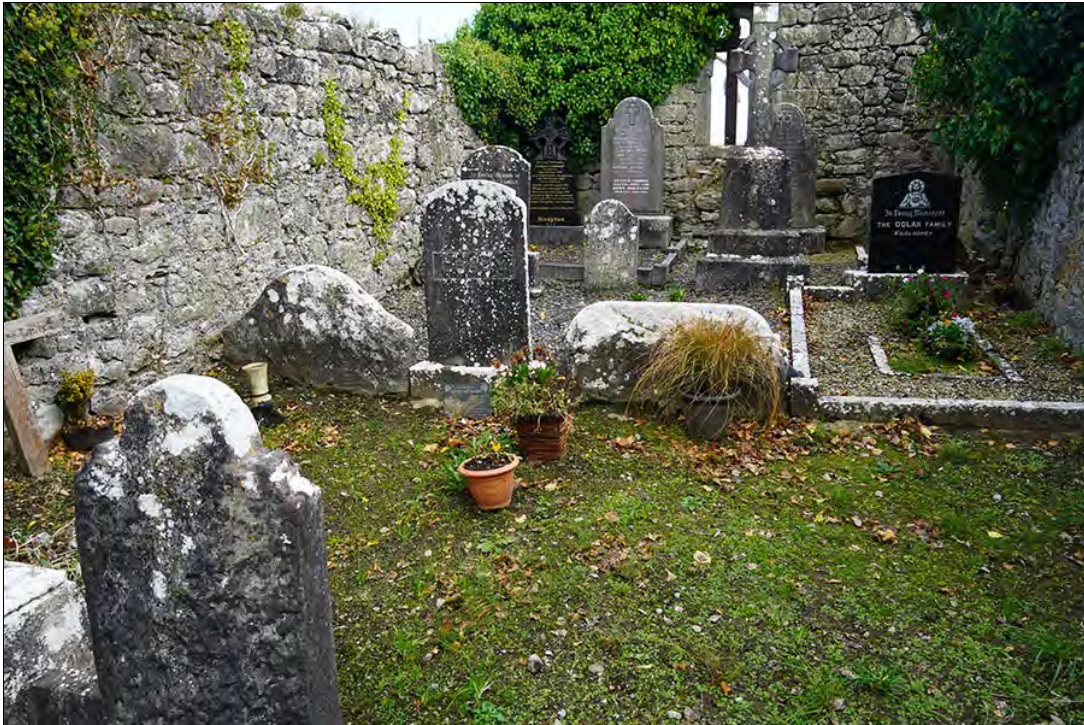
There is no obvious evidence of the differentiation of the interior space. The interior is now filled with graves. The ground level appears to have risen substantially over the years, probably as the result of the insertion of burials.

Figure 2.25. Graves in the interior of the E side of church, from W (F. Coyne).

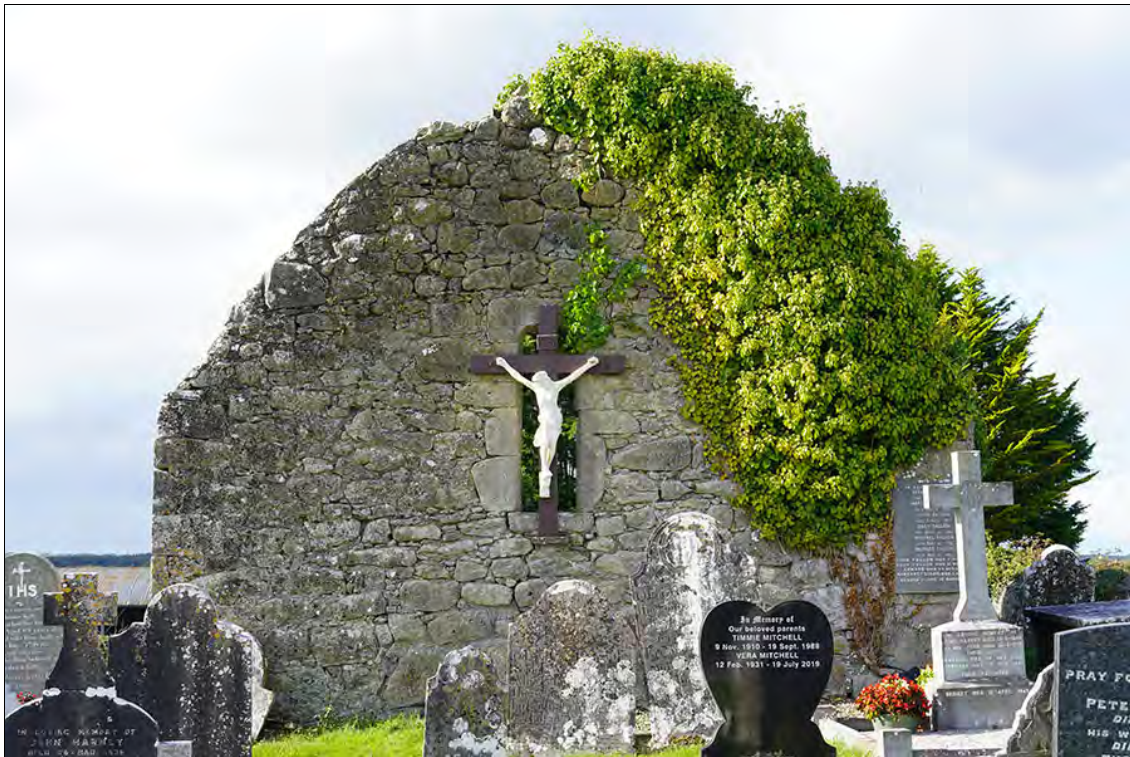
Internally the round headed arch is collapsing, and in need of repair. It probably contained single-light lancet form typical of the type used in late twelfth and thirteenth-century (Cunniffe,<https://field-monuments.galwaycommunityheritage.org/content/archaeology/leitrim-medieval-parish-church-2>). Internally the stones used in the splayed ope are dressed, including one example of a chamfered stone, with diagonal tooling dating to the 12<sup>th</sup>/13<sup>th</sup> century, indicating an earlier phase of use of the church.

The top of the gable has been capped with cement. A modern memorial plaque has been fixed to the gable also.

Figure 2.41. East gable of church, from E (F. Coyne).

| Action No. | Description | Management policy reference | Action duration (short, medium, long term) |
|---|---|---|--|
| 2 | Repair of E gable | 2 | Short |

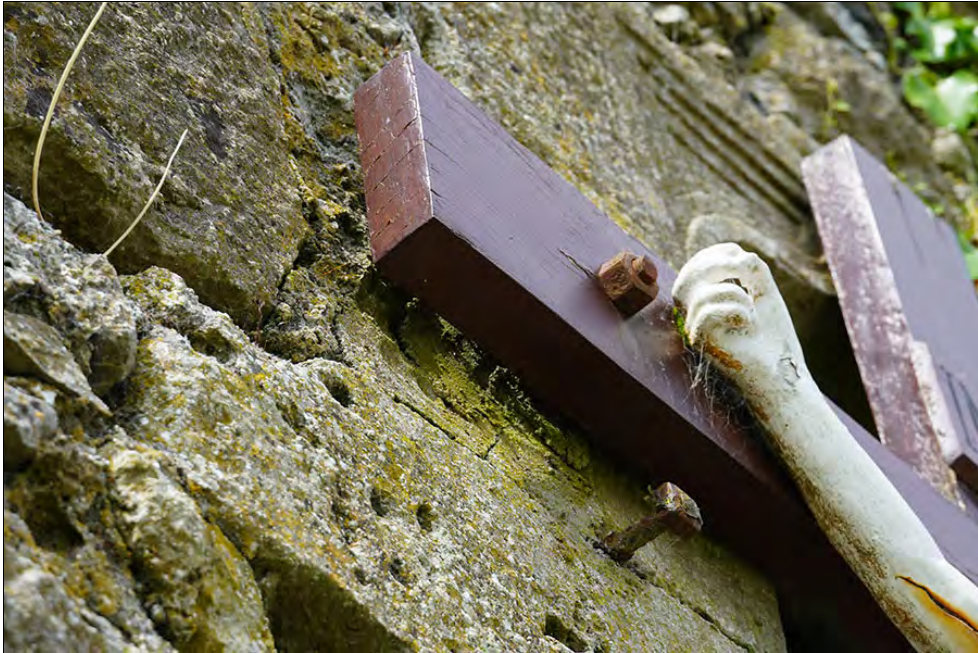
Figure 2.44. Detail of modern bolts on the external face E window, from SE. These were inserted into the bedding joints. (F Coyne).

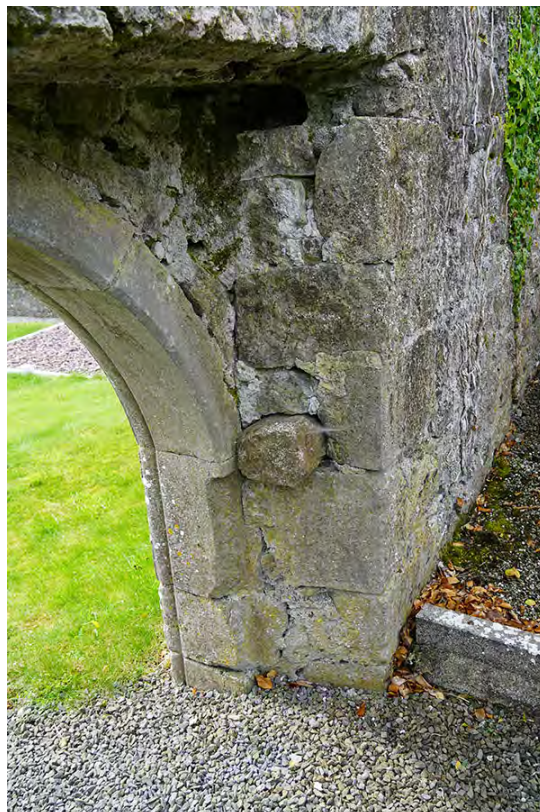
Figure 2.59. Drawbar socket on internal side of door, from NE. Note loose stone placed in socket (F. Coyne).

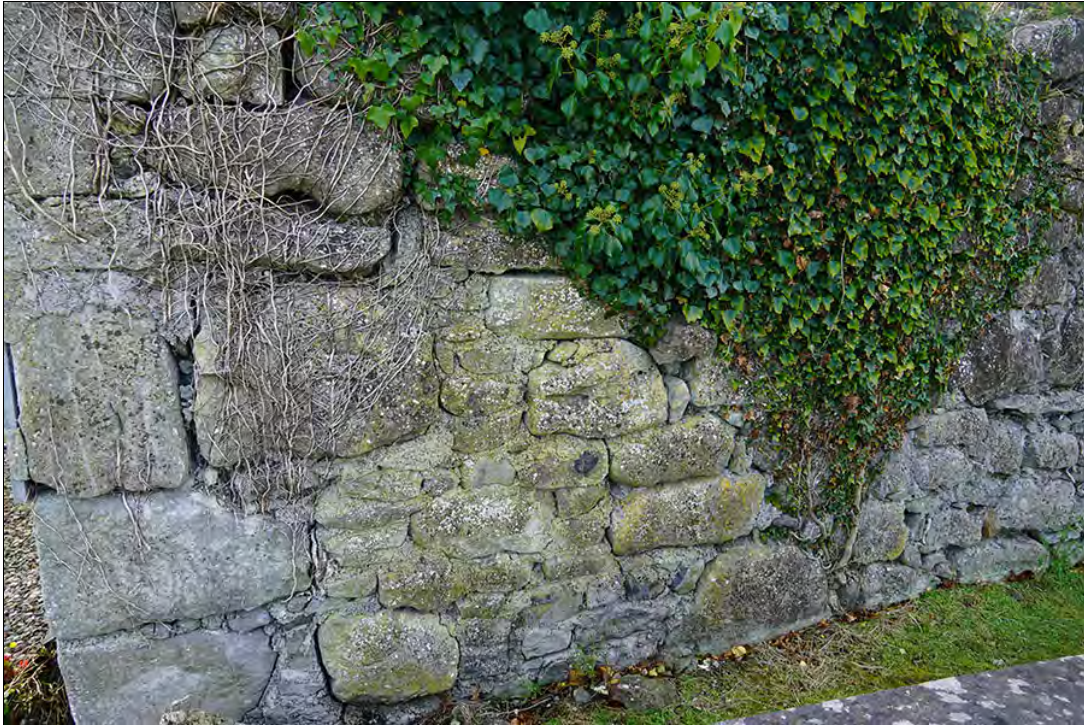
The north wall survives to wall plate level, with dressed ashlar quoins at the NE and NW corners, and elsewhere built of random rubble, bonded with a cement mortar. A substantial crack is visible in the NE corner, visible both internally and externally. It has a substantial covering of ivy.

It is in poor condition.

Figure 2.64. Structural crack in N wall externally at NE corner, from N (F. Coyne).

| Action No. | Description | Management policy reference | Action duration (short, medium, long term) |
|---|---|---|--|
| 1 | Trim ivy from remaining upstanding structure. This ivy should take the form of trimming back to within 5cm of the wall. Repairs are necessary to address the structural crack in the wall in the NE corner, and prevent deterioration of the E gable. | 2 | Short |

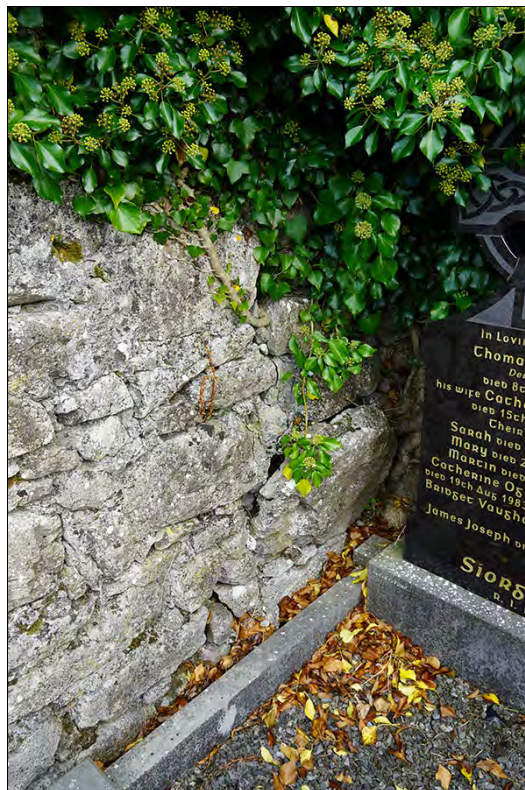
Figure 2.65. Structural crack in N wall internally at NE corner, from SW (F. Coyne).

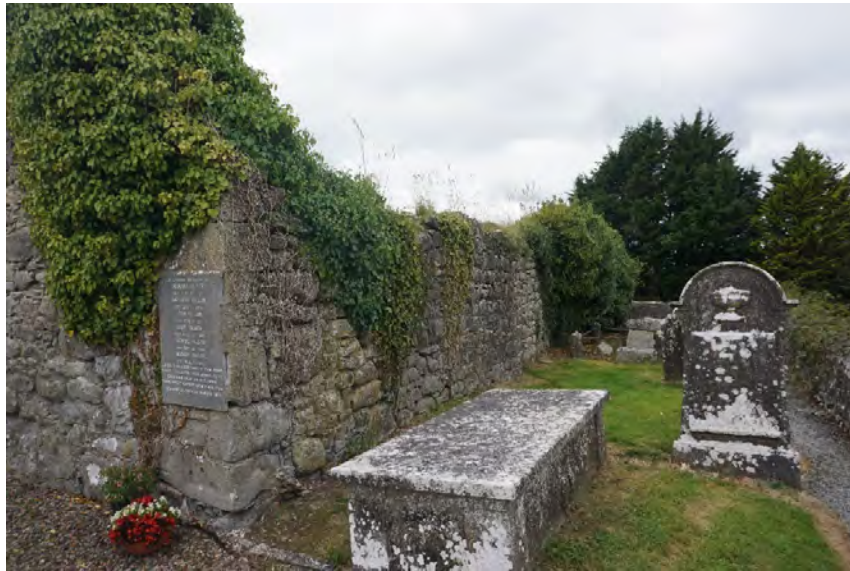
The northern wall of the church, in plane, has noted undulations. The wall top has vegetation present, with ivy growth noted to the western end, covering a large section of the wall.

There are noted attempts at remedial works to this wall, externally and internally, with a cementitious mortar noted within the joints with a sharp sand aggregate. The pinning stones are noted to be few and far between.

Figure View of the northern elevation of St. Grellan's Church.

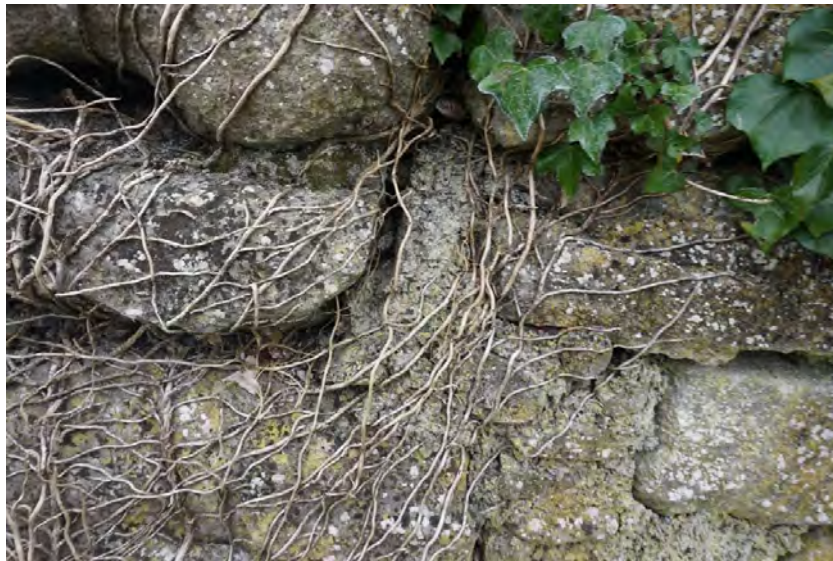
**Photograph 3** Detail from the northern elevation demonstrating the mortar used in the remedial works. Note large aggregates of the sharp sand.

Overall, in spite of the undulations, the wall appears structurally stable, with no cracks visible that would be considered worrying in nature. The wall is well bonded with both gable ends where visible.

- a. Raking out of exiting defective mortar as required.

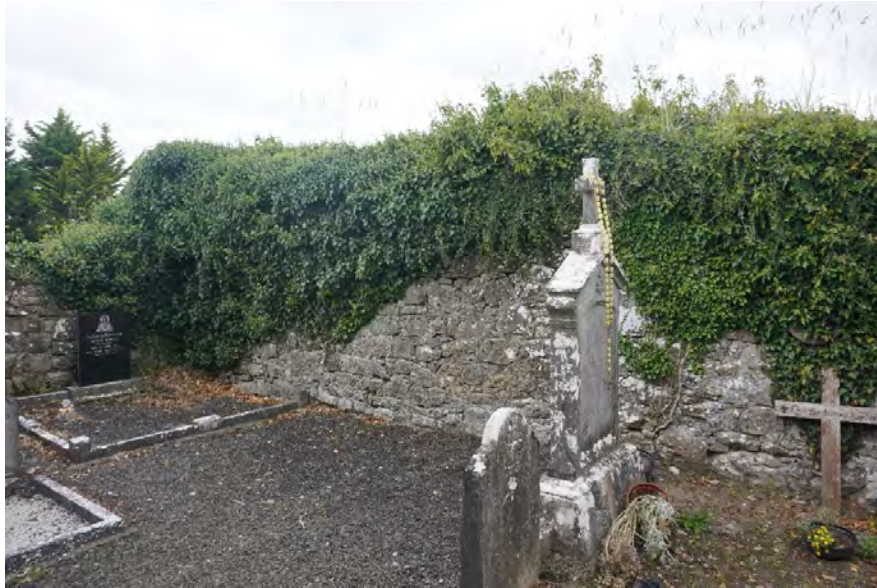
**Photograph 4** Internal view of the northern wall, western end.

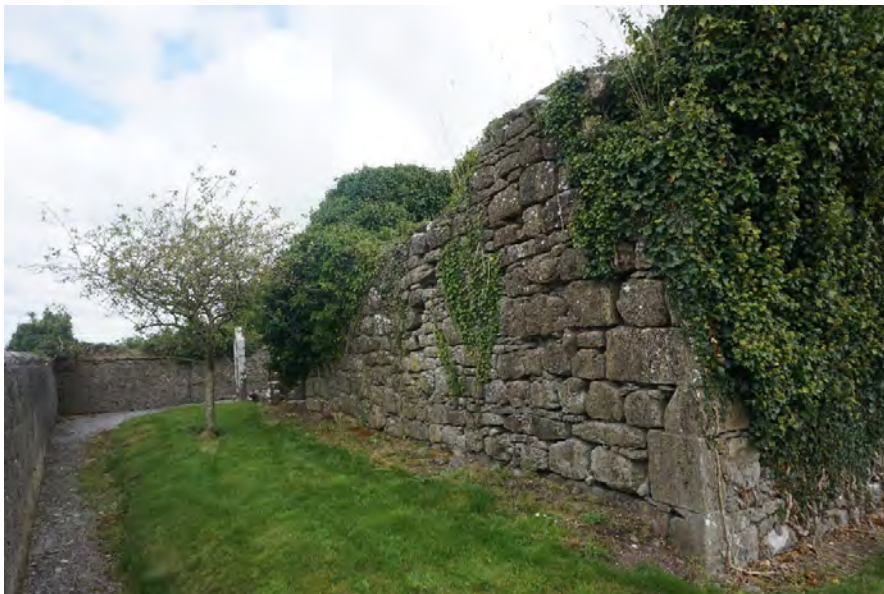
There are notable loose masonry units to the wall top to this elevation.

Where the masonry is visible, it appears structurally sound. The same cementitious mortar used in past remedial works is also noted to the elevation, externally.

**Photograph 5** View of the western wall.

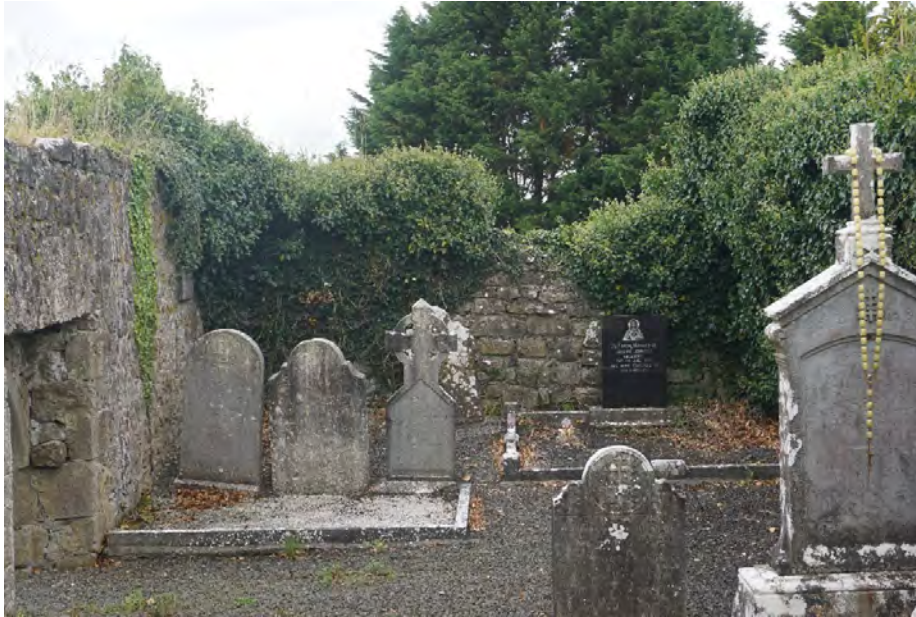
**Photograph 6** Internal view of the western wall. Mostly covered in ivy.

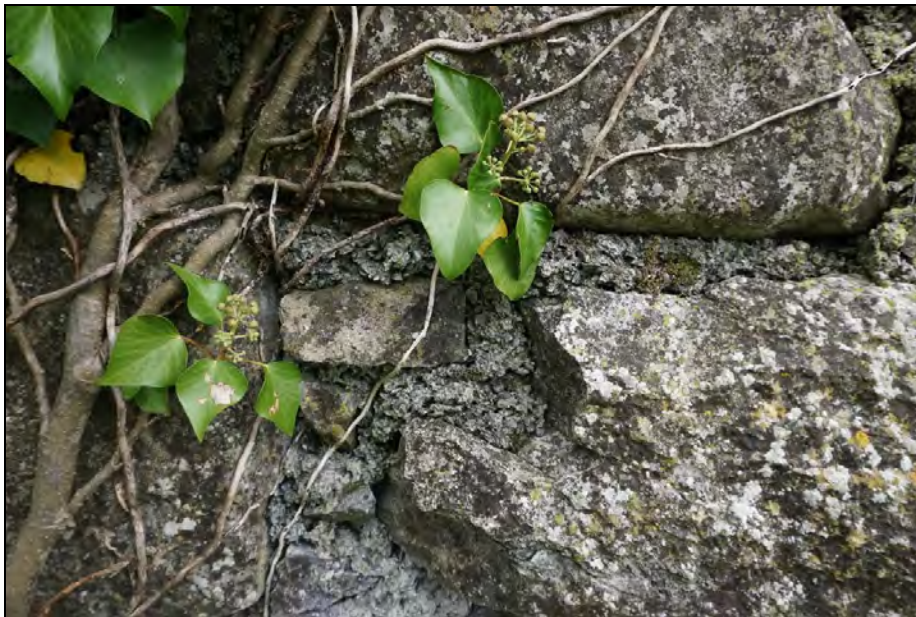
**Photograph 7** Detail from the western wall. Note cementitious mortar and pinning stone reinstated.

Again, the pinning stones are few and far between, a lot noted to have been lost with the deterioration of the original binders. Where present, the pinning stones are loose and in danger of loss.

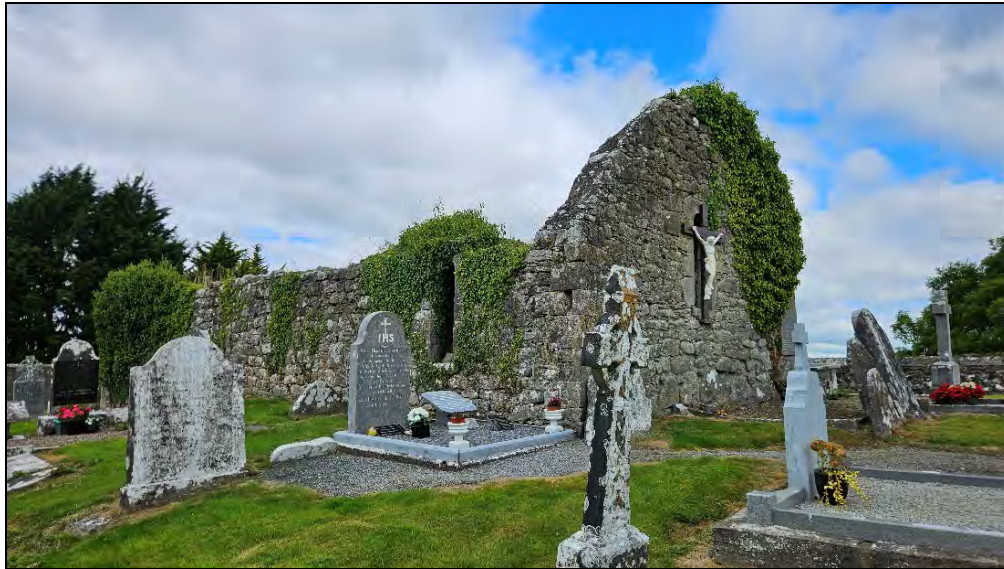
The southern wall is noted to be leaning outwards when viewed in plane, otherwise the wall appears structurally sound.

Photograph 8 View from the southeast facing the southern / eastern elevations.

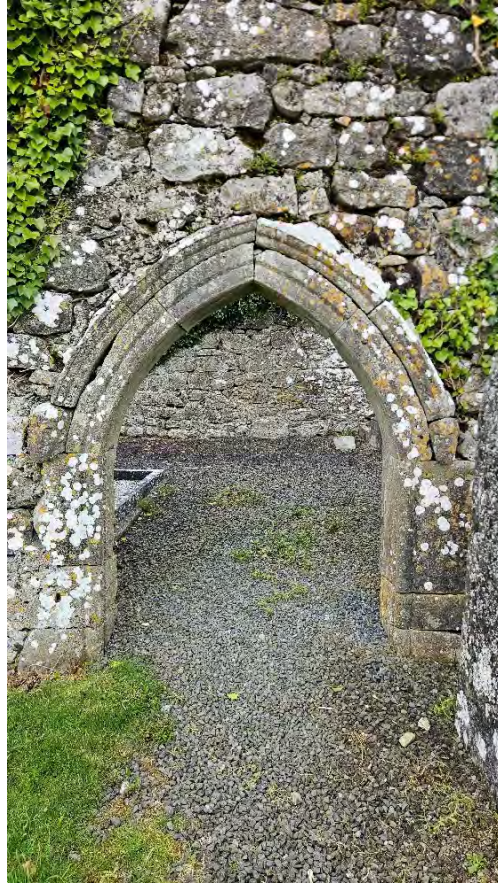
**Photograph 10** Lancet arched door opening. The masonry units are in good repair.

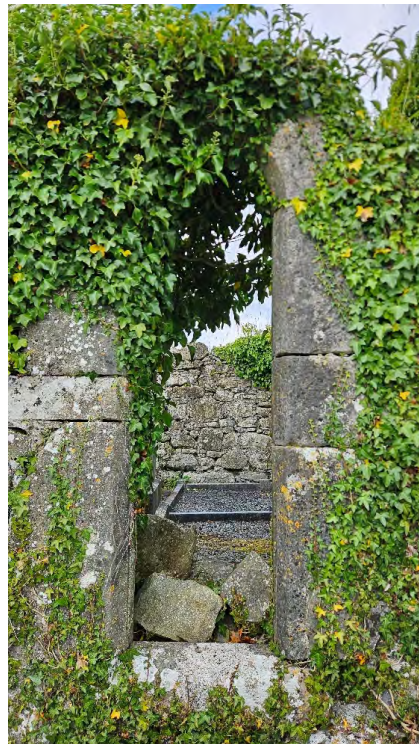
**Photograph 11** View of the assumed Romanesque arched window opening.

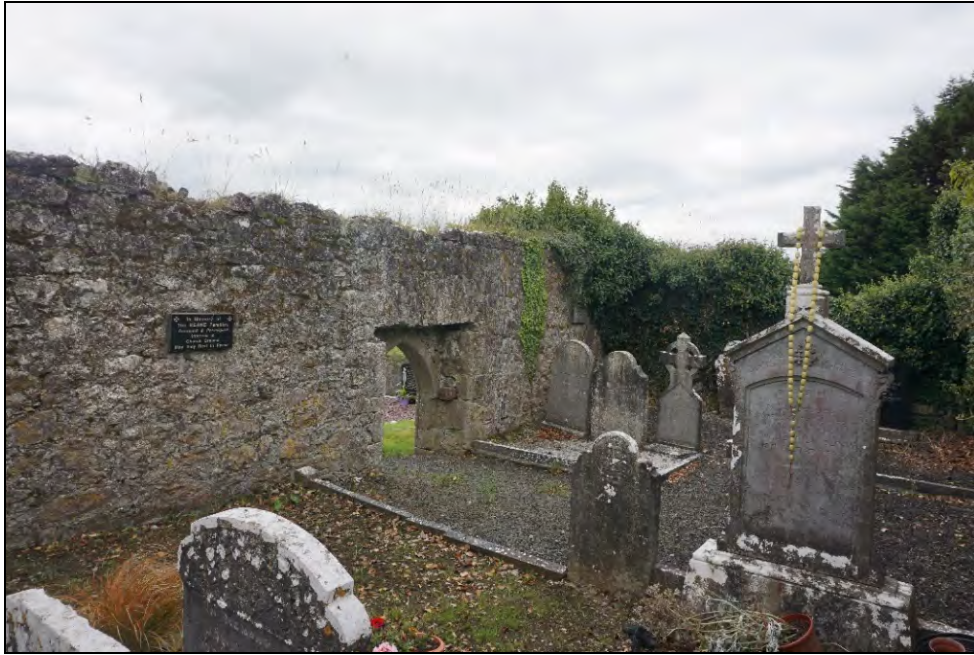
Photograph 12 Internal view of the southern elevation.

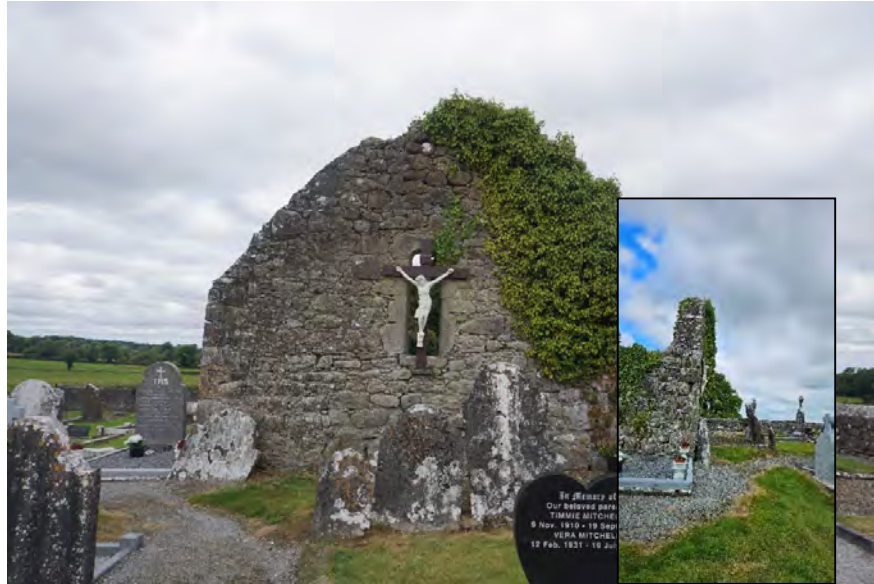
Photograph 13 Eastern elevation view. Inset, side plane view, note lean of the wall outwards.

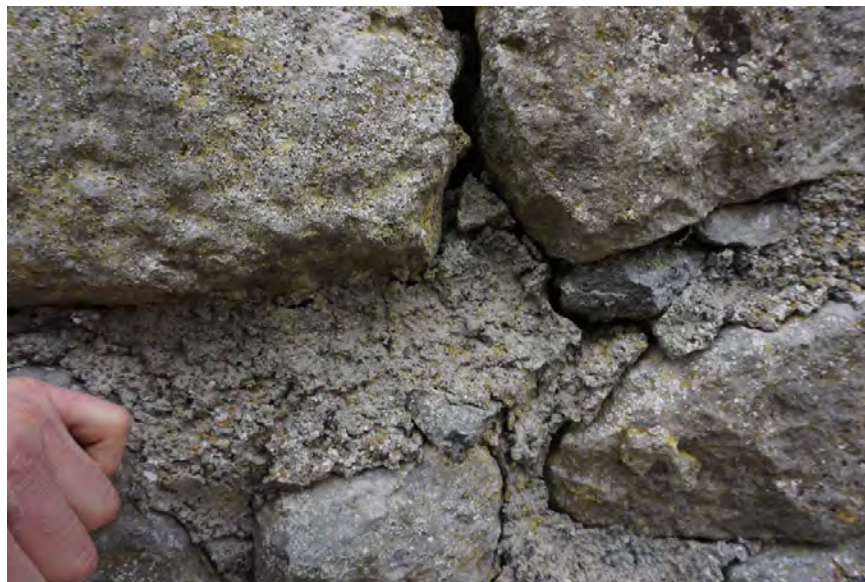
Photograph 14 Detail of remedial cementitious binder.

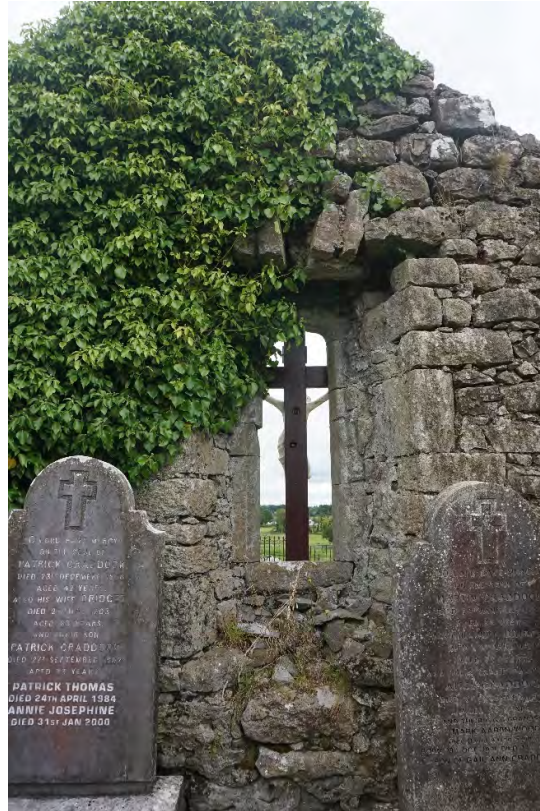
Photograph 15. Internal view of the eastern gable opening. Note missing voussoirs.

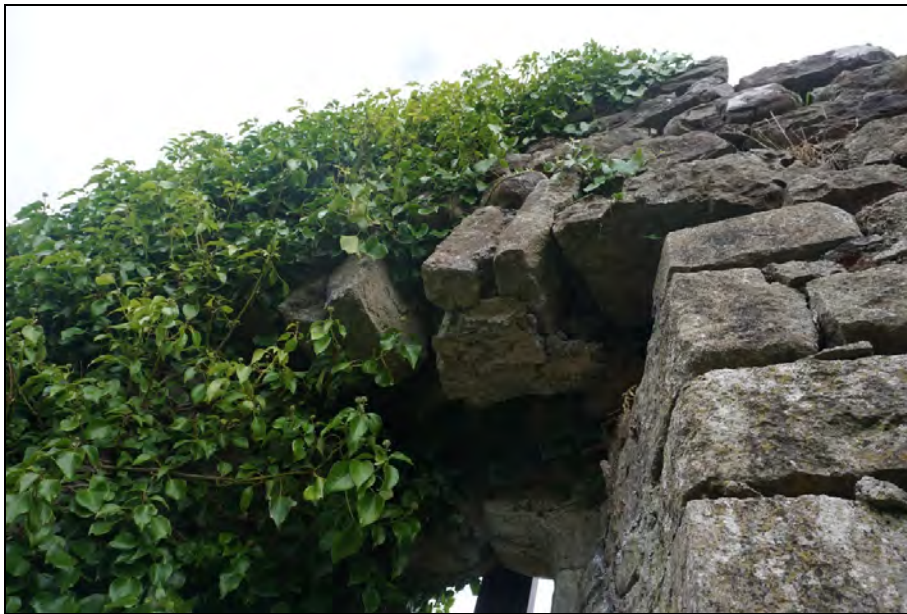
Photograph 16. Bottom-up view of the internal arch soffit. Units dangling dangerously.

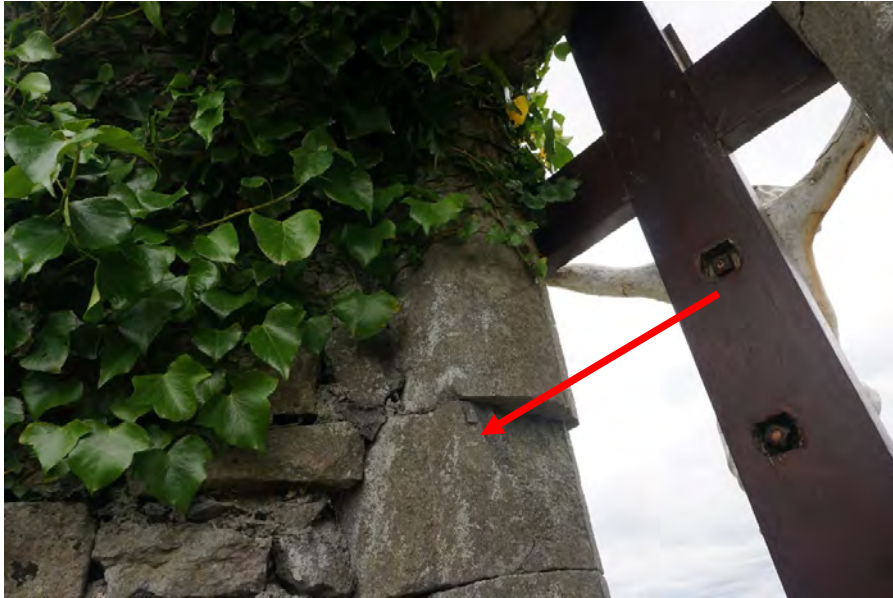
**Photograph 17** View of the window jamb stones. Note shear damage to the lower unit from the pressure of the lean of the wall.
