CMF Reference Code: CMF24-2-GA003

Conservation Management Plan for Kilmeen Church and Graveyard, Kilmeen townland, Co. Galway.

Date: 19 October 2024

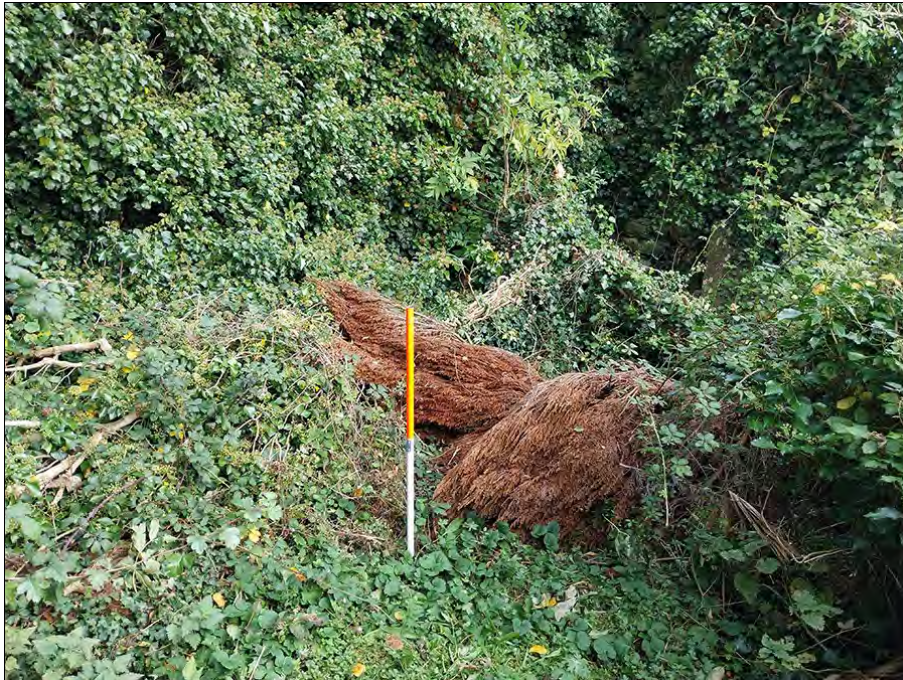
It is not possible to draw any conclusions as to how the interior space was differentiated. The only recognisable feature is the almost completely collapsed ope for an east window. One head stone stands against the S wall in the NE corner of the church.

Figure 2.23. Branch trimmings and undergrowth at the E end of the church, from W (F. Coyne).

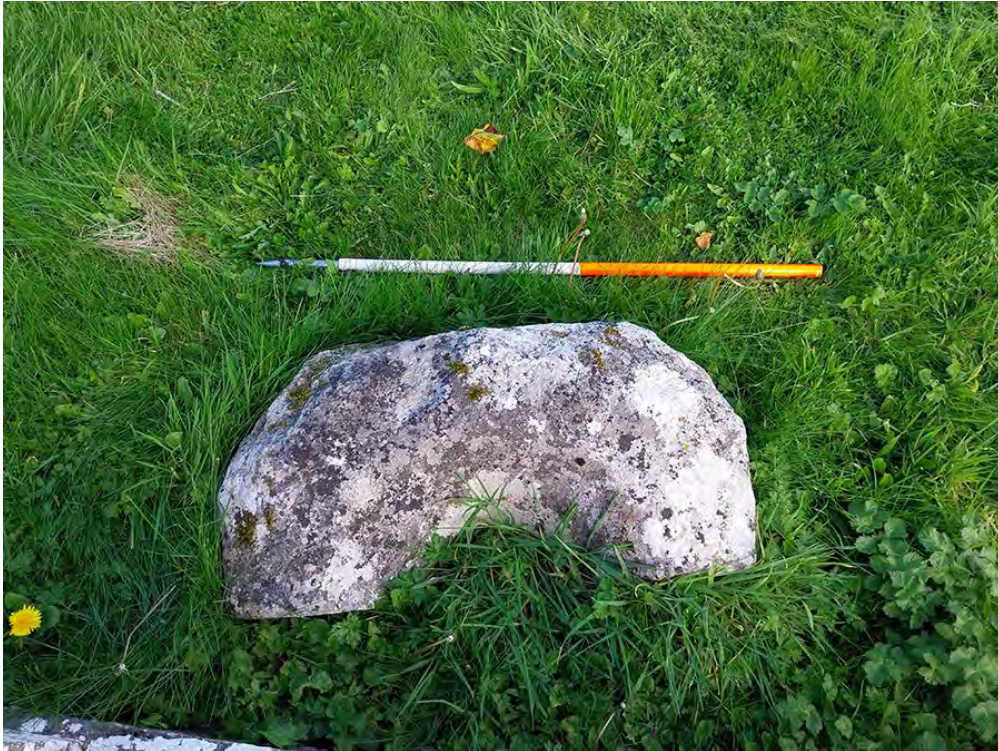
The graveyard contains a few architectural fragments, including a holy water stoop, a window fragment and a red sandstone Romanesque monolithic arch from a window..

Figure 2.30. Rounded monolithic window arch (F. Coyne).

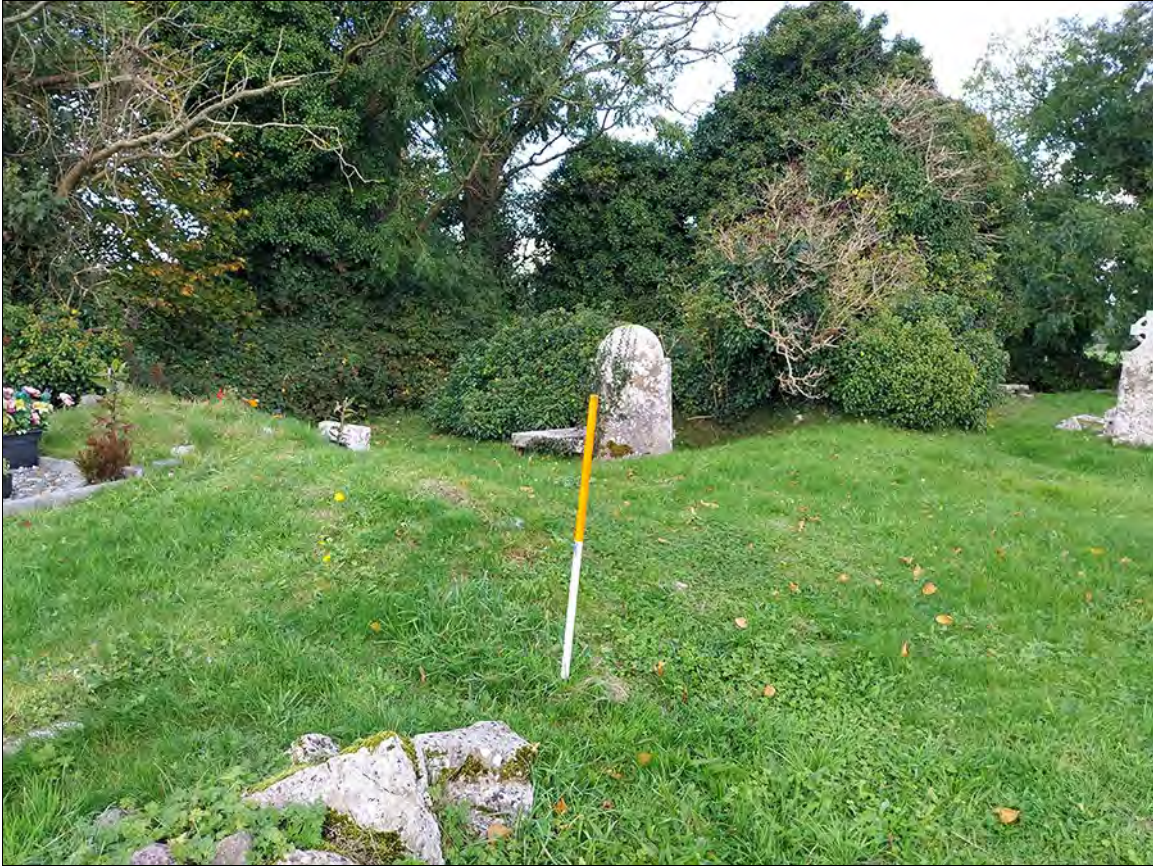
The remainder of the church plan can be identified as a low grass-covered mound, c. 0.40m high and averaging 1m wide. This is visible at the southwest corner and the location of the west gable. Graves have been inserted into the location of the wall at the W end of the church. The location of the north wall of the church is overgrown with mature trees and scrub.

Figure 2.37. Kilmeen Church overgrown with ivy and bushes, from SW (F. Coyne).

The ash trees must be removed, the undergrowth cu back the ivy trimmed to within 5cm of the wall. This work must be carried out by heritage specialists, who have extensive experience of working on medieval structures, as any masonry that may become dislodged, or found to be in imminent danger of collapse can be repaired immediately.

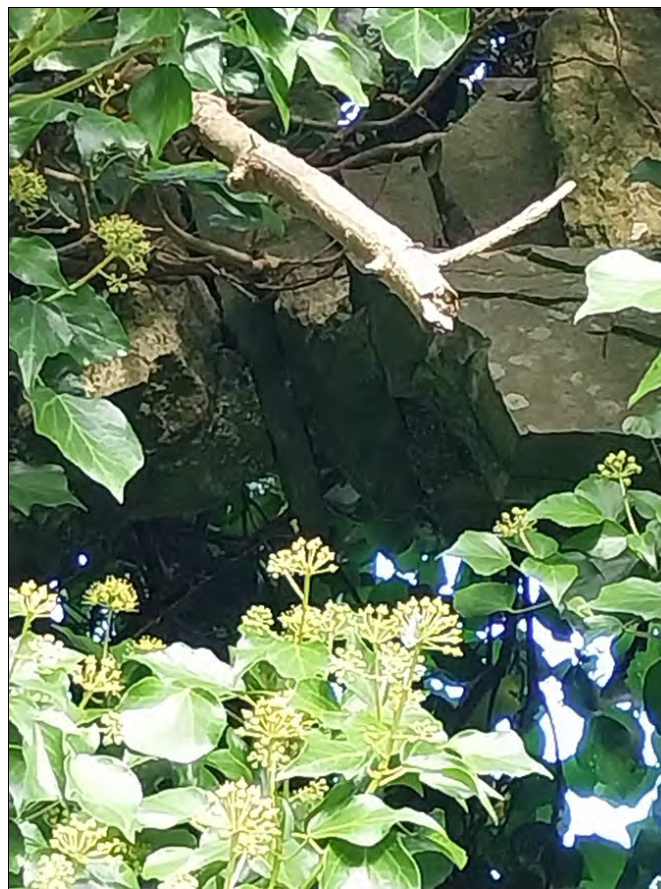
The dense undergrowth and ivy prevented a proper structural assessment of the upstanding remains of the church. It was noted that the east window ope was in perilous condition, and is in danger of imminent collapse. It was decided that trimming the ivy without a resourced immediate remedial action plan would only further endanger the monument.

Figure 2.37. E window, from W (F. Coyne).

The surviving walls of the church are completely covered in ivy, and impenetrable scrub covers the ground around the church walls. Further deterioration to the fabric is inevitable, with the remains of the ope for the E window particularly vulnerable. The ash trees which are suffering from die back also present an immediate threat. There is no point carrying out work on the church only for these trees to fall on it. It is important that an holistic approach is take to any future works, which might be deemed emergency works.

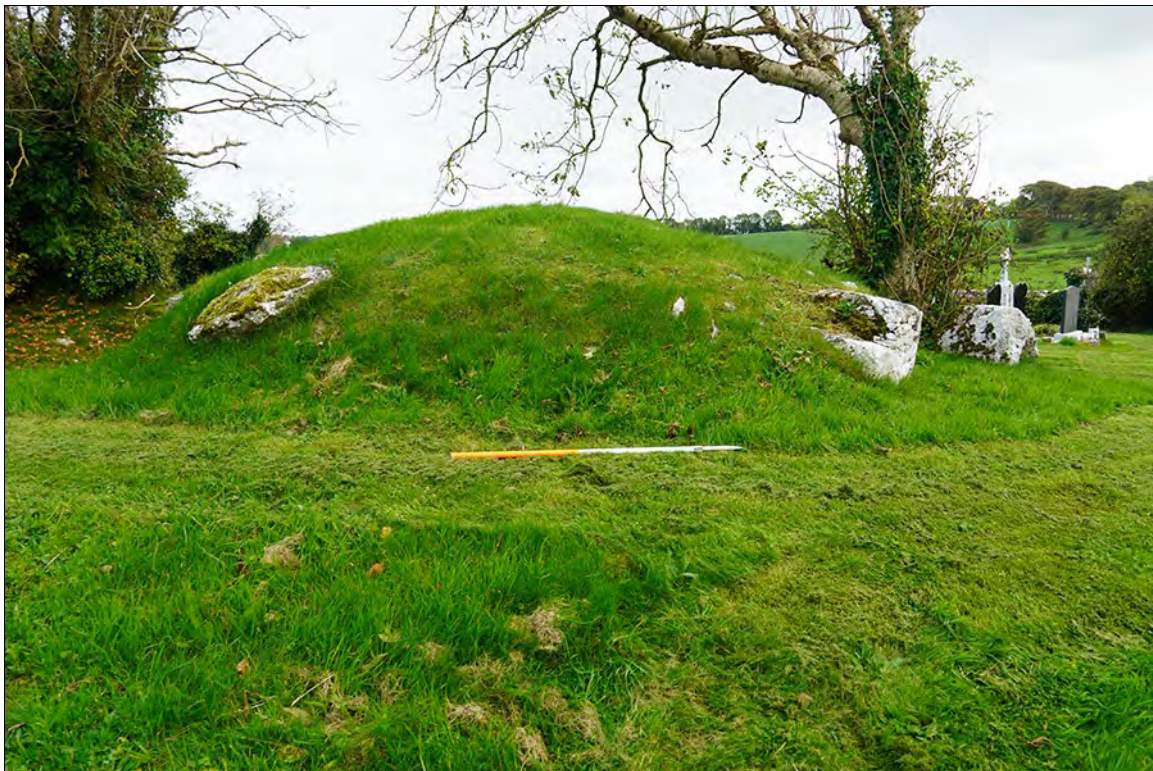
A circular feature, 5m in overall dimension, and a maximum of 1.5m high is situated in the NW side of the graveyard. The circular mound is defined by large undressed boulders, up to 4 courses high. This is most visible on its S side. The boulders average 0.7m to 0.8m in length and 0.5m thick. Elsewhere, at E they are grass covered and not as defined as elsewhere. One boulder has become detached at SW and has rolled a couple of metres to the S. The immediate area to the E measures c. 10m by 10m, defined by an earthen bank, c. 0.7m above interior ground level, and 1.5m wide, area enclosing a slight hollow. This bank is most visible at N, is ill defined as W and visible as a scarp at S. The area of the supposed round tower is 5m in diameter, which makes it very small to be the base of a round tower. The base usually averages 15m in diameter. If there was a round tower here, then perhaps the bank area to the E may have originally incorporated the base, and the current 5m diameter mound represents a later tidying up of the loose stone. However, in this report, the site will be referred to as a round tower. An ash tree, suffering from ash die back stands on the SW side.

Figure 2.38. Round tower, from NE (F. Coyne).

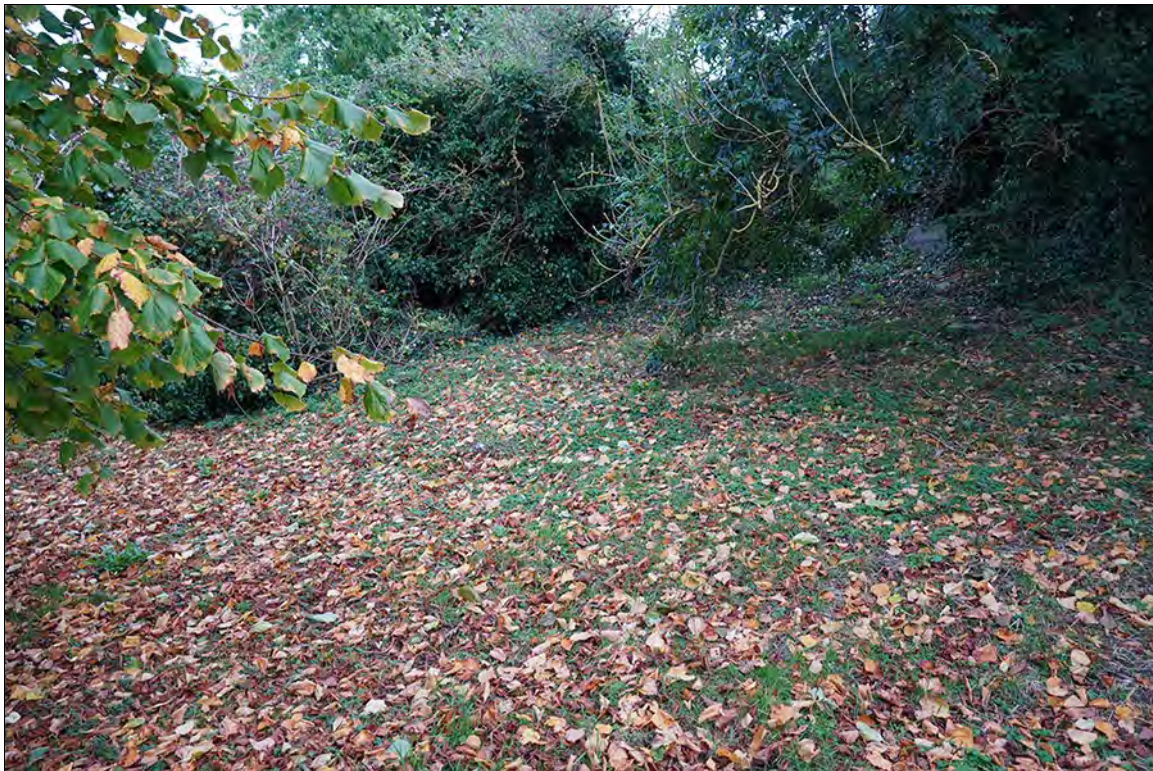
The area indicated as the location of the children's burial ground is located at the NE side of the church. The only possible grave markers were a few stone with barely any above ground register.

Figure 2.41. Possible location of children's burial ground, from SW (F. Coyne).

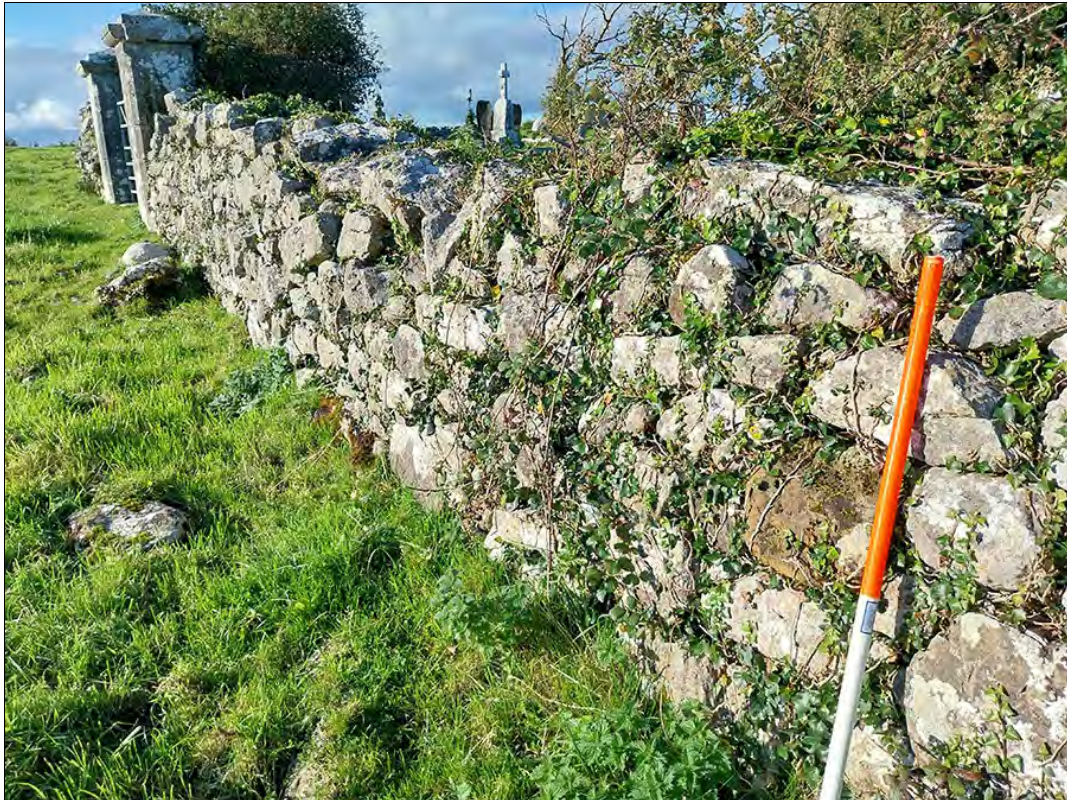
The graveyard is enclosed by a drystone wall, averaging 1m in height and constructed of limestone rubble. It is in good condition generally, with occasionally collapse stones noted externally.. From NW to SW the wall is clearly visible, and from SE to NW is covered in varying degrees of overgrowth. Occasional red sandstones were noted, which may indicated early architectural fragments.

Figure 2.45. View of graveyard wall externally, from SE. Note red sandstone in wall (F. Coyne).

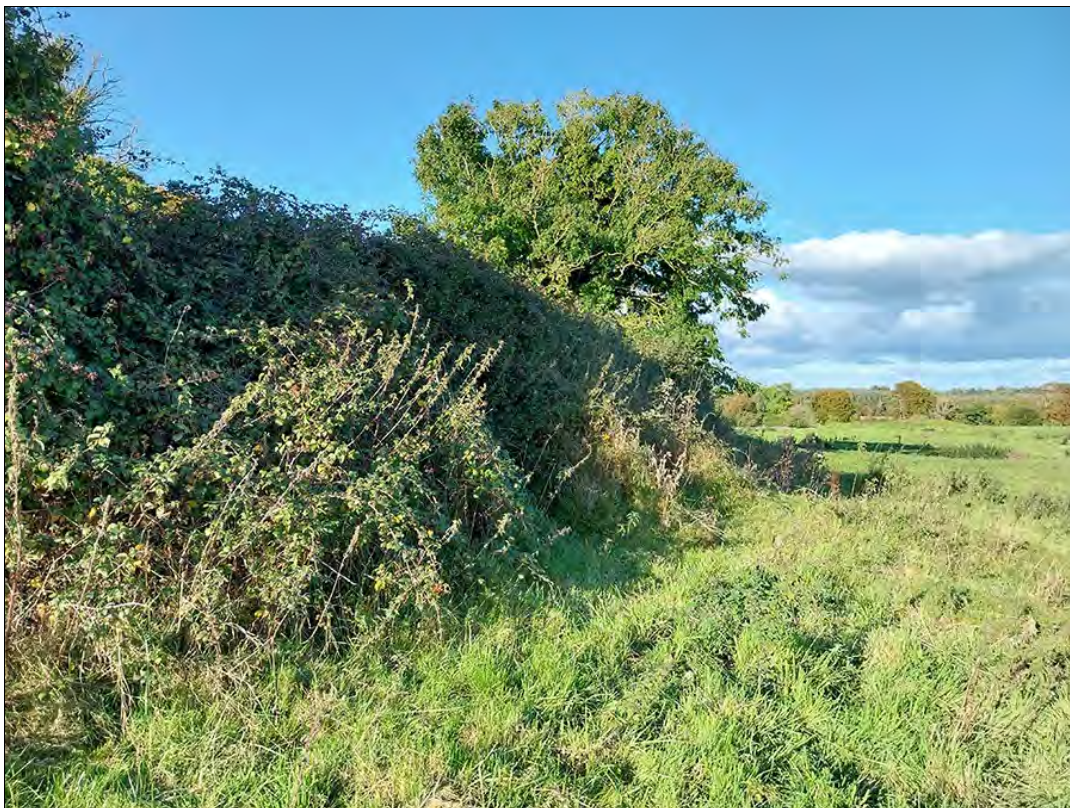
Figure 2.45. Overgrown graveyard wall at E, from SW, (F. Coyne).

The boundary wall of the graveyard is in very good condition although is overgrown from N to E to SE. The gate is new and in good condition.

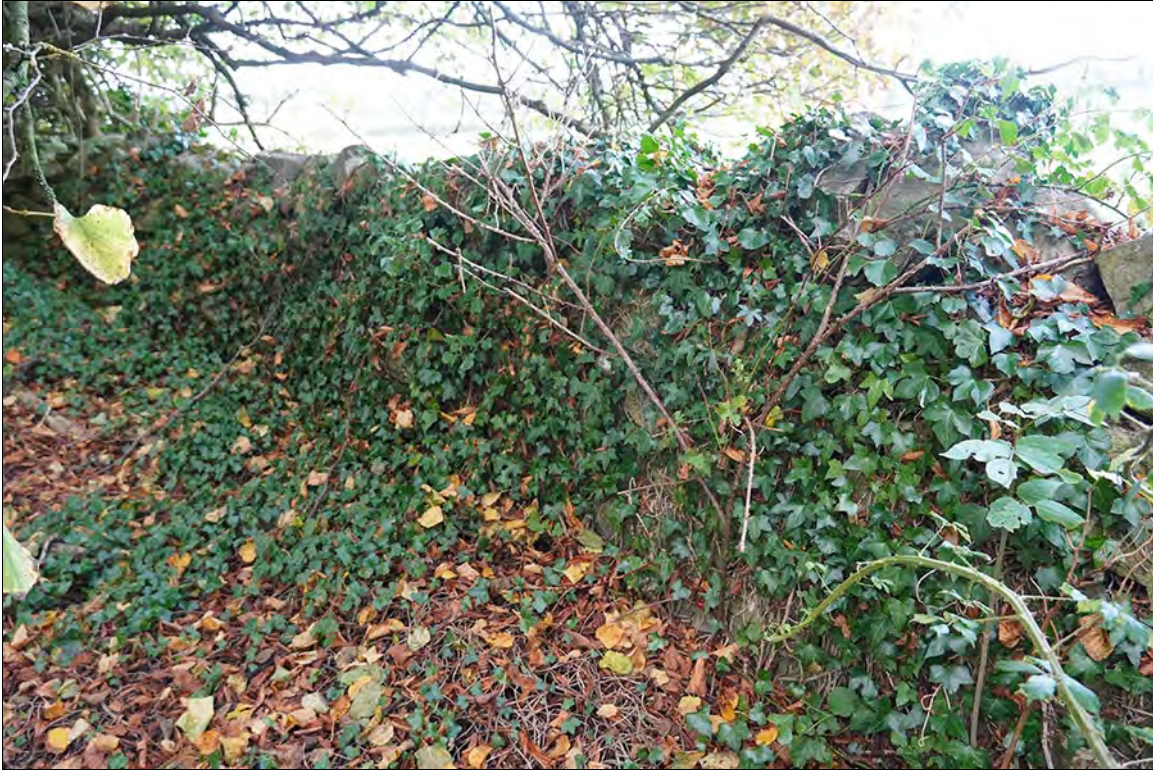
Figure 2.45. Overgrown graveyard wall at N, from SE (F. Coyne).

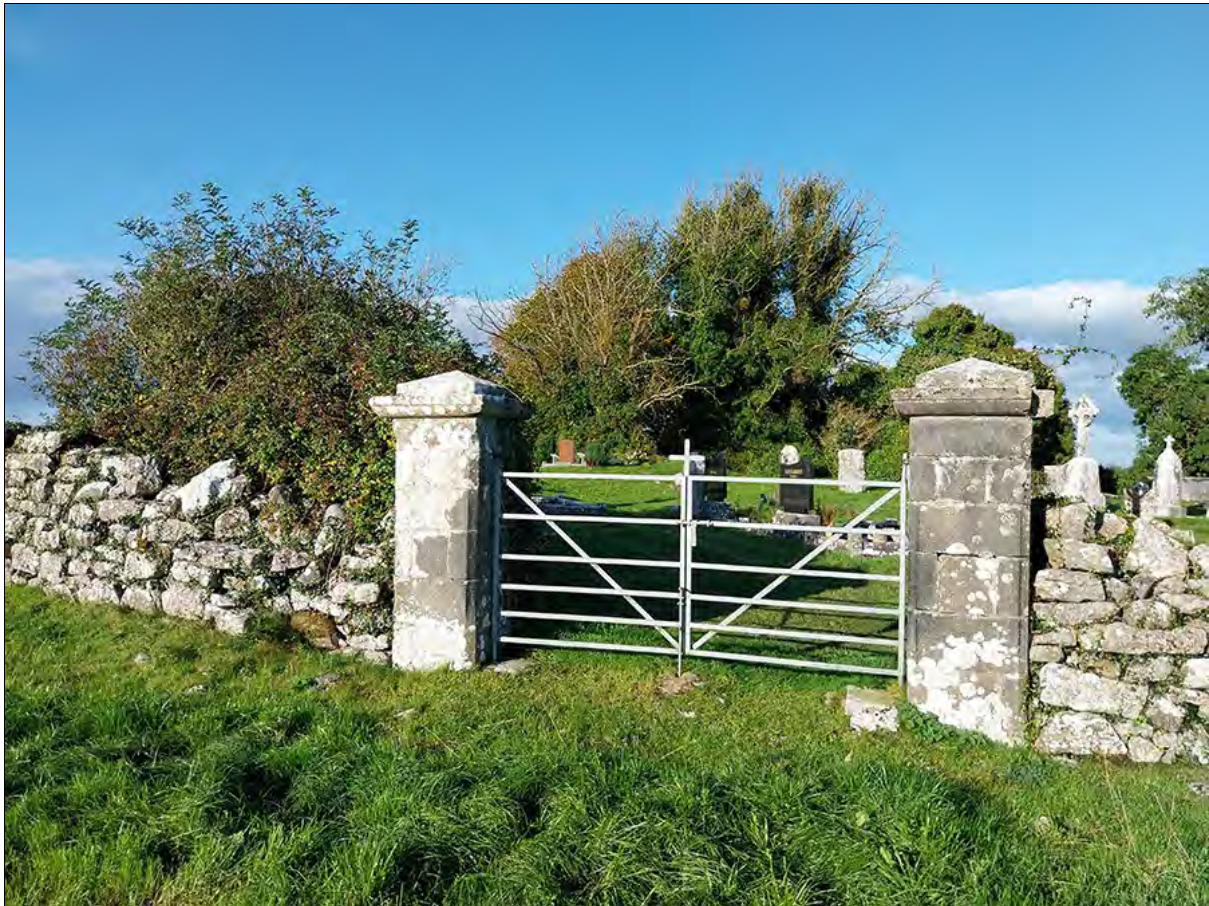
Figure 2.46. gate, from SW (F. Coyne).
