CMF Reference Code: CMF25-2-GA001

## Conservation and Management Plan for Killeely More Church and Graveyard, Killeely More and Beg townlands, Co. Galway.

**Date:** 13 November 2025

Client— Galway County Council

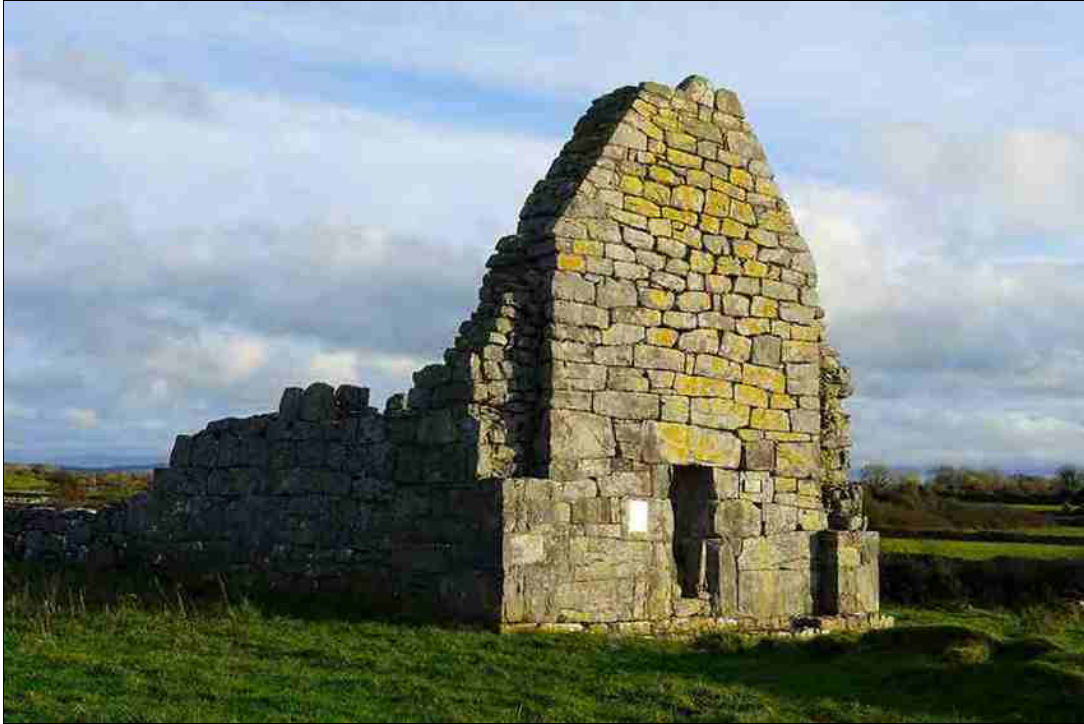
Figure 2.13. Early church at Killeely built in cyclopean masonry style

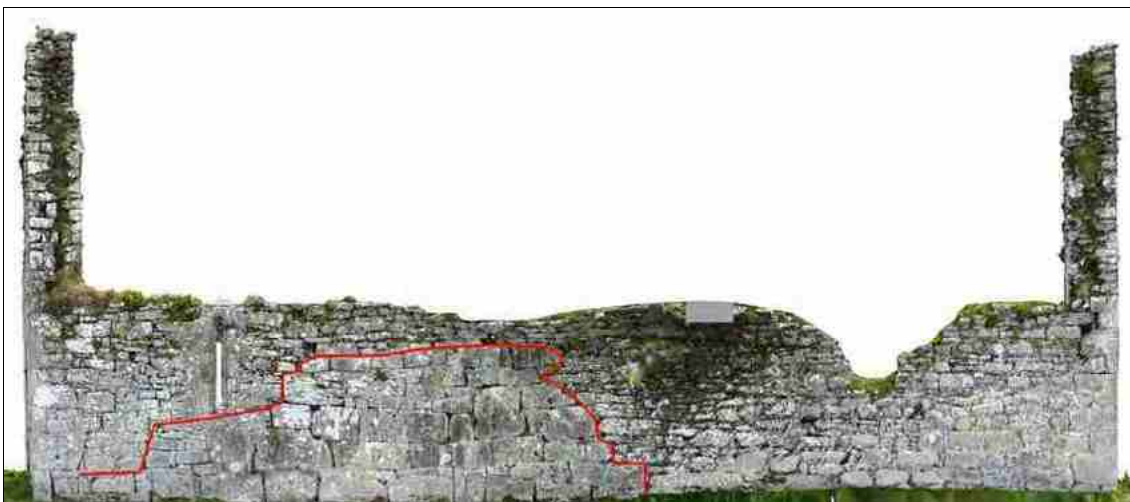
Figure 2.16. Elevation of exterior N of church wall showing cyplopean masonry(after OSECM, annotated by writer)

It is clear when that there are at least three obvious construction phases. The earlier phase, visible as cyclopean masonry dates to the 11<sup>th</sup>/early 12<sup>th</sup> century. These massive blocks of stone are visible in both the north and south walls. It appears that the church was extensively rebuilt in the late 12<sup>th</sup> century, and the quoin stones reused in the gables of the 12<sup>th</sup>/13<sup>th</sup> century church. The windows were added in the 12<sup>th</sup> century in the E, S and N walls.

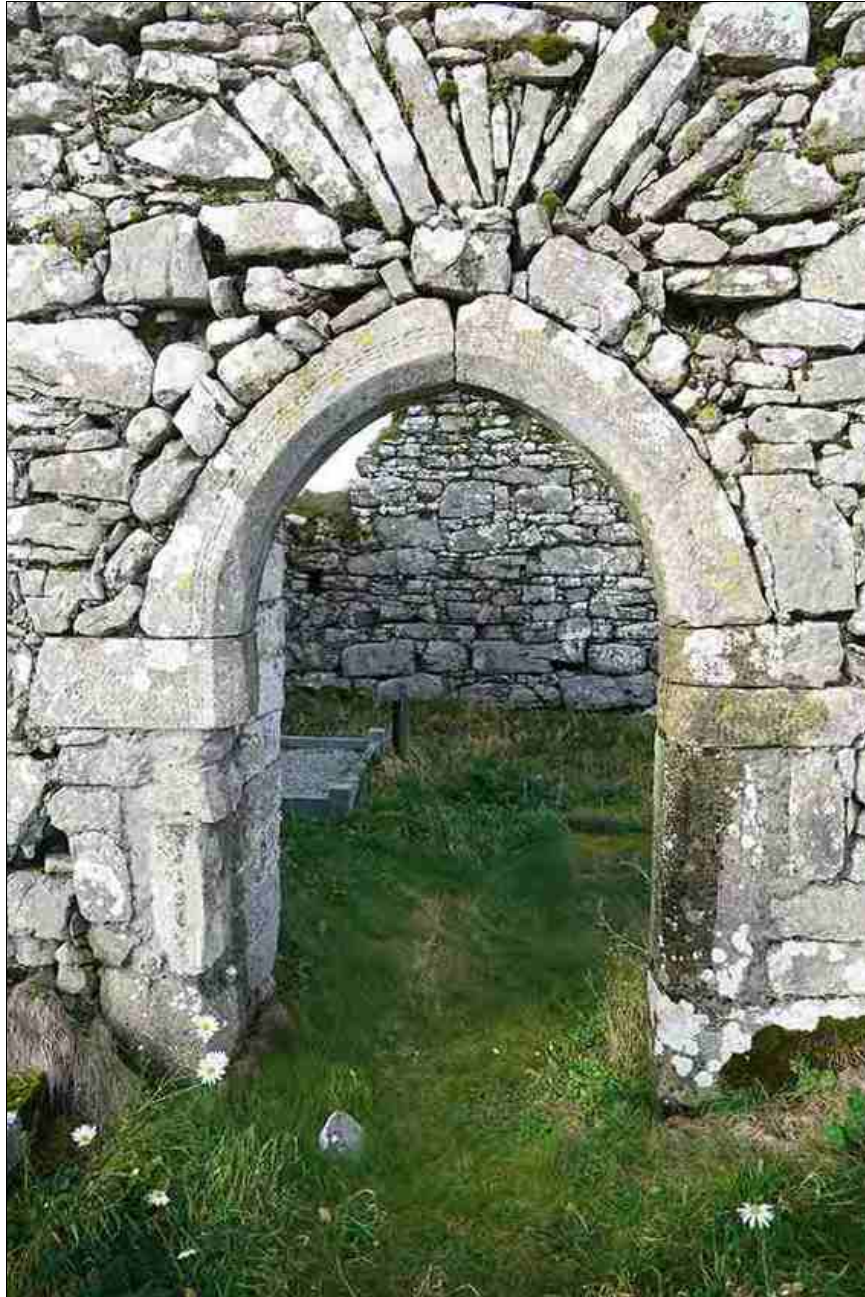
The remains of church now comprises at least three phases of construction. The door is located in the south wall. It consists of a fifteenth century pointed arched doorway, which is a later insertion.

Figure 2.17. Door in the southern wall, from S.

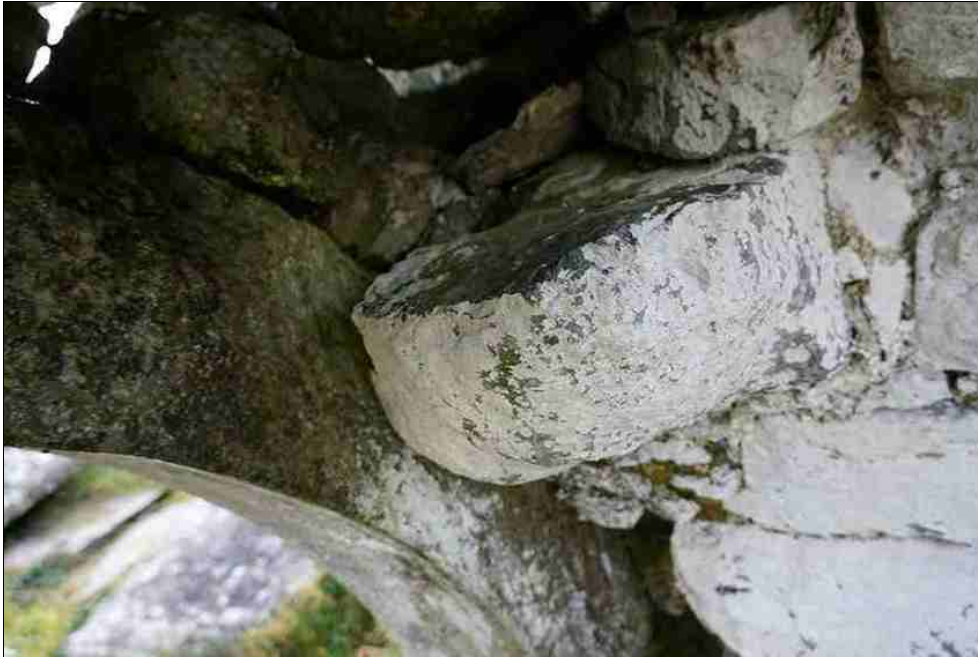
Figure 2.18. Detail of hanging eye, from NW.

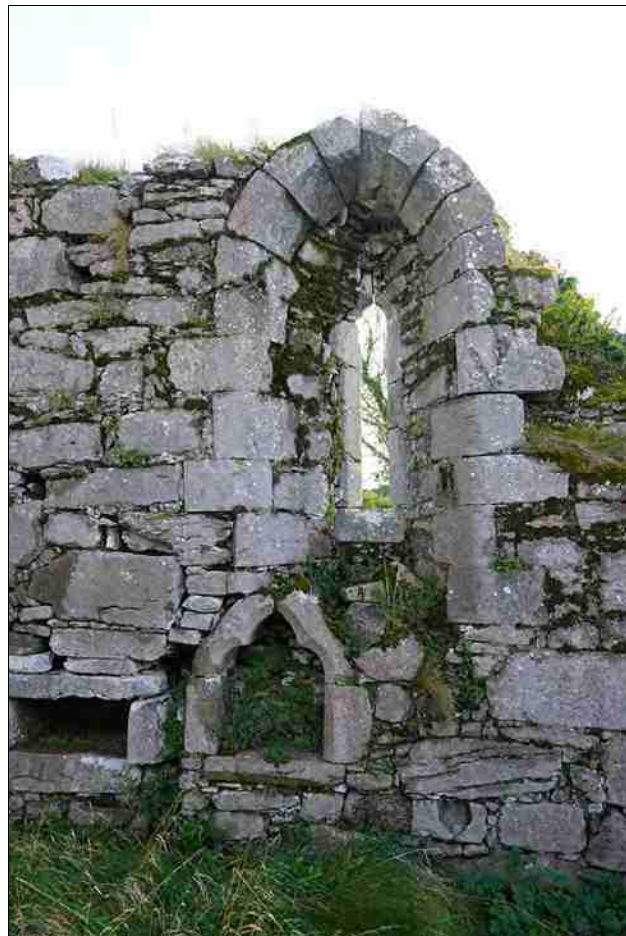
A new door was inserted in the S wall in the late 15<sup>th</sup>/early 16<sup>th</sup> century, and there seems to be extensive rebuilding at the W end of the church at this time. Joist holes in the N and S walls suggest that there a priest's residence/gallery was inserted at this time. The cusped piscina with trefoil head may have been added below the window in the S wall at this time.

Figure 2.19. Aumbrey, piscina and window, from N.

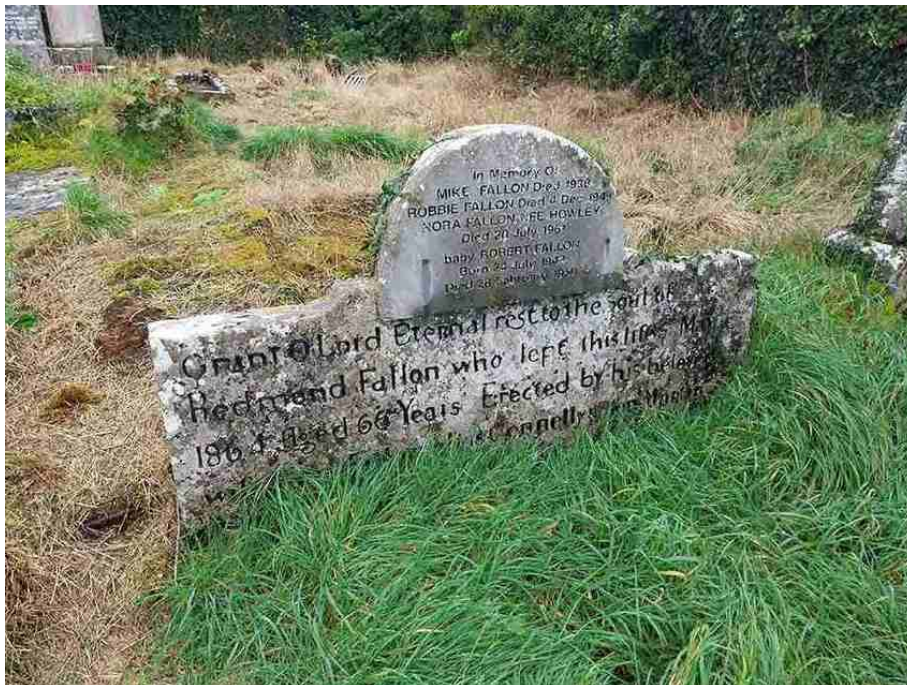
Figure 2.23. Nineteenth shouldered headstone with 20<sup>th</sup> century repair, from SE.

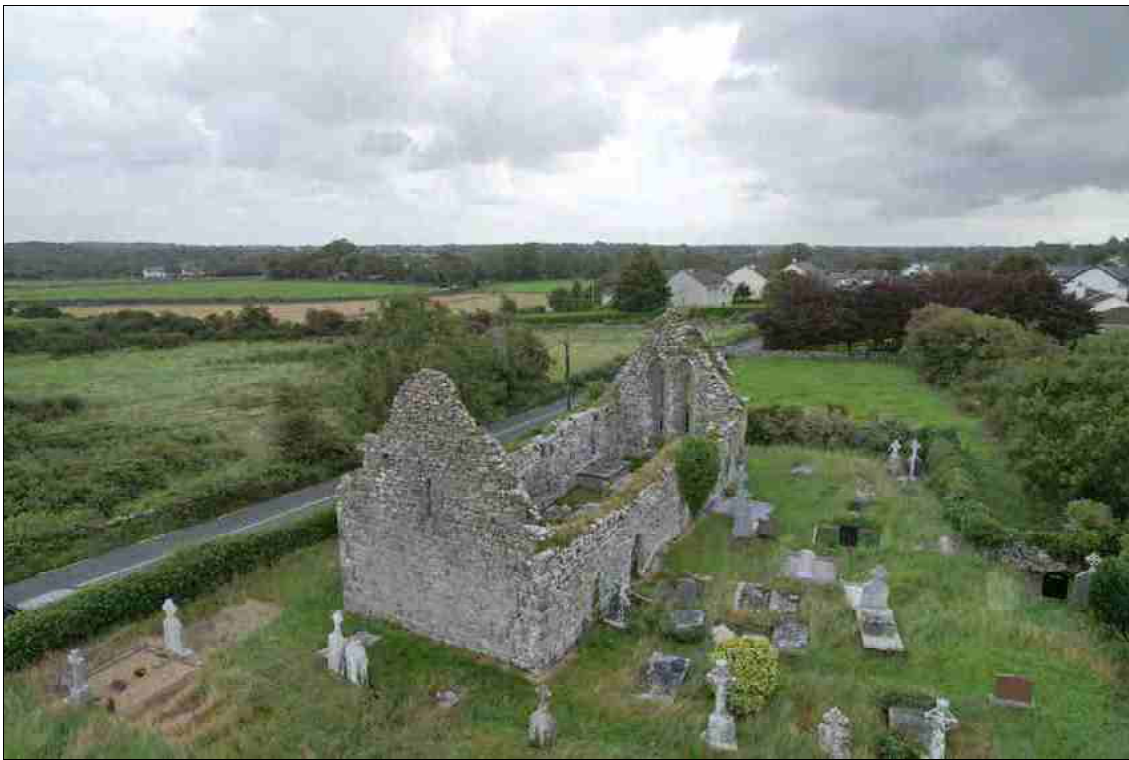
Within a graveyard (GA103-131004-) in Killeely More townland. The graveyard is partly within Killeely Beg townland. This rectangular late-medieval parish church 6.35m E-W; 19m N-S) is in quite good condition. Cyclopean masonry is visible in the N and S walls suggesting an earlier structure, possibly pre 12<sup>th</sup> century.

The masonry in the W side of the church is of poor quality random rubble. This is probably the result of rebuilding in the late 15<sup>th</sup> or early 16<sup>th</sup> century, when the pointed arch doorway was inserted. A priest's residence may also have been inserted at this time, and a new window inserted in the gable.

Figure 2.29. Church, from SW.

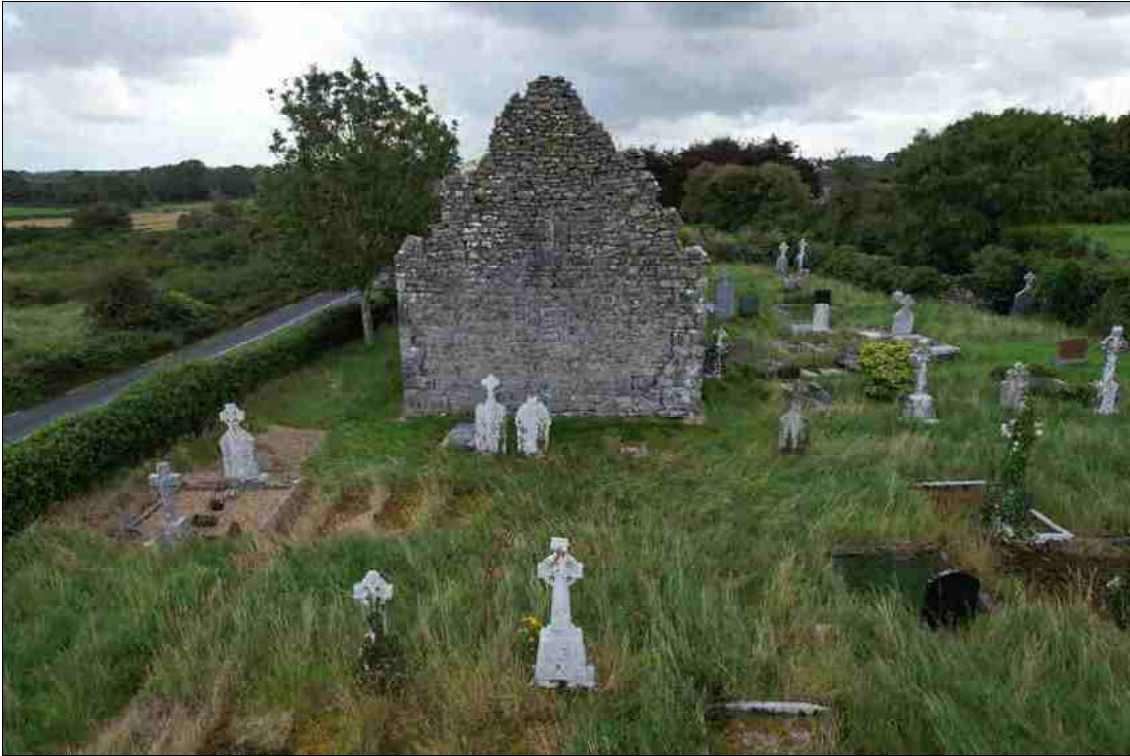
The graveyard is in reasonably good condition. The graves are reasonably accessible, although the grass is high. It measures approximately 60m E-W by 30m N-S.

Figure 2.30. Graveyard, from W.

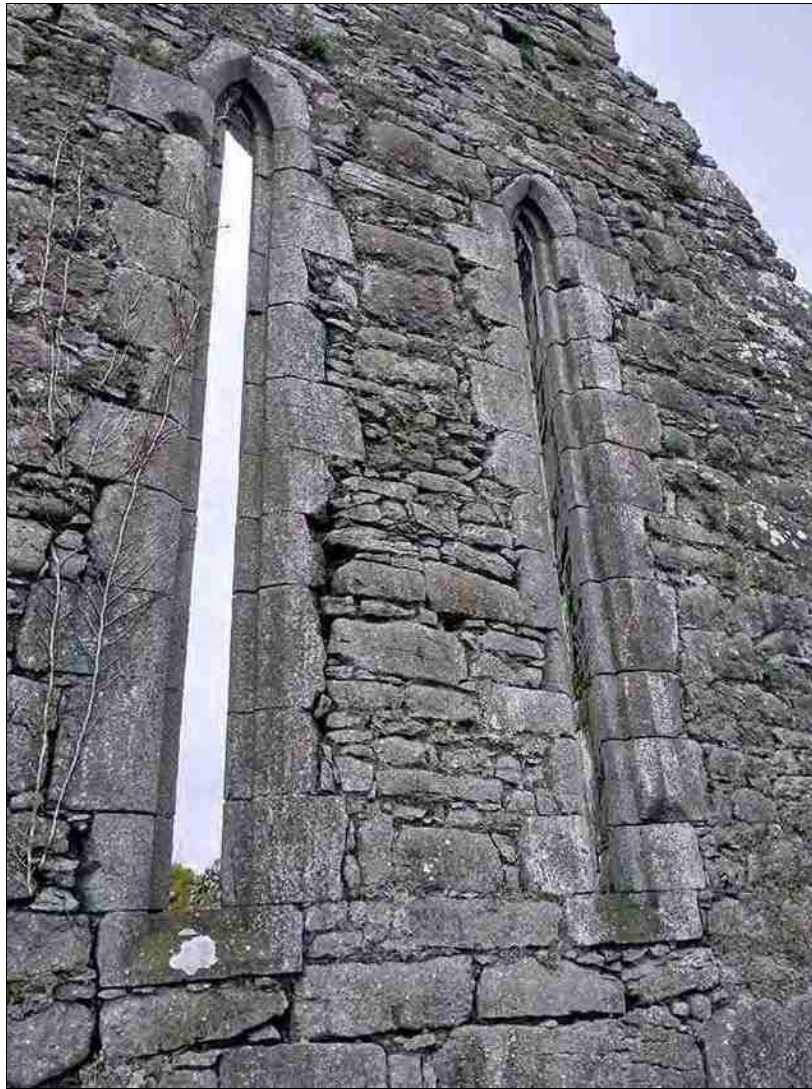
The e window consists of a pair of pointed lancet windows of 13<sup>th</sup> century date. Internally the remains of a sloping cill can be discerned.

Figure 2.31. East window, from SE.

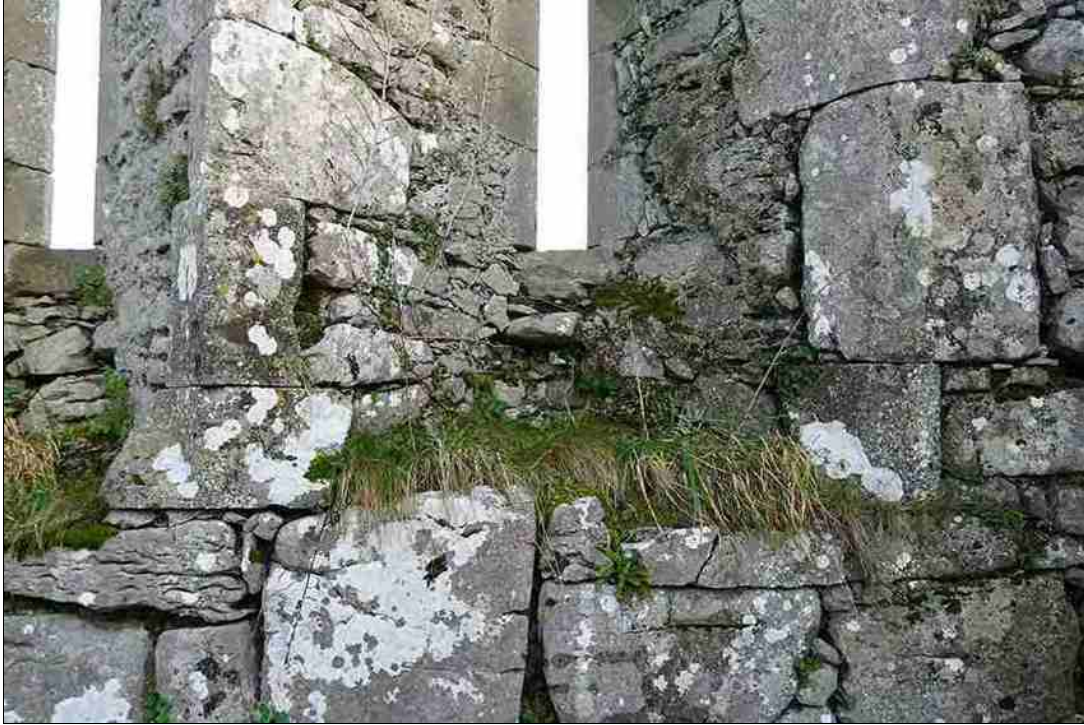
Figure 2.32. Line of cill, from W.

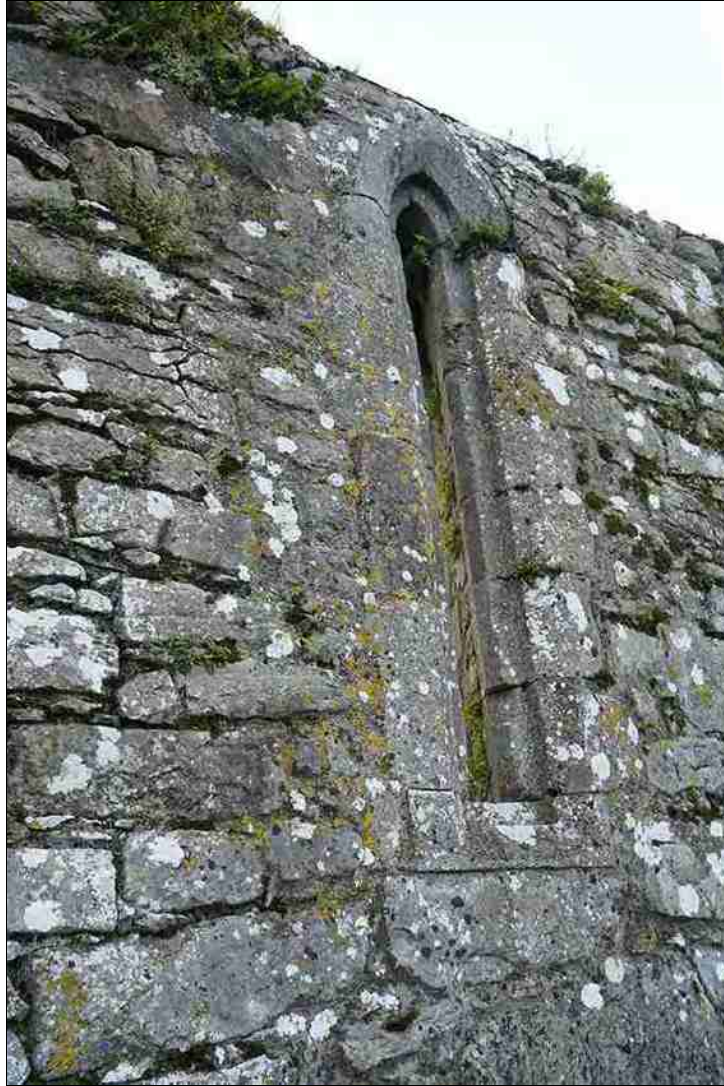
The N wall contains a cut stone single narrow lancet window with 13<sup>th</sup> century diagonal tooling. Internally, the form of the sloping cill can be discerned. To the east side of the window is a hole-its function is unclear.

Figure 2.33. Window in N wall, from NE.

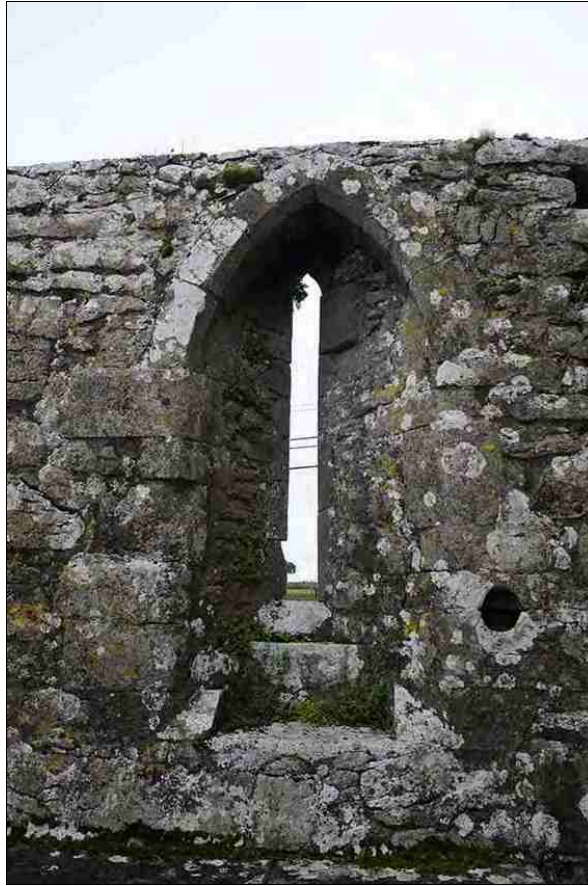
Figure 2.34. Window in N wall, from S. Note hole to right of window.

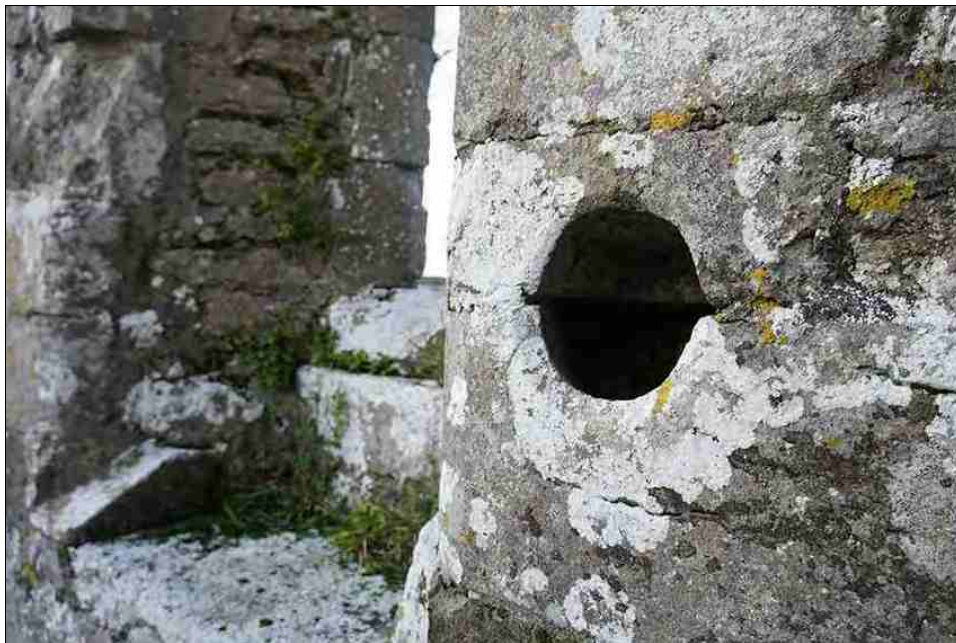
Figure 2.35. Hole on E side of N window, from SE.

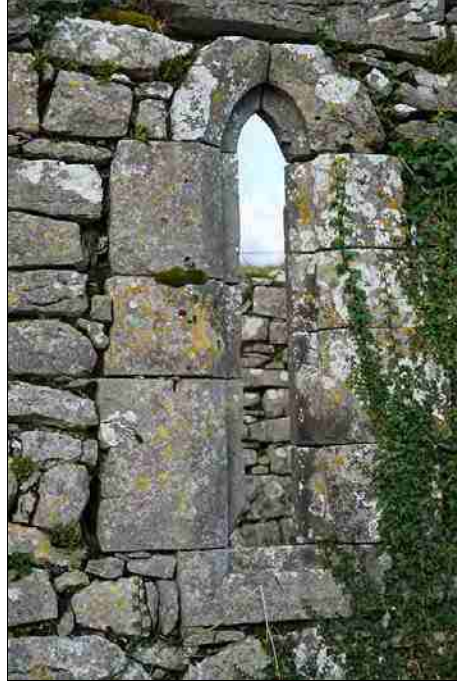
The N wall contains a cut stone single narrow lancet window with 13<sup>th</sup> century diagonal tooling. Internally, the form of the sloping cill can be discerned.

Figure 2.36. External view of window in S wall, from S.

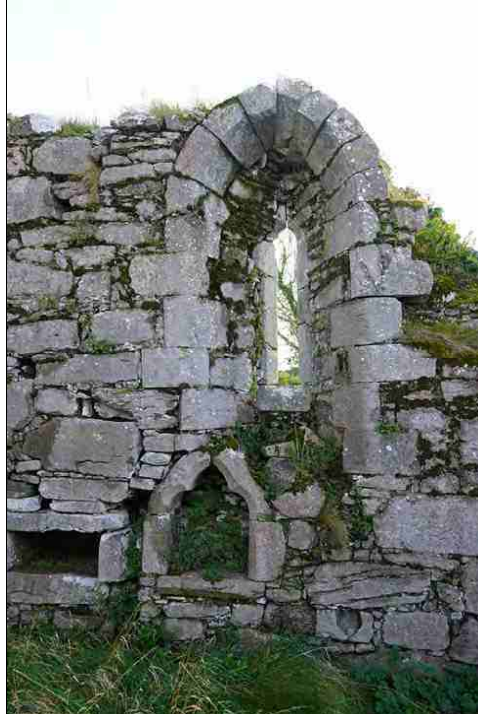
Figure 2.37. Internal view of window in S wall, from S. Note aumbrey and piscina below.

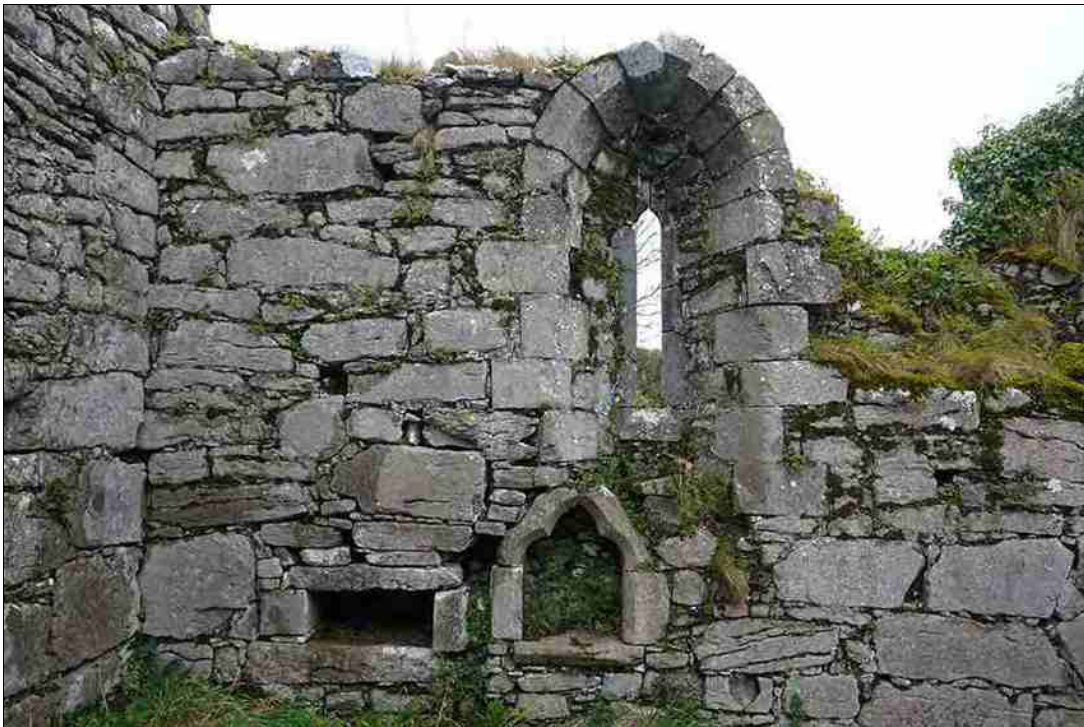
An aumbrey and piscina are located in the S wall at the E end of the church. An aumbrey is a cupboard or recess with a door in the wall of a church used for reservation of the Blessed Sacrament after the Eucharist or Mass, or for the Holy Oils. A piscina is a stone basin used for washing holy vessels used during Mass or Communion services. Piscinas are usually set into a niche in the church wall near the altar (usually to the south side of the sanctuary or chancel). There is a drain hole at the bottom of the piscina to allow water to escape. The ornate piscina in the south wall has an early form of ogee head, is also of thirteenth century date (<https://field-monuments.galwaycommunityheritage.org/content/archaeology/churches/killeely-church>). However, this piscina appears to have been inserted at this location at a later date to the window above.

Figure 2.38. Piscina and aumbrey, from S.

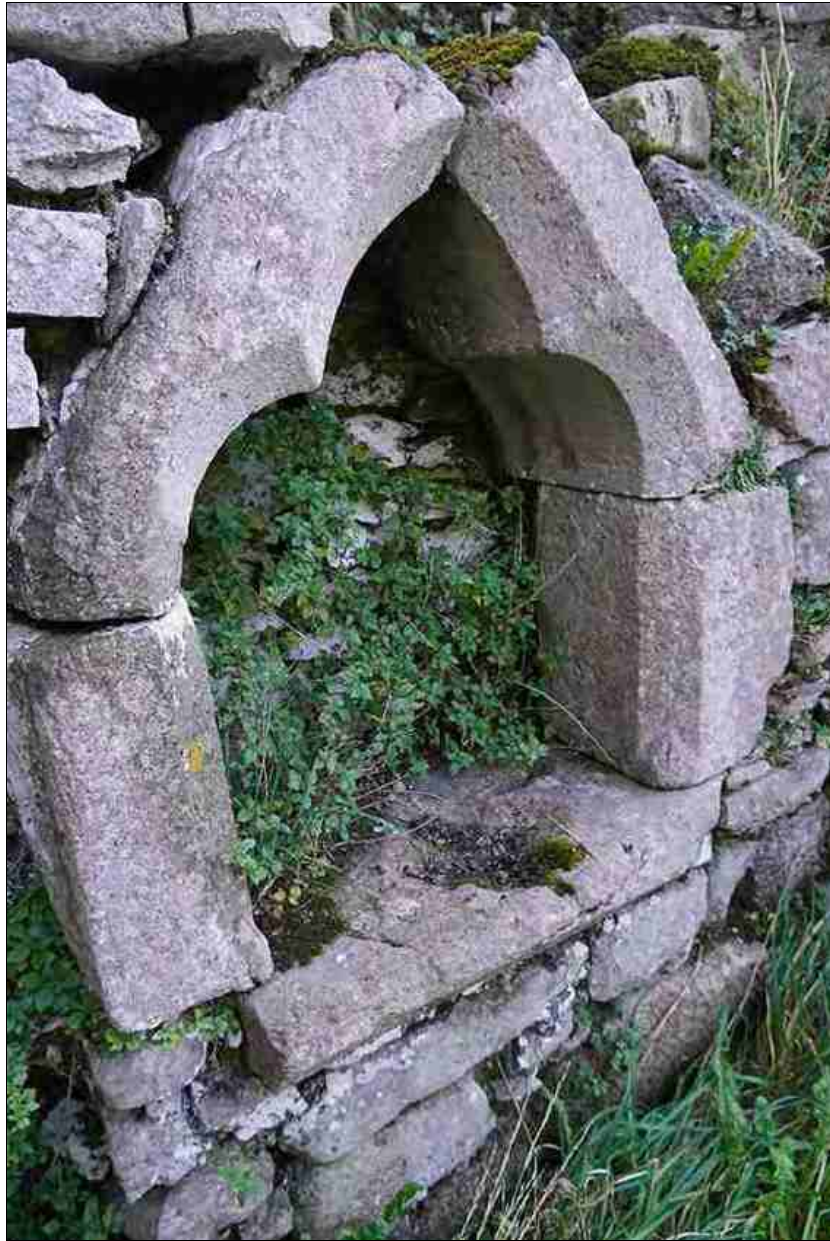
Figure 2.39. Piscina, from S.

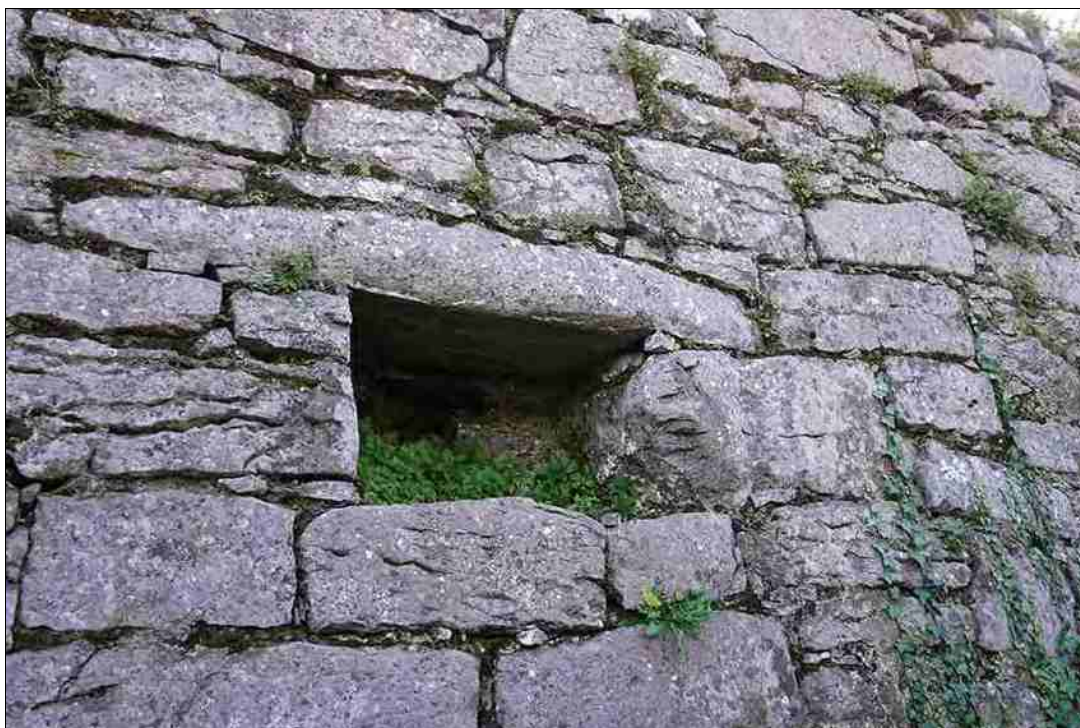
An wall niche is located about midway along the S internal wall. Its function is unclear.

Figure 2.40. Wall niche/cupboard, from S.

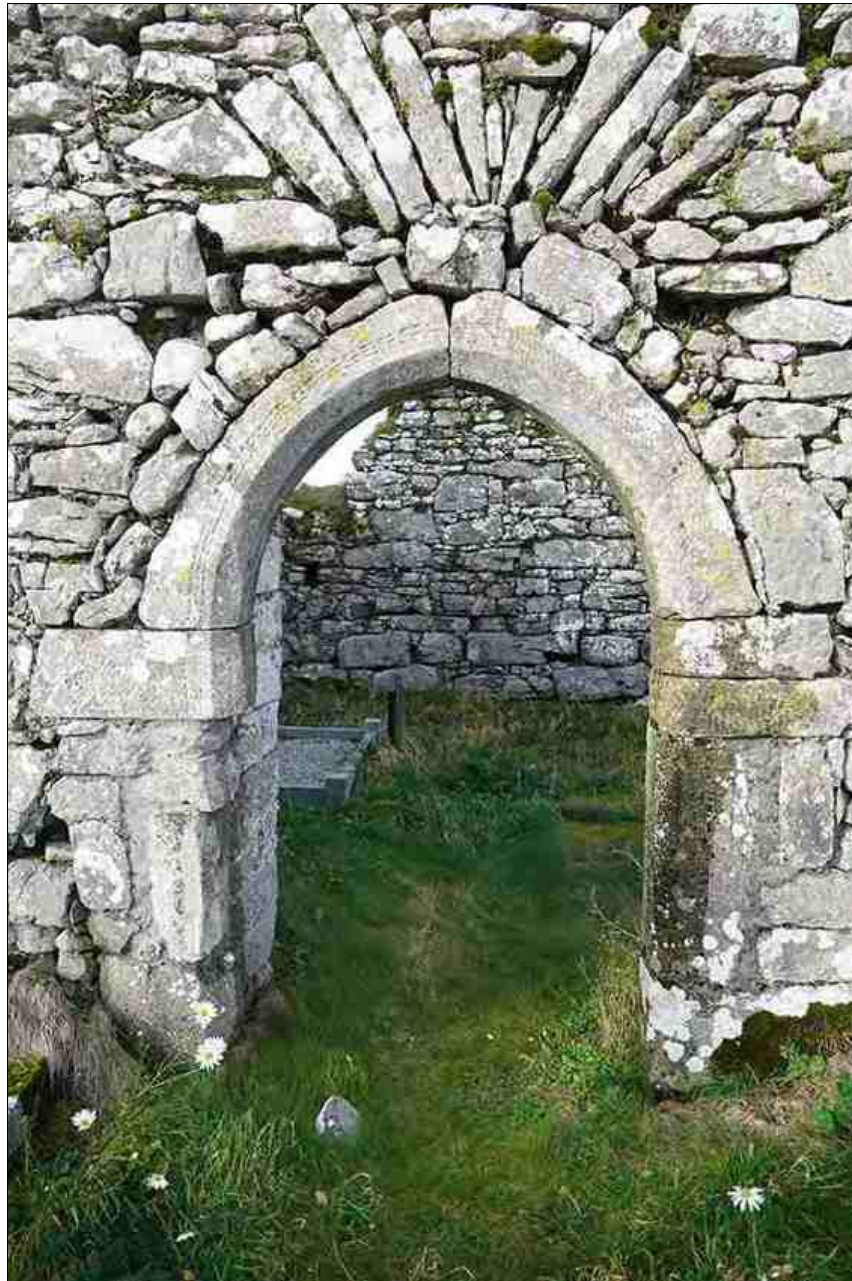
The door in the south wall is in good condition. However, minor repairs may be necessary, as some of the masonry has become loose in the drawbar socket.

The door exhibits two phases of construction-an earlier 12<sup>th</sup>/13<sup>th</sup> century original stonework, and later 15<sup>th</sup> century pointed arch and replacement jambs.

Figure 2.42. Church door, from S.

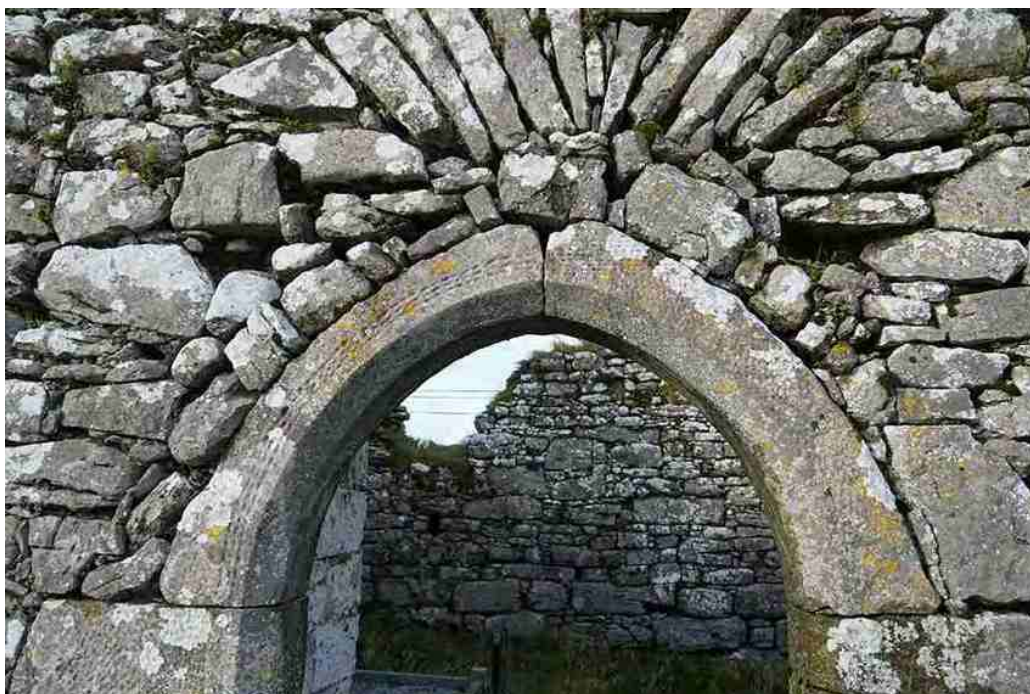
Figure 2.43. Detail of hyphenated decoration and sparrow pecking on S door, from S.

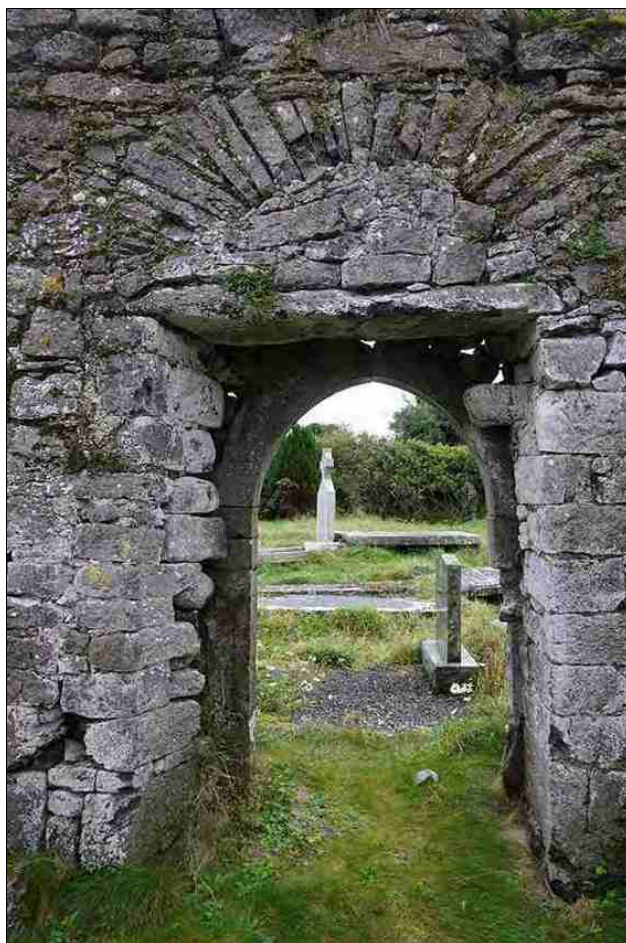
Figure 2.44. Internal view of church door, from N. Note infill and cracked lintel over door.

3.3 The inner door head is formed in a 400mm wide by 100–125mm deep stone lintel spanning that 1.6m clear distance between the support lines. A flattened semicircle of stone is constructed above the lintel, with its crown 600mm above the soffit of the stone lintel. There is a relieving arch and stone masonry above this, also appearing to be of well-selected and largely unworked field stone. The springing point of the arch appeared to be bearing on more solid masonry beyond the reveal lines.

3.4 The underside of the lintel has cracked badly near its mid span: the crack is opened to approximately 10mm wide in places. There is significant risk of collapse.

- 5.4 Carefully remove a small quantity of the packing stone between the lintel and the relieving arch near the springing point to one side. Take care to avoid disturbing the relieving arch stones or allowing them to come loose. Rebuild this packing stone with lime mortar mix allowed to cure for minimum 4 – 5 days; and longer if the curing conditions are not good. Repeat this operation near the springing point on the other side of the doorway and allow cure for a similar. Repeat the operation again on the centre one-third of the packing stones under the crown of the arch.

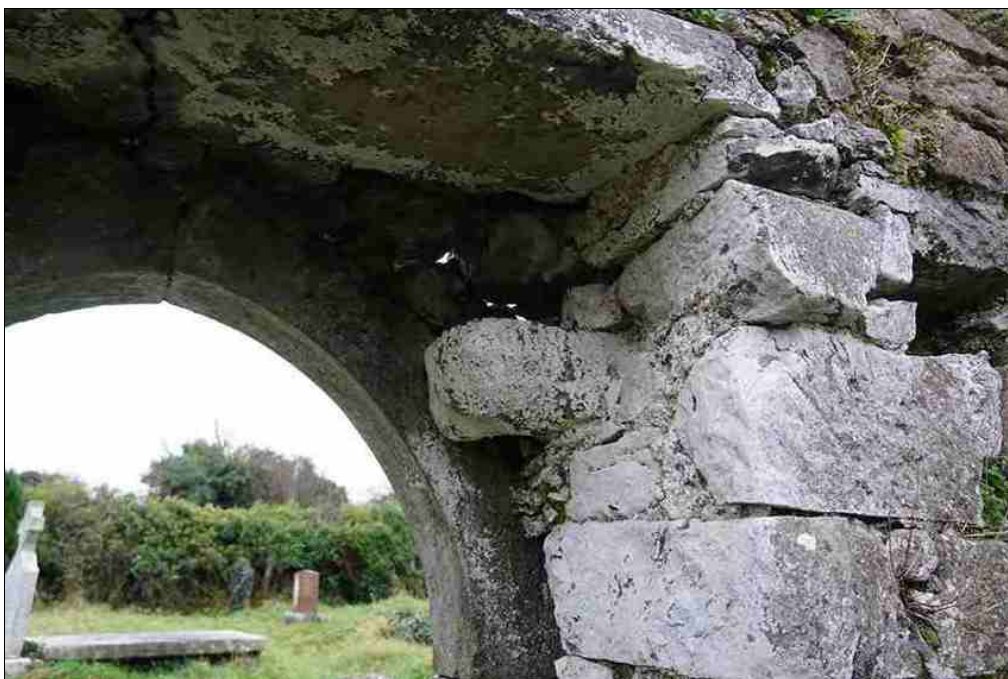
Figure 2.45. Hanging eye for door on W side of entrance.

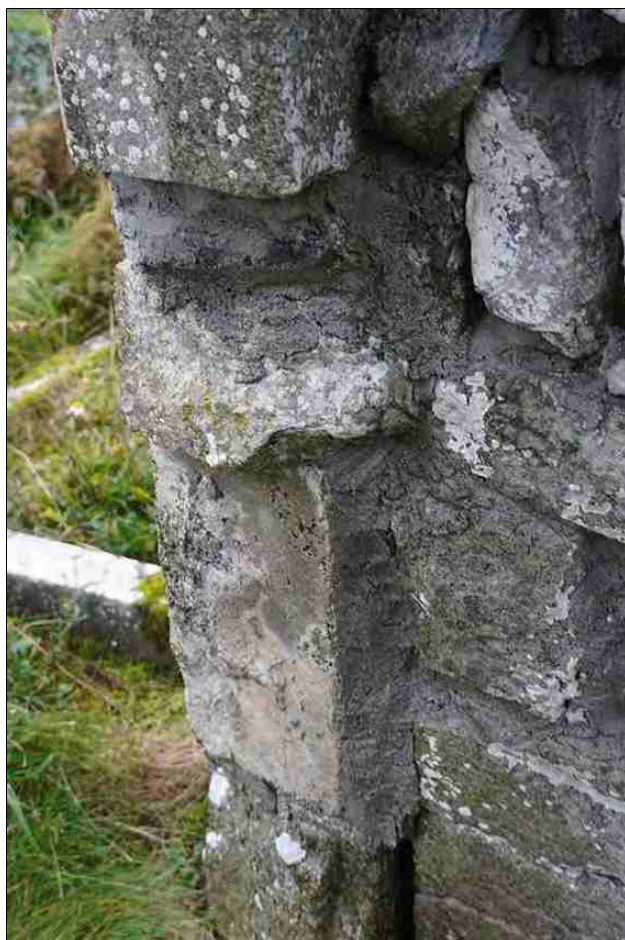
Figure 2.46. Concrete repairs on W side of door. Original door jamb missing at this side.

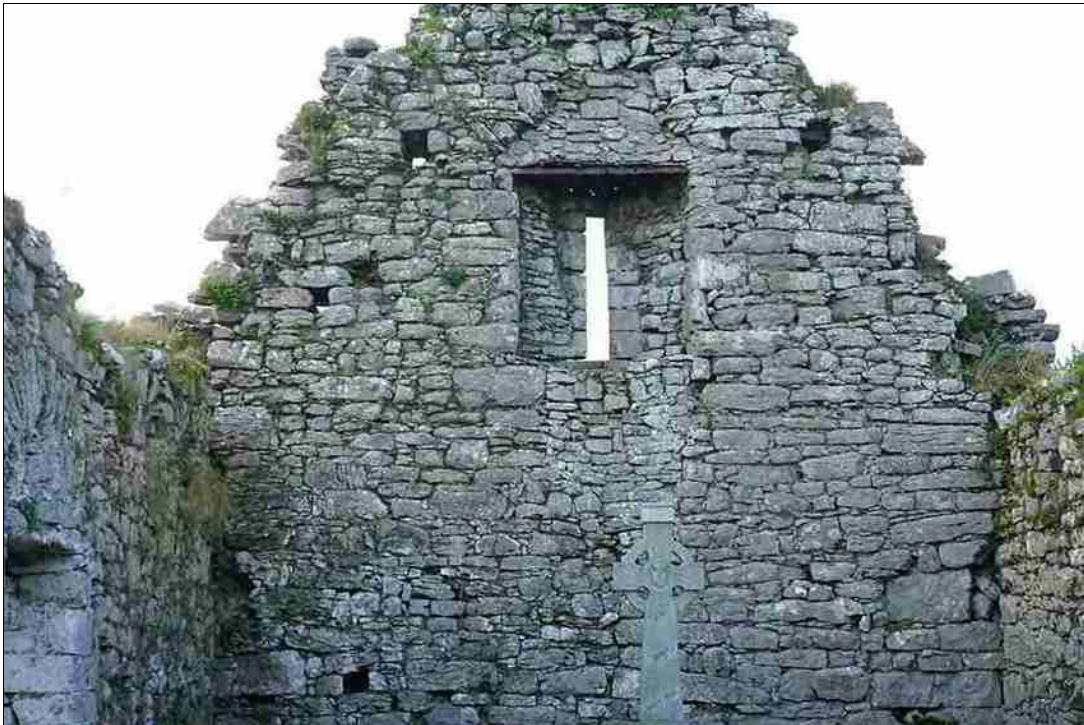
A narrow single light window is situated in the W gable. There has been extensive modern interventions around this window with part of what appears to be a metal gate used as a lintel. Externally, the narrow light has a flat lintel. O'Donovan record sin the O.S. Letters for County Galway (1838, 154) that there was a lancet window in the W gable.

Figure 2.47. Internal view of window in W gable, from E.

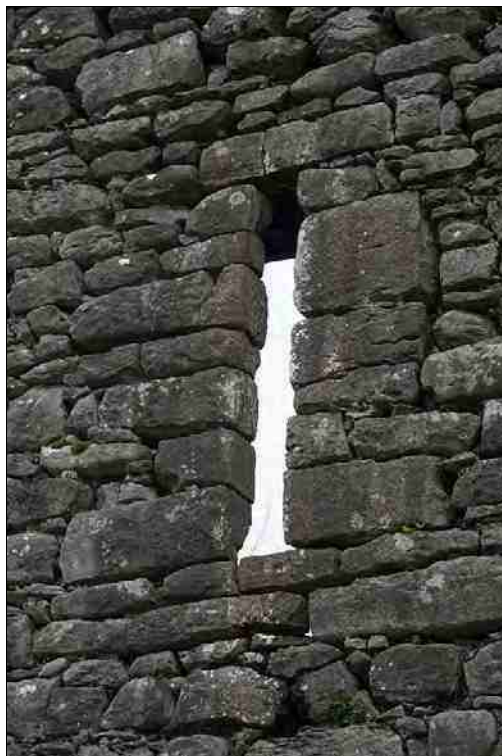
Figure 2.49. Detail of 15<sup>th</sup> century window (external), from W. Note cracked lintel.

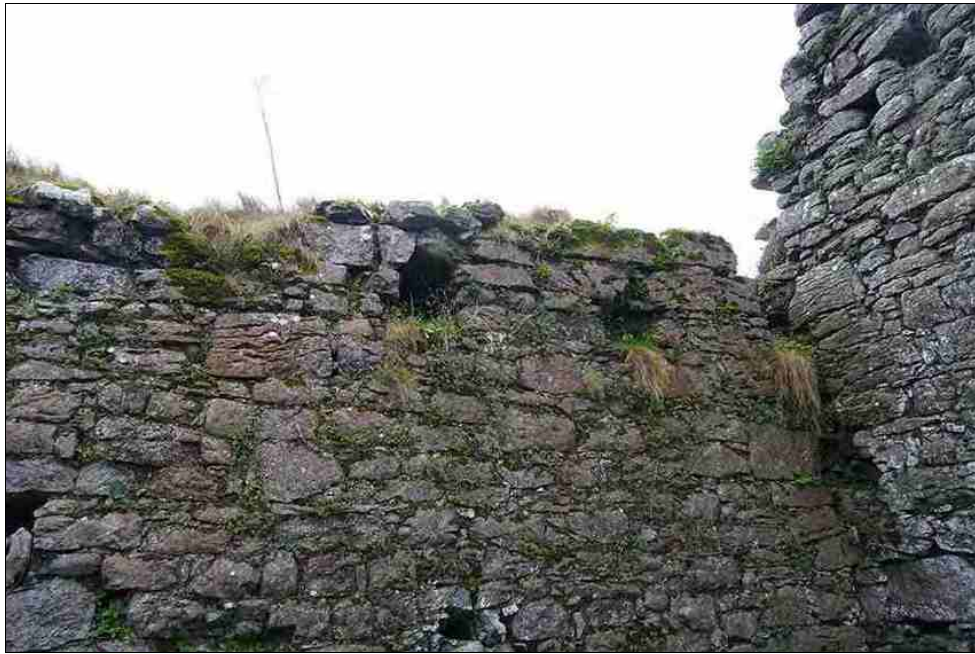
Figure 2.50. Joist holes in S wall, possible indication of a priest's residence, from N.

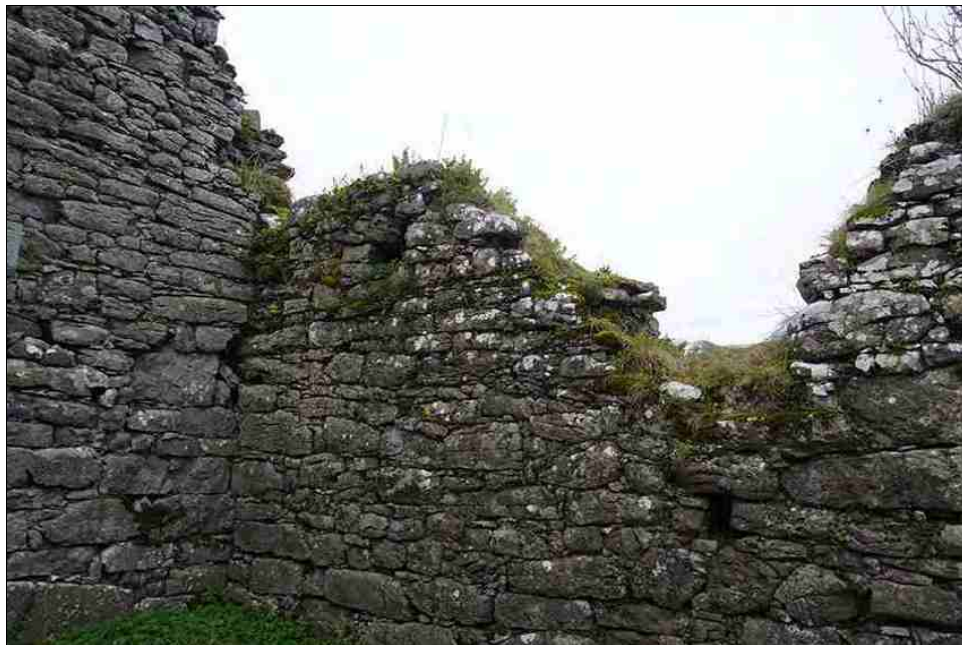
Figure 2.51. Joist holes in N wall, possible indication of a priest's residence, from S..

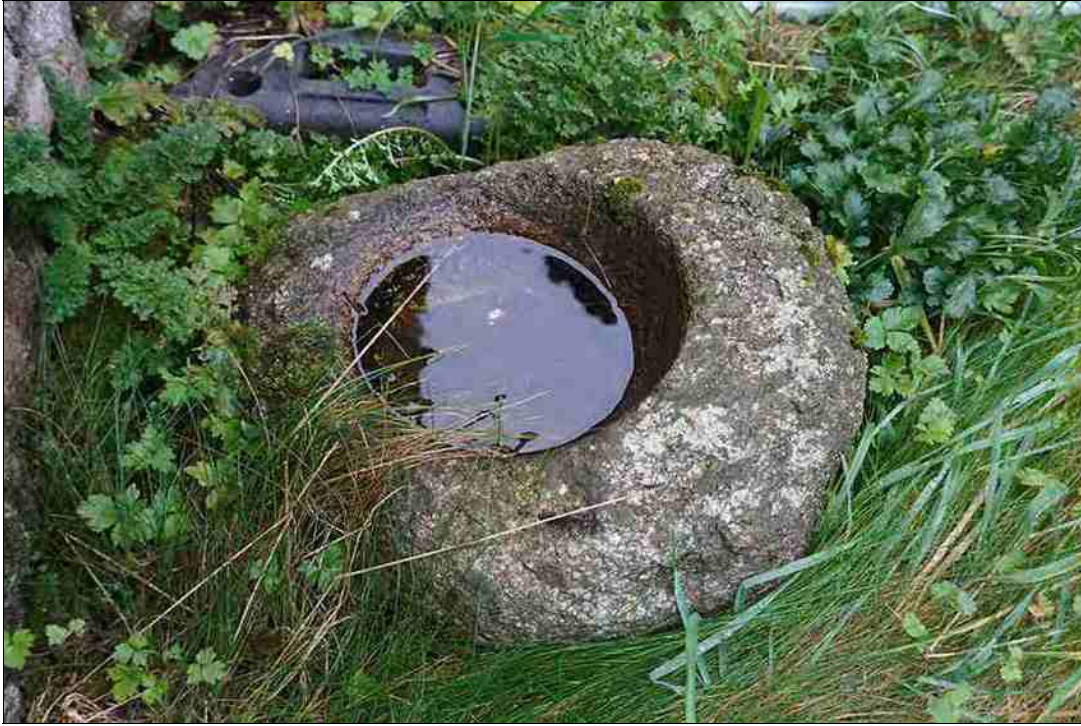
This bullaun stone lies immediately inside the door of the church. It is made from granite, , and measures 0.65m by 0.30m high, with the circular hollow measuring 0.33m in diameter and XXXm deep.

Figure 2.52. Bullaun stone.

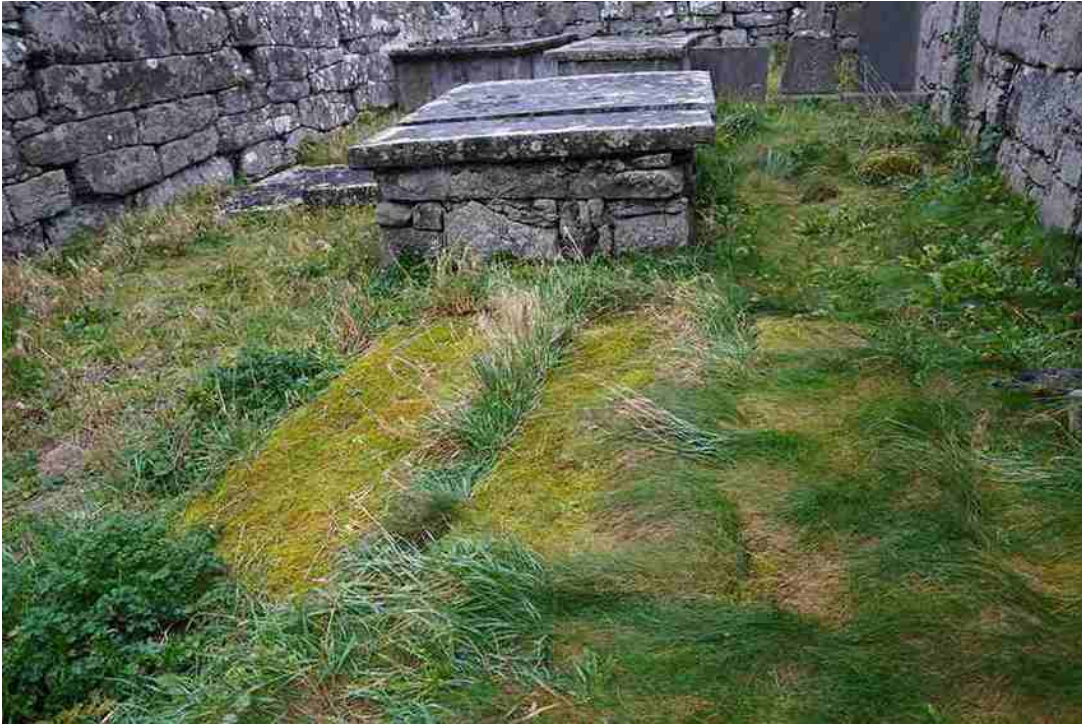
No information is available on the HEV for these graveslabs. All are located within the church.

Figure 2.53. Overgrown medieval grave slabs, from W.
