CMF Reference Code: CMF25-2-GA001

## Conservation and Management Plan for Killeely More Church and Graveyard, Killeely More and Beg townlands, Co. Galway.

**Date:** 13 November 2025

Client— Galway County Council

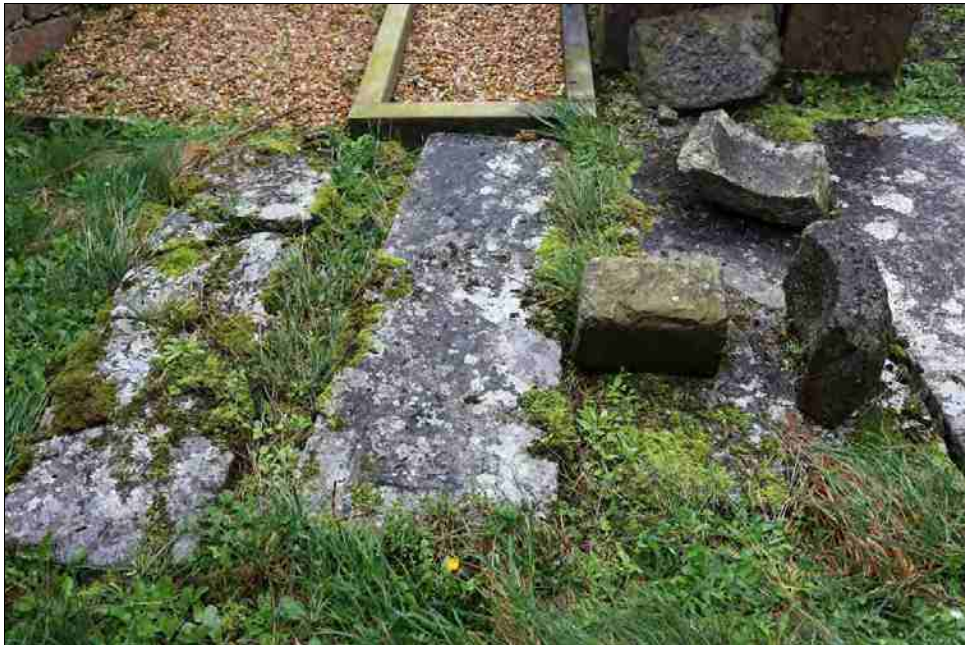
Figure 2.54. Medieval slabs and architectural fragments, from E.

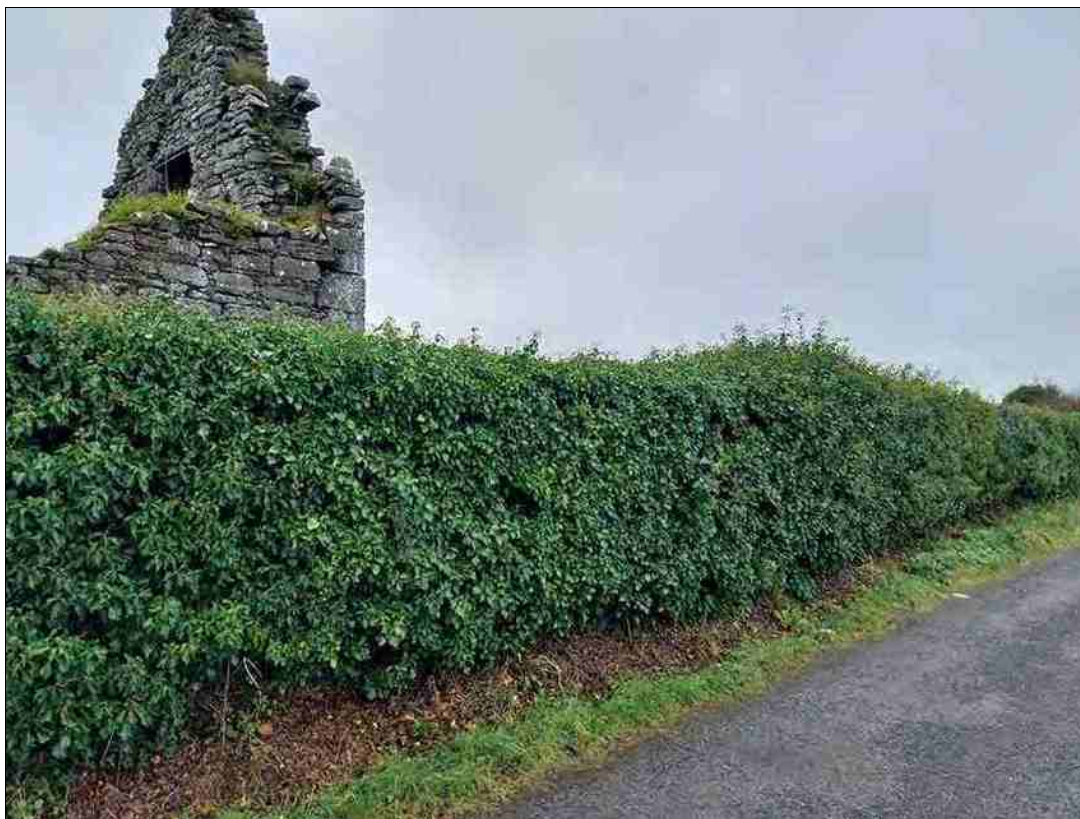
The graveyard is surrounded by a dry stone wall, It is very overgrown, but the wall itself appears to be in good condition. Some very large stones are visible in its lowest courses adjacent to the entrance.

Figure 2.55. Graveyard wall, from NE.

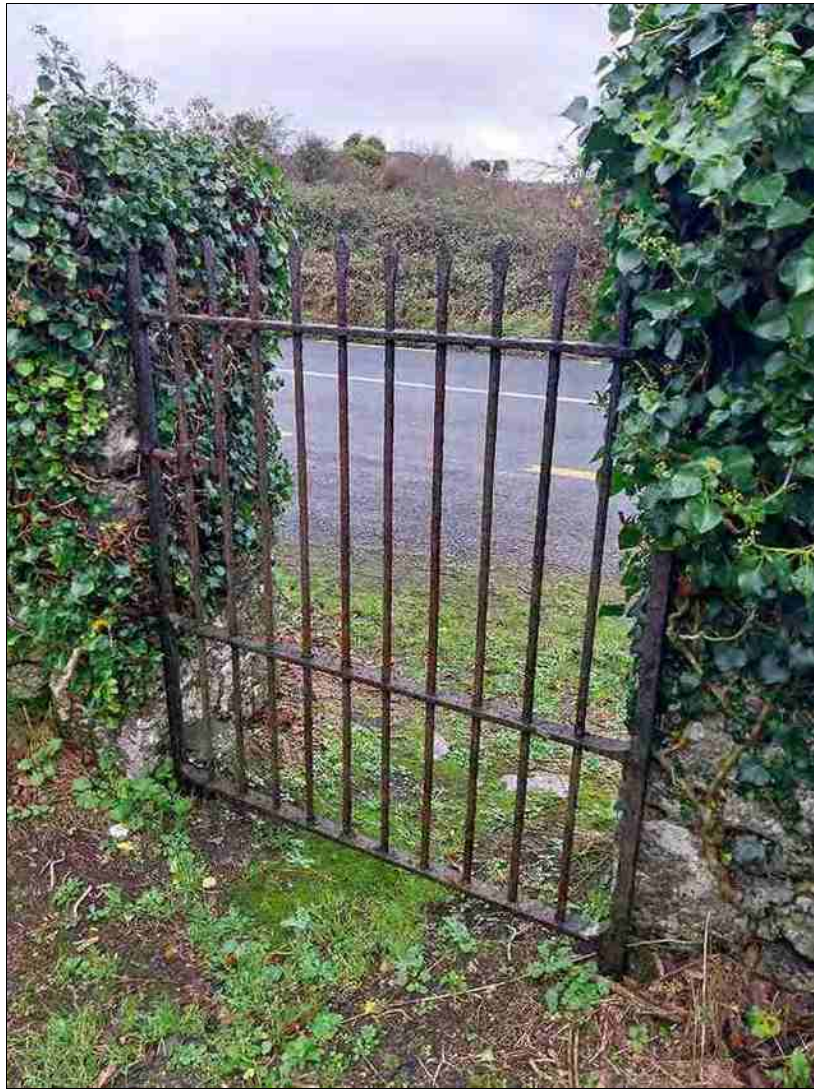
The graveyard is access through a wrought iron gate and mortared stone piers. It appears to be of nineteenth century date. It is in good condition.

Figure 2.56. Graveyard gate, from S.

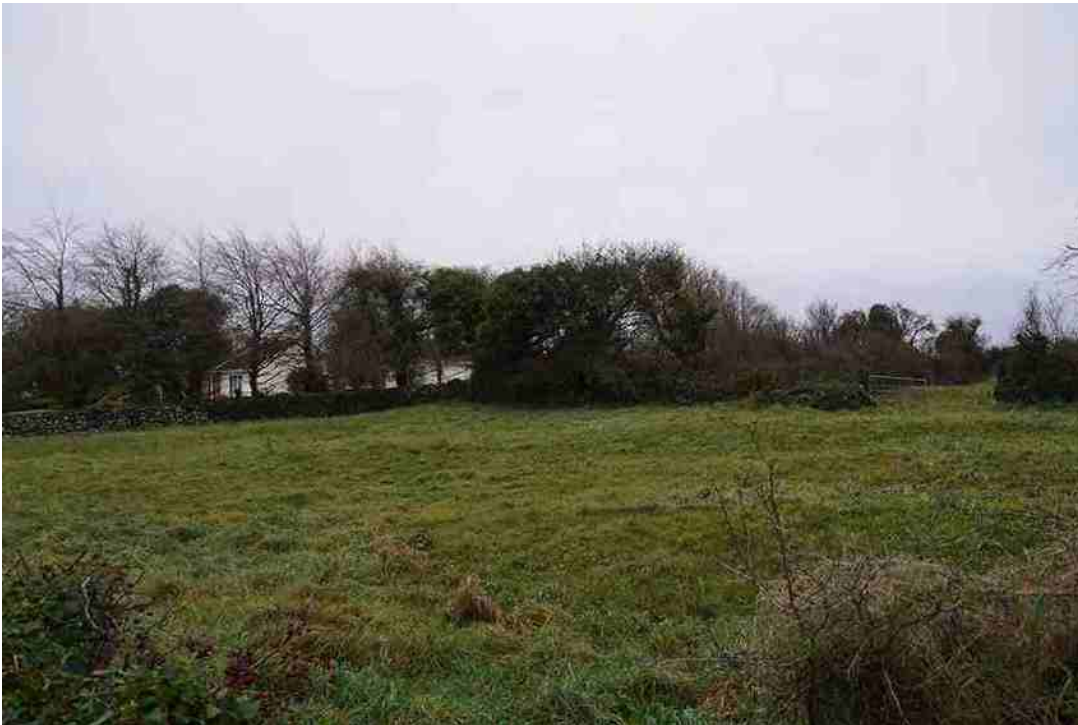
Figure 2.59. Earthen bank in field at E of church, from NW.

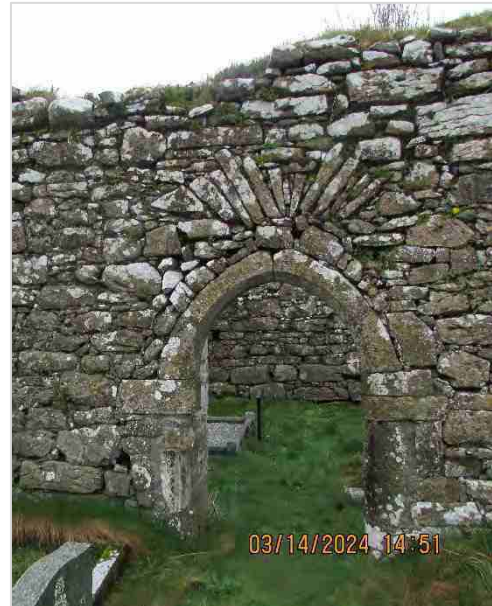
3.1 The external, southern, side of the doorway is approximately 1.1m wide and has carved stone framing, including a pair of curved arch stones approximately over the reveal lines of the doors. Better stability would have been achieved if the springing points were even as little as 50mm beyond the reveal lines. Very little of the original mortar survives in this south-facing external wall.

3.2 The west reveal steps inwards approximately 100mm behind the carved stone framing and then runs square to the inner face of the wall. The east reveal also steps in approximately 100mm behind the carved stone framing and runs in a splayed manner to the inner face of the wall. The doorway is 1.6m wide on the line of the inner face of the wall.

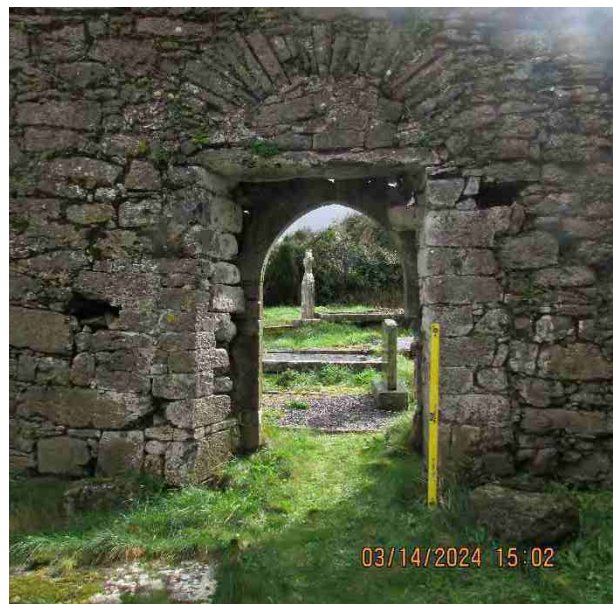
3.3 The inner door head is formed in a 400mm wide by 100–125mm deep stone lintel spanning that 1.6m clear distance between the support lines. A flattened semicircle of stone is constructed above the lintel, with its crown 600mm above the soffit of the stone lintel. There is a relieving arch and stone masonry above this, also appearing to be of well-selected and largely unworked field stone. The springing point of the arch appeared to be bearing on more solid masonry beyond the reveal lines.

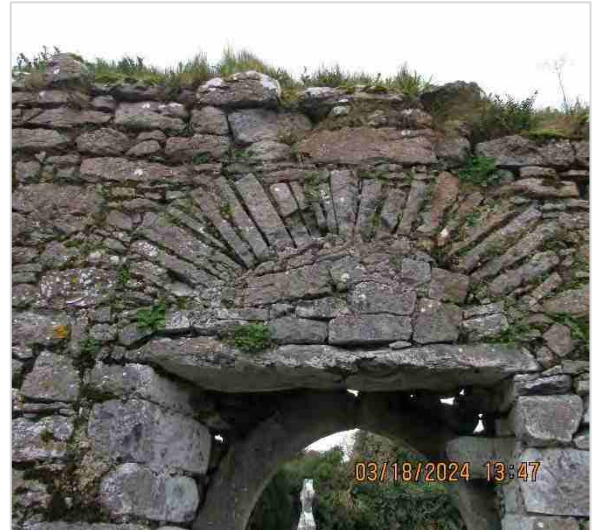
3.4 The underside of the lintel has cracked badly near its mid span: the crack is opened to approximately 10mm wide in places. There is significant risk of collapse.

- 5.4 Carefully remove a small quantity of the packing stone between the lintel and the relieving arch near the springing point to one side. Take care to avoid disturbing the relieving arch stones or allowing them to come loose. Rebuild this packing stone with lime mortar mix allowed to cure for minimum 4 – 5 days; and longer if the curing conditions are not good. Repeat this operation near the springing point on the other side of the doorway and allow cure for a similar. Repeat the operation again on the centre one-third of the packing stones under the crown of the arch.

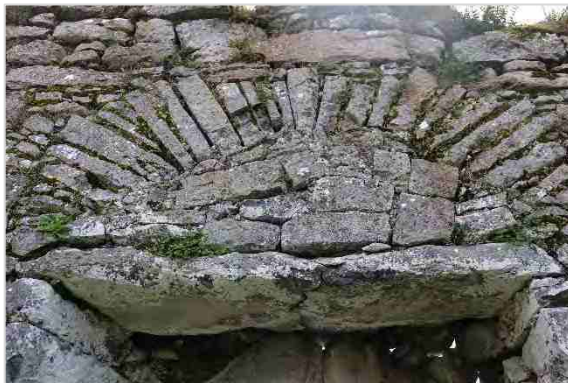
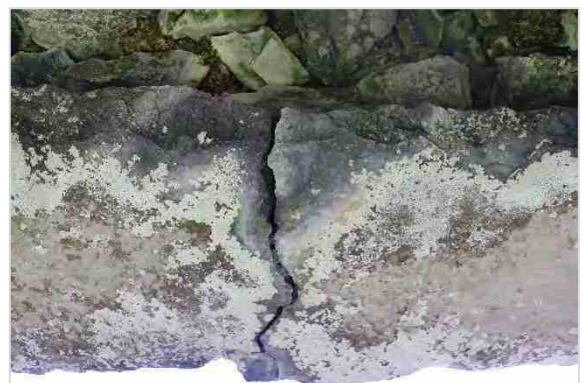
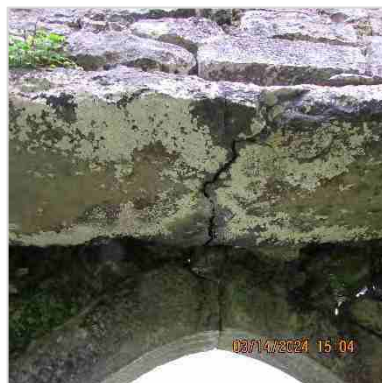
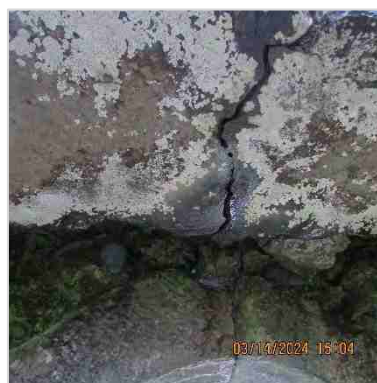
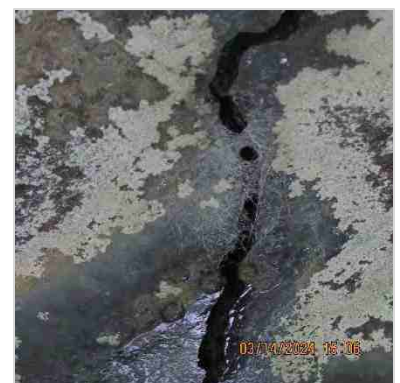
4.1 The crackling appears to have opened over the past five years or so; the faces of the stone within the crack do not appear weathered. If the stone lintel satisfactorily carried the load of the stone overhead for hundreds of years and then appears to have cracked relatively recently, one must ask has there been a change in the status quo to cause such cracking.

- 5.6 Provide 2 no. stainless steel plates to the underside of the lintel. Fix the plate to the underside of the lintel with M8 stainless steel pins, resin-anchored 75mm into the stone lintel. Minimum 4 no. pins each plate each side of the crack; minimum 16 no. total; allow 20 no. Grout any space between the steel plating and the underside of the stone lintel with relatively high-strength grout: 5N Coulinex or similar.

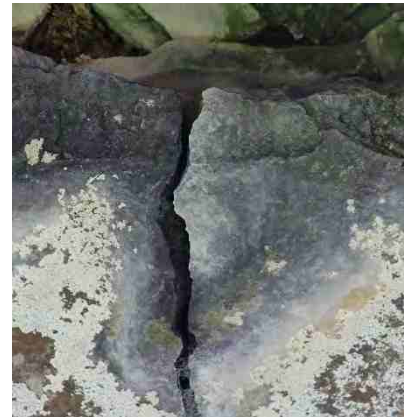
4.2 The soffit of the lintel is planar either sides of the crack, indicating that the crack is not the result of settlement of the masonry to one or both sides of the doorway. The most likely reason for the crack therefore is flexural tension.

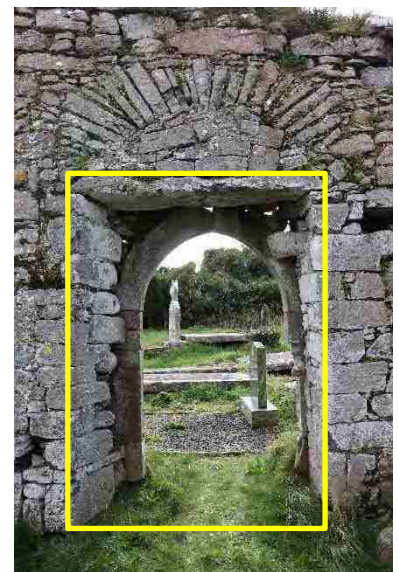
4.3 The span:depth ratio of the lintel is approximately 12 to 14. This is not excessive if the lintel were just to carry the 600mm of flattened semi-circular stone build-up above the lintel up to the underside of the relieving arch. The elastic flexural stresses in such a lintel, if averaging 125mm deep, carrying such a load over this span, are approximately 4MPa. The lintel is of limestone which is a naturally occurring material. Its tensile strength parallel to its bedding planes can be somewhat variable. However a flexural tensile stress of 4MPa would appear to be the generally accepted minimal tensile strength of limestone.

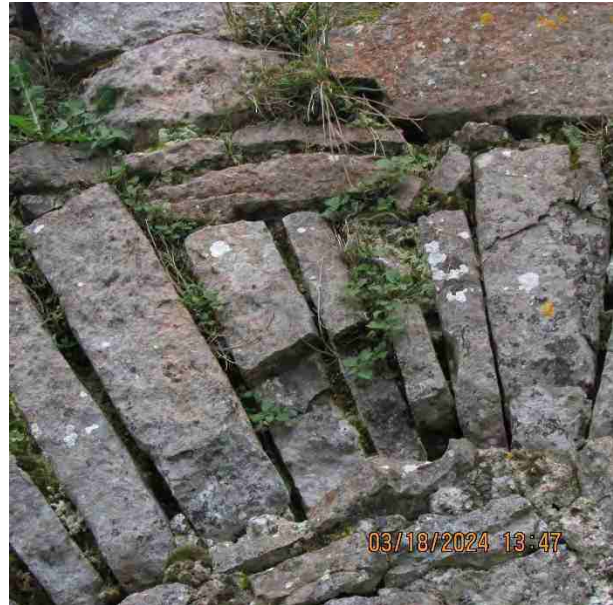
4.6 Such a loss of mortar can form paths for water from the top surface of the wall and also from the south-facing external face of the wall. This water might have been running diagonally and vertically down toward the lintel below. The ingress of water, as noted, can cause mortar erosion and loss. It can also cause washout of small pinning stones, which are crucial to the transfer of compression forces in the relieving arch. The water ingress can also cause freeze-thaw damage. It appears likely the combination of one or more of these three types of deterioration has caused a weakening of the relieving arch overhead.

4.7 If such a weakening of the relieving arch occurred then it might have slipped, even by as little as 5mm, in such a manner that the centre of the relieving arch is placing its load onto the centre of the flattened semicircle of masonry above the lintel. This load must pass down to the lintel.

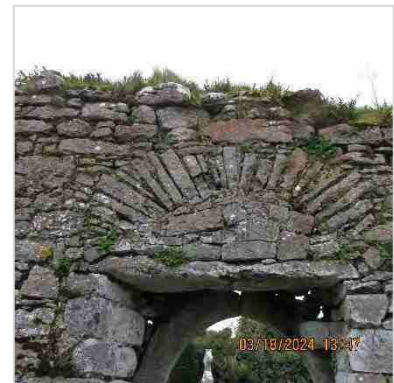
4.8 The top of the wall is 1.6m above the underside of the lintel. If there has been some survival of informal arching action higher up the wall, to pass some of this load to either side of the doorway below, there may still be as much as 800mm or 900mm of masonry passing its load, via the slightly slipped arch to the lintel below.

4.9 The flexural stresses and the lintel below, in this scenario, would have risen to 8MPa. This higher flexural stress may well be the cause of the tensile crack in the soffit of the lintel. If informal arching action is not working, the tensile stress could be as high as 16MPa.
