ATHENRY

MEDIEVAL WALLED TOWN
PAST & PRESENT

PROJECT TEAM: ATHENRY TOWN WALLS CONSERVATION PROJECTS 2007~2020

CONSERVATION WORKS 2007 - 2020

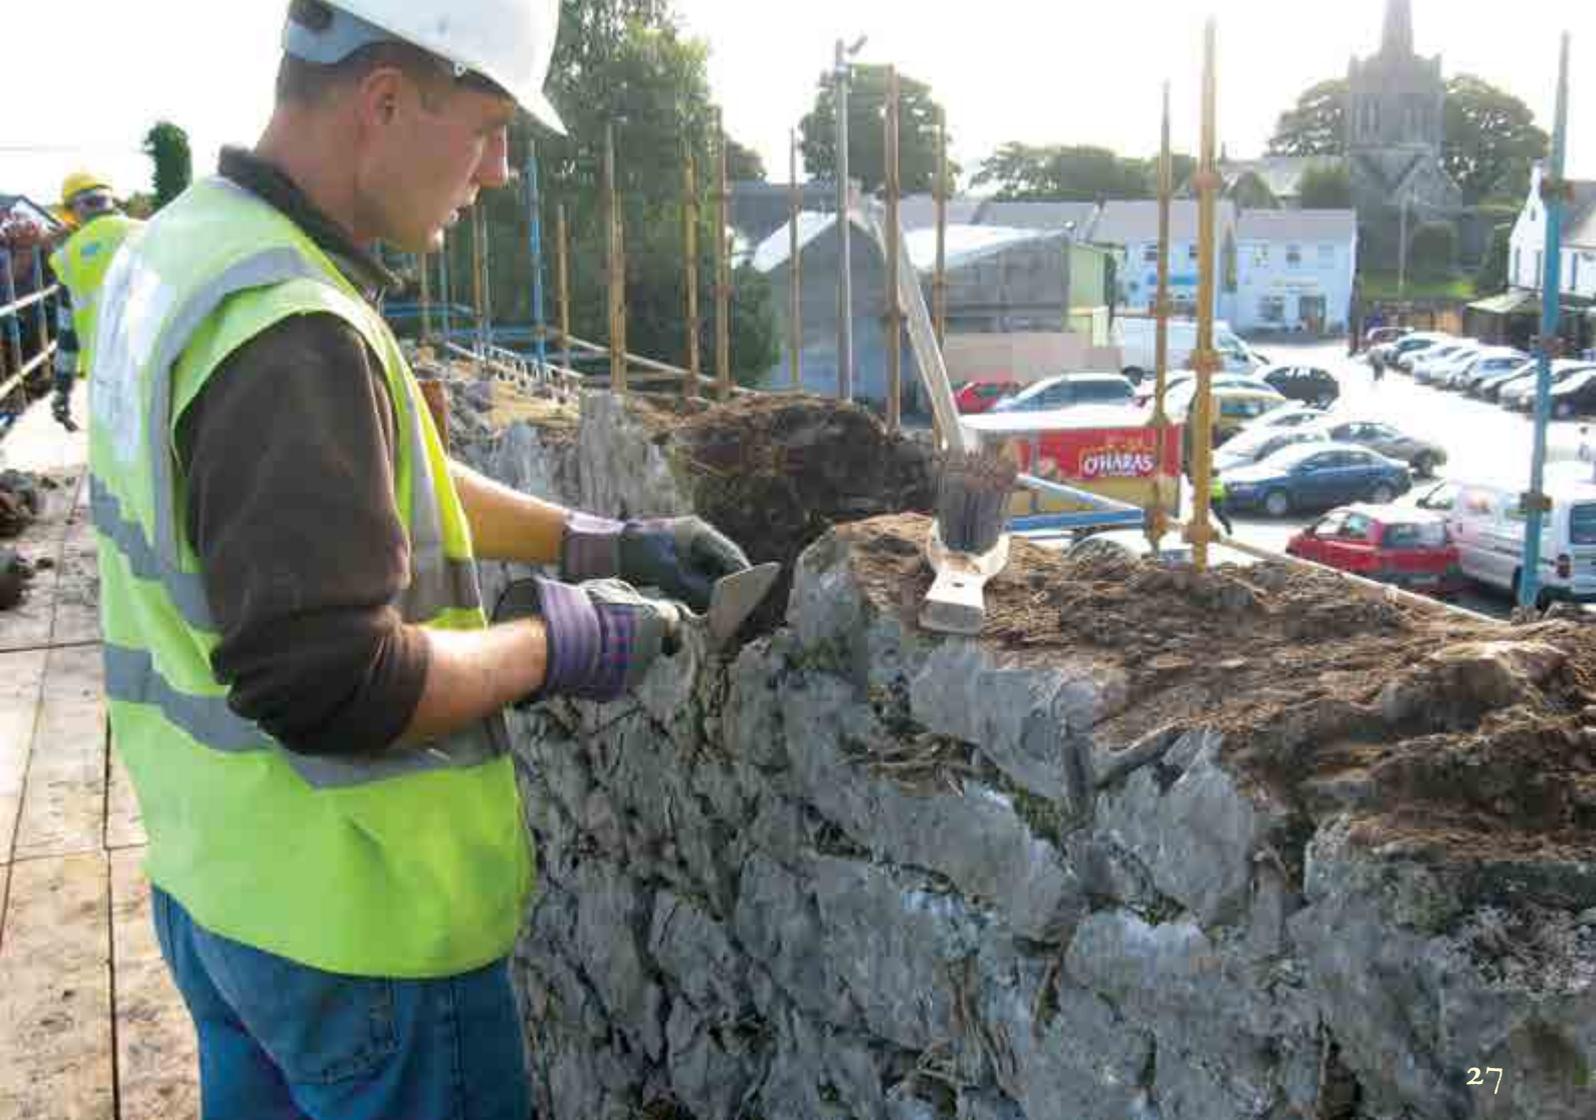
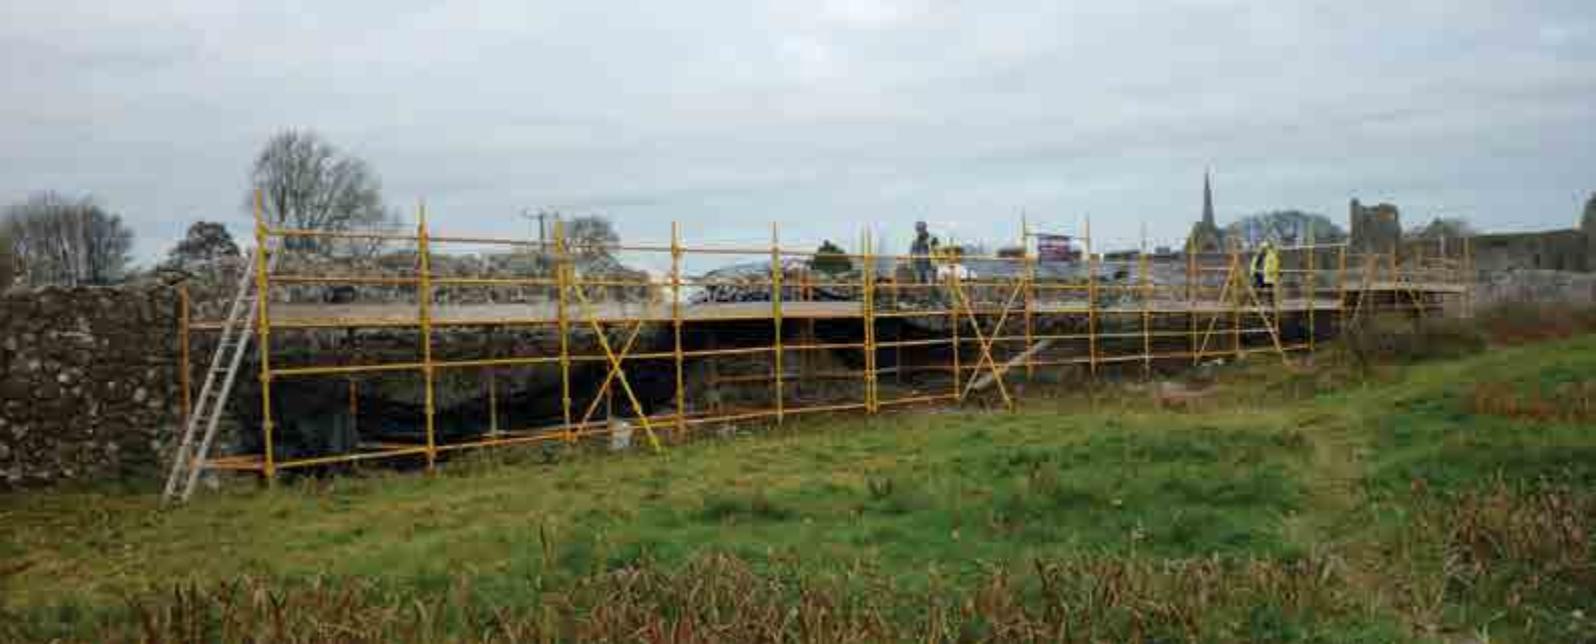
There are five towers on the existing walls and there may have been two others on the portion of the eastern wall which is now lost. Round towers reinforced the three corners, with the castle occupying that role on the north-eastern corner. The best preserved of the surviving mural-towers is the one at the south-eastern corner of the town. It is about ten metres tall and is somewhat external rather than being within the wall. There were entrances on each of the adjoining walls so that defenders

could pass through the tower, and a short stairway leads to a room with loop-holes, allowing those inside to defend the outer faces of both adjoining walls and also the area in front of the tower itself. The other towers are ruined structures now. The mid-mural towers project from the walls like half-moon structures.

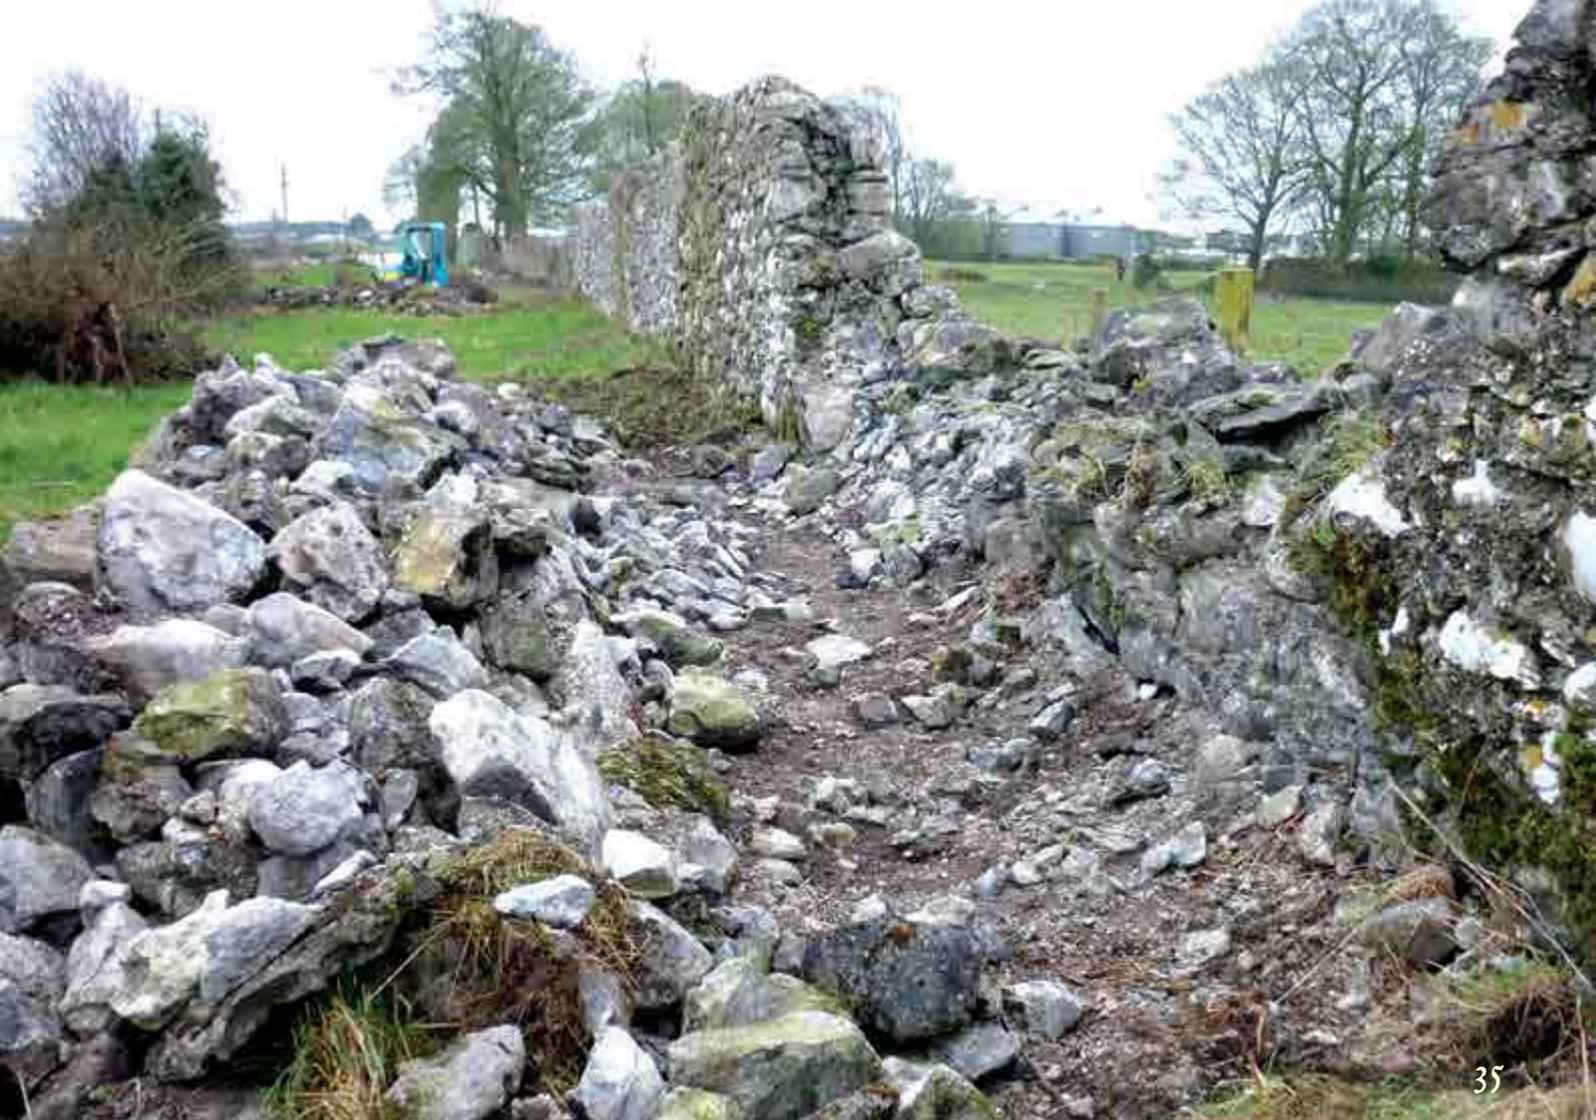
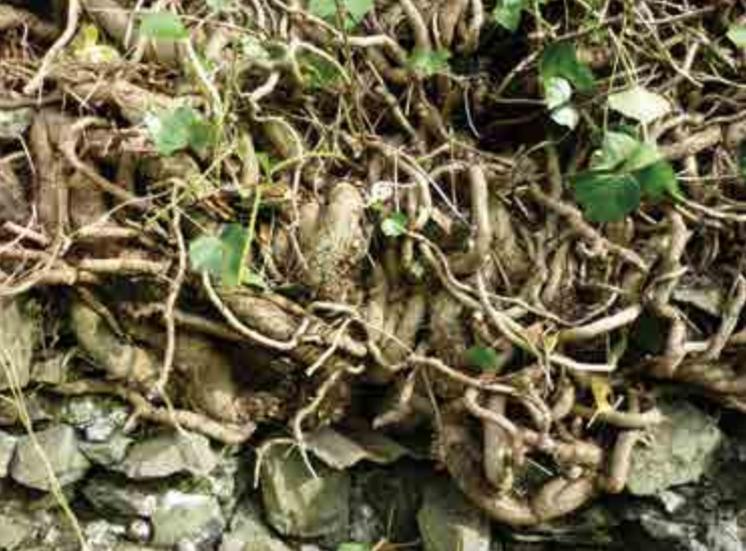
CONSERVATION OF RUINS

When first inspected, the towers and walls were laden down with ivy, which masked their condition and also put the stability of the structures and public safety at risk. There were considerable challenges in drawing and photographing structures extensively covered in thick ivy. To begin, the ivy was cut right back to the walls so the overall form and extent of the feature could be discerned. A cherry picker was used to closely observe the upper levels of the structures without having to step onto the unguarded floors that were clearly in a vulnerable structural state. In some areas, in order to remove the ivy roots, the stones would have had to be taken down, which would risk the wall's partial collapse. While 3D laser scanning was used, it was of limited value as it was unable to record through the thick roots of ivy. Rectified photography was the most effective way to record the walls and to prepare drawings that showed the extent of the ivy after it was cut back to its roots. Stone-by-stone accurate drawings were prepared for exposed areas of facing stone, or to locate and record important architectural details on the towers.

Works were prioritised in the following order: health and safety, integrity of the monument, weathering and protection. This translated in the works programme to - treat and remove embedded roots, then consolidate loose or unstable medieval masonry, and improve its weathering.

The first operation was to treat the ivy growth by spraying herbicide and leaving for two weeks; this being the most efficient way to feed the poison into the root system. After removal of the plant growth by hand, the walls were sprayed with a biocide to remove all small surface growth and all soil from the joints. In order to kill all embedded root systems deep in the fabric of the masonry, the larger roots were tapped with copper tubes filled with root killer, that were topped up

Conservation works consisted of repointing and consolidating the existing fabric with lime mortar while carefully selecting stones identified on the site. As the extent of the damage to the wall due to the ivy was not possible to quantify accurately prior to its removal, judgement was made on site at each inspection as to how much of the wall should be re-pointed. Recovered stone was set aside for consolidation work, with smaller stones and shards re-used for the pinning and pointing works. Scant evidence of lime dash render was identified on both walls and towers, valuable evidence that they were not always bare stone, but once had a protective coat and would have looked quite different to today.

the wall. Loose lime and hard cement mortar joints were raked out and these areas were re-pointed using lime mortar following agreement of samples and suitable mortar mixes.

The condition of the stonework as found meant that a variety of approaches needed to be taken in their repair. Where facing stone remained, it was enough to carefully cut out cement joints, fill voids and re-point in lime-and-sand mortar. Where found, areas of the original lime mortar or render were left in place. Natural hydraulic lime with beach pebbles was used as they were best suited to the thick joints and were similar to the mortar found in the walls. It was important in the short period of time available that the materials used were readily available and relatively user-friendly. There were regular discussions about the lime mortar with the masons when on site to ensure that the mix used was correct and also to agree any adjustments due to exposure or any workability issues.

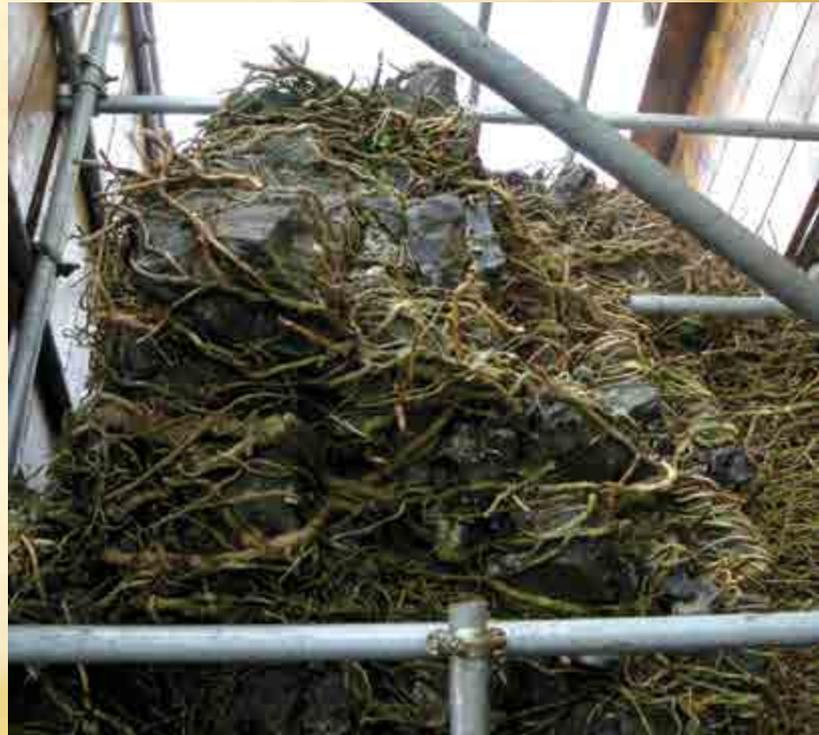
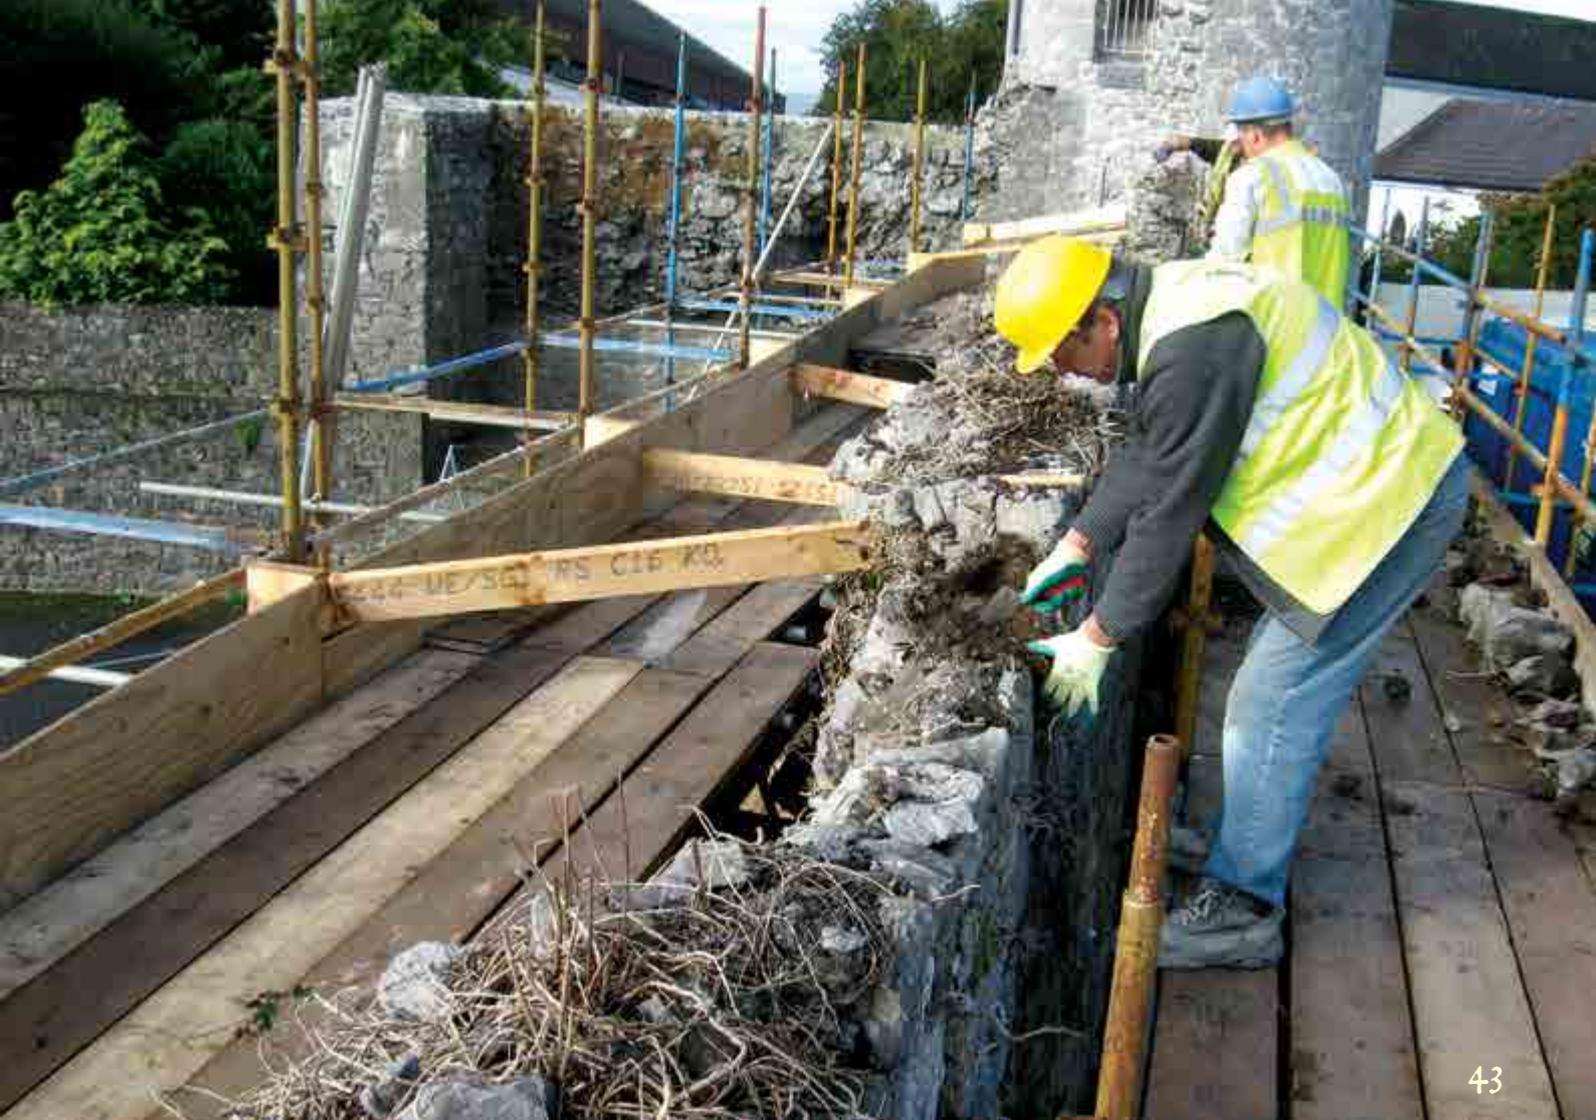
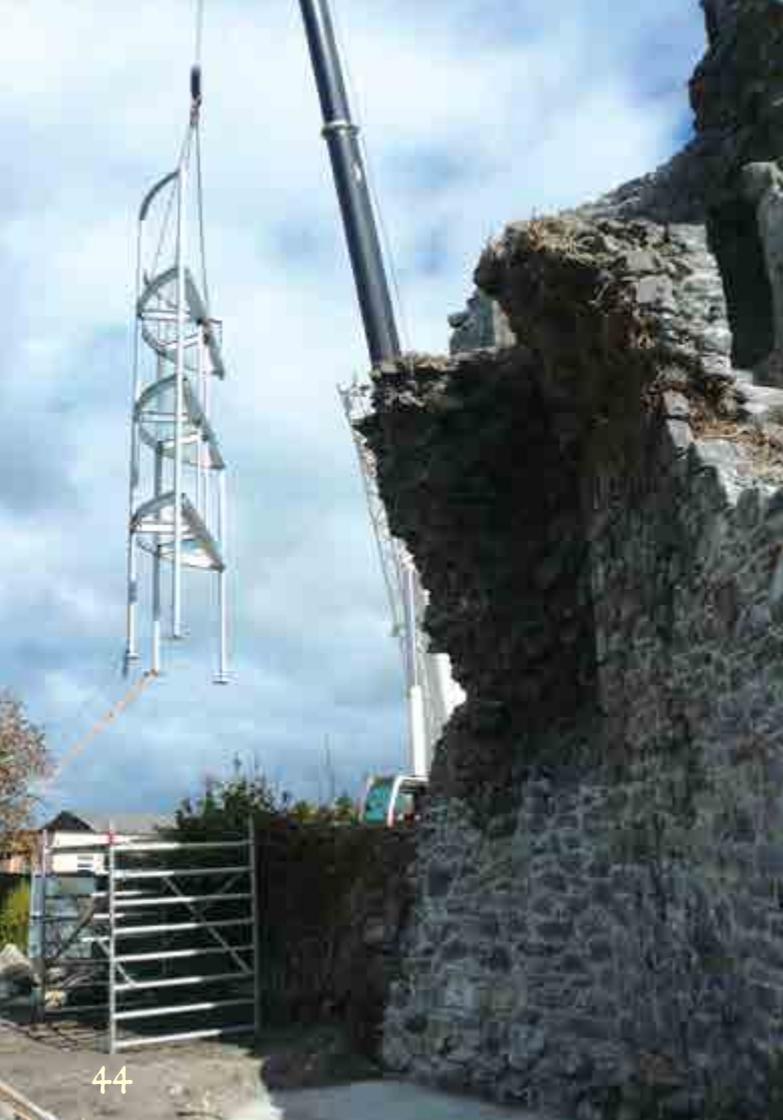
staircase descending in a southerly direction to the remains of the guard house. The upper level of the tower is divided by a central spine wall that forms a chamber to the north with the staircases contained in the southern half. The outer faces of the south and especially the west sides of the tower corbelled outwards dramatically to create a spectacular overhang above the convent garden, the collapse exposing the interior of the tower. A vaulted room had become a huge overhanging corbel and this rough surface was completely covered in thick ivy

roots to form a sort of basket holding the stonework in place. It was determined that the ivy could not be removed without seriously destabilising the structure unless some method of propping it could be devised to ensure that the stones could be safely consolidated.

To achieve this, the architects designed a free-standing steel framework consisting of slender columns and curved ring beams placed beside the tower, but not bearing on it. This propped the structure and provided access to the corbels so that they could be safely consolidated. The architects designed an elegant screen of stainless steel cables to the framework that reinstate the cylindrical form of the tower in a sensitive way, while maintaining a clear distinction between new and old fabric. The framework was designed to be lightweight, a shadow to complete the oval form of the tower before it collapsed. This would allow access to the tower for inspections and maintenance and had the potential to provide platforms to allow visitors to the tower. Stones that fell from the corbel would not fall to the ground and could be retrieved. If desired, the steel rope screen could carry creepers to mask the impact of the modern framework while creating an interesting garden feature and return the tower to its former silhouette. The framework was used in the painstaking consolidation of the masonry, a new gate and two new steps were added, along with the range of masonry repairs that were carried out on the previous phase.

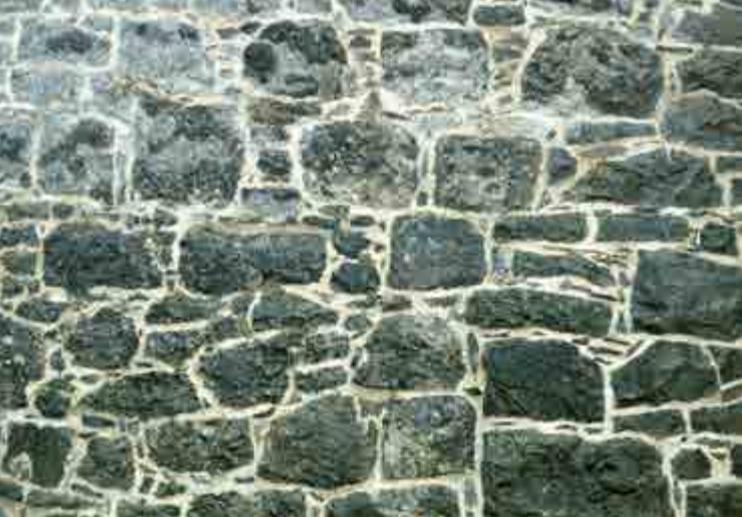
The section of town wall to the east side of the north-west tower was in poor condition and also in need of urgent repair. The wall was at risk due to its proximity to traffic and from encroaching development. The north face of the wall was originally much higher and it would have been possible to access the tower from the wall-walk. The scar showing its full extent is visible on the east face of the tower. The wall heads were uneven due to erosion or partial demolition over time, with the south face fallen away to expose the rubble core. This had been pointed with hard cement mortars that were stronger than the masonry, leading to trapped moisture and frost damage and further erosion. The bottom two and a half metres of the wall to the south side have been buttressed

with shaped, random coursed stonework using hard cement mortars, added when the carpark was built. The stonework to the external face of the wall is very similar to the facing stonework on the towers, and has been repaired in areas using hard cement mortars.

The north side of the wall facing onto the school yard of Scoil Chroí Naofa was the first section to be addressed, as this was the side in best condition and the most accessible. The 30m-long section of wall consisted of facing stone that was pointed up where the original lime mortar had eroded away; in other areas hard cement mortars had been used in the relatively recent past. As soon as the ivy removal commenced on the town wall section located in the carpark, it was clear that the wall was very vulnerable and would collapse without first stabilising it along its length. Sections of the wall had eroded so far that only the facing stones remained and would not have survived the removal of the ivy. The wall heads had been undermined by the ivy roots to the extent that the top section of the wall mostly consisted of soil and roots with isolated stones. A cost-effective solution using timber shores and scaffolding was devised by the structural engineer. This allowed the skilled masons to work alongside the workers removing the ivy, setting aside recovered stones for re-use and methodically moving along both sides of the wall. In 2011, the works involved the conservation of the wall section that runs along the remaining area of the schoolyard. It is located in a garden belonging to one of the townhouses adjacent to the north gate. This wall is a continuation of the previous section of wall and the same methodologies were used in its repair.

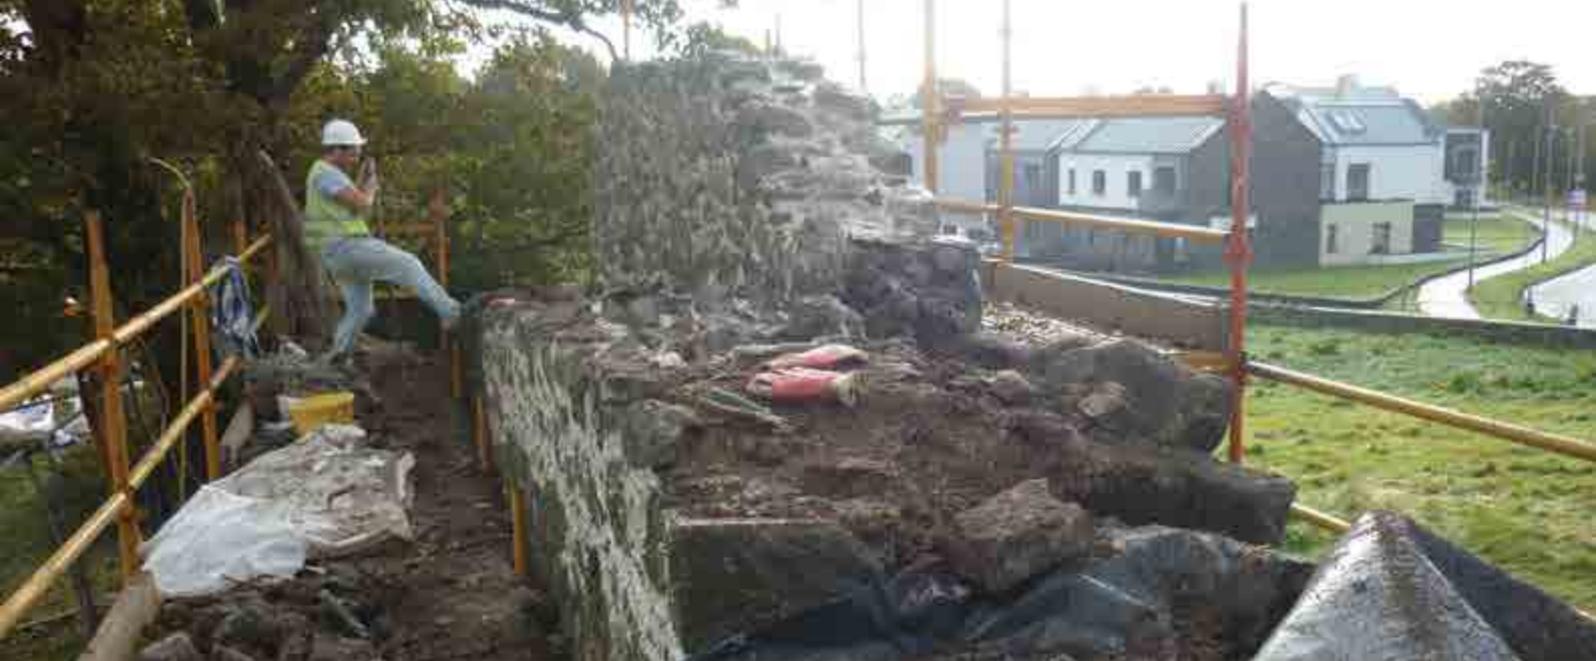
In 2012–2013, the eastern town wall was repaired. The eastern town wall is 400m long, and links the south-east tower to the ruins of the priory. It is situated in fields close to the town centre and is highly visible on the approach road from the new motorway. It appears that approximately 250 metres of this wall was re-built in a new alignment behind the original wall after the priory fell into disuse in the seventeenth century. The remnants of the original wall remain below the fields to the east side of the thinner rebuilt wall; they remain visible as parallel banks in the adjacent field to the east. In large sections, the wall is no thicker than a traditional dry stone field wall,

and loose random rubble masonry survives in many places. From the surveys undertaken previously, sections of mortared wall were identified and scheduled for pinning, pointing and flaunching of the wall heads. Alongside mortared wall sections were drystone sections that had been taken down in order to treat ivy. These were rebuilt so that no stones were left at the base of the wall. These works continued to the south-eastern section in 2014, when the walls to either side of the south tower were repaired, including one of the tallest sections of the town wall still standing.

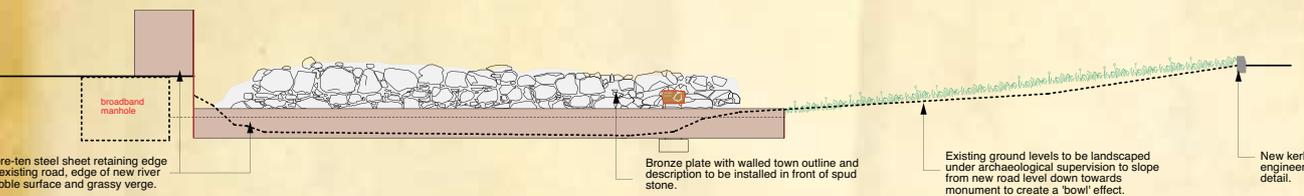
Approximate line of broadband ducting

Core-ten steel sheet retaining edge of existing road, edge of new river cobble surface and grassy verge.

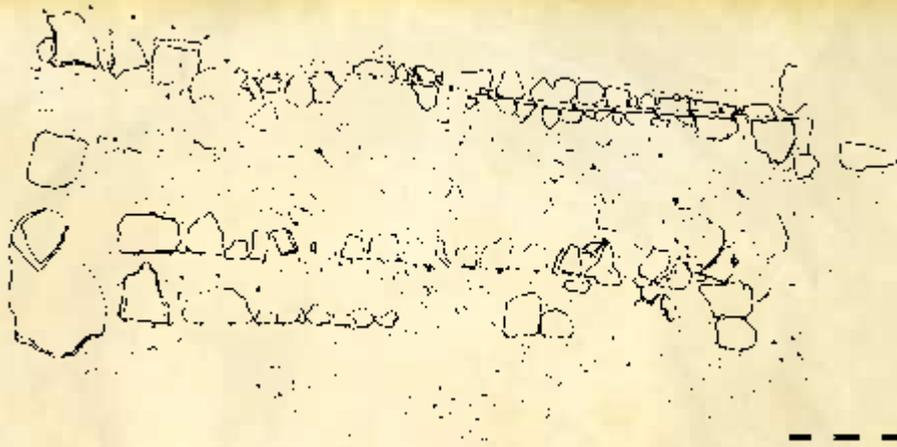
New kerbing to roundabout to engineer's specification and detail.

The proposal created a gently-sloping grass bowl to surround the fragment, supplemented with a river-cobble strip to the west side, relating to the original location of the road passing under the gate. Core-ten steel retains and guards the edge of the footpath, and the immediate surrounds of the gate fragment. This creates an edge for mowing the lawn, and a gravel bed to the base of the ruin that will also make the monument easy to maintain to prevent vegetative growth in the future. Given the need to guard the edge of the hole surrounding the monument, this single vertical element draws attention to the low-lying and relatively small fragment. A short inscription is placed on the guarding along with the outline of the walled town, with the location of the gate indicated. It is important that the signage, while giving some explanation of the monument, would not be so large as to dominate the setting.

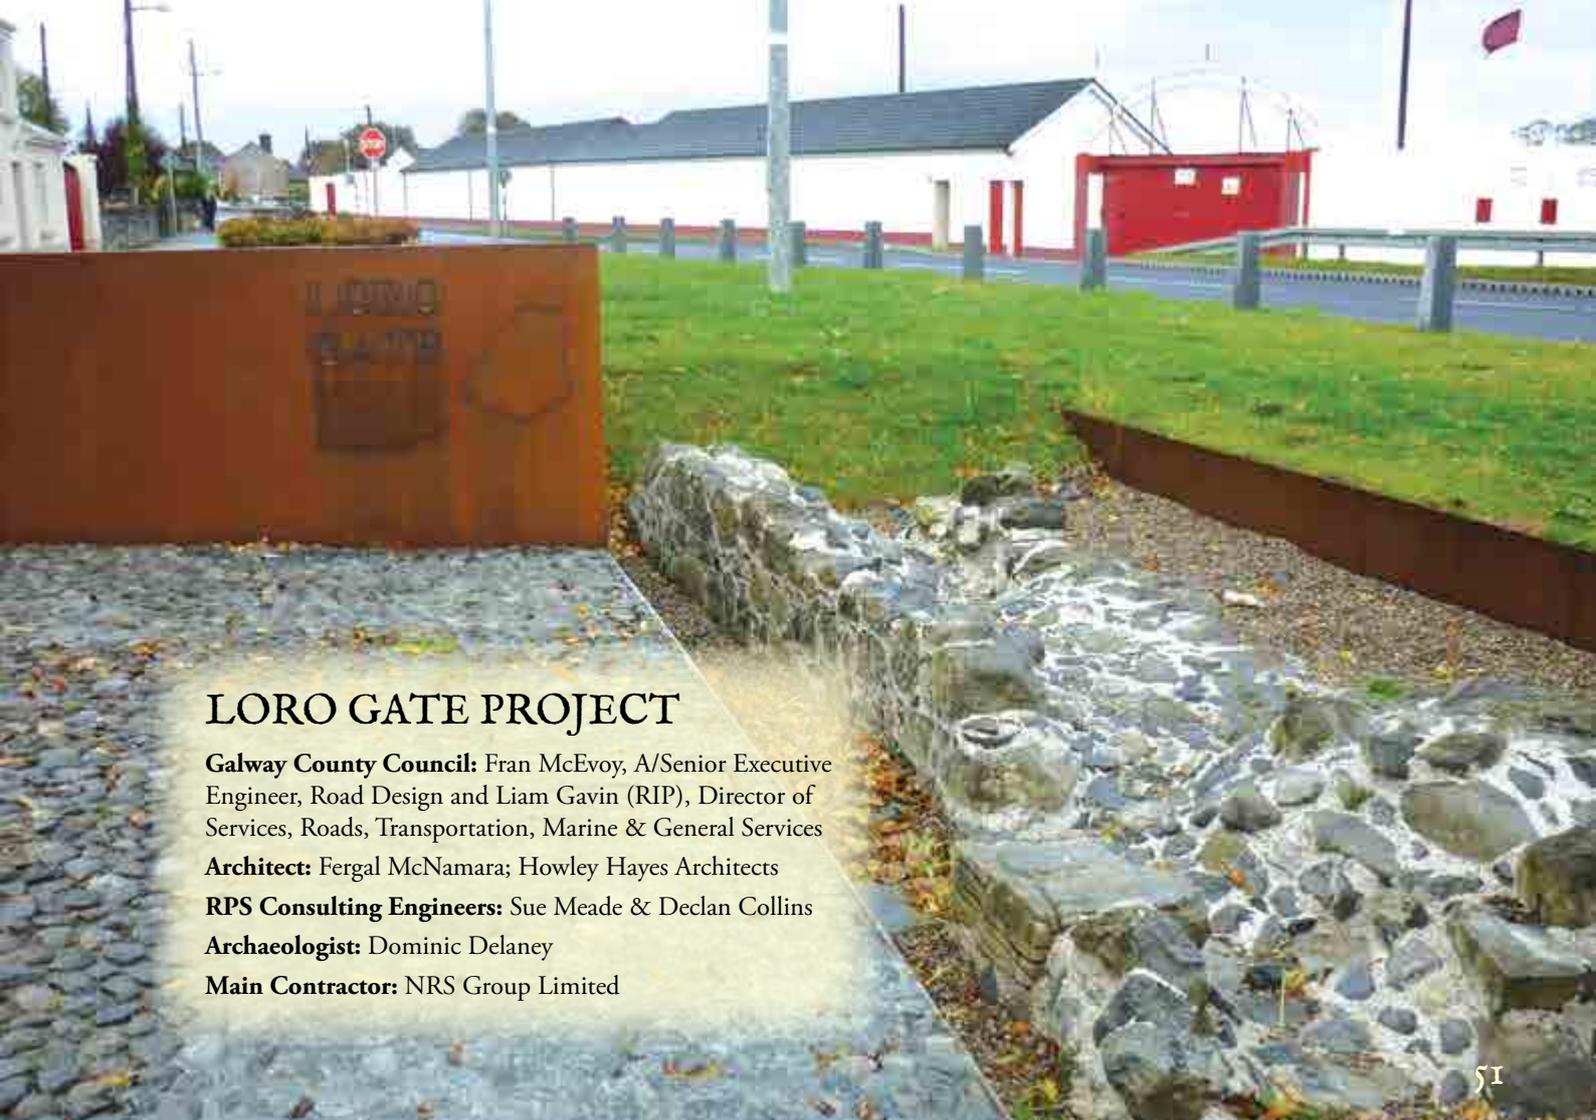
LORO GATE PROJECT

A photograph of the Loro Gate Project site. In the foreground, a cobblestone path leads to a low wall made of stacked grey stones. To the left, a large, rusted metal wall features a circular emblem. In the background, a white building with a dark roof and a red structure are visible, along with a grassy area and a road. The sky is overcast.

The stonework was first cleaned down and treated with a biocide to remove the encroaching vegetation on the wall. Loose stones identified as being archaeological material were placed onto the structure under supervision of the archaeologist, and loose fragments used in the lime mortar re-pointing of the joints and flaunching of the wall head. The flaunching made the top surface run to fall, stopping water from pooling, leading to freeze-thaw action and further erosion. It also made the gate fragment an undesirable place to sit for passersby so that stones would not be dislodged over time. The spud stone was reset close to its original location as evidence of its previous use as a gateway.

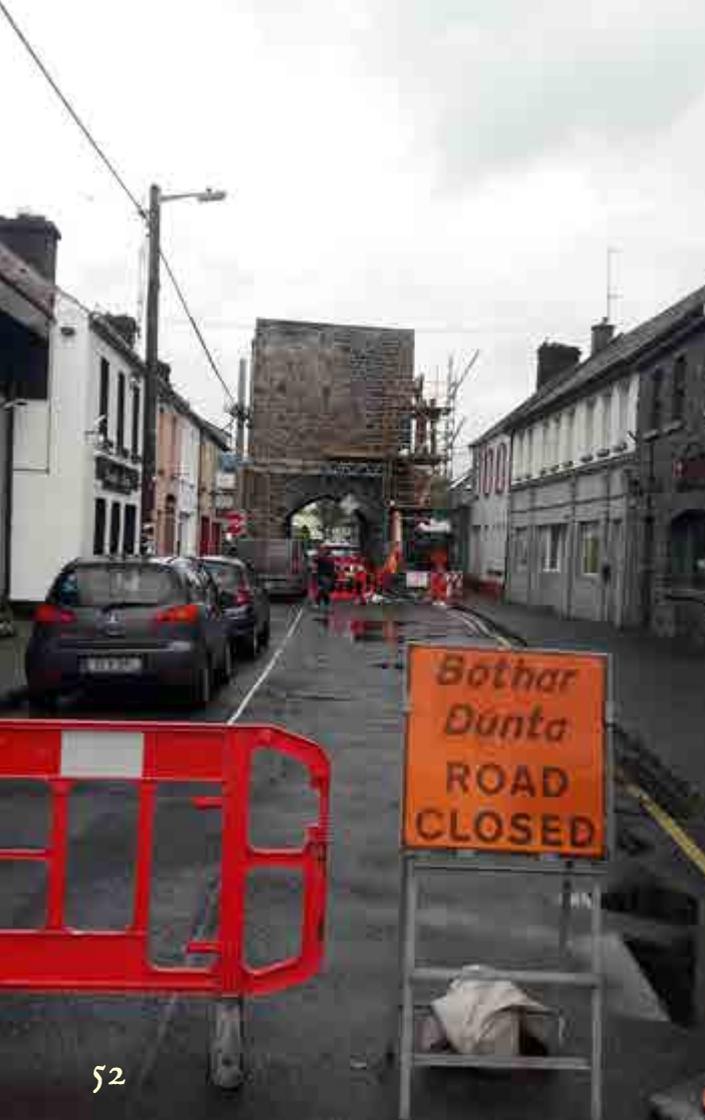
THE NORTH GATE

The North Gate is an essential component of the medieval fortifications of Athenry. It is situated at the end of North Gate Street and is the sole remaining entrance gate into the historic centre of Athenry; it is the most visible landmark of the structures located along the town wall. At present, it is an important part of the one-way traffic management system in the town as one of the exit points. Unlike the towers at the corners of the walls, the North Gate is rectangular in plan, with a tall room over an arched passageway that once held a portcullis and still retains its murder hole. It is built of coursed limestone rubblework with ashlar quoins and voussoirs to the pointed arches. The ashlar stonework is part of later repairs, the remains of the original arch are visible to the south side with protruding voussoirs to either side.

Early photographs, dating from the early twentieth century, show the North Gate in similar condition to that found at the north-west and south-east towers. The eastern half of the Gate was fallen away to half its original height, the new archways are visible, along with the pattern plates. The wall heads are covered with ivy, with a small tree visible to the north side. In the Gazetteer it is noted that extensive rebuilding of the Gate was undertaken by Galway County Council as recently as 1977. At this time a new concrete roof was added, with the upper eastern section of the wall re-built with new stone and using cement-rich mortars.

The North Gate is listed as Gazetteer Number 5 in the appendix to Athenry Town Walls Conservation & Management Plan prepared by Gifford Consulting Ltd for Galway County Council and issued in July 2008. Its condition was listed as being fair, but the roof construction was not inspected at that time, and subsequent inspections confirmed that its condition was poor and vulnerable to further deterioration due to lack of maintenance and use of concrete and hard cement mortars.

Repairs and stabilisation works were carried out to the south walls in 2015, which included repointing, vegetation removal and capping to the walls, and in 2016 further repairs were carried out to portions of the walls which were at risk of collapse. During the same period the area around the North Gate was re-paved and the tower was inspected. By early August 2018, the tenth phase of works to the town walls had commenced on site and focused on repairs to the North Gate. Works were prioritised in the following order: health and safety, integrity of the monument, protection. This translated in the works programme to: treatment and removal of vegetation and embedded roots; consolidation and repointing the west and south facades which had not been rebuilt in the 1970s.

In 2019, works continued on the North Gate to carry out repointing to the north and east facades, and to roof repair, with the removal of a failing asphalt roof and installation of a new flat roof and lead capping to parapet walls. The existing concrete slab was retained, as its removal would compromise the integrity and structure of the tower. A new discrete rainwater disposal system was installed on the south façade. The work in 2019 was funded by Galway County Council, The Heritage Council and The Department of Rural and Community Development under the Rural Regeneration Fund
