ATHENRY

MEDIEVAL WALLED TOWN
PAST & PRESENT

PROJECT TEAM: ATHENRY TOWN WALLS CONSERVATION PROJECTS 2007~2020

CONSERVATION WORKS 2007 - 2020

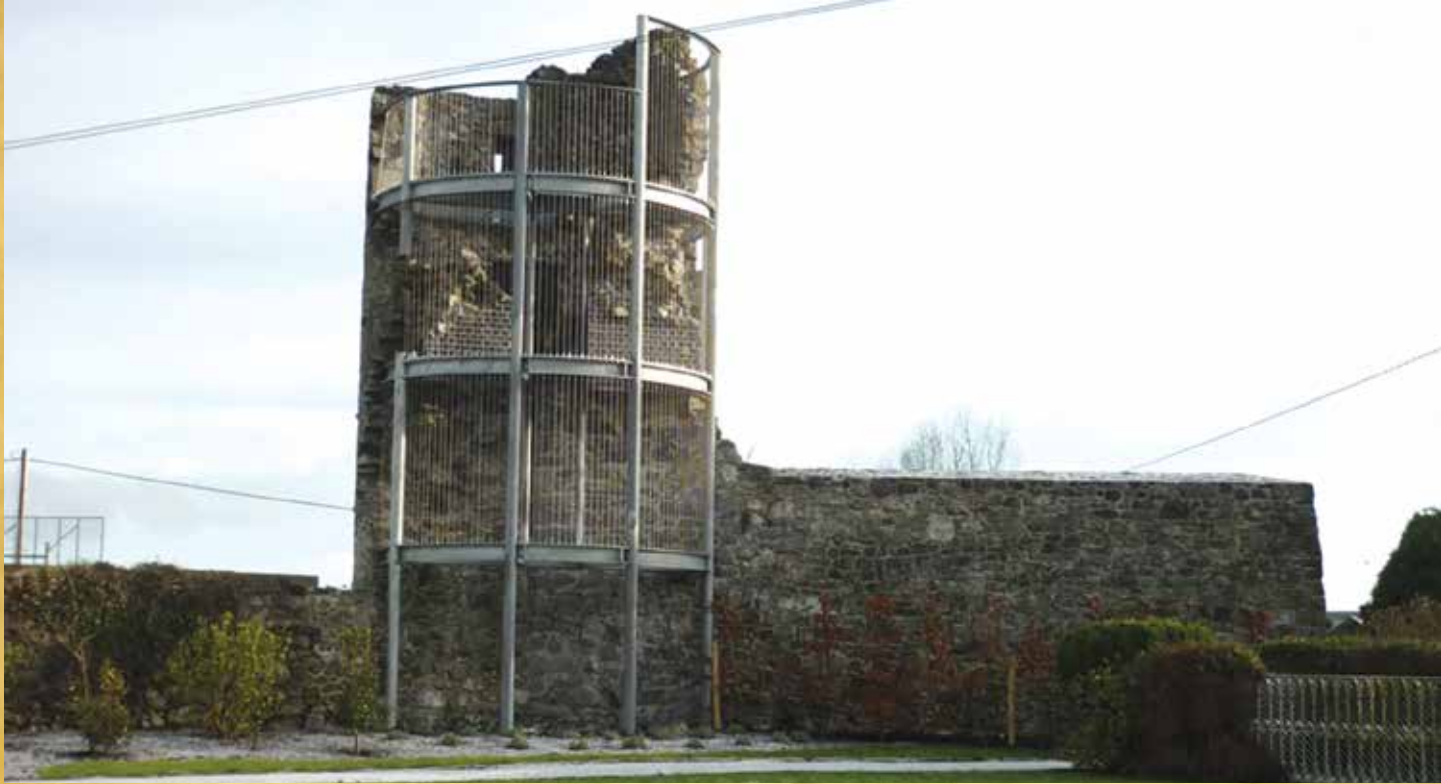
roots to form a sort of basket holding the stonework in place. It was determined that the ivy could not be removed without seriously destabilising the structure unless some method of propping it could be devised to ensure that the stones could be safely consolidated.

To achieve this, the architects designed a free-standing steel framework consisting of slender columns and curved ring beams placed beside the tower, but not bearing on it. This propped the structure and provided access to the corbels so that they could be safely consolidated. The architects designed an elegant screen of stainless steel cables to the framework that reinstate the cylindrical form of the tower in a sensitive way, while maintaining a clear distinction between new and old fabric. The framework was designed to be lightweight, a shadow to complete the oval form of the tower before it collapsed. This would allow access to the tower for inspections and maintenance and had the potential to provide platforms to allow visitors to the tower. Stones that fell from the corbel would not fall to the ground and could be retrieved. If desired, the steel rope screen could carry creepers to mask the impact of the modern framework while creating an interesting garden feature and return the tower to its former silhouette. The framework was used in the painstaking consolidation of the masonry, a new gate and two new steps were added, along with the range of masonry repairs that were carried out on the previous phase.

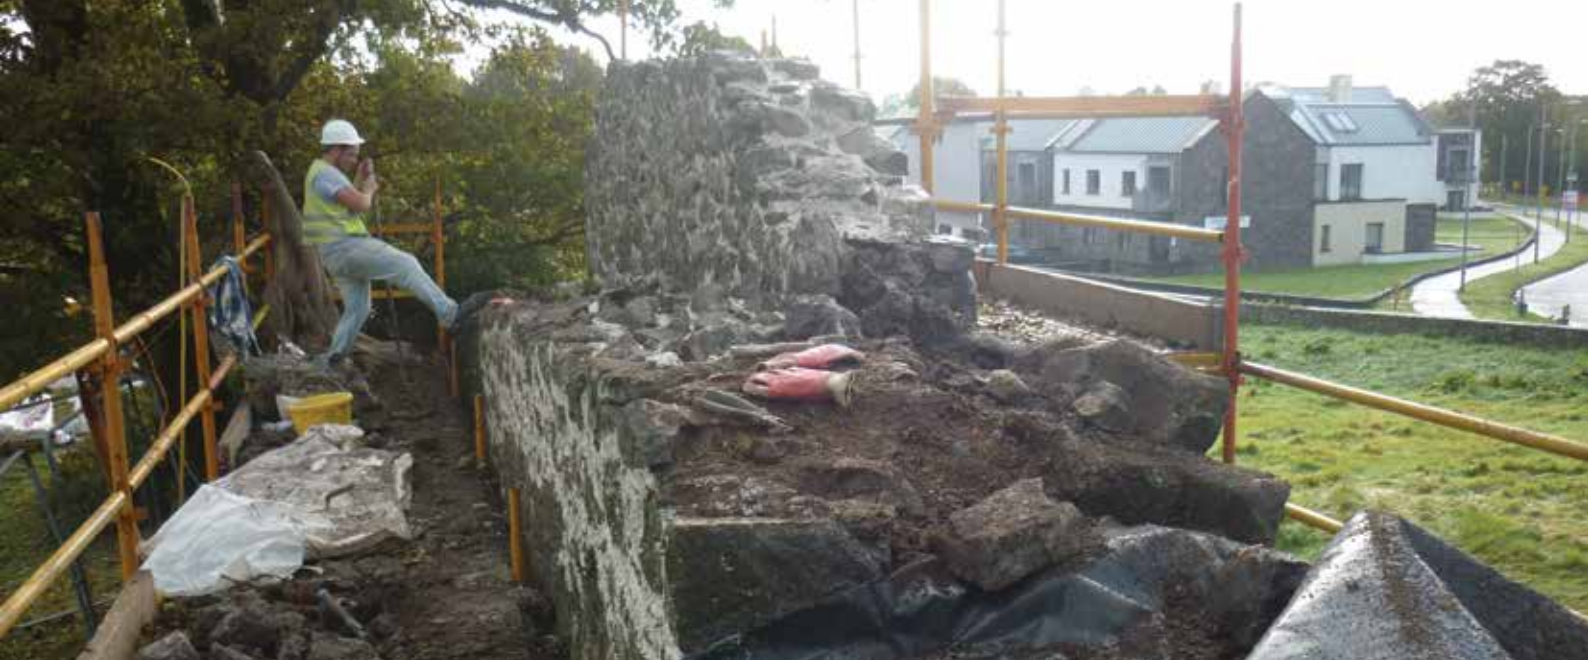
In 2012-2013, the eastern town wall was repaired. The eastern town wall is 400m long, and links the south-east tower to the ruins of the priory. It is situated in fields close to the town centre and is highly visible on the approach road from the new motorway. It appears that approximately 250 metres of this wall was re-built in a new alignment behind the original wall after the priory fell into disuse in the seventeenth century. The remnants of the original wall remain below the fields to the east side of the thinner rebuilt wall; they remain visible as parallel banks in the adjacent field to the east. In large sections, the wall is no thicker than a traditional dry stone field wall,

and loose random rubble masonry survives in many places. From the surveys undertaken previously, sections of mortared wall were identified and scheduled for pinning, pointing and flaunching of the wall heads. Alongside mortared wall sections were drystone sections that had been taken down in order to treat ivy. These were rebuilt so that no stones were left at the base of the wall. These works continued to the south-eastern section in 2014, when the walls to either side of the south tower were repaired, including one of the tallest sections of the town wall still standing.

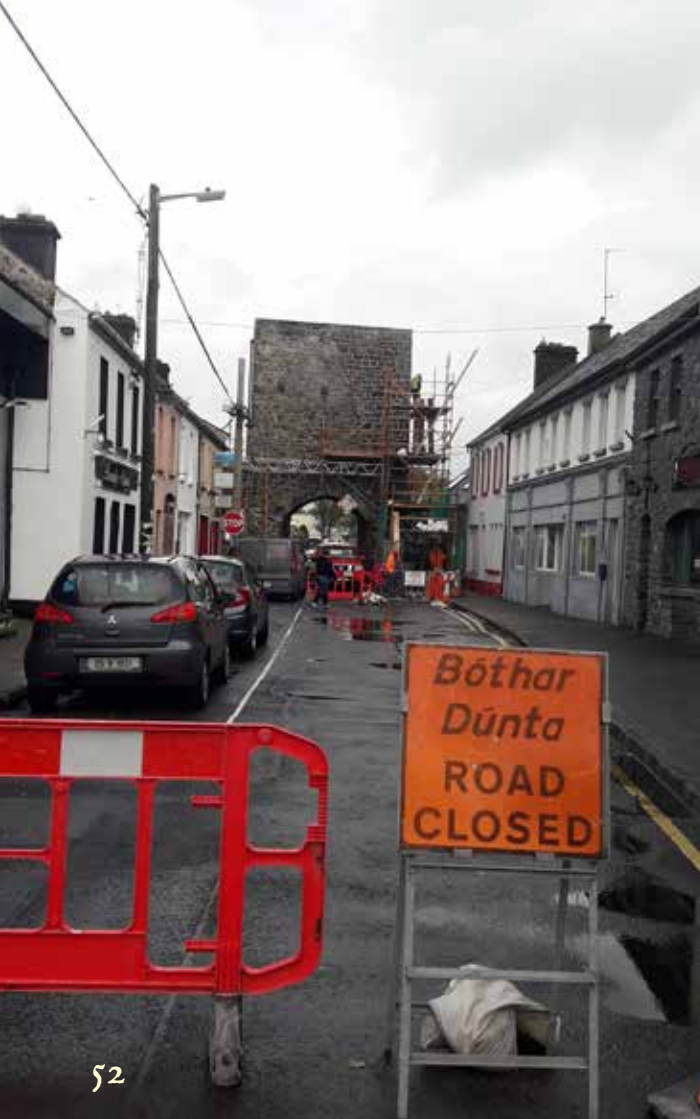
THE NORTH GATE

Early photographs, dating from the early twentieth century, show the North Gate in similar condition to that found at the north-west and south-east towers. The eastern half of the Gate was fallen away to half its original height, the new archways are visible, along with the patress plates. The wall heads are covered with ivy, with a small tree visible to the north side. In the Gazetteer it is noted that extensive rebuilding of the Gate was undertaken by Galway County Council as recently as 1977. At this time a new concrete roof was added, with the upper eastern section of the wall re-built with new stone and using cement-rich mortars.

The North Gate is listed as Gazetteer Number 5 in the appendix to Athenry Town Walls Conservation & Management Plan prepared by Gifford Consulting Ltd for Galway County Council and issued in July 2008. Its condition was listed as being fair, but the roof construction was not inspected at that time, and subsequent inspections confirmed that its condition was poor and vulnerable to further deterioration due to lack of maintenance and use of concrete and hard cement mortars.

Repairs and stabilisation works were carried out to the south walls in 2015, which included repointing, vegetation removal and capping to the walls, and in 2016 further repairs were carried out to portions of the walls which were at risk of collapse. During the same period the area around the North Gate was re-paved and the tower was inspected. By early August 2018, the tenth phase of works to the town walls had commenced on site and focused on repairs to the North Gate. Works were prioritised in the following order: health and safety, integrity of the monument, protection. This translated in the works programme to: treatment and removal of vegetation and embedded roots; consolidation and repointing the west and south facades which had not been rebuilt in the 1970s.

In 2019, works continued on the North Gate to carry out repointing to the north and east facades, and to roof repair, with the removal of a failing asphalt roof and installation of a new flat roof and lead capping to parapet walls. The existing concrete slab was retained, as its removal would compromise the integrity and structure of the tower. A new discrete rainwater disposal system was installed on the south façade. The work in 2019 was funded by Galway County Council, The Heritage Council and The Department of Rural and Community Development under the Rural Regeneration Fund
