INDEX TO GAZETTEER

<p>GAZETTEER NUMBER 1</p> <p>Zone: West</p> <p>Feature Name: Section of Town Wall on the boundary between St Mary's Churchyard and car park</p> <p>Phase/Construction Date(s):</p> <p>Phase 2: 14th century Phase 6: 19th century Phase 7: 20th century</p>	<p>Location:</p>

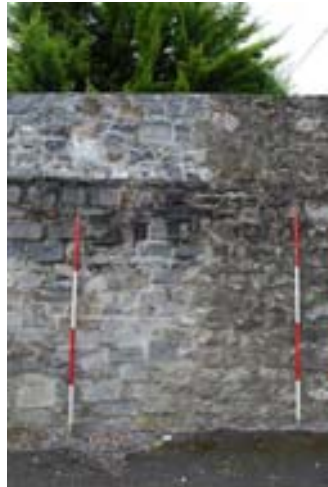
<p><i>Join between original wall on the right and new stones of the gateway section on the left, looking west</i></p>

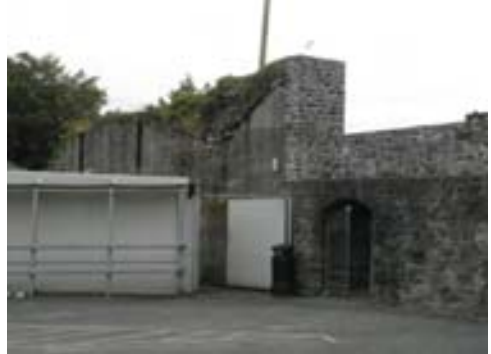
<p><i>Internal face with scar of undulating roof of 1960s building, looking south-east</i></p>

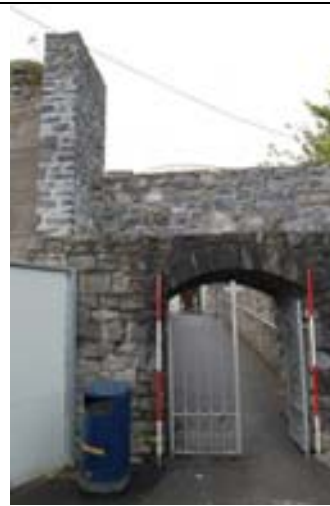
New gateway with new section of wall above, looking west (internal face)

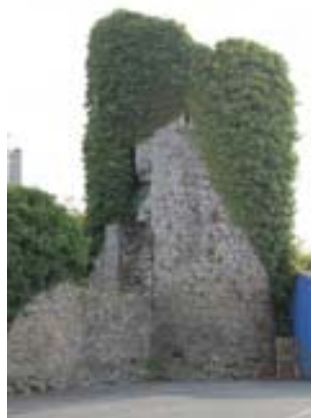
<p><i>External face, looking south-west</i></p>

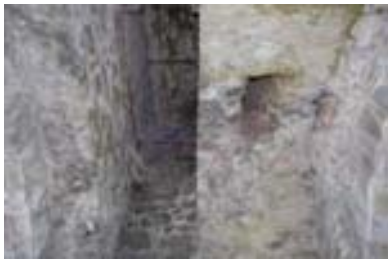
<p><i>Murder hole and slot for portcullis</i></p>

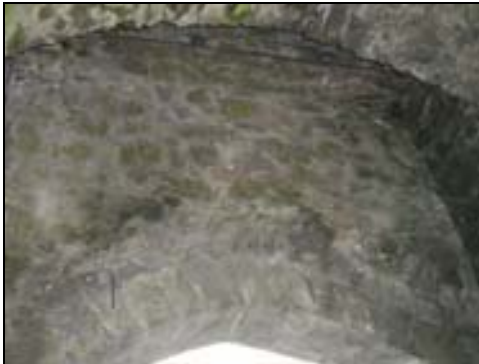
Access	Good access to the perimeter of the building and beneath the arch at ground level. Access to the first floor would require a ladder and a temporary road closure.	
Completeness	The gate-house has been significantly reconstructed; earlier photographs show the upper east part of the building missing, and the rebuild line is clearly visible to north and south elevations.	
Verticality	Reasonable - good.	
Stability	No signs of overall instability.	
Stonework/mortar	<p>All stonework previously repaired/reconstructed/re-pointed and generally in reasonable condition, although one area of stonework to the inside face of the south wall, above the arch, is loose and requires repair to stabilise it and avoid loss of fabric. Stones could potentially fall on vehicles, if no repair is carried out in the near future.</p> <p>One stone cantilevering out of the south wall, just above the west springing point of the arch is significantly fissured and could disintegrate with further frost damage; it is recommended that this is pinned with non-ferrous pins.</p>

Wall tops	Parapet wall tops are regular, but do not appear to have a coping and have significant vegetation growth.
Vegetation	There is vegetation growth visible, particularly at high level and to the original stonework. After vegetation removal, re-pointing would be required.
Openings	The existing window openings appear in good condition from the outside. The openings in the first floor also appear in good condition.
Previous repairs / modifications	The upper east part of the building has been reconstructed, but appears in reasonable condition.
Other	The ironwork appears to be in reasonable condition with no significant corrosion visible from the ground, but this needs to be verified from the upper level. Pigeons are roosting in the upper room. There is no mesh in window / floor openings to prevent access. This presents a health hazard to anyone entering the space for inspection or repair.

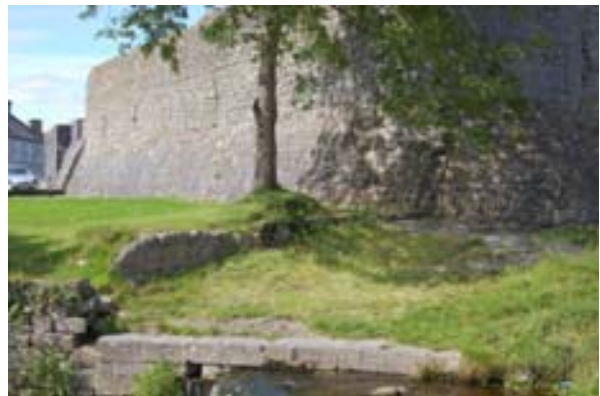
<p><i>Exterior of south curtain wall with possible scar of adjoining town wall, looking north-west</i></p>

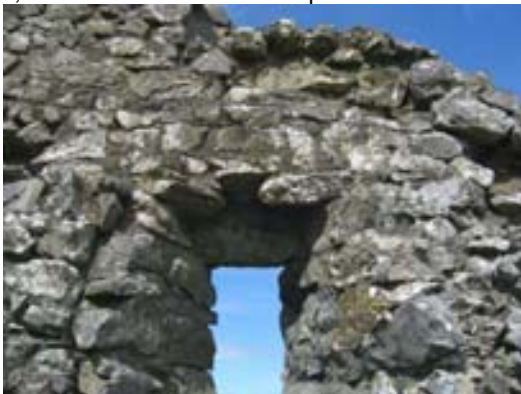
Vegetation	Minor vegetation growth on older sections of wall.
Openings	<p><u>North-East quarter:</u> 3 slit openings. The furthest north has a lintel stone missing, which needs replacement. The furthest south has also lost a lintel. The stonework appears reasonably stable, but the lintel should be replaced.</p>

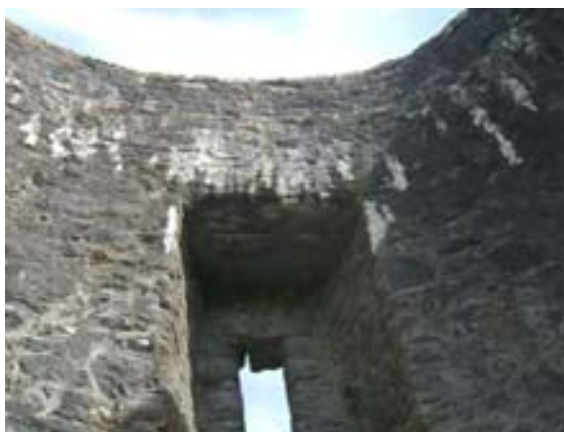
There are 3 openings at low level and 2 at high level. The upper opening to the south appears to have concrete lintels spanning over the window reveal, and lime/salt runs around. The narrow opening in the external wall has a cracked stone lintel; however it does not look as though any further movement can occur. The arch to the other upper opening (to the south-west) is in good condition.

At low level the opening to the south-east is in reasonable condition. The opening to the south has a lintel missing to the inside face. The opening to the south-west has 2 shallow stone lintels missing to the inner face, and a cracked deep stone lintel to the external face.

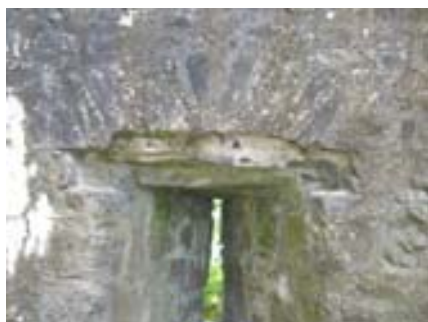
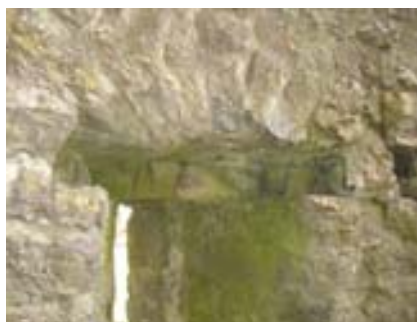
South-West quarter:

There are 5 openings equally spaced along this stretch of the curtain walls. The sills are approximately 1m above internal ground level. The windows are narrow rectangular slits (approximately 1m x 100mm) on the outside face of the wall, widening towards the inside face with a splayed reveal. The reveals are in reasonable condition. All have lintels above, some of which are split and in poor condition at each location. These lintels should be replaced to avoid loss of the stonework above. There appears to have been some plastic repair which is now reaching the end of its lifespan.

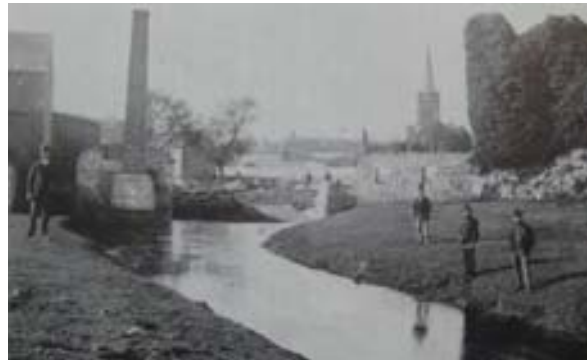
<i>Site of weir between mill to the left and Town Wall to the right of the river, looking south (OPW)</i>	
Description: The construction of a corn mill to the south of the river in the late 18 th century required the construction of a weir and mill chase. Traces of the weir remain with large flag stones on the riverbed. The mill and weir obliterated the Town Wall and crossing point.

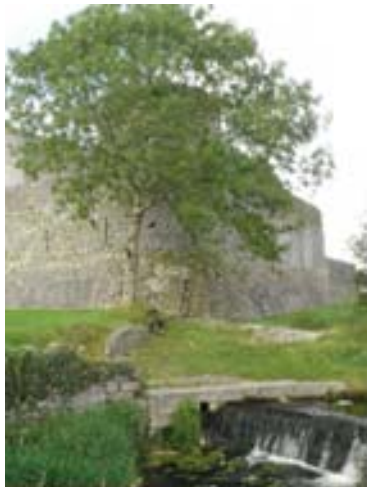
<i>Site of weir</i>			
Statutory Protection	National Monument; RMP GA-084-001; RPS 132		
Condition	Good: see condition survey record.		
Significance	Local: the weir may have marked an early crossing point of the River ClarIn, being so close to the Castle, but the weir itself may not have been constructed until the 18 th century as part of a millstream for a corn mill.		
Vulnerability / Issues	<ul style="list-style-type: none">Any surviving below-ground archaeological remains may be affected by intrusive ground works/development in the area.

Verticality	Appears plumb.	
Stability	Appears stable.	
Stonework/mortar	Stonework to weir generally in good condition. Where visible, stonework and mortar to the circular tower are in reasonable condition.	
Wall tops	Not visible.	
Vegetation	Weir clear of vegetation. Tower almost completely obscured by ivy.	
Openings	None visible.	
Previous repairs / modifications	-	
Other	-

Policies / Recommendations	<ul style="list-style-type: none">Planning conditions should be applied to any development works to record any below-ground archaeological remains within the vicinity.		
References	Bradley, J and Dunne, N (1992) <i>Urban Archaeological Survey part XIX Galway</i> Rynne, E (1995) Athenry in <i>More Irish Country Towns</i> , edited by Simms, A and Andrews, J.H, 106-117 Rynne, E (1981) <i>Survey of Town Walls</i> Thomas, A (1992) <i>Walled Towns of Ireland volume 2</i>		
Illustrations	Photograph - OPW Photographs – Gifford, 2007

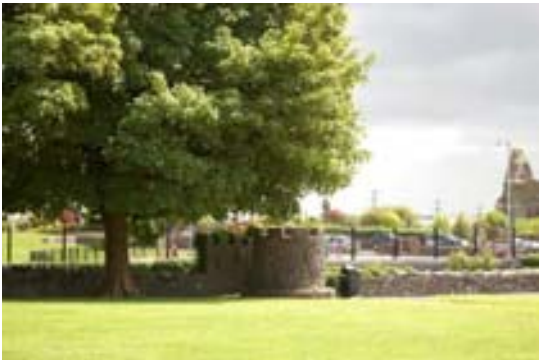
<i>Park with line of wall, looking south-east</i>	
Description: The line of the Town Wall lies within the 20 th century park. Houses were built along the interior of the wall in the 19 th century, which were demolished in the 20 th century as part of the landscaping of this area. The houses were built against the wall, explaining the windows present in the wall in the photograph of the mill (Gazetteer no. 8). The houses may have been occupied by workers of the corn mill that was situated on the river, to the south of the Castle. Professor Rynne excavated a section through the fosse to the west of the River Clarin between the Castle and Britten Gate – the fosse was 5.5m wide, and 1.7m deep. The wall itself was found to survive to 1.35m in height, with a plinth of 0.6m (Rynne, 1985).

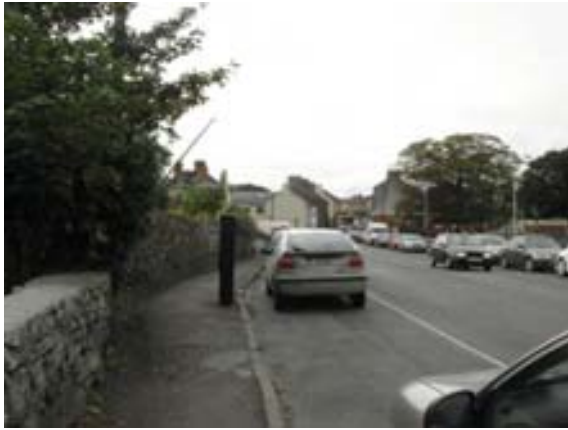
<p><i>Site of Britten Gate</i></p>

<p>Description:</p> <p>Britten Gate was the main east entrance to Athenry. All above ground remains have been removed, possibly when the Priory was used as a barracks in the 18th century. The first edition OS map of 1838 marks the gate as 'Iveagh Gate', which may indicate that some traces of the gate survived at this time. The 1931 edition map marks it as 'Nicholas Gate (site of)' indicating that all standing remains had gone by that time.</p> <p>The remains of a large stone building or enclosure survives in the field to the south-west of the road junction, close to the site of the Britten Gate. The remains of the building may date from the English usage of the Priory as a barracks in the 18th century, or as a police barracks in the 19th century.</p>

<p>Statutory Protection</p>	<p>National Monument; RMP GA-084-001; GA-084-001-9; RPS 132</p>
<p>Condition</p>	<p>Unknown: possible below ground remains survive.</p>
<p>Significance</p>	<p>National: forms part of the Town Walls circuit. Original entrance that formed part of the Town Wall circuit.</p>
<p>Vulnerability / Issues</p>	<ul style="list-style-type: none"> Any surviving below-ground archaeological remains may be affected by intrusive ground works in the area.
<p>Policies / Recommendations</p>	<ul style="list-style-type: none"> Planning conditions for archaeological mitigation of below-ground remains should be applied to any future intrusive development/ground works in the vicinity of the gate.
<p>References</p>	<p>Bradley, J and Dunne, N (1992) <i>Urban Archaeological Survey part XIX Galway</i> Rynne, E (1995) Athenry in <i>More Irish Country Towns</i>, edited by Simms, A and Andrews, J.H, 106-117 Rynne, E (1981) <i>Survey of Town Walls</i> Thomas, A (1992) <i>Walled Towns of Ireland volume 2</i></p>

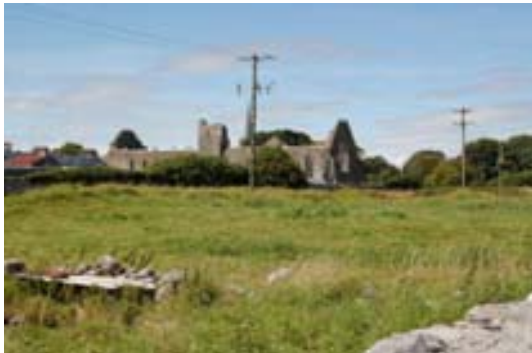
<p><i>East section of Town Wall in field, looking north-west</i></p>

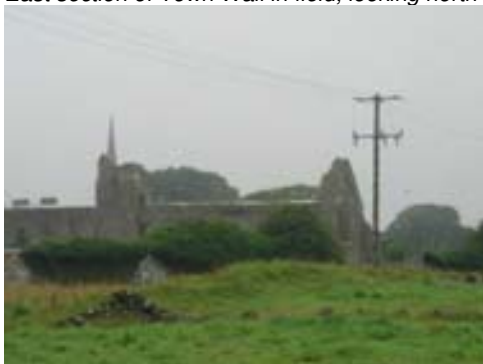
<p><i>Town Wall ramparts, looking north-west</i></p>	
Description: From the site of the Britten Gate (Gazetteer no. 10), the line of the Town Walls is visible as banks remaining in the fields to the east of the Priory wall. The banks are constructed of stones, in piles and possibly as remnants of built wall. There are two rows of banks (ramparts), spaced approximately 2m apart and rising to 1m high. The fosse survives along the external face of the outer banks of the wall. The standing wall that marks the eastern boundary of the Priory and continues south, is situated in close proximity to the line of the Town Wall and may have been constructed due to a reduction of the Priory lands, after it went out of use in the 17 th century.

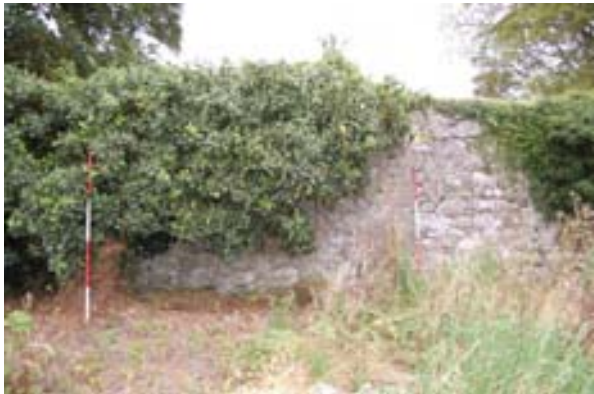
<i>East section of Town Wall, looking west</i>
Statutory Protection	National Monument; RMP GA-084-001; RPS 132	
Condition	Poor: see condition survey record.	
Significance	National: forms part of the Town Walls circuit.	
Vulnerability / Issues	<ul style="list-style-type: none">The permitted ivy and other vegetation growth over the last few years has ensured a dense covering of the majority of the Wall and the strong possibility that roots will have entered into the stonework.

Item:	Comments:	
Description	Adjacent to the South-East Tower the wall is approximately 3m high, 0.6m wide. To the north it is approximately 2.5m high. The ground level rises slightly towards the north. At the base of the wall is a ditch.	
Access	Good access at ground level.	
Completeness	Complete, but areas of rebuild.	
Verticality	Where visible, appears reasonable.	
Stability	Where visible, no signs of overall instability, but see below (internal face).	
Stonework/mortar	The stone work appears in variable condition, becoming increasingly poor towards the north, with large areas of open joints.	
Wall tops	The wall top appears irregular, with some areas of loose stones. Some areas of previous mortar capping visible.	
Vegetation	Areas of heavy ivy growth. Grass and other vegetation growing from the wall top.	
Openings	-	
Previous repairs	Some areas of rebuild.	
Other	<p>A large tree has fallen and is resting on the wall; this does not appear to have caused much damage, but should be removed as soon as possible.</p>

Policies / Recommendations	<ul style="list-style-type: none">A scheme should be implemented to ensure repair, checks on vegetation and any new collapses are addressed in a consistent and appropriate manner.Planning conditions for archaeological mitigation of below-ground remains should be applied to any future intrusive works in the vicinity of the wall.	
References	Bradley, J and Dunne, N (1992) <i>Urban Archaeological Survey part XIX Galway</i> Rynne, E (1995) Athenry in <i>More Irish Country Towns</i> , edited by Simms, A and Andrews, J.H, 106-117 Rynne, E (1981) <i>Survey of Town Walls</i> Thomas, A (1992) <i>Walled Towns of Ireland volume 2</i>	
Illustrations	Photographs – Gifford, 2007

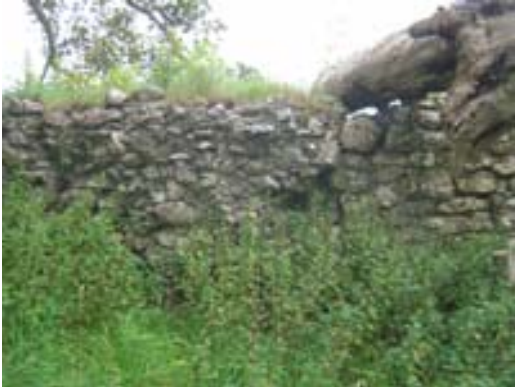
Zone: East	Gazetteer no. 12 – Condition record Feature Name: East wall surviving on original alignment from south of Priory to South-East Tower	Face: Internal

Item:	Comments:	
Description	Adjacent to the South-East tower the wall is approximately 1.2m high, 0.6m wide, and appears to have been rebuilt. To the north it is approximately 1.5m-2m high, and thicker (indicating probably original) but the internal face has collapsed in places. There is a further area of rebuild approximately 1.5m high x 0.6m wide.	
Access	Good access at ground level.	
Completeness	The internal face is missing in places, and other areas have been rebuilt. Where the internal face has collapsed, the line of the face is visible at ground level in most instances.	
Verticality	The areas of rebuild are of poorer construction and are visibly leaning outwards in places.	
Stability	The areas of rebuild/ poorer construction are potentially unstable. Where the internal face of the earlier wall is missing, the slenderness of the wall has been increased.	
Stonework/mortar	Where exposed the core work is in poor condition and requires consolidation.

Wall tops	The wall tops have previously been protected with a mortar capping.	
Vegetation	Grass, ivy and small trees are growing from the wall tops.	
Openings	-	
Previous repairs / modifications	Previous areas of rebuild are distinctly different in style and of poorer construction.	
Other	-

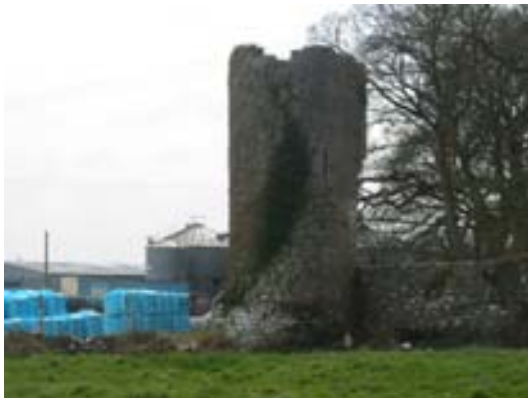
<p><i>South-East tower, looking south-west (external face)</i></p>

Statutory Protection	National Monument; RMP GA-084-001; GA084-001-10; RPS 132		
Condition	Fair: see condition survey record.		
Significance	National: forms part of the Town Walls circuit. This Tower, together with the North-West Tower, preserve the original construction of these structures that has been lost elsewhere and indicate that this point of the Wall needed extra defence.		
Vulnerability / Issues	<ul style="list-style-type: none">• The permitted ivy and other vegetation growth over the last few years has ensured a dense covering of the majority of the wall and the strong possibility that roots will have entered into the stonework.• Access available to unwanted visitors which has caused littering within the tower and

its environs and may have added to the degradation of the structure.
Policies / Recommendations	<ul style="list-style-type: none"> • A scheme should be implemented to ensure repair, checks on vegetation and any new collapses are addressed in consistent and appropriate manner. • Planning conditions for archaeological mitigation of below-ground remains should be applied to any future development works in the vicinity of the tower. • Signage should be appropriate at this location to form an interest point on a possible section of a visitor walk.
References	Bradley, J and Dunne, N (1992) <i>Urban Archaeological Survey part XIX Galway</i> Healy, A (1989) <i>Athenry, A Brief History and Guide</i> Rynne, E (1995) Athenry in <i>More Irish Country Towns</i> , edited by Simms, A and Andrews, J.H, 106-117 Rynne E (1981) <i>Survey of Town Walls</i> Howley Hayes (2007) <i>South-east Tower, Athenry: Conservation Report and Repair Recommendations</i> . Unpublished. Thomas, A (1992) <i>Walled Towns of Ireland volume 2</i>

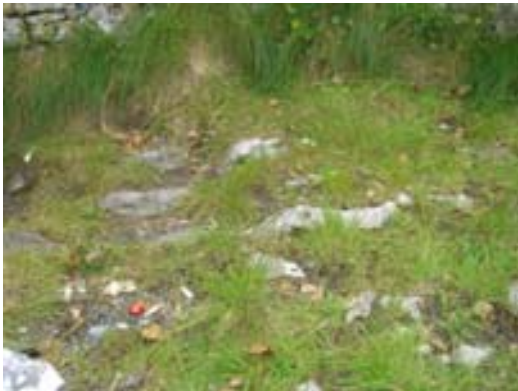
Access	Good access at ground level.	
Completeness	Appears reasonably complete to current height where visible, except to south-west where wall previously abutted tower. Some tumbled stone visible around the base of the tower.	
Verticality	Appears reasonably plumb where visible.	
Stability	No signs of overall instability where visible.	
Stonework/mortar	<p>Random limestone rubble (slightly squared stones) with some coursing. The stone size is larger than generally used for the walls, and some of the galleting is present in joints. Condition appears reasonable where visible. Remains of wet dash.</p> <p>Dressed stone quoins around door opening. Core work (to scar where wall has previously abutted) has vegetation growing from it and requires some consolidation. The upper surface of the roof is of rough stonework, with vegetation growing in the joints.</p>

Wall tops	Obscured by ivy.

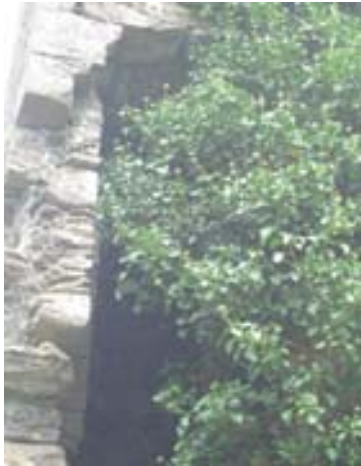
Vegetation	Significant ivy growth, to all perimeter except at the north.
Openings	<p>Arrow slit visible externally to the north appears in good condition. Door opening to the west appears in generally reasonable condition, but jambs very loose and lintel stone cracked.</p>

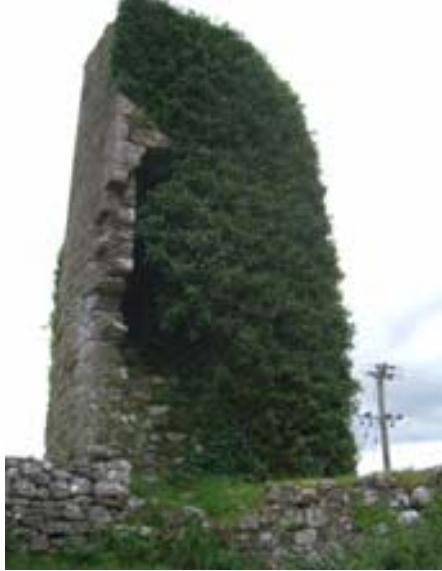
Zone: East	Gazetteer no. 13 – Condition record	Face: Internal
	Feature Name: South-East Tower	
Item:	Comments:	
Description

<p>A single internal chamber occupies the tower, floor level at approximately 4m above local ground level (inside the town walls). There are arrow slit openings to the north, east and south.</p> <p>The base beneath the chamber is thought to be solid.</p> <p>The chamber has a solid stone pointed arched vault, spanning east to west.</p> <p>To the south of the door opening there is a stone spiral stair leading up to the roof, with a wall separating the staircase from the main chamber. The roof is flat on its upper surface and there are the remains of crenelations approximately (at 500mm x 500mm at 500mm centres) to the perimeter.</p>	
Access	Good access at ground level. Access to high level possible, but dangerous. Barbed wire around the base of the tower is ineffectual at preventing public

access.
Completeness	The internal walls have a significant number of individual missing stones (some may be putlog holes?), and an area missing around the doorway. The roof is complete. The staircase has 3 missing treads.
Verticality	The internal walls appear reasonably plumb.
Stability	No signs of overall instability. Some loosening of facework internally, particularly around the doorway.
Stonework/mortar	<p>The roof shows signs of damp ingress and has a few loose stones internally.</p>

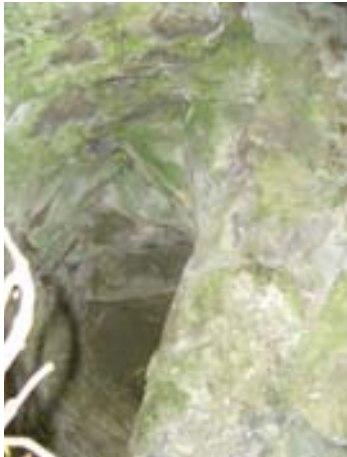
<p>The walls appear to be reasonably flat, of roughly squared stone in variable sizes, coursed, and may have been rendered previously. A number of pockets are present in the internal masonry, which may be original, but are more likely to have been created by removal of stones, and should be made good to prevent climbing.</p> <p>The floor is covered with debris.</p> <p>Roughly dressed stones occur around the door and window openings, and to the treads of the circular stairs</p> <p>The treads to the spiral stair are small in plan and generally worn. Some have broken corners. There is some ivy growth in joints. The wall to the staircase is in reasonable condition.</p>

Wall tops	Wall tops are generally obscured by ivy.
Vegetation	-
Openings	There are 3 openings at lower level; all with dressed stone heads and jambs The condition of the arrow slits is generally good. The door opening requires some repair, with loose stone bulging out of position at one side.
Previous repairs / modifications	There has been some previous consolidation work and possibly more extensive repair.
Other	Debris needs removing from chamber.

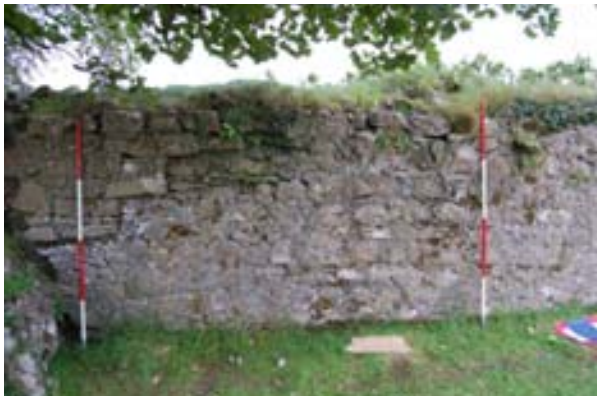
<p><i>Internal face, with stepped overlapping section, looking east</i></p>

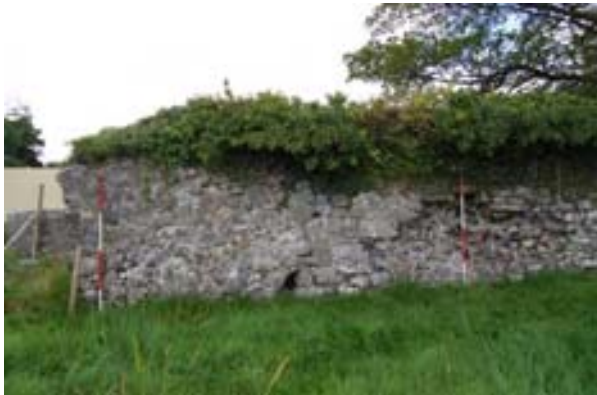
<p><i>External face, with large section of facing stones lost through ivy root growth, looking west</i></p>

Access	Reasonable access at ground level to most areas. Some areas difficult to access due to undergrowth.	
Completeness	<p><u>North-East section:</u> Complete</p> <p><u>South-West section:</u> Near the south-west end an area of facework approximately 3m long has collapsed, revealing thick ivy roots stems/roots.</p>	
Verticality	<p><u>North-East section:</u> Appears reasonably plumb.</p> <p><u>South-West section:</u> Visible bulge outwards at approximately 12m from the Co-op boundary. Leans inwards visibly at south-west end.</p>	
Stability	Some areas of potential instability. The area of stone above the collapsed facework to the south-west end is also potentially unstable.

Vulnerability / Issues	<ul style="list-style-type: none"> • The wall is largely overgrown in places, with ivy prominent around and within the wall structure. Careful removal and monitored growth is required, to avoid collapse from removal. • The land east and west of the river is in possession of a housing and mixed use development which at present has limited its land use to the west area of the river. A zone of archaeological potential (protection) has been allocated along the interior face of the wall. The land to the east of the river may be vulnerable as a site for future development. • Archaeological investigations in 2007 are addressing certain sections west of the Clarin riverbank as part of the Oyster Homes development. The results of these investigations are as yet unpublished. Little is known about the archaeological potential of the east side of the Clarin.
Policies / Recommendations	<ul style="list-style-type: none"> • A topographic/radar survey of the entire area could identify archaeological features of interest located along the interior of the wall. A scheme should be implemented to ensure repair, checks on vegetation and any new collapses are addressed in a consistent and appropriate manner. • Planning conditions for archaeological mitigation of below-ground remains should be applied to any future development works in the vicinity of the wall.

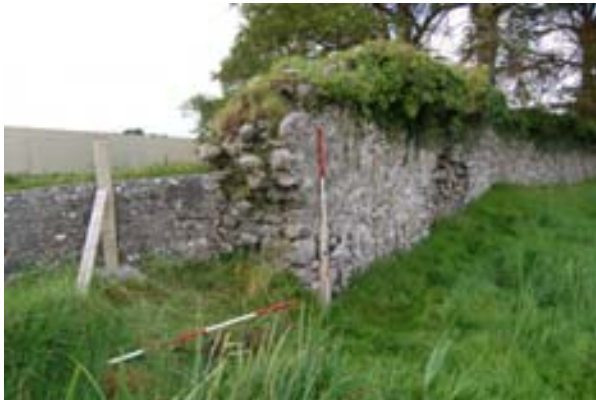
<p><i>External face of wall, looking north-east</i></p>		
Statutory Protection	National Monument; RMP GA-084-001; RPS 132	
Condition	Poor: see condition survey record.	
Significance	National: forms part of the Town Walls circuit.

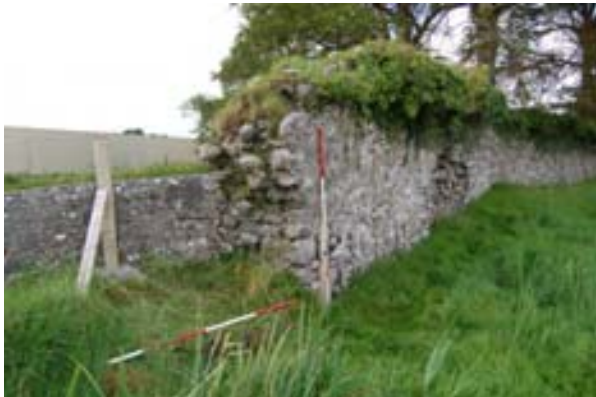
External face of wall, looking north-east

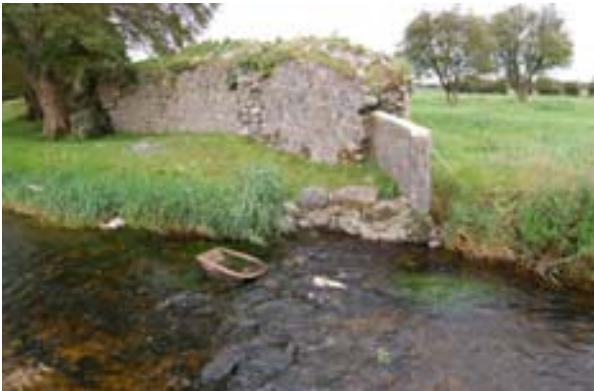
<i>Internal face of wall at river crossing, looking north-east</i>
Statutory Protection	National Monument; RMP GA-084-001; RPS 132	
Condition	Unknown. Break in wall. Mill stream approximately 3m wide at this point and changes direction, running parallel with the wall to the west. End of wall to west has been faced, but end of wall to east is a rough break.	
Significance	National: forms part of the Town Walls circuit. The crossing of the River Clarin could have been a breaching point for invaders, but as the land on the interior was away from the town centre it may have been less of a temptation.

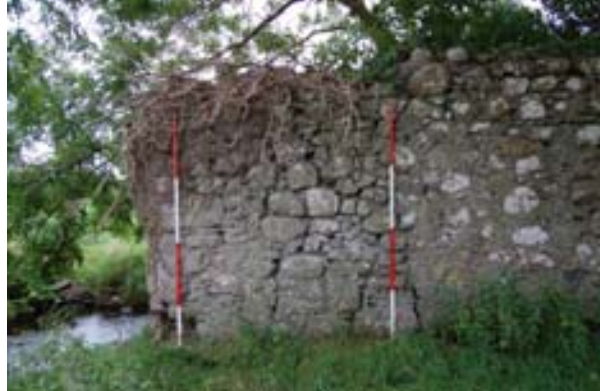
<p><i>Internal face of wall at river crossing, looking south-eastwest</i></p>

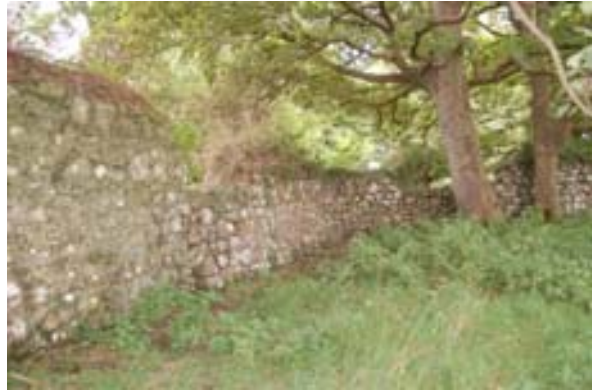
<p><i>Leaning section at return of wall, looking south-east</i></p>

Zone: South	Gazetteer no. 16 – Condition record Feature Name: Wall between River Clarin and Spittle Gate	Face: Internal
Item:	Comments:	
Description	<p>The west section runs north-east to south-west following the line of the river. The wall changes direction and the east section of wall runs generally east-west. The west section is approximately 2m high x 1.2m wide. It steps down to approximately 1m at the bend, and then gradually increases to 3m adjacent to the Spittle Gate.</p> <p>At the river the wall end has been faced at an obtuse angle to the internal face.</p>	
Access	Good access at ground level.	
Completeness	The wall face appears complete.	
Verticality	The east section of wall exhibits bulging and leans outwards towards the bend. Elsewhere it appears reasonably plumb where visible.	
Stability	<p>Areas adjacent to the bend potentially unstable. There is a vertical crack near the end of the wall at the river, for the full height of the wall, which may indicate some rotation of the end block approximately 1m long x 2m high x 1.2m thick.</p>

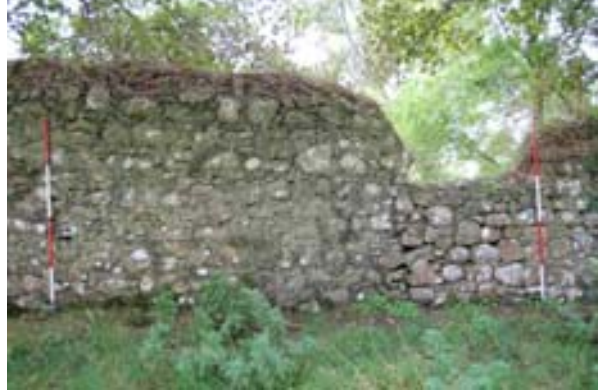
<p><i>Straight joint on internal face of wall, west of the return and east of the gateway, looking south</i></p>

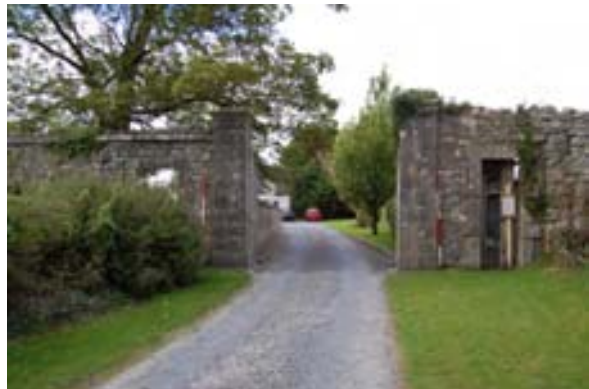
<p><i>External face of wall at site of Spittle Gate, looking north</i></p>

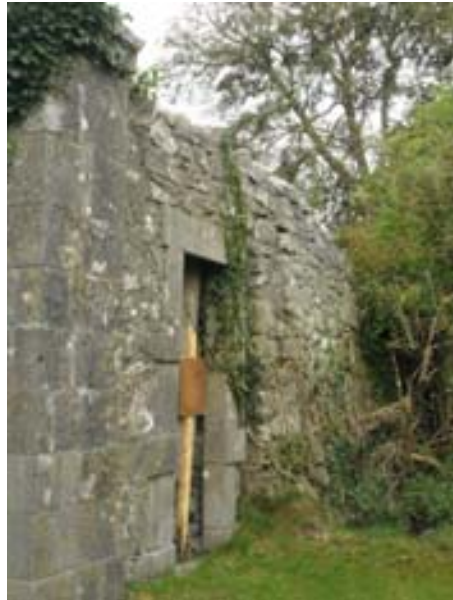
<p><i>External detail of pedestrian entrance east of Spittle Gate</i></p>

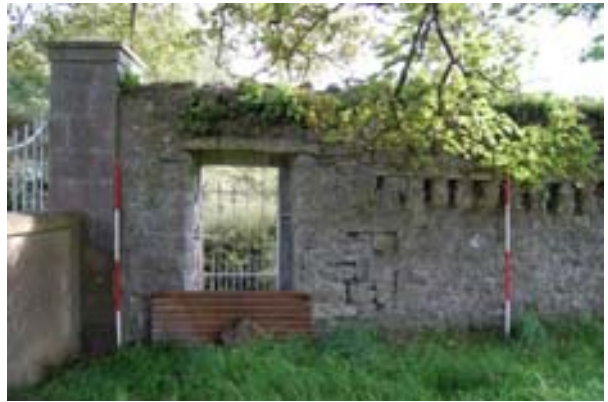
<p><i>Internal face of west doorway, west of gateway, with notches, looking south</i></p>

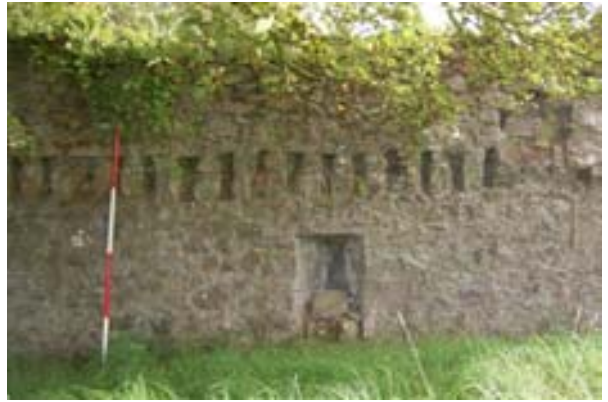
<p><i>Internal face of Wall with notches and splayed arrow slits below, looking south</i></p>

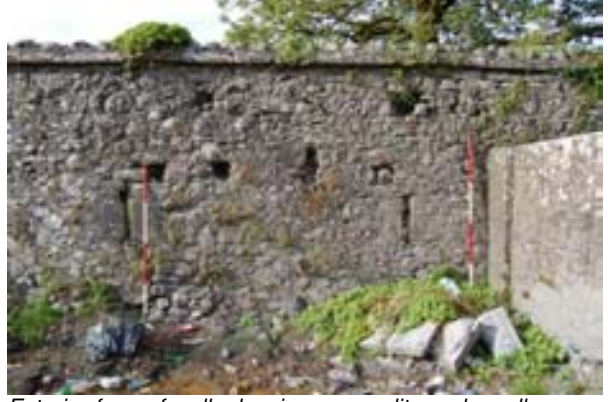
<p><i>Exterior face of wall, showing arrow slits and small square notches above, looking north</i></p>

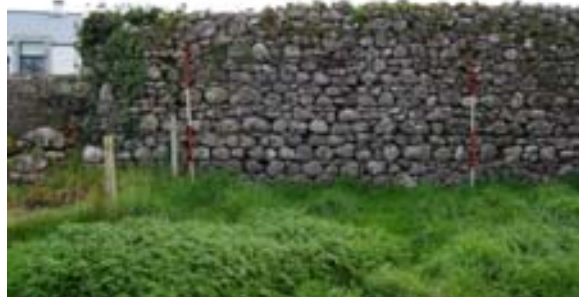
<p><i>Coursed, rebuilt section of wall with horizontal joints, looking south</i></p>

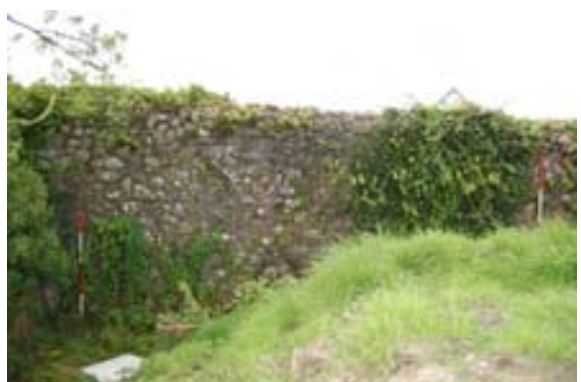
<p><i>Interior of wall at south-west corner of GAA grounds, showing build up of material to raise ground levels to the west, looking south</i></p>
Description: <p>The Town Wall extends west from Gazetteer no. 18, with a fragmented section, which has been reinforced with a concrete panel wall built along its exterior. To the west of this, a second section of the wall has been rebuilt with rounded limestone blocks, some laid in courses, with galleting. Horizontal joints are present, possibly indicating sections of construction, completed up to these points. This rebuilt section continues beyond a perpendicular boundary wall and joins with the next section of wall to the west, which appears to be of original build.</p> <p>The level of the land in the interior of the wall steadily descends to the west and the wall rises to a maximum height of approximately 4m on the interior. This ground level continues into the south-east corner of the GAA grounds, from which point it sharply rises towards the west.</p> <p>The ground levels have been raised within the GAA grounds, to provide a level pitch and viewing facilities. Nevertheless, the wall survives to a height of approximately 2m or less in places. Concrete capping with inserted glass bottles have been applied to keep out unwanted visitors. A large section of wall is situated behind the grandstand, which protrudes over the wall and is clearly visible from the exterior.</p> <p>On the exterior, the level of the land rises gently towards the tower and dips down to the west. Evidence for the fosse is present as a bank along the base of the exterior of the wall of less than 1m in width, which slopes away from the wall.</p> <p>Sections of the exterior of the wall show areas of rebuild or repair, but it appears largely complete with unvarying construction techniques. Render survives in places, although where it has been lost, the joints have become opened, through exposure to the elements and root action from ivy and other vegetation. The wall changes angle towards the west end, as it approaches the Loro (Swan) Gate. This short section appears to have been rebuilt, where it meets the south-west corner of the GAA grounds. The stones are of random sizes and are uncoursed and not aligned to any plains. This section was rebuilt in the 20th century with works to widen the entrance to the town at Prospect/Swangate.</p>

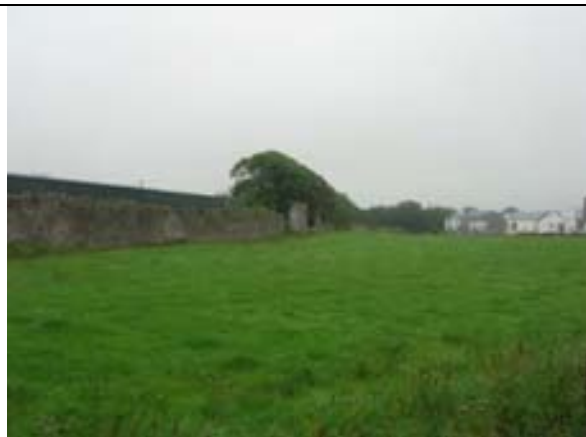
External face of wall from west end with tower in distance, looking south-east

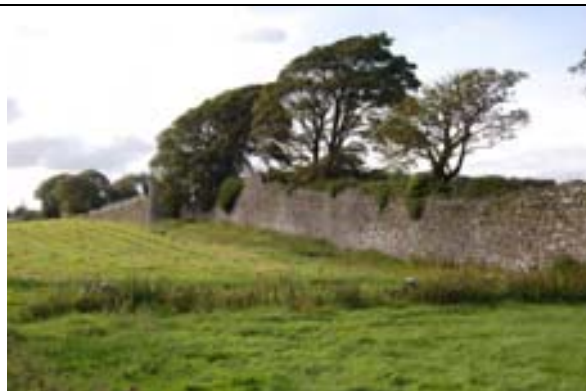
External face of wall from east end with bank along the base, looking north-west

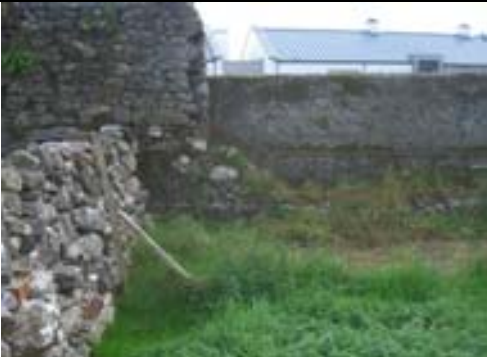
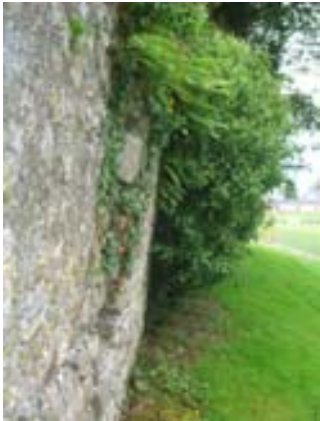
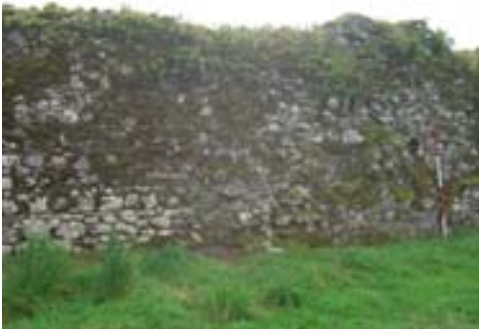
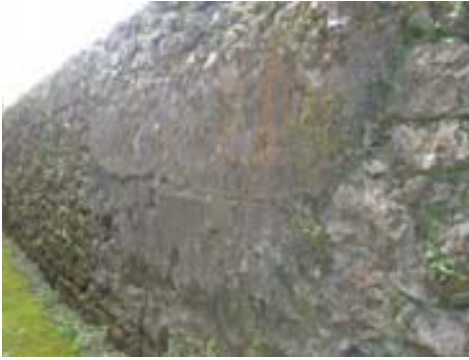
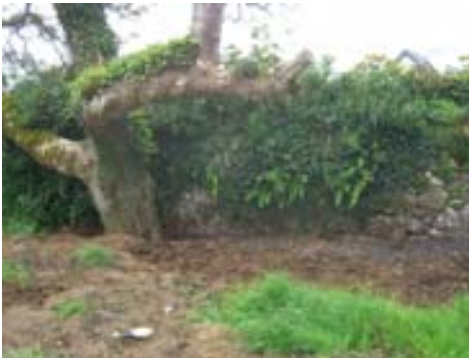
Access	Good access at ground level, except at the west end (behind building).
Completeness	Adjacent South Tower (Gazetteer no. 20), inner face missing down to approximately 1m above ground level, and the revealed face rebuilt. Towards the east end of the wall within the fields the wall is in poor condition, with much of the facework missing and corework exposed. There is an area of modern cement pointing.
Verticality	The wall leans outwards slightly in places. To the east of the tower the wall leans outwards and the adjacent section bulges inwards.
Stability	To the east of the tower the wall appears in imminent danger of collapse where bulging.

Stonework/mortar	Stonework to random coursing. Large area of missing facework to the east end. Patches of loose stones, and missing packing stones. Isolated missing stones to rear of stand. Joints to lower part of the wall generally require repointing.

Wall tops	As external face.
Vegetation	Minor vegetation growth in joints. Towards east end, patches of ivy growth to wall tops.
Openings	-
Previous repairs / modifications	Adjacent South Tower, face of wall rebuilt and ledge capped with mortar, inset with broken glass. To the back of the stand an area has been rebuilt, with concrete render to the face.

The raised ground levels to the east end of the pitch may be putting additional pressure on the wall.

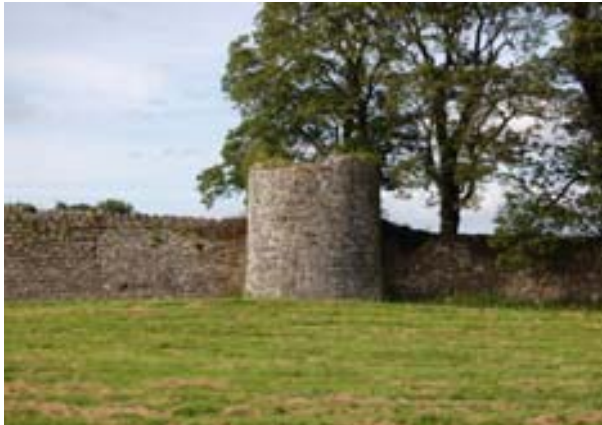
<p><i>External face of South Tower, looking north</i></p>

Statutory Protection	National Monument; RMP GA-084-001; RPS 132	
Condition	Poor: see condition survey record.	
Significance	National: forms part of the Town Walls circuit. The tower is evidence of a perceived threat on such a long stretch of exposed wall and might have been added after the wall's construction, to improve the defences at this location.

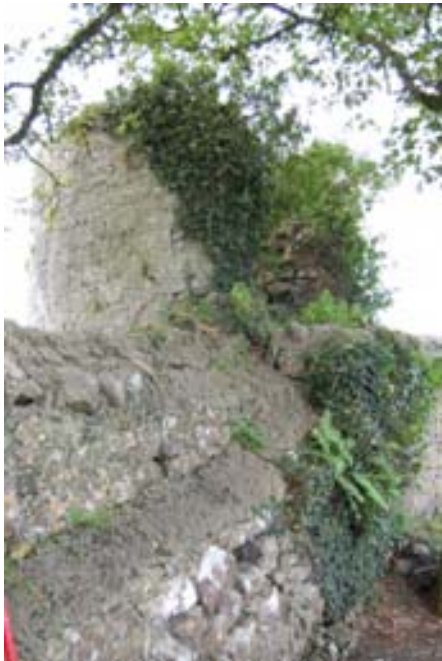
<p><i>Internal face of wall and tower with concrete capping, looking south-west</i></p>

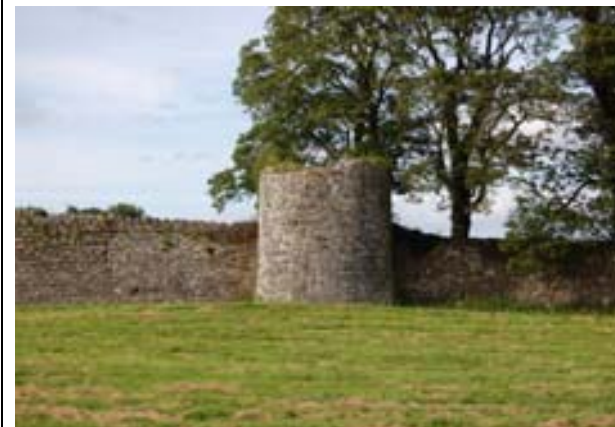
External face of South Tower, looking north

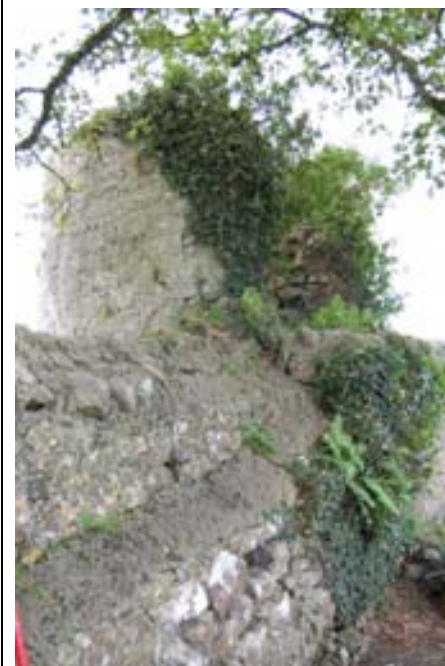
Internal face of wall and tower with concrete capping, looking south-west

Vulnerability / Issues	<ul style="list-style-type: none"> • The tower has barbed wire applied to the interior to stop unwanted visitors accessing the GAA grounds. • There is no signage that could inform visitors to the GAA ground of the origin/purpose of the tower. • Vegetation has been left to grow inside the tower, adding to its instability.
Policies / Recommendations	<ul style="list-style-type: none"> • The GAA ground could utilise the presence of the wall and tower along its southern boundary, as design features. • Alternate means of preventing unwanted access out should be investigated that would not involve attaching items to the wall. • Vegetation should be carefully removed or cut back and consolidation works carried out on the tower. • A scheme could be implemented to ensure repair, checks on vegetation and any new collapses are addressed in a consistent and appropriate manner. • Planning conditions for archaeological mitigation of below-ground remains should be applied to any future development works in the vicinity of the tower.

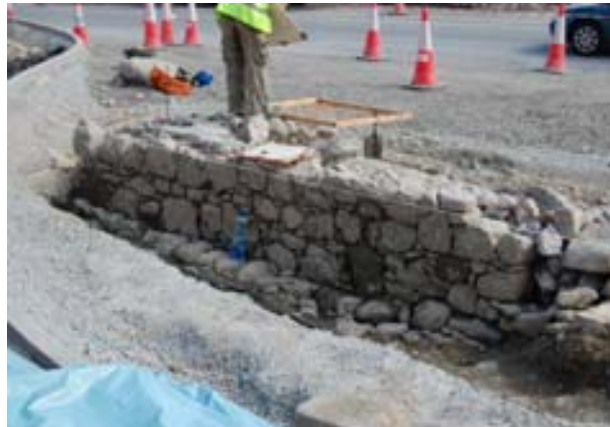
<i>Internal face of gate, looking north-east</i>

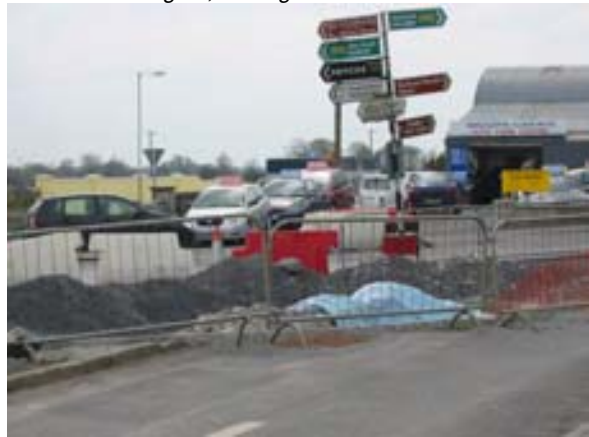
<i>Setting of Loro Gate remains</i>

Statutory Protection	National Monument; RMP GA-084-001; GA-084-001-013; RPS 132	
Condition	Modern road. No standing remains above ground, but road works in 2007 have uncovered the remains of the gate below ground, thought to be the west abutment of the gate. Currently being recorded by archaeologists. Stonework appears similar to elsewhere.	
Significance	National: forms part of the Town Walls circuit. The presence of the below-ground remains of the Loro Gate is significant as evidence of the possible preservation of other below-ground remains of features related to the Town Walls. The gate itself formed one of the main entrances to Athenry and its situation on the west branch of the road fork shows the street alignment contemporary with the gate. It also shows the original construction techniques used, with neat facing on the exterior faces and a rubble core, pad stones and footings. It is the one surviving original gate found to date, as the North Gate dates from the 16 th century.

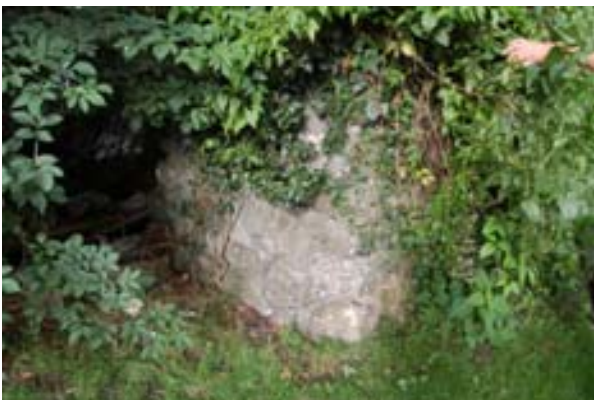
<p><i>Finished end of wall as dressed in the late 20th century, with the existing wall continuing at a reduced height, to the south-east, (looking north-west)</i></p>	
Description: The line of the wall between Loro Gate and the South-West Tower is preserved by the lower courses of the wall, that survive along a property boundary. In the last 10 years, the wall has been reduced in height, leaving the lower courses at ground level and a wooden fence marking the boundary. A section remains in the south-west corner, which has been neatly finished off and battered in recent times.			
Statutory Protection	National Monument; RMP GA-084-001; RPS 132		
Condition	Very little standing remains. Short length of wall (approximately 3m long x 3m high) adjacent and abutting the South-West Tower (Gazetteer no. 23) is covered with ivy and not visible. The majority of the wall is reported to have been demolished to ground level (c1960). Footings may remain in bank on line of boundary fence (some stones visible).

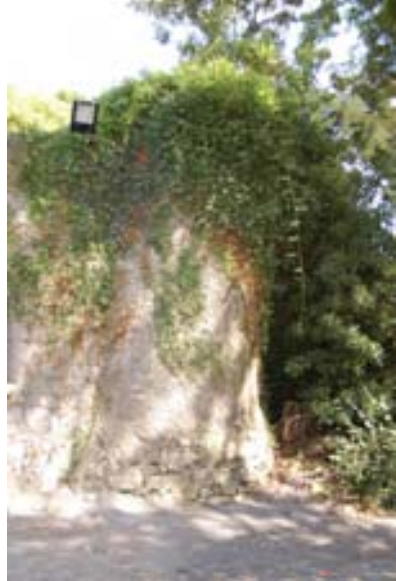
<i>South-West Tower, looking north-east</i>

Zone: South	Gazetteer no. 23 – Condition record Feature Name: South-West Tower	Face: External
Item:	Comments:	
Description	<p>Circular tower approximately 2.5m diameter x 4m high. Widens at base to approximately 3m diameter. A building (stables?) has been built up against and partially contains the tower to the north-west. A small area of tower wall is visible from within the building. The remains of the Town Wall to the south-east (Gazetteer no. 22) abut the tower, but the rebuilt wall to the north-east (Gazetteer no. 24) does not. The majority of the tower is obscured by ivy.</p>

Wall tops	Obscured by ivy.	
Vegetation	Ivy covers all wall tops and upper part of the tower.	
Openings	None visible	
Previous repairs / modifications	-	
Other

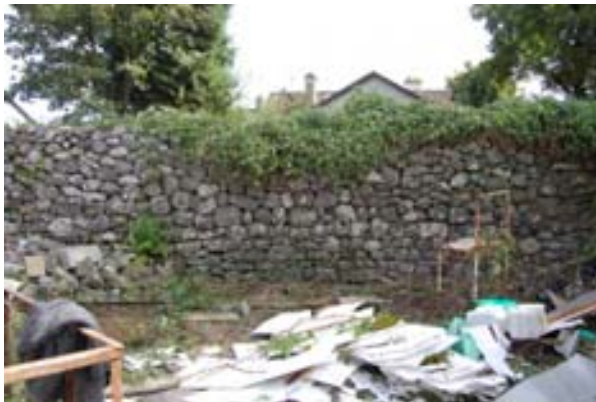
Phase/Construction Date(s): Phase 2: 14 th century Phase 7: 20 th century		
Description: As the wall continues northwards from the South-West Tower, it has been largely rebuilt at various periods, but not necessarily using the original techniques. The wall is approximately 2m in height, c.1m thick and leans to the exterior in places. The first section to the north of the South-West Tower was rebuilt, following a collapse in the 20 th century. The small packing stones (galleting) between the larger stone blocks have not been applied and the stones are largely uncoursed. Vegetation from the gardens on the interior side has established growth along the top of the wall and along its internal face, opening the joints between the stones.		<i>Exterior face of wall, looking south- east</i>

Zone: West	Gazetteer no. 24 - Condition record Feature Name: 20 th century rebuild of Town Wall from South-West Tower to Gazetteer no. 25	Face: Internal
Item:	Comments:	
Description	As external face.	
Access	Good access at ground level.	
Completeness	Appears largely rebuilt.	
Verticality	Leans inwards.	
Stability	Leans onto the blockwork boundary wall between the properties.	
Stonework/mortar	As external face.	
Wall tops	Wall tops loose and covered with ivy.	
Vegetation	Ivy growth.	
Openings	-	
Previous repairs / modifications	Rebuilt.	
Other	Rubbish has been piled against the foot of the wall at the north-east.

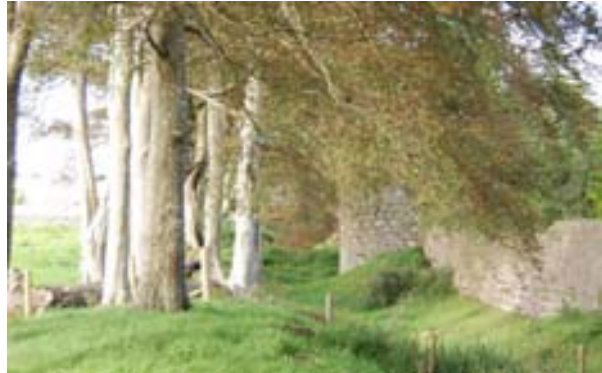
<i>External face of wall with fosse, looking north, showing West Tower (Gazetteer no. 27)</i>

Stability	Potentially unstable in places.	
Stonework/mortar	<p>Coursing random, some areas rendered. Some areas good condition, but generally quite poor condition. Some open joints and cracking in joints. Some loose/ missing stone particularly at the base of the wall. Significant amount of tumbled stone at base of wall and in ditch.</p>

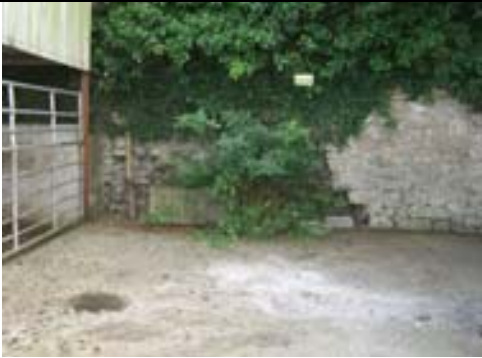
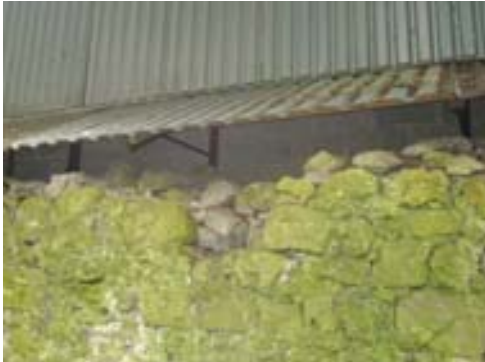
<p>One area of collapsed face at low level towards the north-east end requires support to loose stones above and consolidation/repair. Other areas of collapse of facing adjacent to and behind buildings at the north-east end.</p>

Wall tops	<p>Mortar capping visible in a few locations, but elsewhere wall tops are generally covered with ivy. Wall top in one location sheltered by the overhanging roof of a barn on the inside of the wall, but stonework appears loose and unprotected.</p>

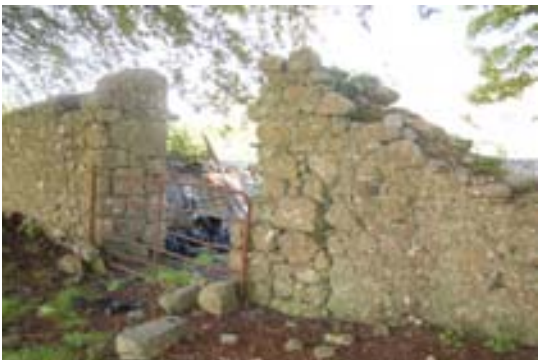
<p><i>External face of gate posts, looking north-east</i></p>

Verticality	Reasonable.	
Stability	South-west pier likely to be lost as a recognisable feature unless repaired.	
Stonework/mortar	<p>Poor condition. South-west pier has lost a number of stones and others are loose. The joints are open and mortar missing.</p> <div data-bbox="620 732 1055 1308" data-label="Image"> </div>	
Vegetation	Minor vegetation growth.	
Openings	<p>A modern field gate is leant against the piers, held in place by tumbled stones. This should be replaced with a field gate hung on timber posts adjacent to the piers, or on stainless steel pintels built into the piers.</p>	
Previous repairs / modifications	-	
Other	-
