INDEX TO GAZETTEER

<p>GAZETTEER NUMBER 1</p> <p>Zone: West</p> <p>Feature Name: Section of Town Wall on the boundary between St Mary's Churchyard and car park</p> <p>Phase/Construction Date(s):</p> <p>Phase 2: 14th century Phase 6: 19th century Phase 7: 20th century</p>	<p>Location:</p>

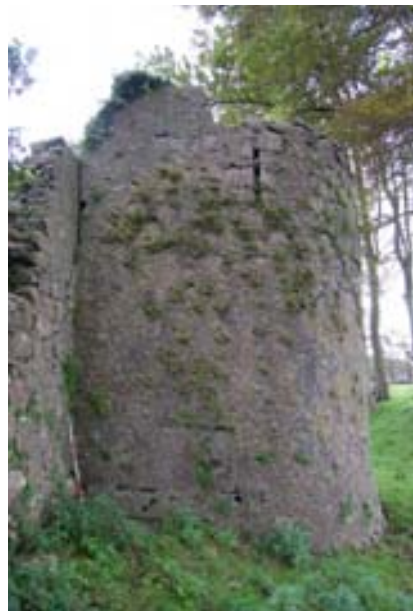
<p><i>North face of tower, looking south</i></p>

Completeness	Reasonable.		
Verticality	Reasonable.		
Stability	No signs of overall instability.		
Stonework/mortar	<p>The face stones are very large, not squared, with varied height coursing. The joints are open with mortar and packing stones missing. There appears to be loose stonework at high level.</p>

Wall tops	The wall tops are in poor condition, with loose stones visible. There appears to have been a protective mortar capping applied previously.		
Vegetation	Minor vegetation growth in joints. Some ivy to wall tops particularly adjacent town walls.		
Openings	Thin rectangular (blocked?) openings are visible to the west and north faces, and possibly also to the south face (although this is difficult to distinguish).		
Previous repairs / modifications	-		
Other	-

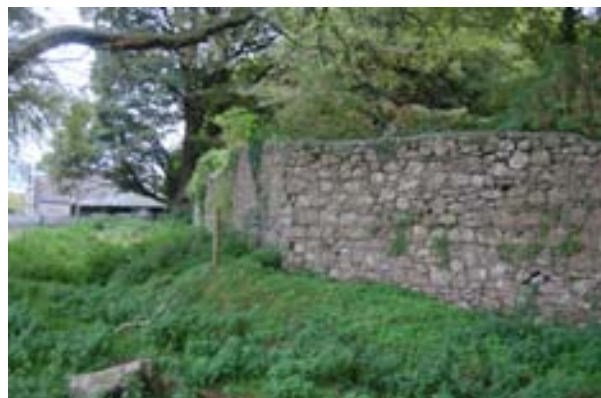
<i>Site of North-West Tower, looking north (external face)</i>	
Statutory Protection	National Monument; RMP GA-084-001; RPS 132.		
Condition	Unknown: possible below ground remains survive. No remains of this tower are visible: it is understood to have been demolished in living memory. It is possible that the footings survive in the infilled fosse and rampart area.

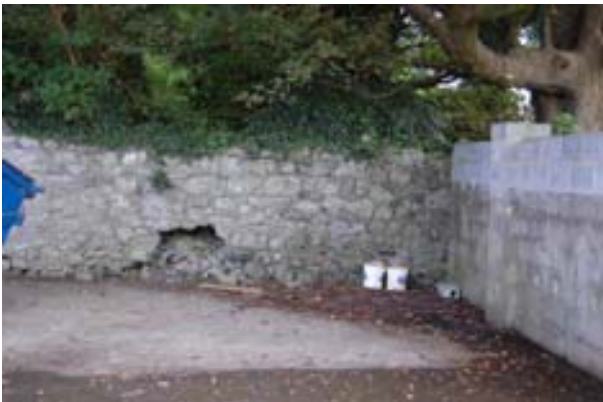
<i>External face of wall, looking east</i>
Description: The north end of the wall leads into the yard of a butcher's, where modern cattle sheds have been built less than 1m from the external face. The wall appears to have been rebuilt recently along this section, with uncoursed stones set in a hard concrete-based mortar, replacing the original wall. Part of the face has fallen away, revealing the internal core. The wall continues towards the site of the Nicholas Gate, where it forms a boundary between the butcher's property and a property to the east.		
Statutory Protection	National Monument; RMP GA-084-001; RPS 132.	
Condition	Unknown - no upstanding walls visible; modern buildings.	
Significance	National: forms part of the Town Walls circuit. This section of the Wall survives in places although at times it is degraded or hidden behind modern buildings.

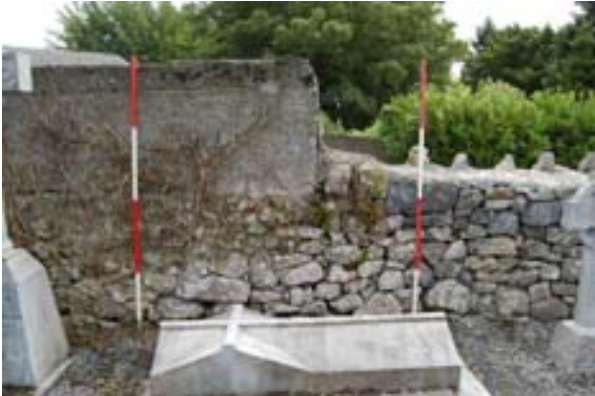
<i>External face of wall, looking south-east</i>
Statutory Protection	National Monument; RMP GA-084-001; RPS 132	
Condition	Good: dry stone boundary wall approximately 1m high. Abuts (Gazetteer no. 1) wall at its north-eastern end.

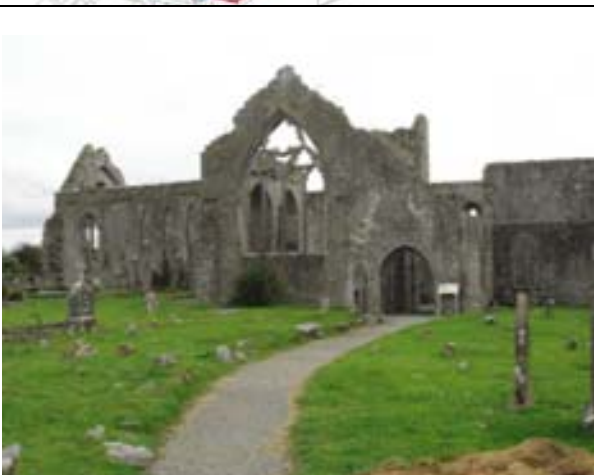
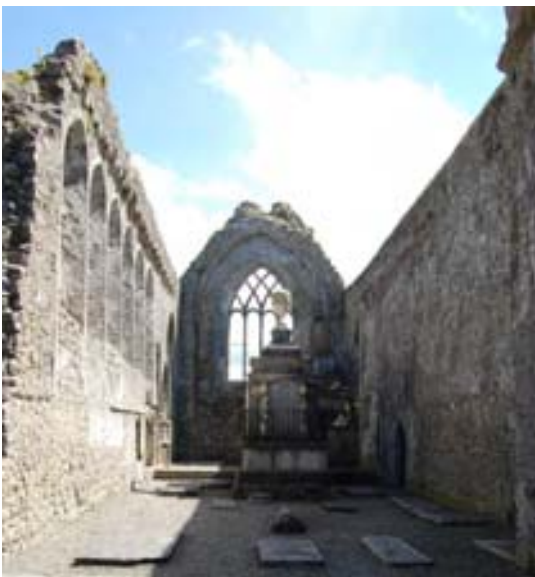
<p><i>Priory, looking south</i></p>

<p><i>East end of Priory chancel, looking east</i></p>

Statutory Protection	Register of National Monuments no. 164; RMP GA-084-001; GA-084-001-14; GA-084-001-25; RPS 1234. Under ownership of OPW.		
Condition	Not included in condition survey.		
Significance	National: the Priory forms part of the medieval heritage of Athenry. It also raised the status of Athenry as a University town in the 17 th century.		
Vulnerability / Issues	<ul style="list-style-type: none">Visitors may add to the wear and tear of the building and the tombs are under constant threat of being damaged especially that of Lady de Bermingham in the centre of the chancel.The east tracery window has been restored but the rest of the building requires consolidation and graffiti removal.

<ul style="list-style-type: none"> • The east boundary wall of the Priory is very overgrown.
Policies / Recommendations	<ul style="list-style-type: none"> • Consolidation works of the remains would enhance the survival of Priory and its boundary walls. • Vegetation should be carefully removed or cut back and consolidation works carried out to the revealed sections. • The Priory and its walls should be continually monitored for further degradation.
References	Bradley, J and Dunne, N (1992) <i>Urban Archaeological Survey part XIX Galway</i> Rynne, E (1995) Athenry in <i>More Irish Country Towns</i> , edited by Simms, A and Andrews, J.H, 106-117 Rynne, E (1992a) <i>Athenry A Medieval Town</i> Rynne E (1992) <i>The Poet's Athenry</i> Rynne, E (1981) <i>Survey of Town Walls</i> Thomas, A (1992) <i>Walled Towns of Ireland volume 2</i>
Illustrations	Photographs – Gifford, 2007

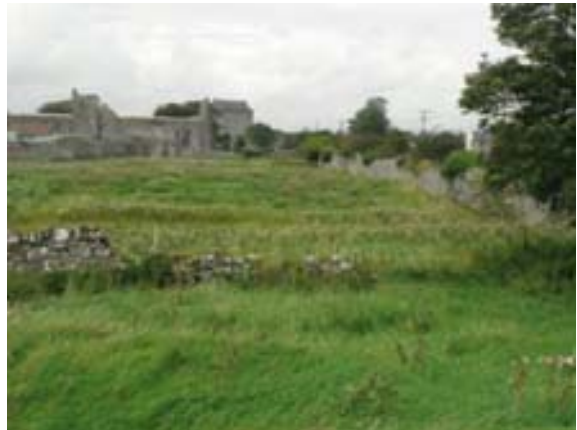
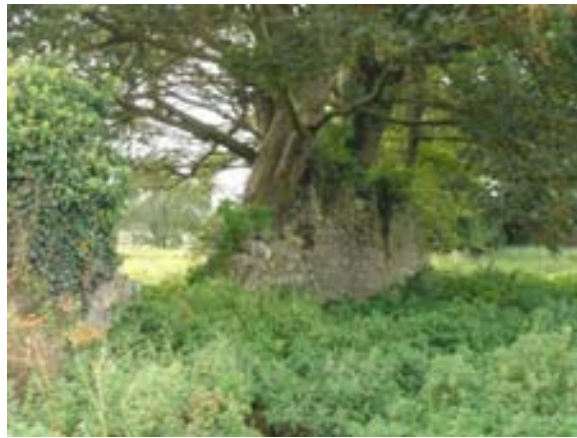
<p><i>Possible dividing wall, looking north</i></p>

<p><i>Detail of dividing wall, looking south</i></p>

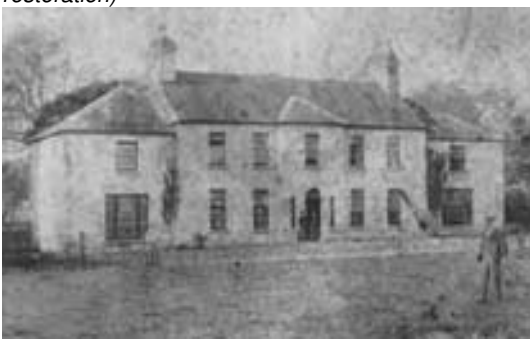
<p><i>Image of Athenry House, courtesy of Galway County Council</i></p>
Description: Athenry House dates to c.1780 and is constructed of limestone rubble and ashlar dressings, with rough dashed render. It is a two-storey gable-ended house with single-storey extensions added to either end c.1820. It is constructed of shaped limestone blocks with dressed blocks at the openings. It is situated on the west bank of the River Clareen to the south of the town, with an entrance at the east end of Cross Street with ashlar gateposts and iron gates. A second entrance is located at the site of Spittle Gate, to the south, which now forms an entrance to a later house, erected to the south of Athenry House. A modern house was added to the north-east of the main building which has since become derelict. The fields to the west side of the River Clarin contain elements of walls and other unidentified grass-covered lumps which may be remains of earlier buildings or divisions relating to Athenry House. A rare example of a triangular dovecote (normally circular) is located within the grounds of Athenry House. The dovecote along with other outbuildings is required by Galway County Council to be preserved in any future development. Athenry House is currently being restored to form the entrance feature of a proposed new hotel complex.

Statutory Protection	RMP GA-084-001; RPS 131 (GA-46-M-502275)	
Condition	Not included in condition survey.	
Significance	Local: Athenry House is a prominent building, with a large amount of land close to the town centre.	
Vulnerability / Issues	<ul style="list-style-type: none">Athenry House has been left derelict for a long period, but is currently being restored as part of a hotel complex.There is a lack of understanding of the entire archaeological potential present in the grounds, including the other standing structures within the grounds.	
Policies / Recommendations	<ul style="list-style-type: none">Athenry House and the other standing remains require removal of vegetation and urgent consolidation works. The structures should be continually monitored for further degradation.A topographical/radar survey of the grounds could be carried out to determine the extent of below-ground features and existing walls to add to the interpretation of this section of Athenry.

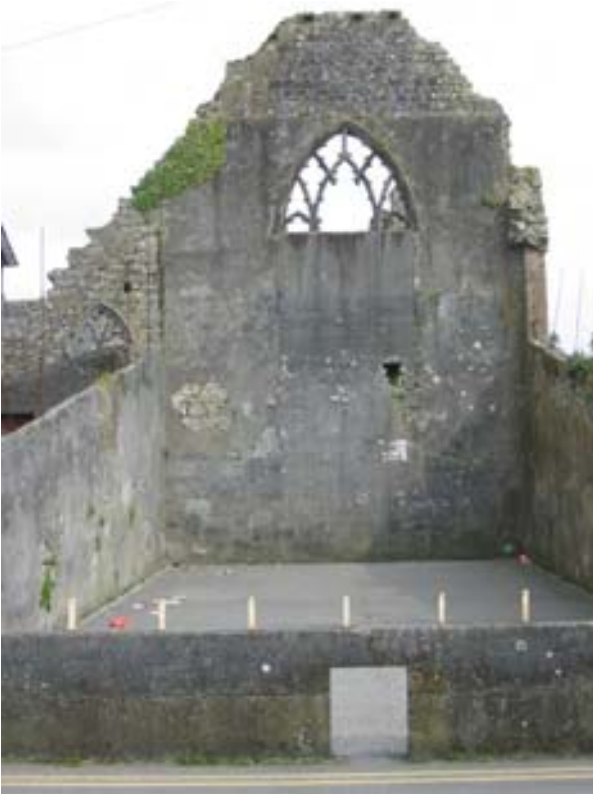
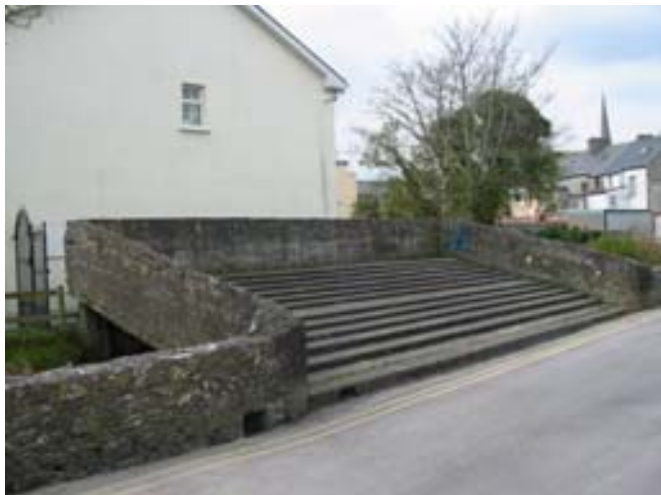
<i>Handball alley viewing stand</i>		
Statutory Protection	Register of National Monuments no. 164 (Dominican Priory); RMP GA-084-001; GA-084-001-14	
Condition	Not included in condition survey.	
Significance	National: the alley is one of only two alleys in Ireland known to have been built onto a National Monument (the other is at Lorrha in County Tipperary, E Rynne, pers.comm). Handball alleys are the only vernacular buildings unique to Ireland. Rare survival and added value of an extant viewing stand. The earliest written record of a handball game is in the town statutes of Galway which in 1527 forbade the playing of ball games within the walls of the town.

Vulnerability / Issues	<ul style="list-style-type: none">The handball court was added to the west end wall of the National Monument and it may be vulnerable of removal, related to restoration of the west Priory wall and tracery window..	
Policies / Recommendations	<ul style="list-style-type: none">A new handball alley has been built to the north of Kenny Park GAA ground so this alley could be converted for a new use, suitable for its location. Consolidation works could be carried out to protect the west end of the Priory and to enhance the area of the alley.	
References	Bradley, J and Dunne, N (1992) <i>Urban Archaeological Survey part XIX Galway</i>
