# Issertkelly Church and Graveyard

Conservation Management Plan (CMF22-2-GA001)

November 2022

This conservation management plan was commissioned by Galway County Council to assess the current condition and make recommendations for any necessary repairs to the ruin of the Church of Iisert Kelly, also known as Iisertkelly, near Loughrea, Co Galway. It is grant funded by the Community Monuments Fund, from the Department of Housing, Local Government and Heritage. It has been prepared by Howley Hayes Cooney Architecture in association with Rory Sherlock Archaeology; Bernie O'Doherty Archaeologist, John Britton Engineering; and MKO ecology. The surveys and enabling works on which this report is based were carried out in August and September of 2022.

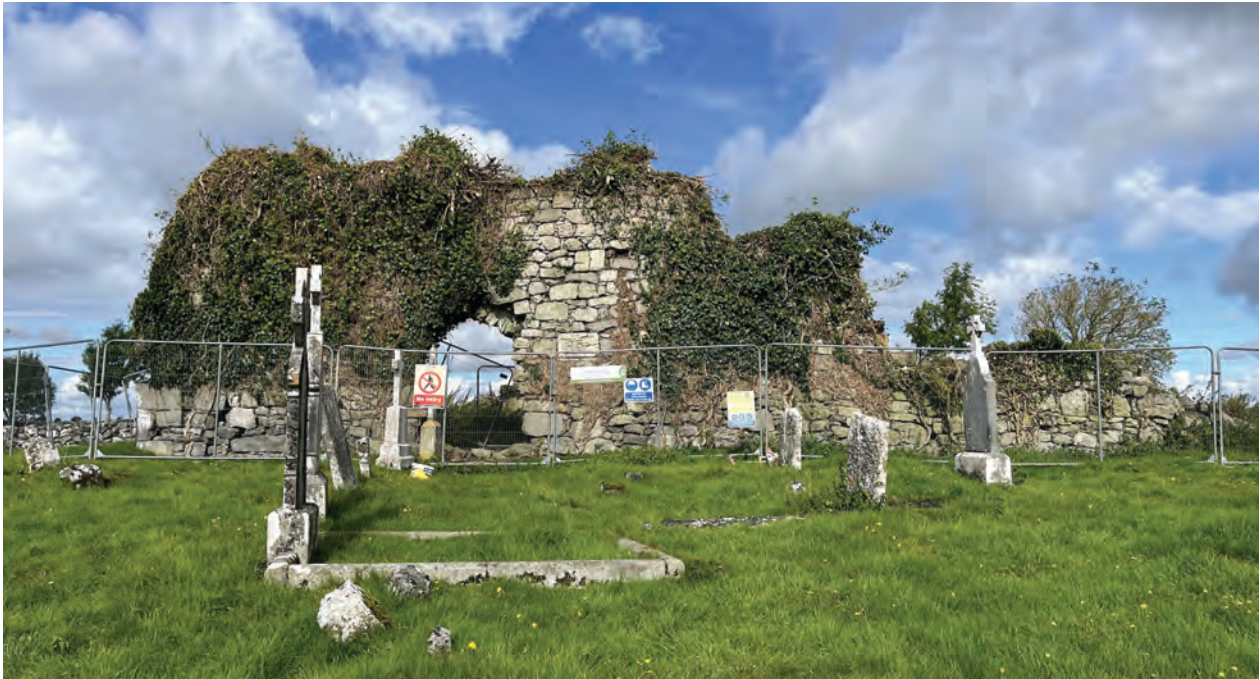
*Figure 1 - View of the south wall of Issertkelly*

The ruined church and graveyard at Issert Kelly (or Isert kelly / Isserkelly ) is a medieval stone church with adjoining graveyard, and has long been in a ruinous state, with a significant loss of masonry to the north, east and west wall, with only a portion of the south wall still upstanding (fig 1). Located within the townland of Issert Kelly North, approximately 13km south-east from the town of Loughrea and the graveyard is likely still in use and visited occasionally by local parishioners with relatives buried there. The church appears to consist of a single cell structure, though it is difficult to determine this accurately due to the significant collapse of the walls. Vegetation trimming was undertaken at the site in September 2022, to reveal the condition of the upstanding south wall. Of particular concern now is the stability of this wall which is leaning forward, and the integrity of the entrance arch. There are also significantly large rooted trees sitting on the top of the wall tops.

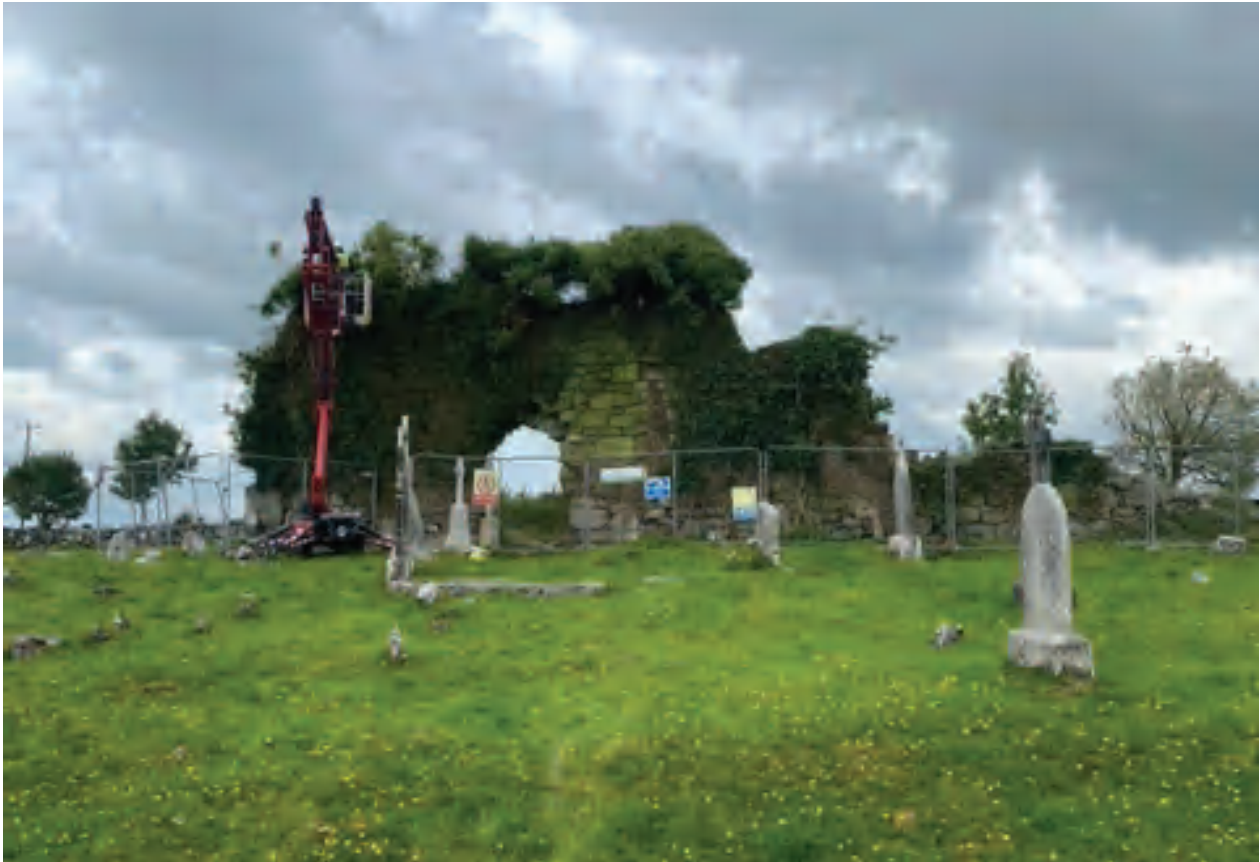
Figure 6 - Vegetation removal underway at the site in September 2022

The extant church at Issert Kelly is a rectangular, single cell building, constructed of un-coursed rubble limestone. Orientated traditionally, the structure measures some 24m long by 9.8m wide, with wall thickness of 1.25m, and is probably of medieval date. Vegetation removal carried out as part of this project has allowed for the examination of the south wall, remnants of the west wall, and the entrance opening and the remains of one window in the south wall (fig 6).

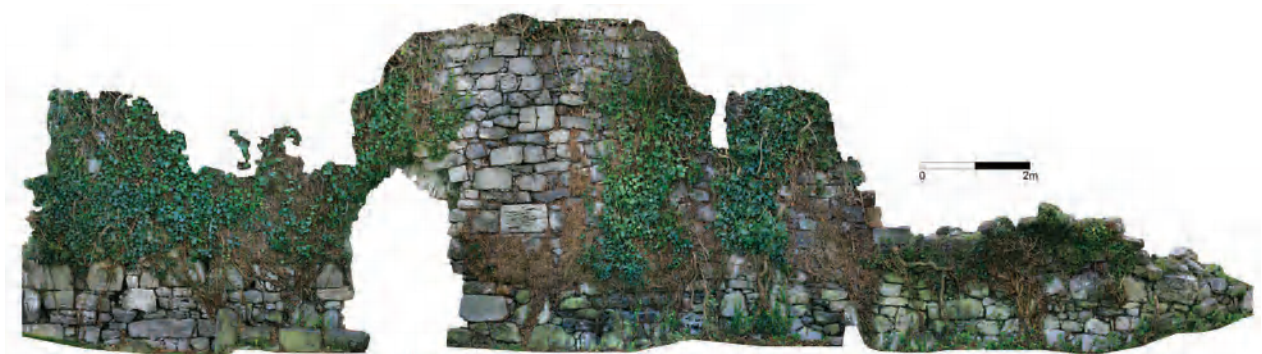
The south wall is the most intact wall left of the structure, ranging between 1m to 5m in height with an average wall thickness of 800-900mm, and it contains the main entrance to the church (fig 7 & 8). Constructed of large boulder stones, indicating some age, several of the quoin stones are still in place on the west end, including one which was inscribed with a letter 'T'. Given the font, this is thought to be an eighteenth or nineteenth century inscription (fig 11) . The north west corner is still intact at low level, as

There is evidence of somewhat recent collapse of the south wall internally, and this is not

*Figure 7 - South wall, exterior (R Sherlock Archaeology)*

surprising given the extent of vegetation growing on the structure in recent years. Prior to the removal of vegetation from the wall, it was difficult to see the wall at all.

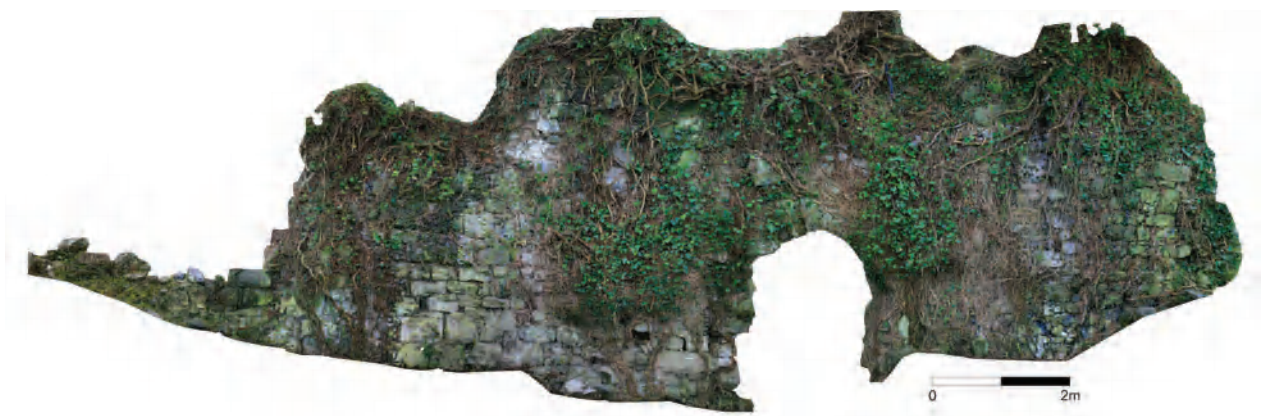
*Figure 8 - South wall interior (R Sherlock Archaeology)*

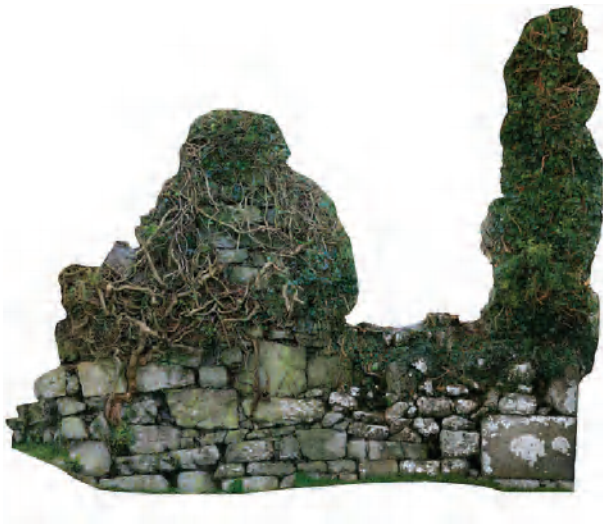
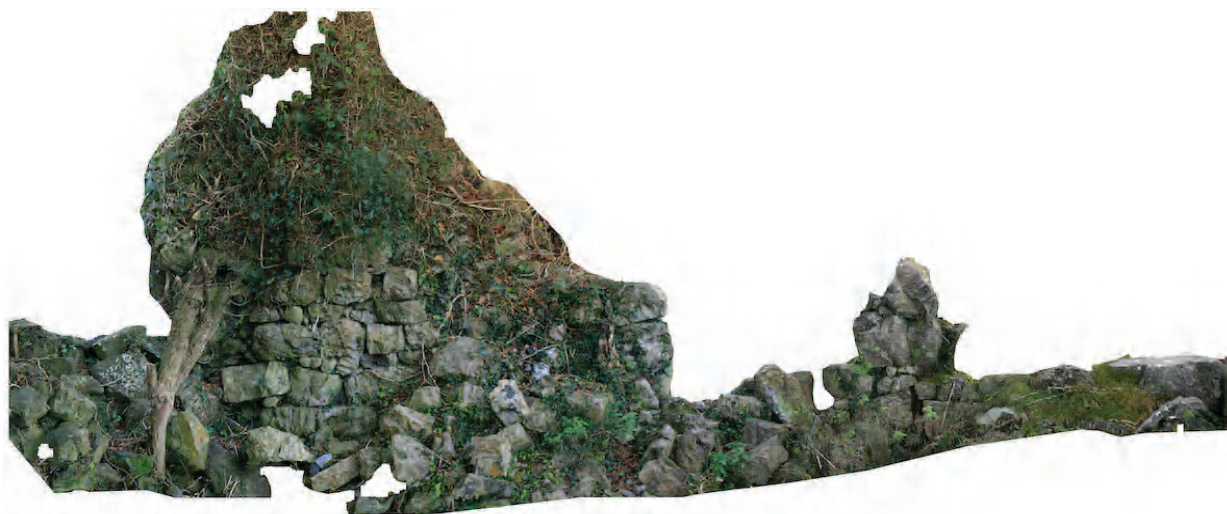
The west gable has suffered collapse, and stands at 500mm to 2.5m in height, and still retains its south-west corner, with includes one substantial quoin stone (figs 9&10). With the removal of more vegetation, it might be possible to see the lower south corner of a centrally placed window in this wall. The north end has completely collapsed, and evidence of the collapsed masonry is still visible on the ground around the structure.

Figure 9 - West wall exterior (R Sherlock Archaeology)

Figure 10 - West wall interior (R Sherlock Archaeology)

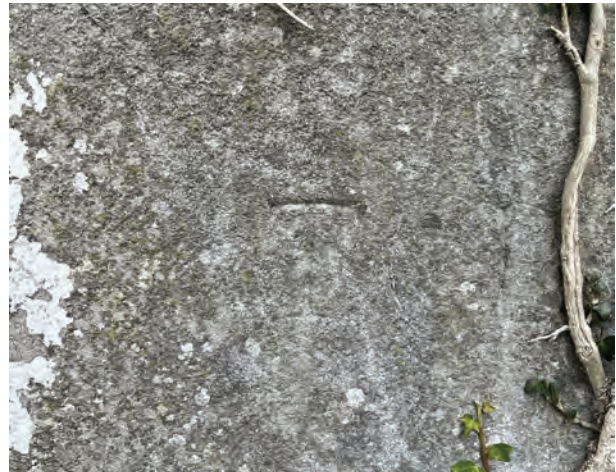
Figure 11 - Inscribed 'T' on a south wall quoin stone

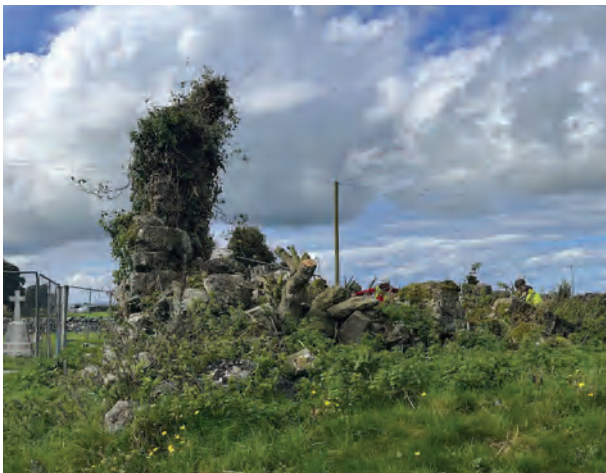
Little remains of the east gable, the walls survive as a collapsed insitu mound, to less than a metre in height (fig 13). As with the north wall the masonry for this wall is still visible on site, which at least gives some delineation to the chancel end of the church.

Figure 13 - View of the east gable, with the south wall visible on the left

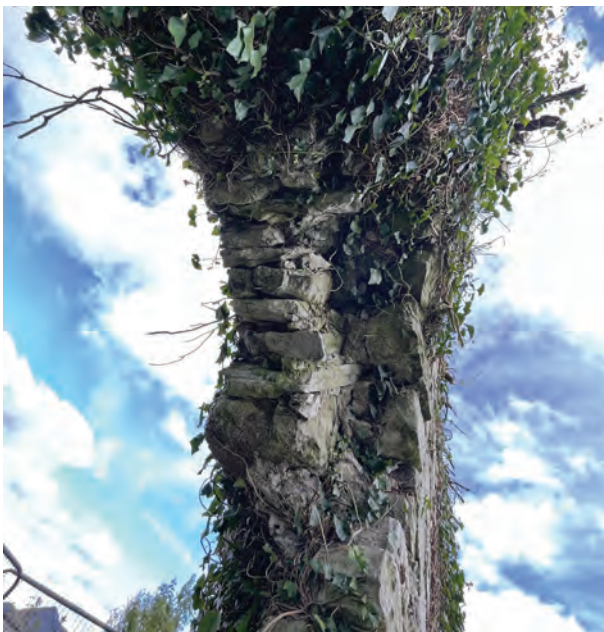
The arched entrance in the south wall is in very poor condition (fig 16). Missing the cut stones to both reveals, which has resulted in deep pockets of unstable masonry, it is also missing all of its outer voisseurs stones to the arch (figs 17). Although the inner face appears to retain its voisseurs, the joints have lost all mortar, and the arch needs to be repointed (fig 18).

Figure 18 - The underside of the arch

- Immediate support of the south wall to prevent collapse – propping as outlined in the proposals in Appendix A. Longer terms methods to take down the top portion of this wall and rebuild should be undertaken once propping is in place.
- Removal of vegetation to prevent ongoing damage to the ruined walls.
- Repairs to the arched entrance way with reinstatement of masonry to the entrance reveals and lost arch voisseurs overhead.

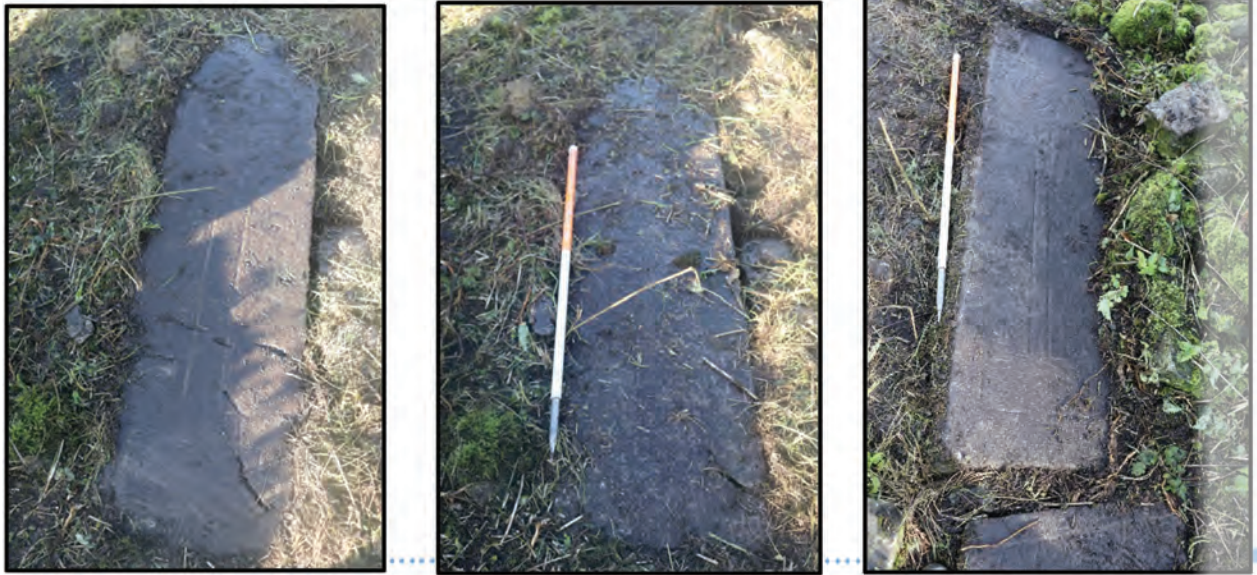
The above ground archaeological fabric is interesting and further architectural detail may come to light in the masonry, when the ivy and ground cover are fully removed, or which might be discovered amongst the fill material following cleaning and sorting of the loose rubble banked along the walls of the church. If non-invasive archaeological investigation or limited excavation reveals details of an early monastic settlement further north the significance of the site will rise accordingly. A number of graveslabs were uncovered within the main nave, one of which dates back to the early eighteenth century (fig 23).

Figure 23 - The graveslabs uncovered within the nave

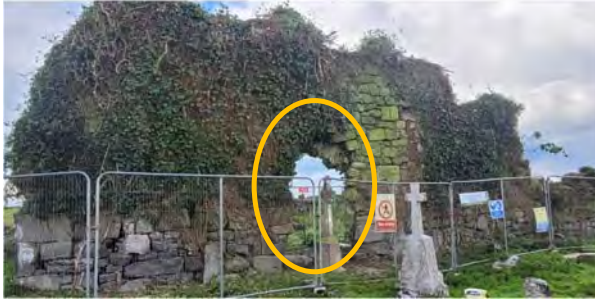
**South-Facing Wall**

The South Wall, with the arched doorway circled below, is the largest wall of the ruins and is quite imposing, being visible upon approaching the ruins from the main road. The wall measures approximately 800-900mm in width and ranges from 1-5m in height.

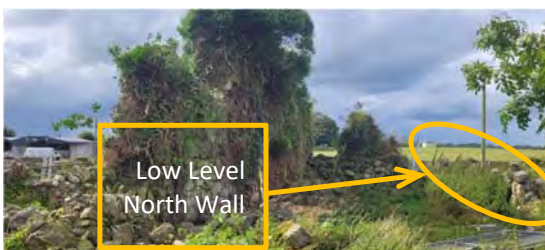
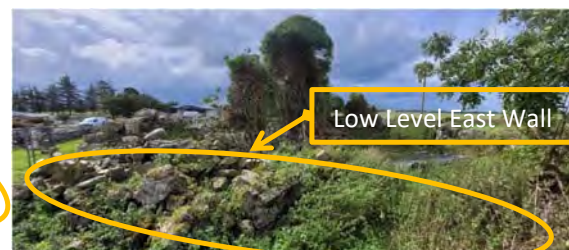
These walls are generally 800-900mm thick. They are significantly reduced in height, standing only 0.5m to 1.0m high. Although these walls are relatively low, typically only just above existing ground levels, they remain important, as they define the outline of the structure. The East Wall is currently surrounded by internal stone rubble, most likely from past partial South and East Wall collapses.

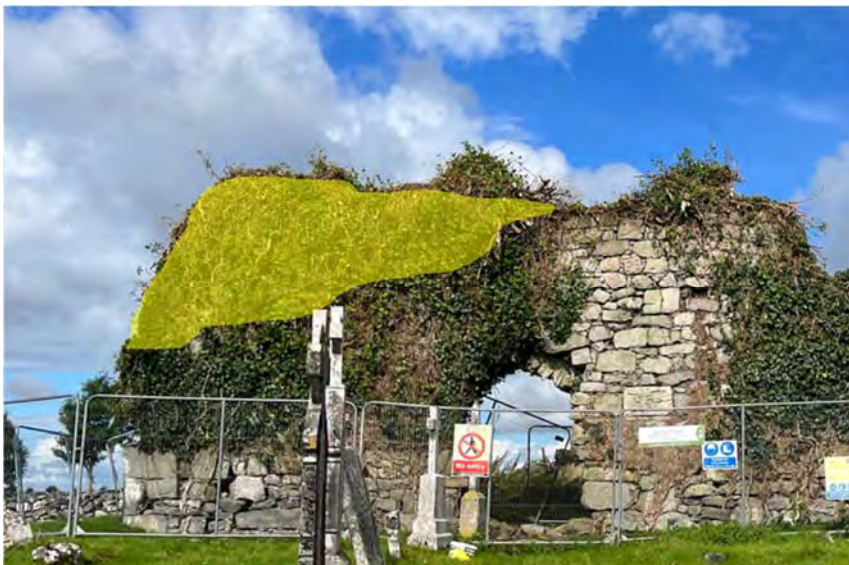
The leaning wall to the southwest should, in the interim, be propped to prevent collapsing of the structure under self-weight; separate correspondence regarding this has already been communicated. In order to remove the props, the wall will need to be partially taken down and rebuilt. The reduction will be dependent on the amount of lean and the height of the wall, so will vary along the length. From preliminary onsite measurement, the wall will need to be reduced to approximately 2m above existing ground level. The height to which the walls are rebuilt is subject to Archaeologist/Conservation Architect advice and the availability of salvaged stone. The image below highlights (in yellow) the estimated area of wall to be carefully taken down and rebuilt.

The arched entrance here is in danger of collapse if left to deteriorate. It is recommended that the door jambs are consolidated by rebuilding these with suitable reclaimed stones, filling the core also. Whilst, structurally speaking, these could be re-built with suitable facing stone, there may be a preference to have these built using commissioned cut stone, subject to budget constraints and Archaeologist/Conservation Architect advice. This work should be only carried out by a specialist stone mason. Along with rebuilding the jambs, the outer voussoir stones should also be rebuilt using suitably reclaimed stone.

As mentioned above, the whole of the wall should be re-pointed with an NHL lime mortar. Considering the budget limitations, this should be done on a phased basis, addressing the areas most at risk first. Where large voids are present due to loss of pinning stones, suitable reclaimed pinning stones should be inserted and pointed. The wall cap should be cleaned down, then rough raked using lime mortar and flat salvaged stone, with any loose stone re-bedded in-situ in such a manner as to positively disperse water.

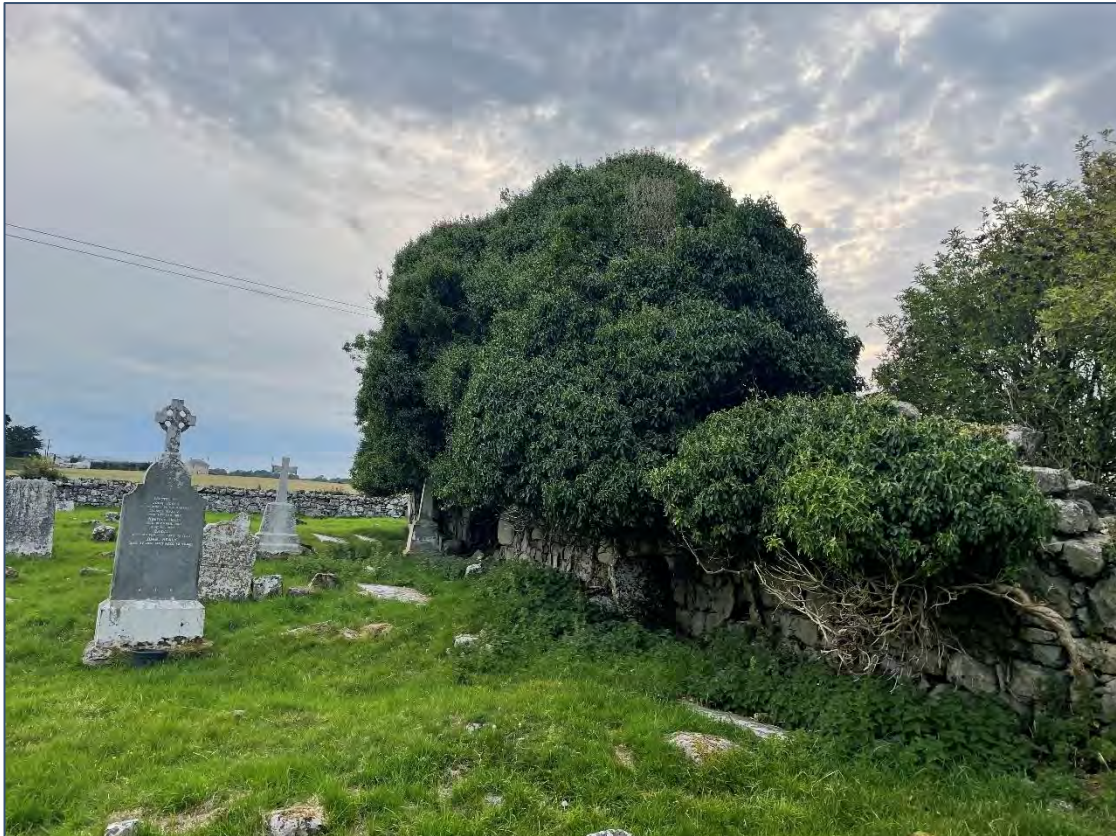
Plate 3.2. Ruined church and graveyard

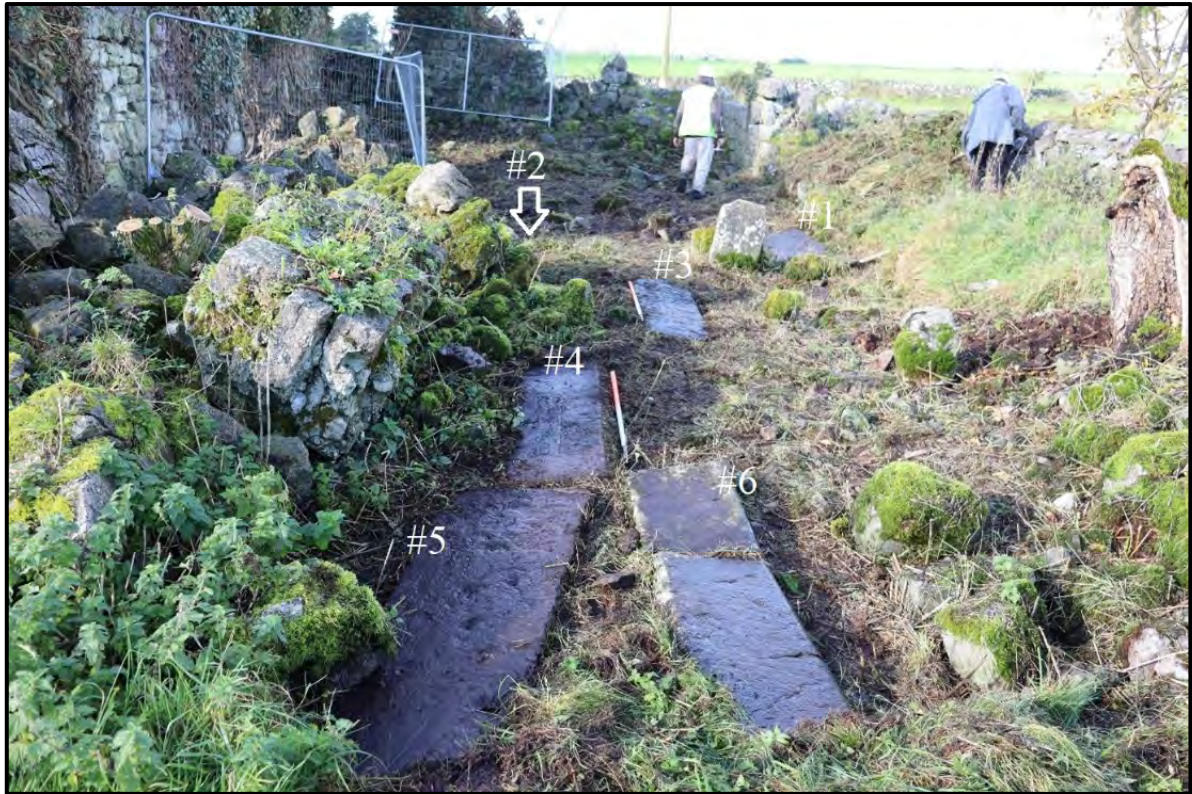
Six recumbent grave-slabs were uncovered, these are numbered 1 to 6 for ease of reference. Their locations are outlined in **Error! Reference source not found..**

*Plate 4: Location of slabs within the church interior, numbered #1 to #6*

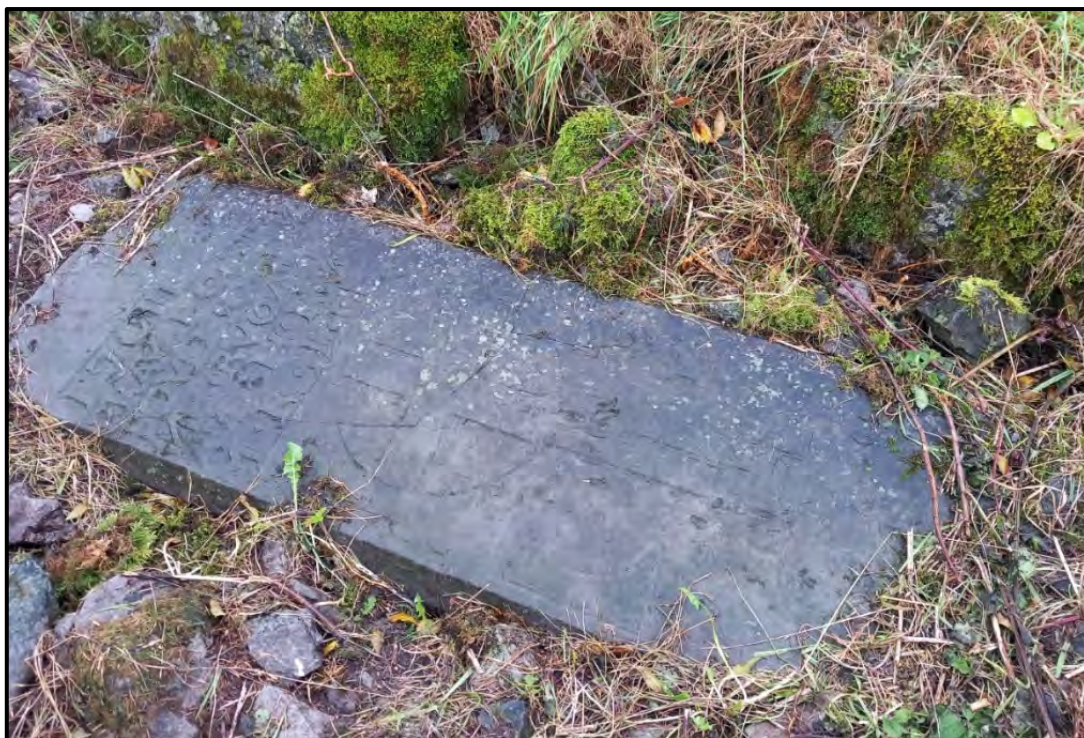
**Slab #1** is a cross-incised stone located adjacent to, and parallel with, the interior of the northern wall. Writing on the top (eastern extent of the slab) depicts the following:

The arms of the crucifix are encircled. The base of the shaft of the cross is on a stepped pedestal. A carving of an anvil is located under the southern arm of the cross, suggesting a blacksmith is laid to rest here. The edge of the slab is chamfered and the whole slab is sloping from north to south, measuring c.1.2m in maximum length. The wording was recorded by O'Keeffe 1838.

*Plate 5: Looking northwest showing Slab #1 recently uncovered adjacent to north wall (previously recorded by O'Keefe, 1838)*

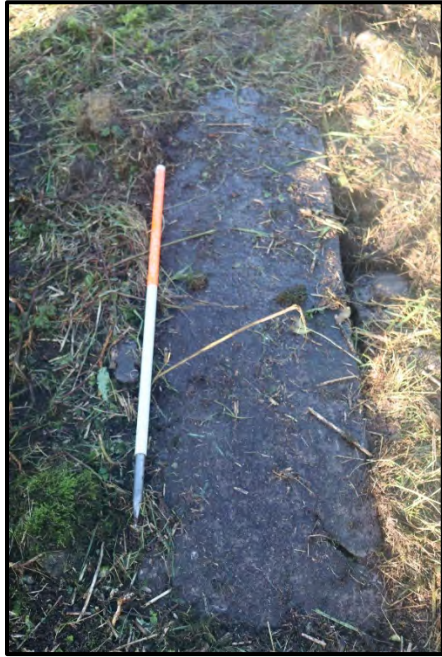
**Slab #2** is located c.4m from the door, lying in an east west orientation, with a simple crucifix, not fully exposed. Measures 1.56m in (exposed) length.

*Plate 8 Looking west showing Slab #2*

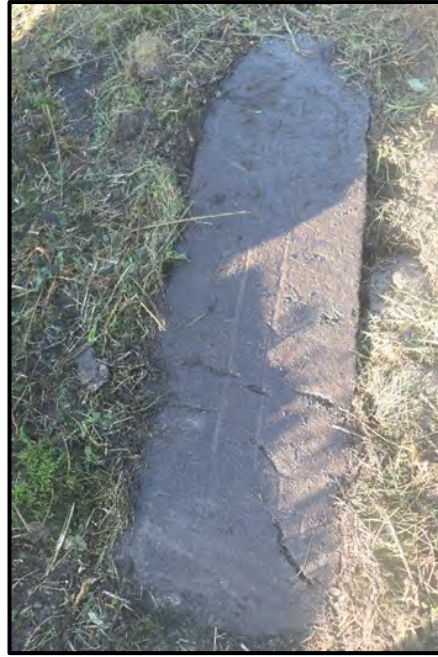
**Slab #3** measures 1.92m in length and c.0.5m wide, lying in E/W orientation. A crucifix is incised, arms of which within a circle. The shaft of the cross continues down to the eastern end to a stepped pedestal. Located in the middle of the church.

*Plate 9 Looking west showing Slab #3*

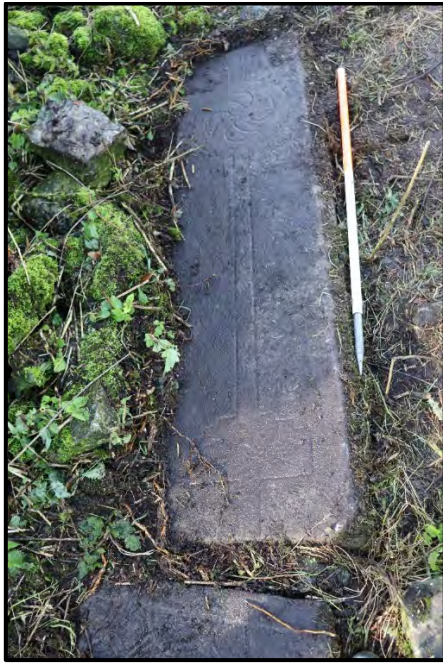
**Slab #4** c.1.75m length, 0.48m wide. The arms of a crucifix visible outside the circular curvilinear design. The shaft continues to a stepped pedestal then continues beneath the pedestal to the end of the stone, creating a cross effect.

*Plate 10 Looking west showing Slab #4*

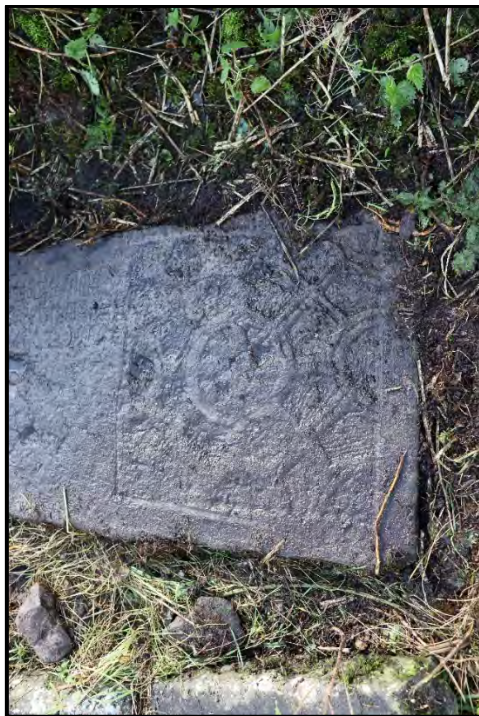
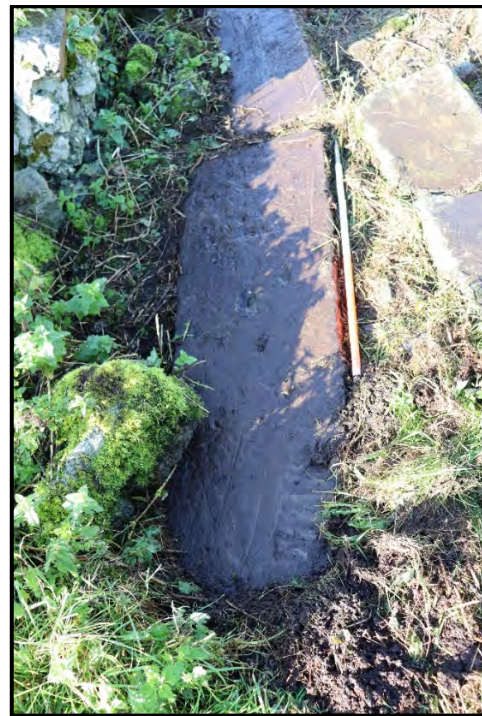
**Slab #5** Recumbent slab with geometric design within an outlined square at the western extent/ head of the slab. Writing along the length of the southern extent, not legible. What looks like a plough and spade at the base indicating a tiller/farmer. The slab appears slightly splayed. Located directly east of Slab #4.

*Plates 12 & 13 Detail on Slab #5 – geometric design and spade and plough? (Triangle) detail at eastern extent*

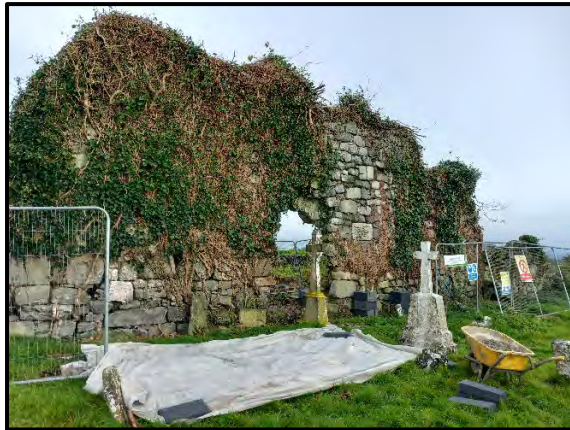
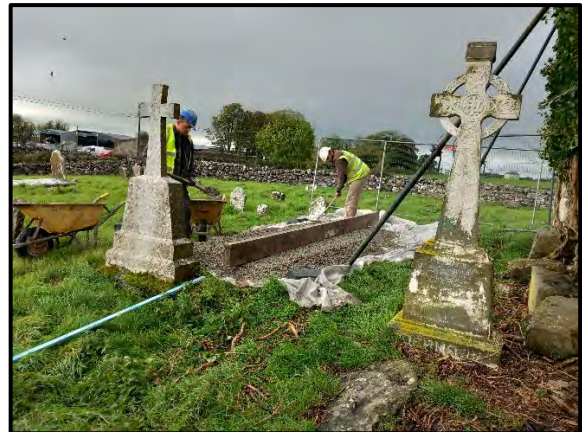
Propping of the south wall was carried out under archaeological supervision. It was an overcast and windy day. A protective layer of terrem was laid on the ground and stone was brought in using a wheelbarrow. A platform for cement blocks was created. The stone was compacted by hand, using a plank to ensure level surface. Note that a whacker was not used for fear of vibrations disturbing ground beneath. Cement blocks were carried by hand and placed on top of the platform. Scaffold was

*Plate 17 Looking north east showing terram on surface to protect ground beneath stone base. Plate 18 Stone on terram.*

then propped against the blocks. S (12) Notification to NMS was updated to include the insertion of steel pins to stop any slippage of scaffolding. Steel pins were inserted at appropriate locations within voids on the wall. These shall be easily removed when required. The site was fenced off. Further signage shall be erected by Galway County Council in the coming days to ensure the public are aware of the unsafe nature of the site.

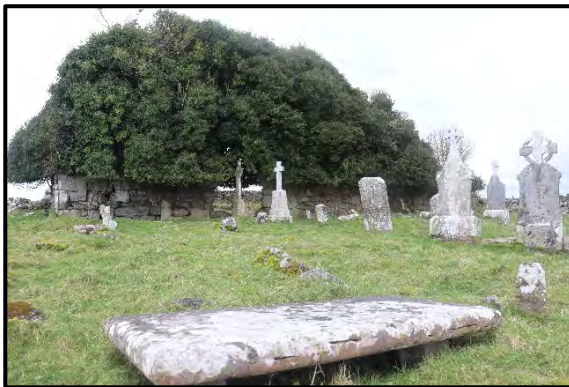
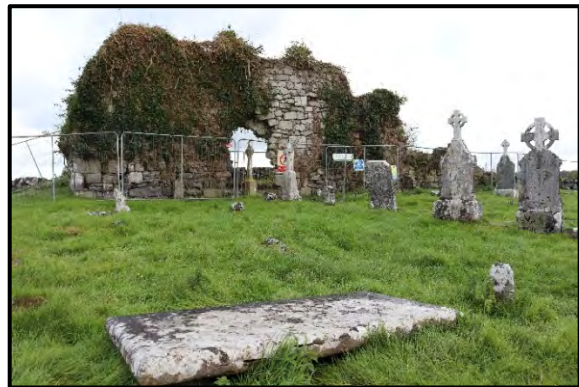
*Plates 20 & 21 Looking North west showing church before and after ivy trimming .*

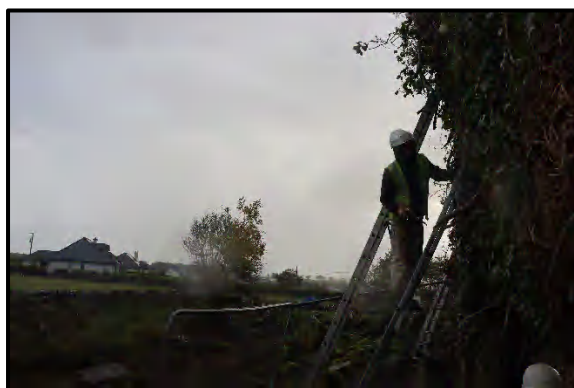
*Plate 22 Insertion of Eco-plugs by Mathieu & Mitchell.*

A second phase of archaeological monitoring of site clearance was then carried out by Bernie Doherty over three days. Eco-plugs (filled with biocide) were inserted into the roots of ivy which are still intact within the joints of the walls of the church (Plate). Holes were drilled into the root system at various intervals (Plate). The eco-plugs were then inserted, which will allow a slow release of the biocide into the roots. This should prevent regrowth of ivy while maintaining the structure in its current state.

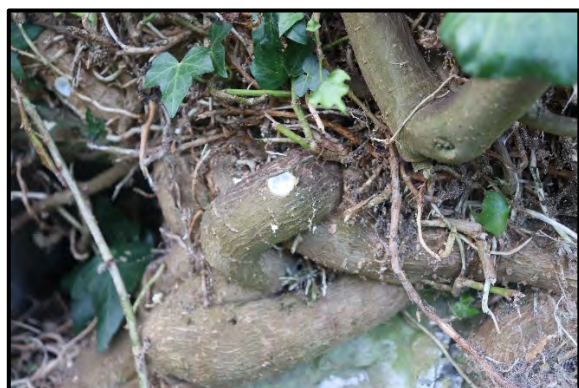
*Plate 23 Example of eco-plug within ivy root stem*

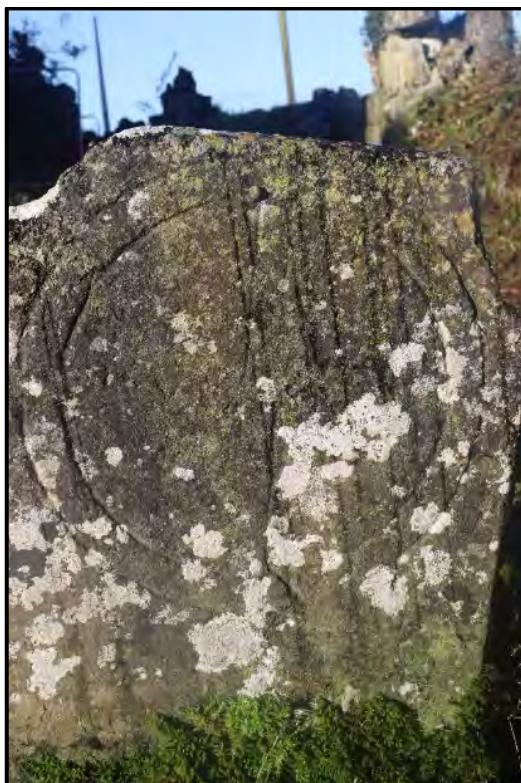
*Plate 24 An upright incised stone is located within the church to the south east of slab #1. A double circle is obvious, and possible incision of a vertical shaft of cross, but arms not obvious.*

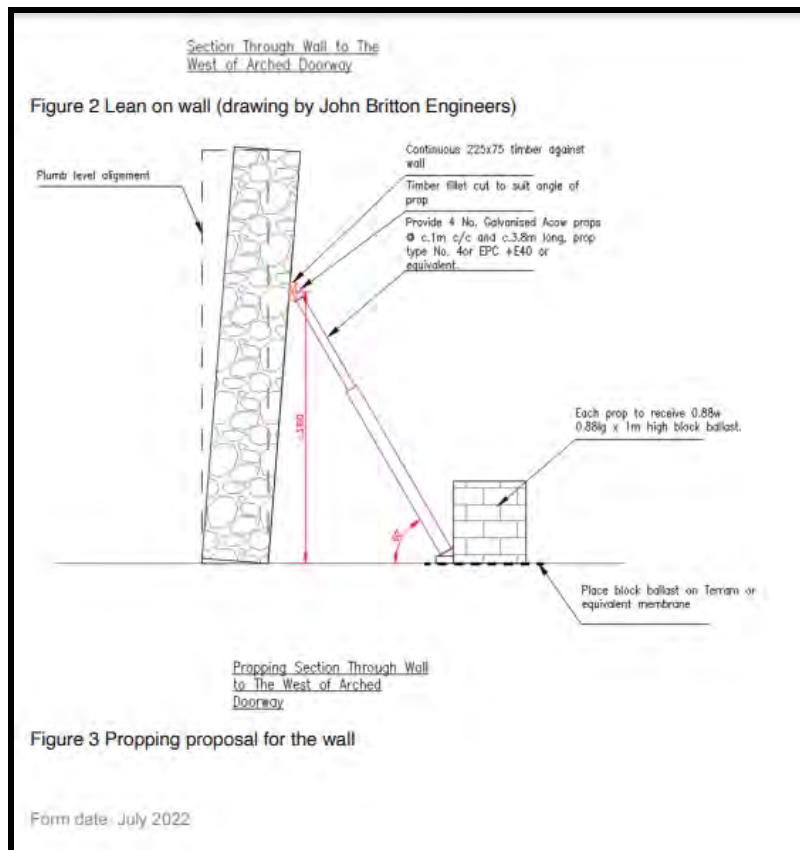
#### 4 Report Extract John Britton Engineer (Conditional Survey)

Extract from S(12) Notification showing the proposal to prop the wall as prepared by Howley Hayes Cooney Architects and John Britton Engineers

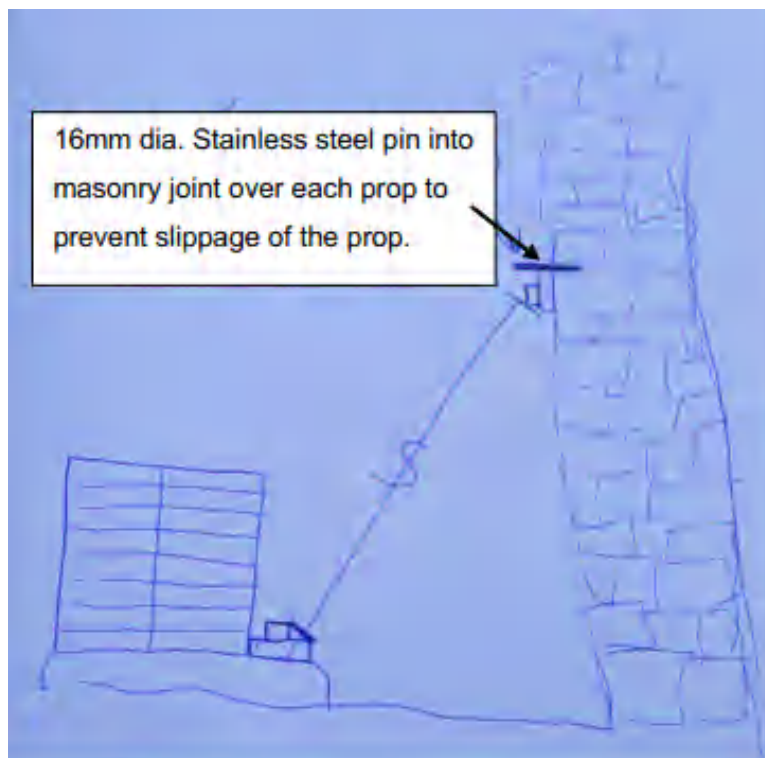
Figure 6 Sketch showing the requirement for insertion of steel pin into masonry joint as updated to NMS October 2022

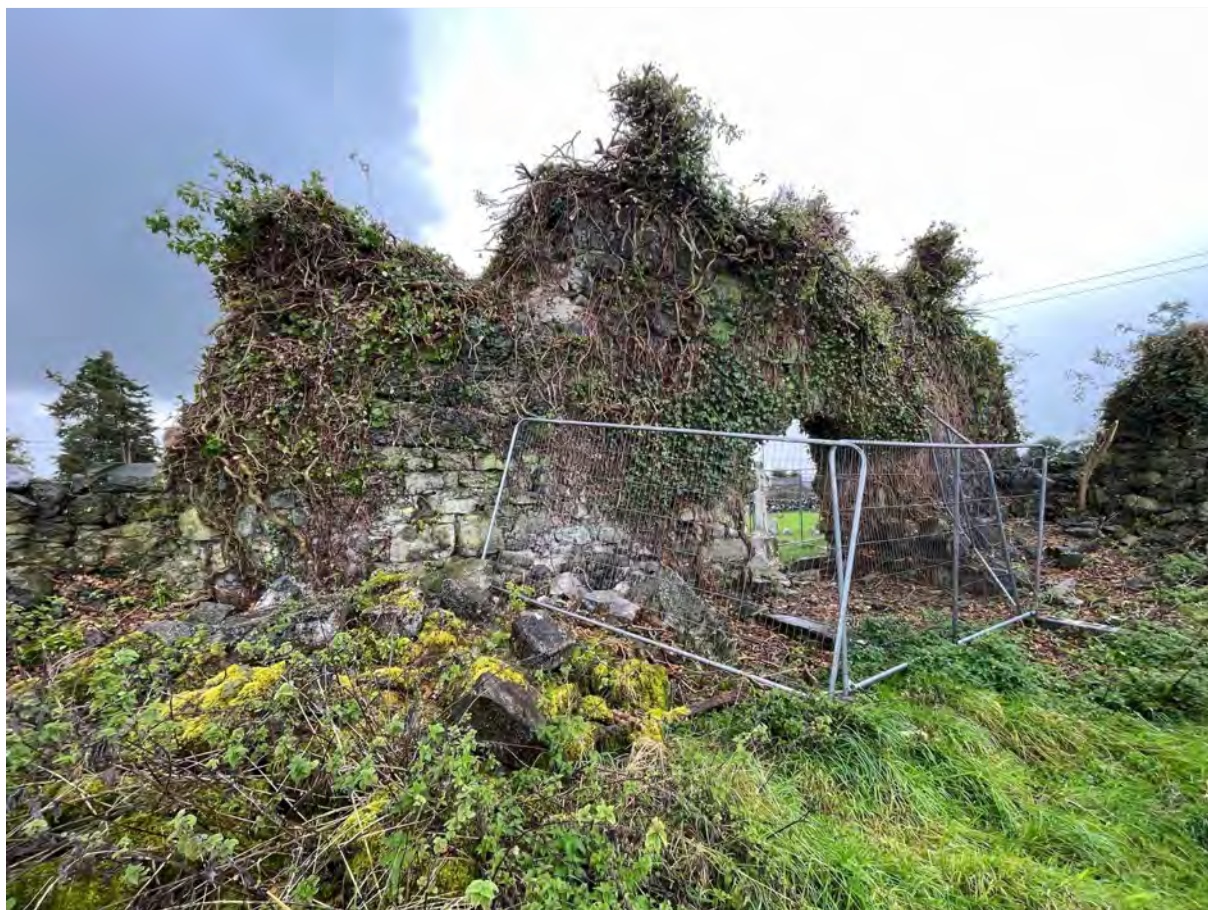
Figure 2 View of the wall post vegetation removal

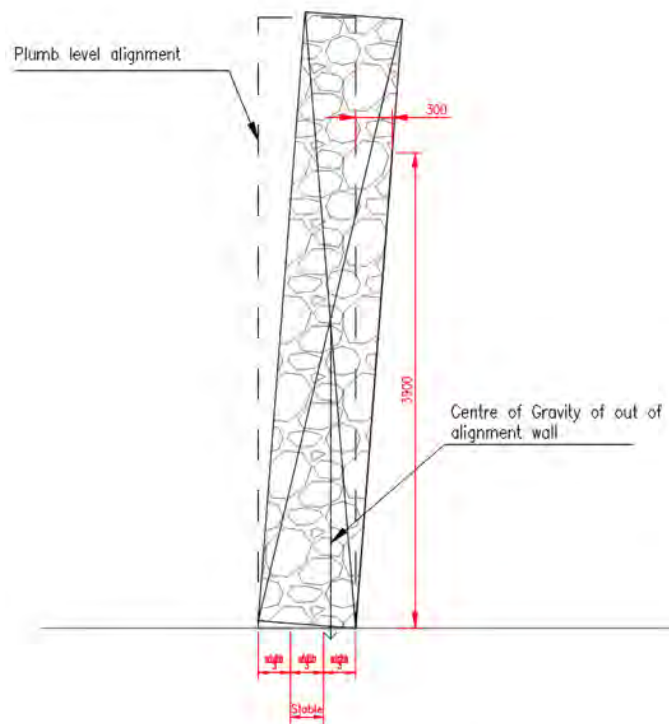
A significant lean to the southwest corner of the south facing wall was observed and using a spirit level, this was measured to be approximately 300mm out of alignment over 3.9m in height. For stone walls to remain stable under self-weight, the centre of gravity should lie within the middle third of the base of the wall. Based on measurements taken onsite, it would appear that the centre of gravity for this wall is outside the middle third, as shown in Appendix A, and is in imminent danger of collapse. A section of the wall to the west of the arched doorway should be propped until such a time that conservation work can be carried out on the structure. Galvanised props should be installed to prevent the wall from moving further out of alignment. Since the site is a graveyard, excavation for prop foundations cannot occur and in order to resist the horizontal thrust from the props, ballast can be provided by stacking blocks at the base of the prop. This method is flexible in that props can be positioned in and around existing graves. The props will need temporary fixings at the top of each prop, in the form of stainless steel rods, which will be fixed into the masonry joints (Figure 5). The rods will be 16mm diameter and will fit within the masonry joints. These rods will be removed, along with the propping, at a later date to facilitate full repair / rebuild of the wall as required.

Section Through Wall to The  
West of Arched Doorway

Figure 2 Lean on wall (drawing by John Britton Engineers)

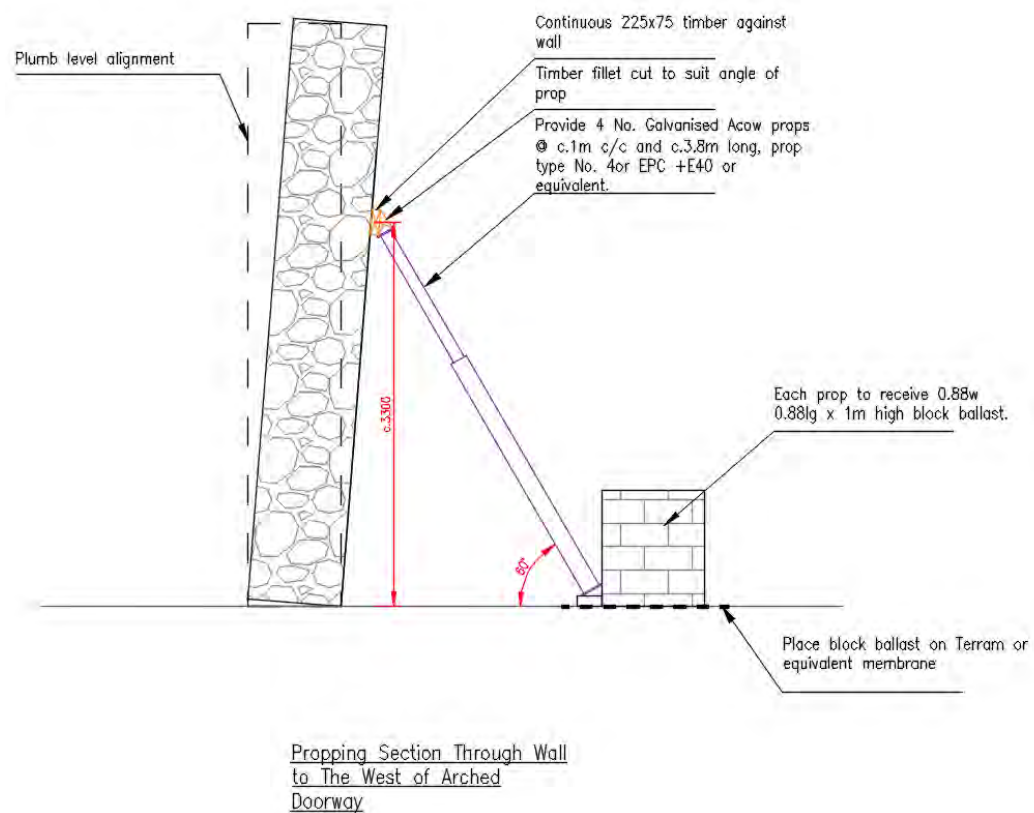
Figure 3 Propping proposal for the wall

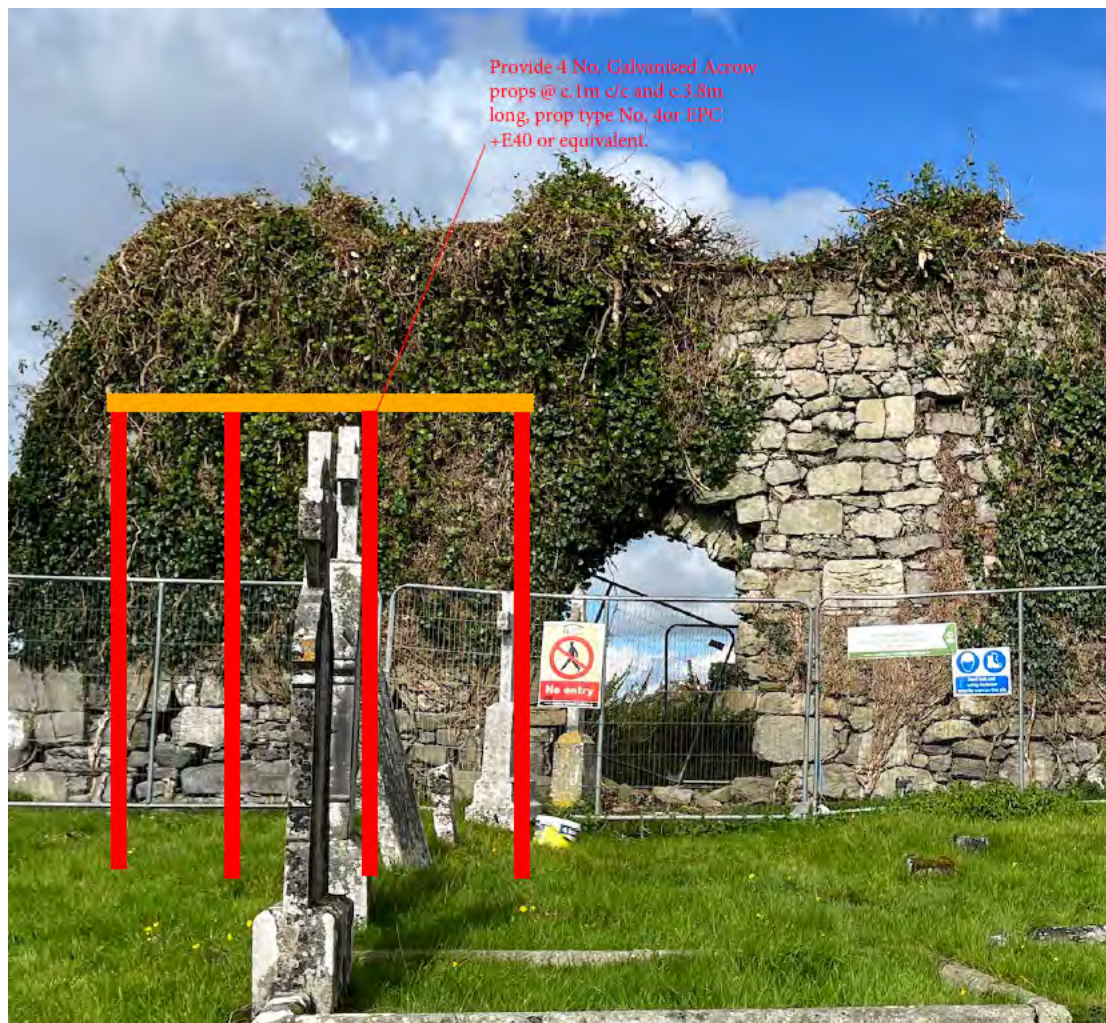
Figure 4 Location of propping

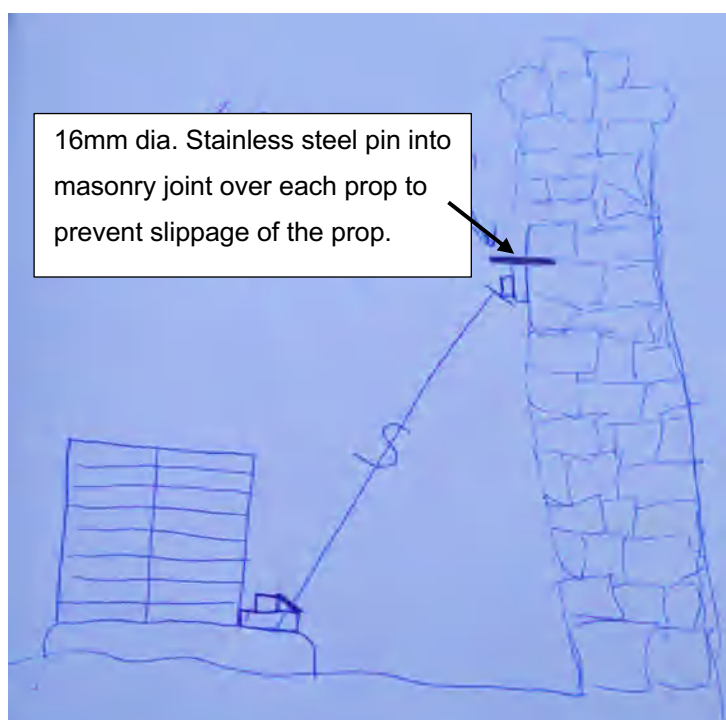
Fig 5 – sketch from contractor showing the insertion of a stainless steel pin
