# Issertkelly Church and Graveyard

Conservation Management Plan (CMF22-2-GA001)

November 2022

This conservation management plan was commissioned by Galway County Council to assess the current condition and make recommendations for any necessary repairs to the ruin of the Church of Iisert Kelly, also known as Iisertkelly, near Loughrea, Co Galway. It is grant funded by the Community Monuments Fund, from the Department of Housing, Local Government and Heritage. It has been prepared by Howley Hayes Cooney Architecture in association with Rory Sherlock Archaeology; Bernie O'Doherty Archaeologist, John Britton Engineering; and MKO ecology. The surveys and enabling works on which this report is based were carried out in August and September of 2022.

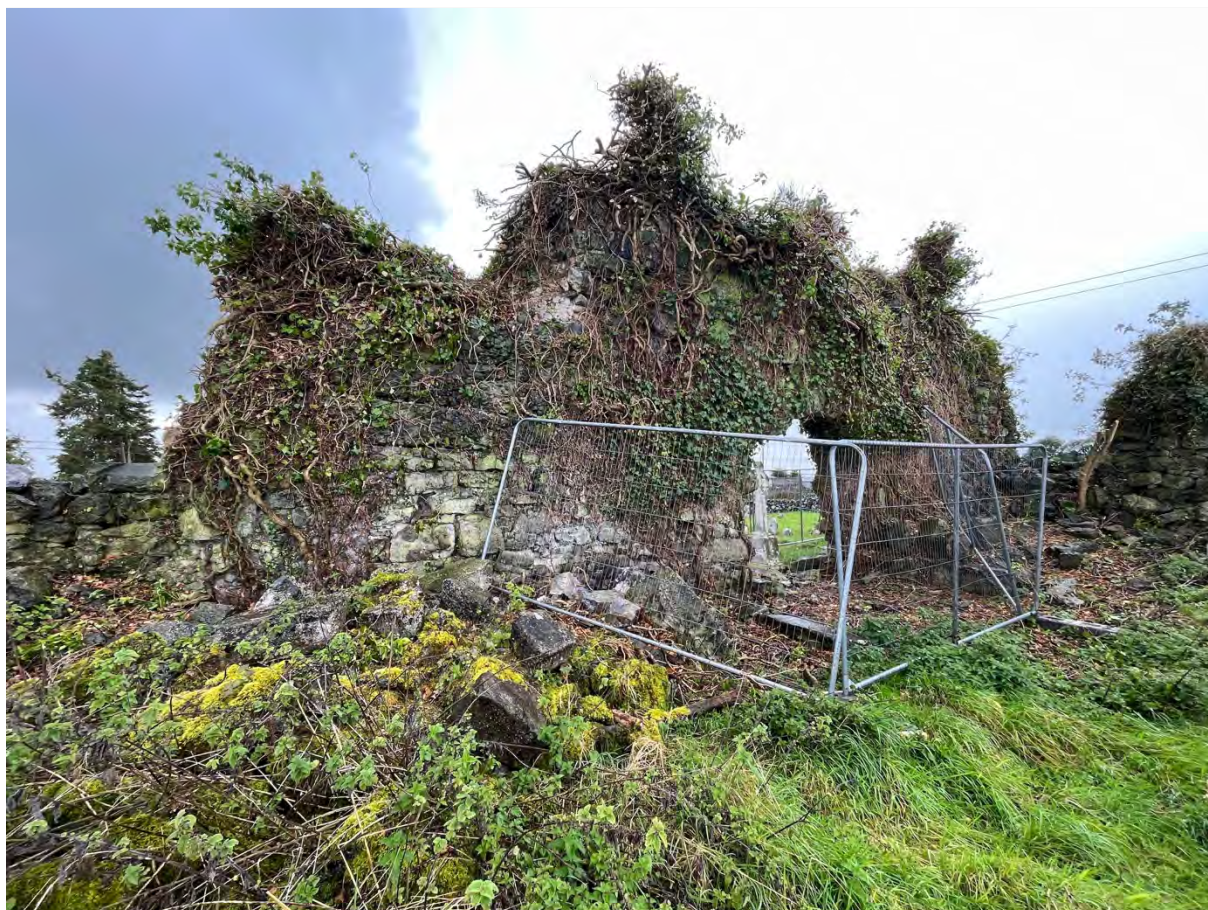
Figure 2 View of the wall post vegetation removal

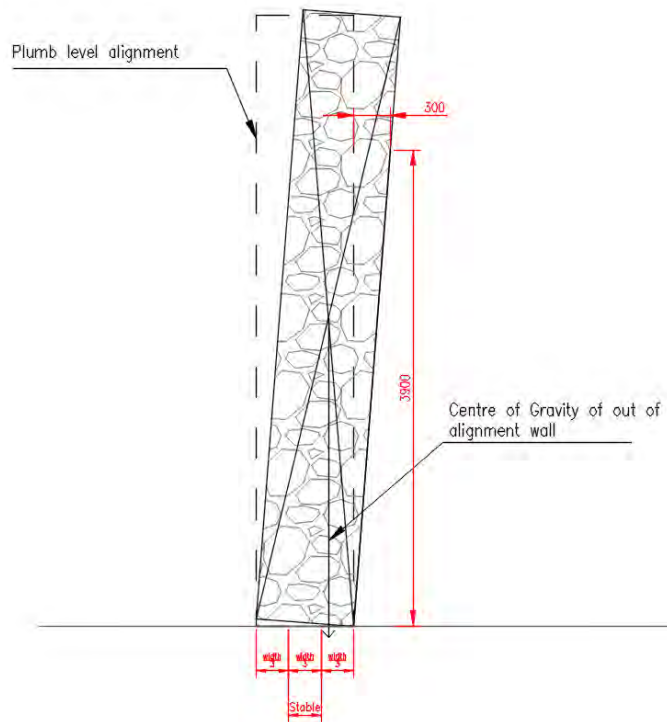
Section Through Wall to The West of Arched Doorway

Figure 2 Lean on wall (drawing by John Britton Engineers)

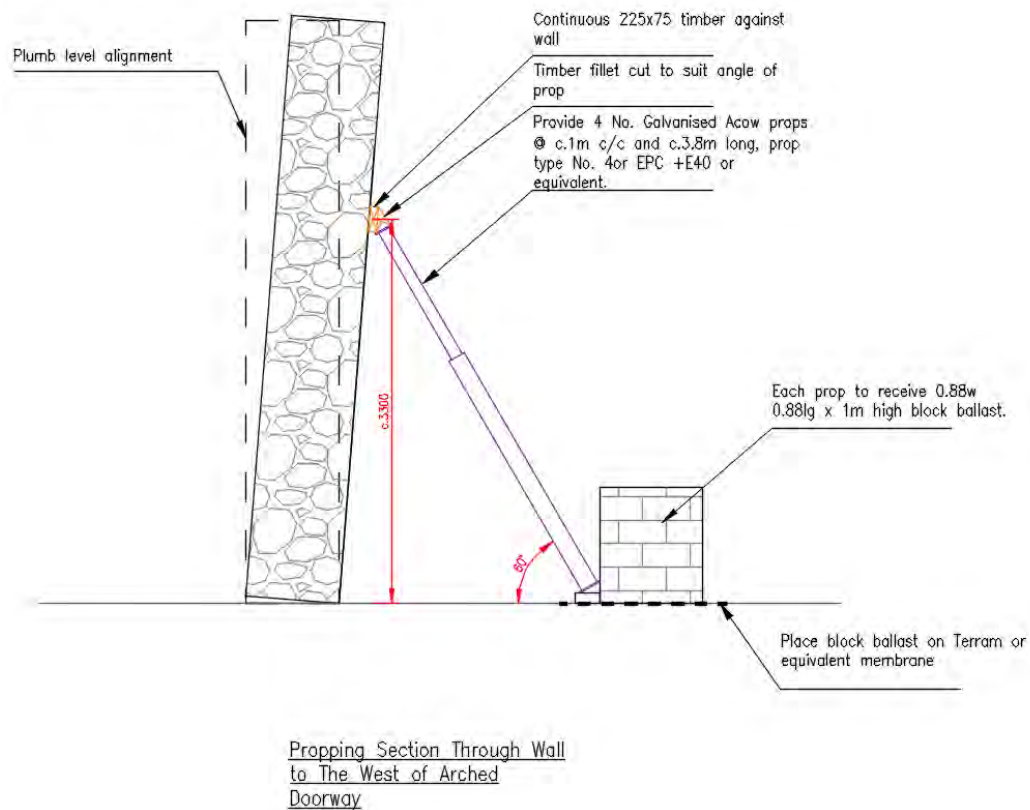
Figure 3 Propping proposal for the wall
