ÆGIS Ref.: 825-1

Conservation Management Plan for Moylough Castle, Moylough townland, Co. Galway.

Report Status: Final

Date: 15 November 2024

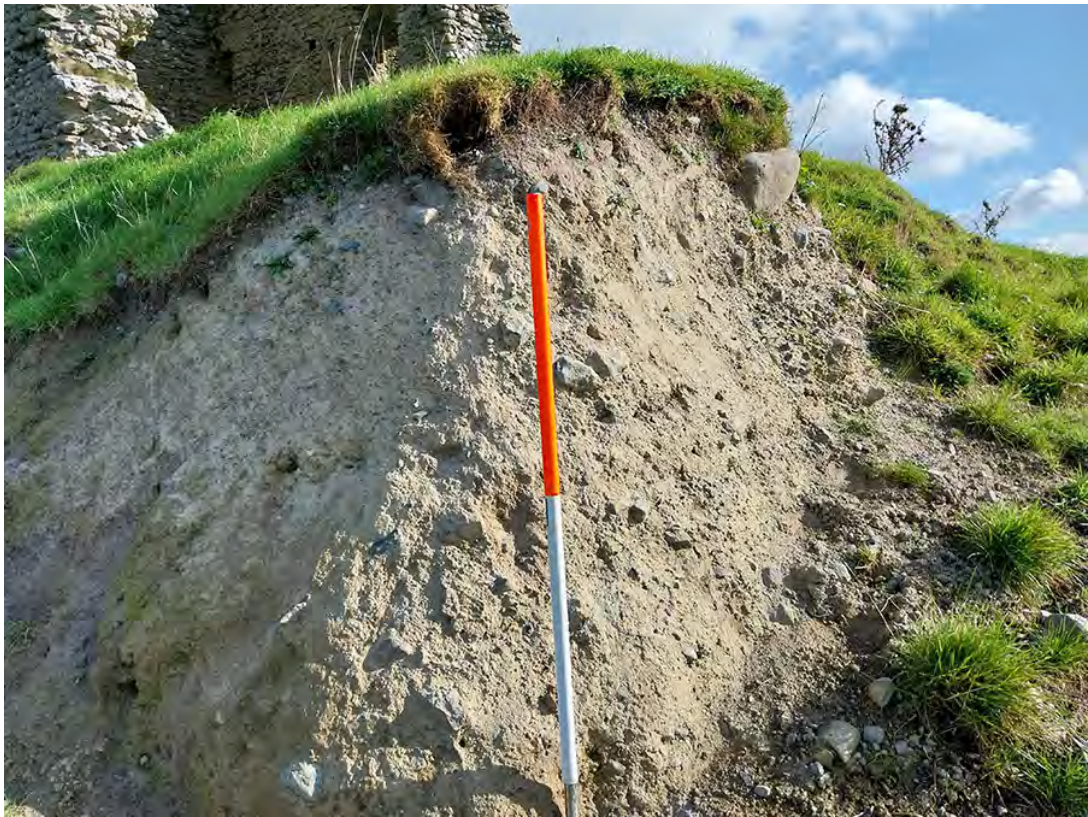
Figure 2.27. Boulder clay in eroded part of knoll, from W (F. Coyne).

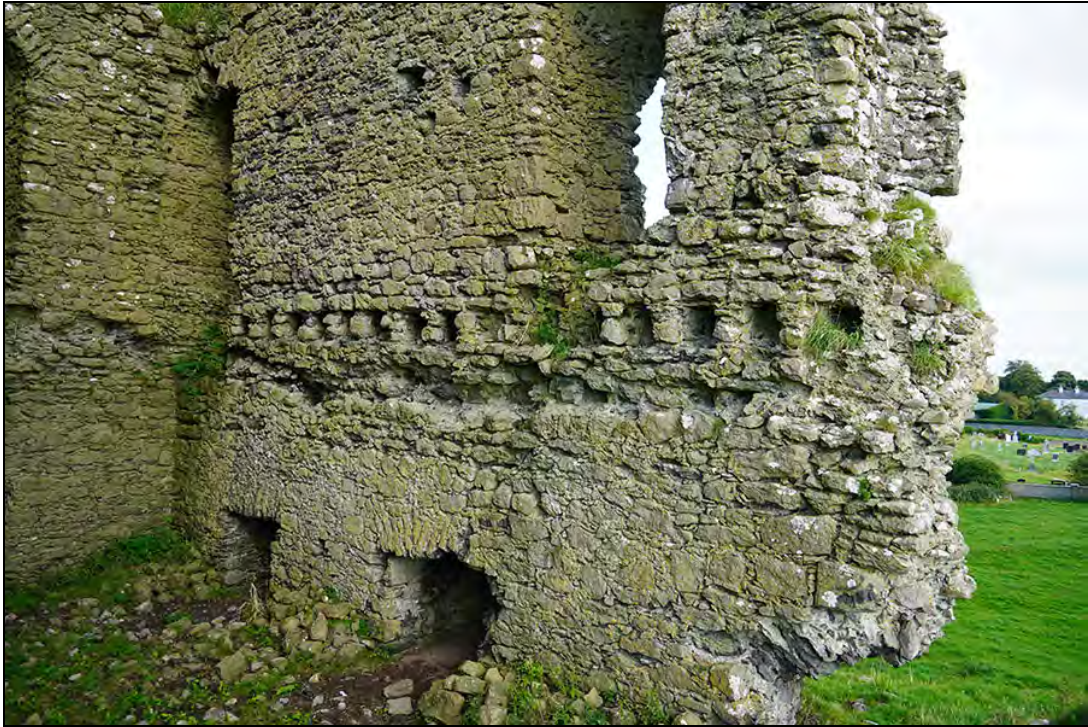
On first glance, the castle appears to have only a single phase of use. However, a scar which stretches around the three remaining walls may suggest a collapsed vault, which replaced the earlier timber floor. It is possible that the timbers which spanned the castle rotted where they were inserted into the wall. Later building utilized a series of corbel, on which rested oak beams.

Figure 2.35. Scar in masonry and beam sockets, from W (F. Coyne).

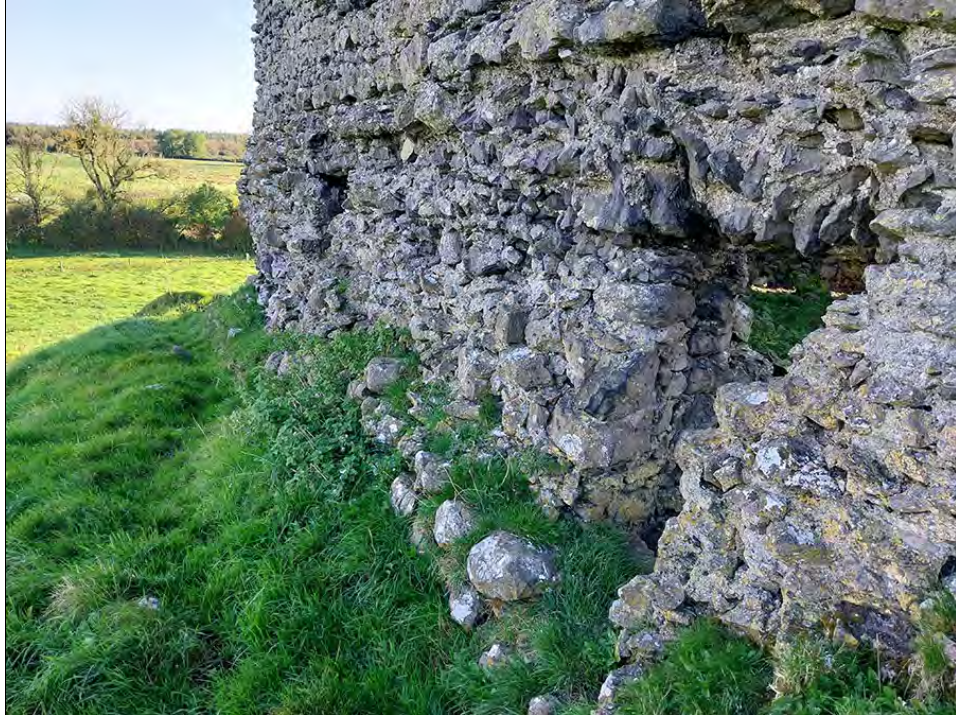
The castle originally had a base batter which projected approximately 0.4m beyond the vertical wall. It was built up from large rectangular basal stones. This has been robbed out from all the walls except for part of the SE wall.

Figure 2.39. Robbed out base batter on NW wall (F. Coyne).

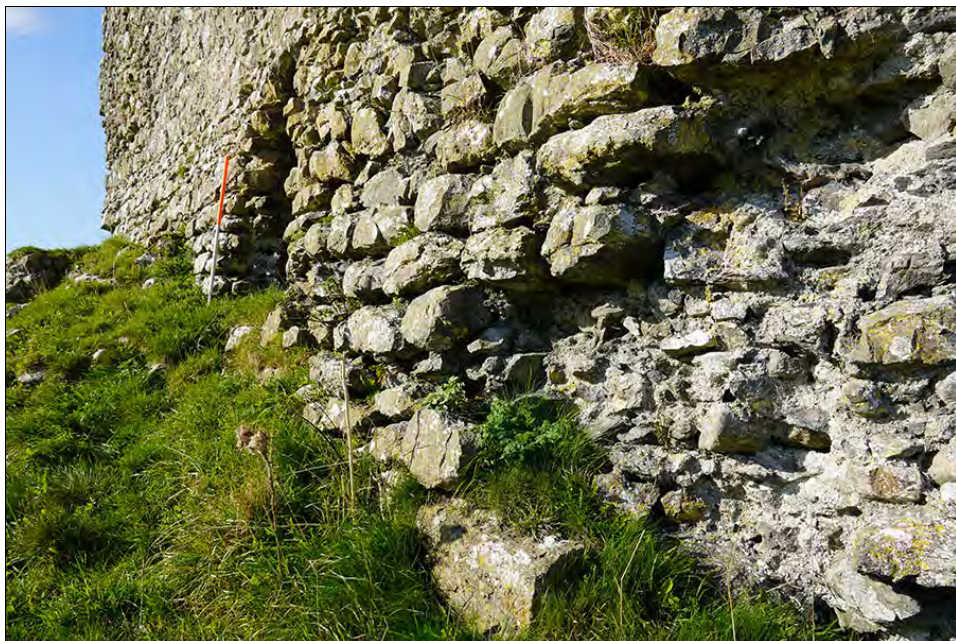
Figure 2.40. Robbed out base batter on NE wall. Note intact batter to rear (F. Coyne).

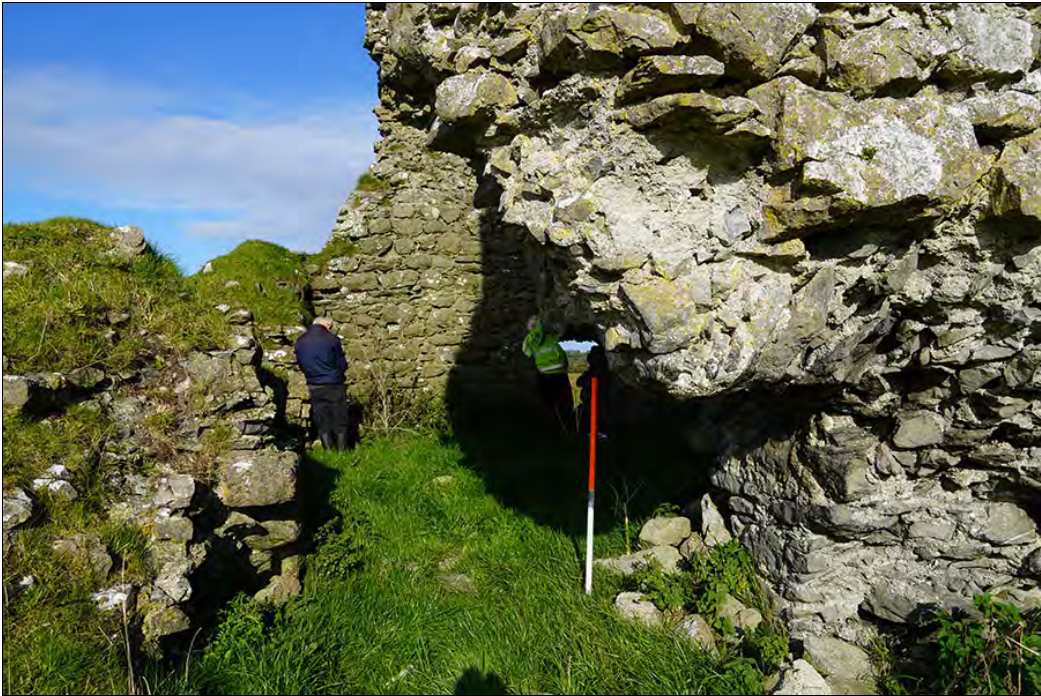
Figure 2.43. Window 1, partially collapsed, from SE. Only the N side of the embrasure survives. (F. Coyne).

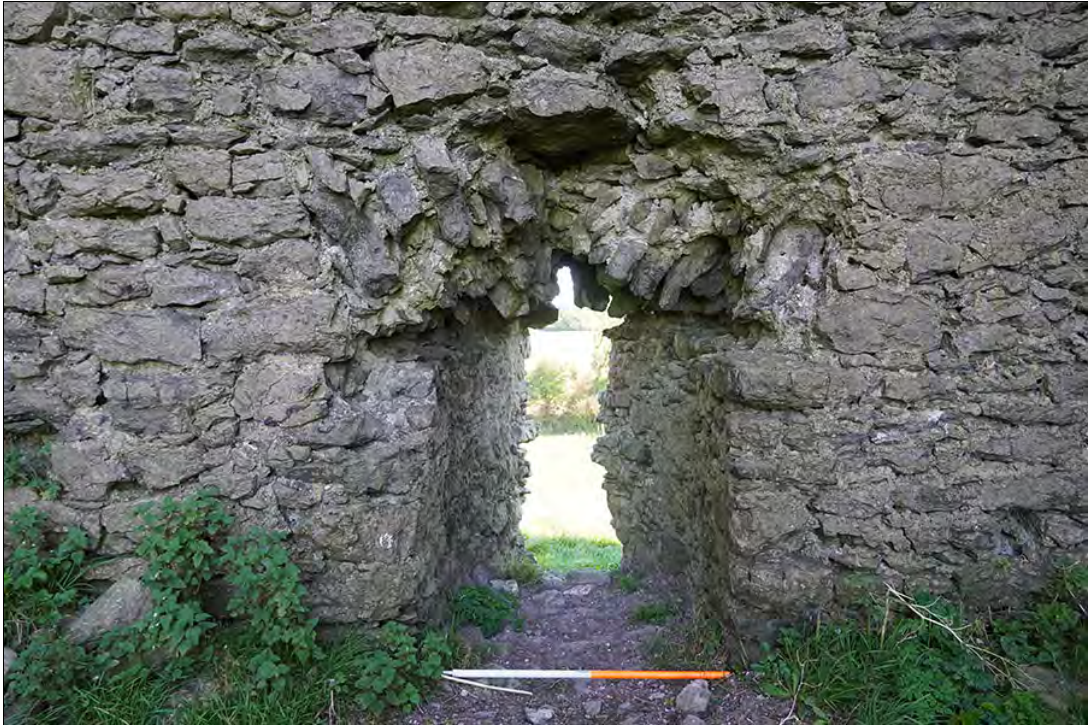
Figure 2.47. Window 4, note slot for timber lintel and robbed out flat arch, from SW (F. Coyne).

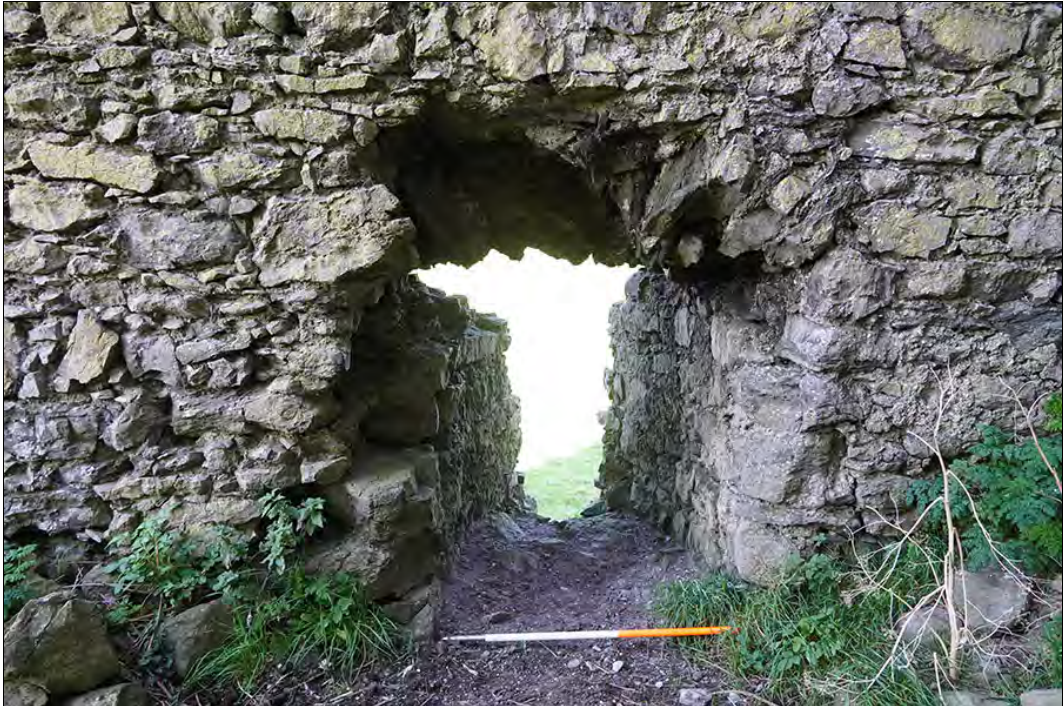
Figure 2.48. Window 5, note slot for timber lintel and robbed out flat arch, from NW (F. Coyne).

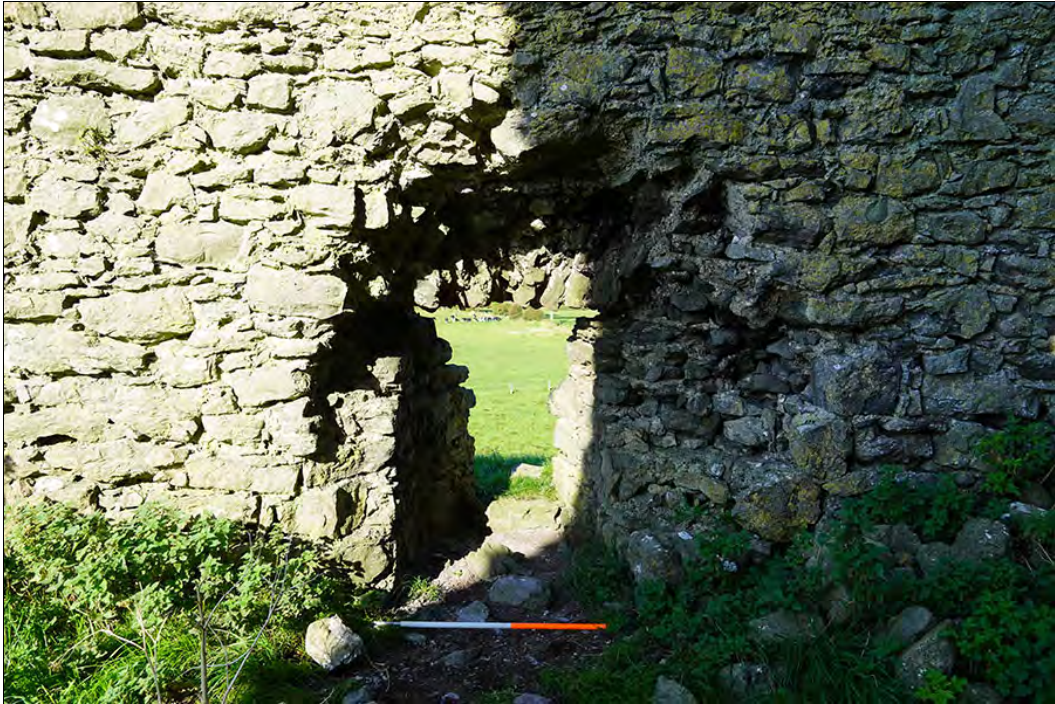
Figure 2.49. Window 6, note robbed out flat arch and jambs, from SW (F. Coyne).

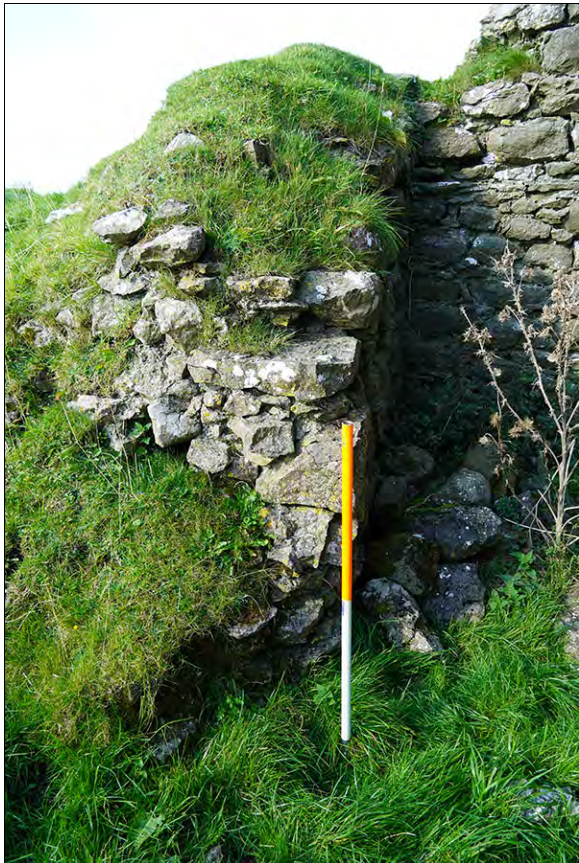
Figure 2.50. Window 7, only portion of the embrasure is visible, from SE (F. Coyne).

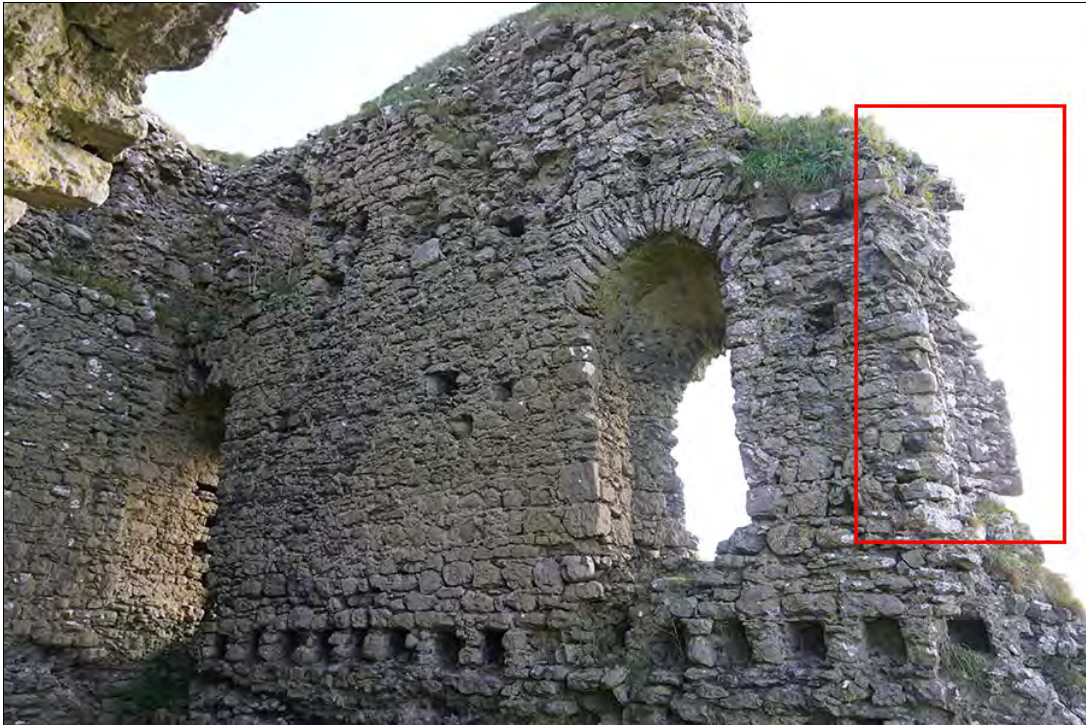
Figure 2.53. Window 1.1, only left side of embrasure remaining, from NW (F. Coyne).

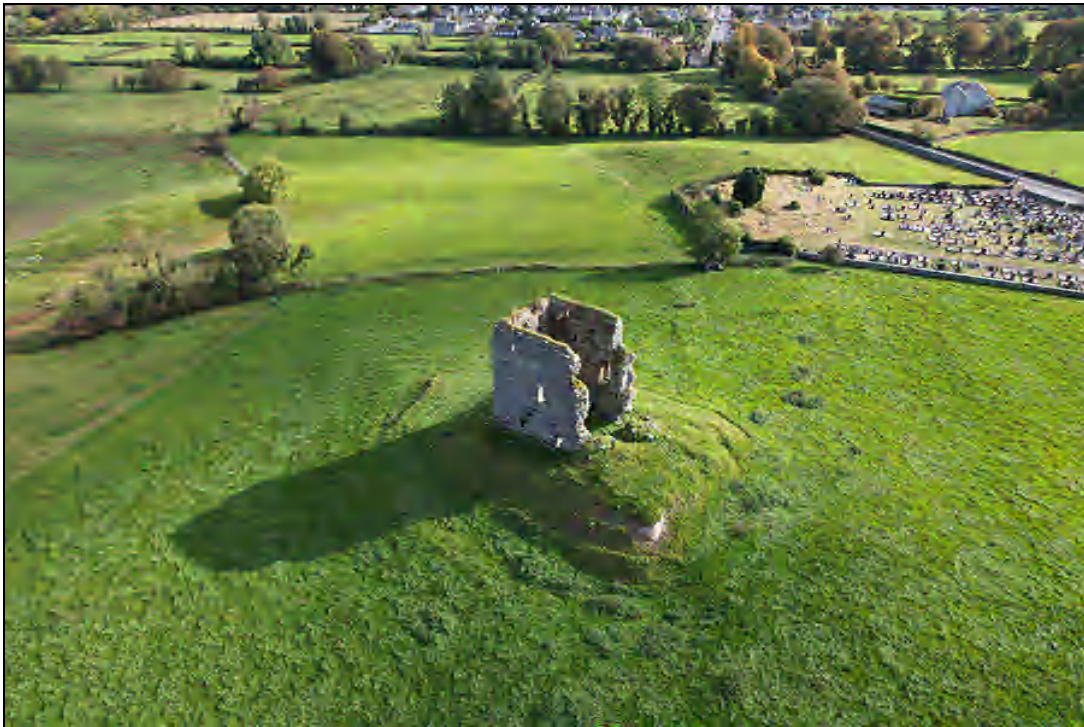
A series of earthworks are visible on aerial photographs, and also on drone images to the eastern side of the castle. These are also visible at ground level in places. They are constructed of compact earth and gravel.

Figure 2.71. Castle with visible earthworks to right, from W (F. Coyne).

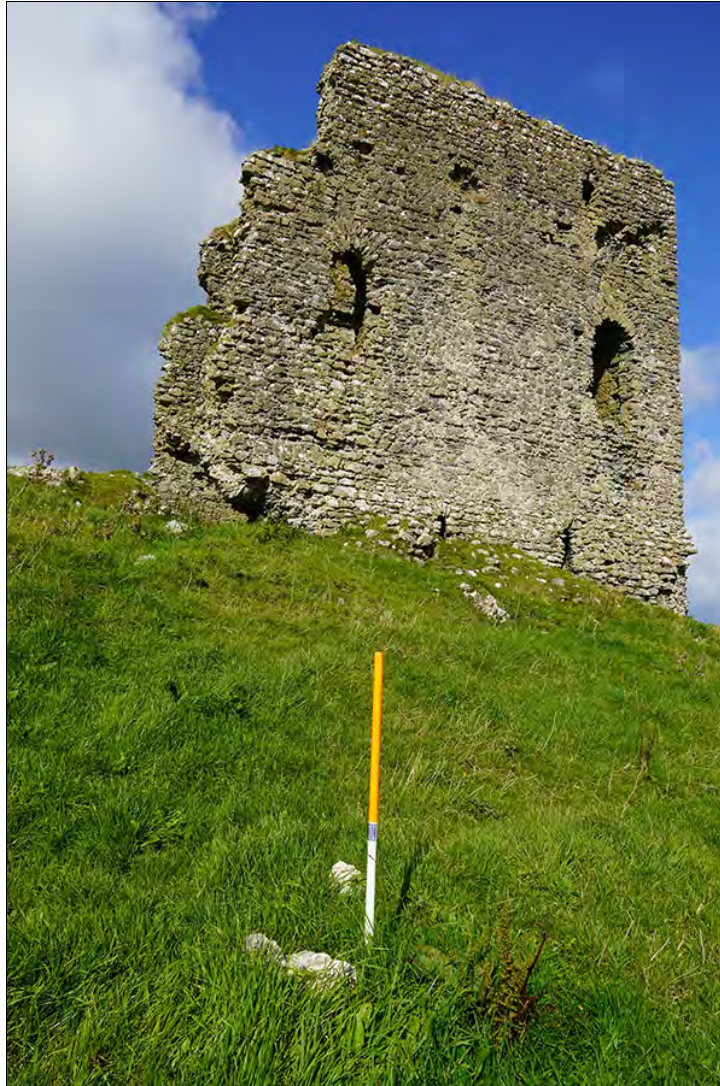
Figure 2.73. Castle with fallen masonry in immediate foreground, from S (F. Coyne).

The site is on private land. However, a sign should be erected to warn of the danger of possible falling masonry.

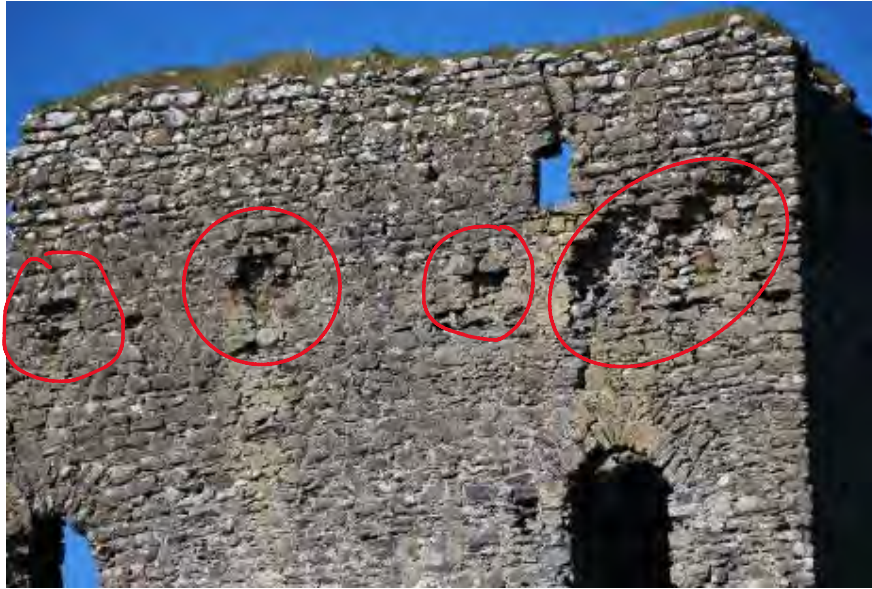
Photo No. 3 (0170)

2. There are no signs of separation at the two corners externally.
3. The three walls are substantially vertical with no very evident leaning, tilting or bulging.
4. Generally small individual isolated stone areas on the wall faces internally and externally have fallen out especially at high levels. These areas would not have been robbed. These areas would have fallen out due to bad binding with mortar or lack of mortar or lack of tying-in on through stones. These are like an outer leaf or skin or leaf of stone masonry that has detached and fallen out – see photo no.'s 3 (0170), 4 (0171), 5 (0172) and 6 (0202).

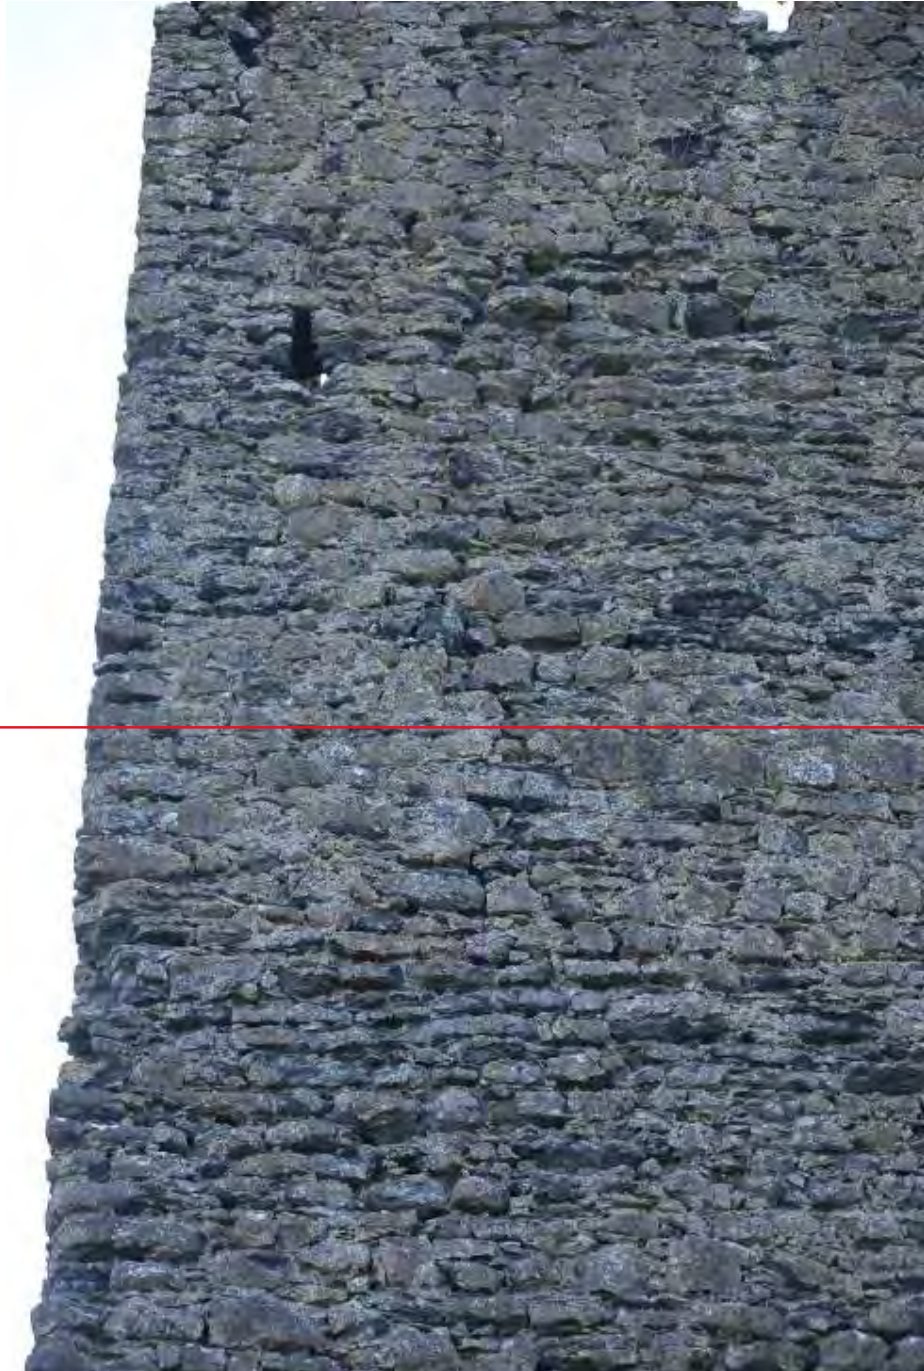
Photo No. 7 (0186)

6. Much of the lower levels of the Castle walls externally have a level of horizontal coursing in the masonry - see photo no. 7 (0186) below whilst the upper level in photo no. 8 (0188) is more random rubble with very little or no face pointing.

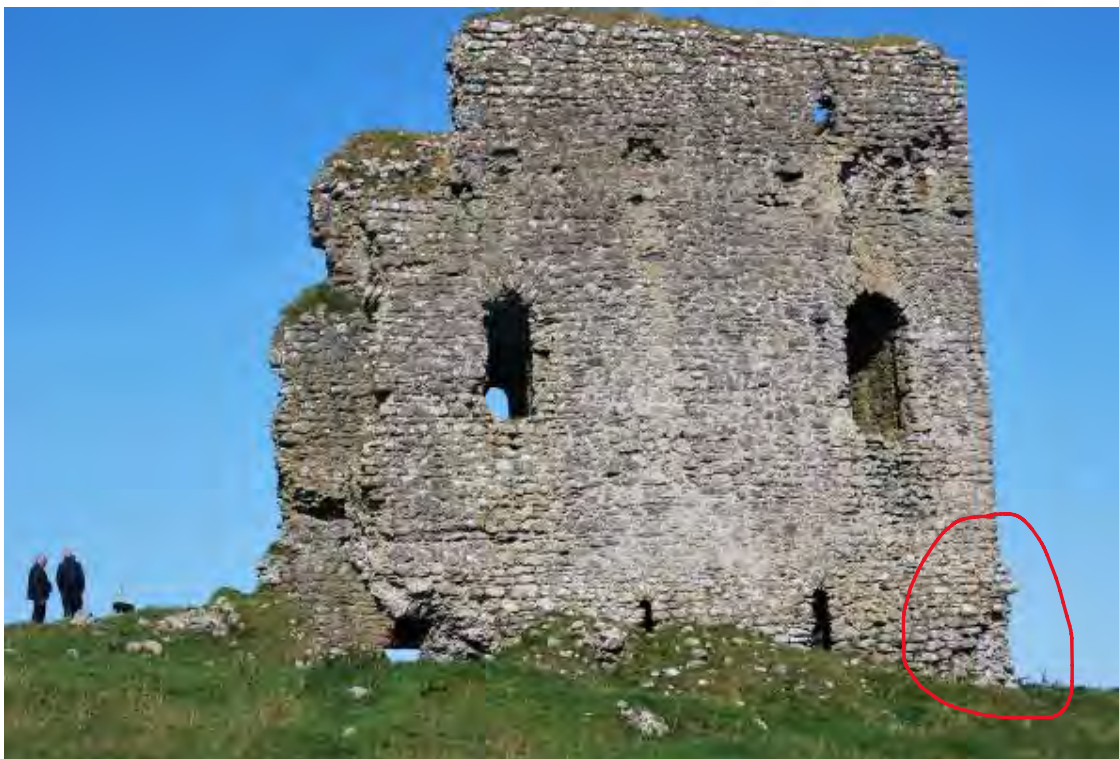
Photo No. 17 (0167)

The stone at the two rear North-West and North-East corners have been robbed as seen from the above photo no.'s 17 (0167), 18 (0174) and 19 (0175).

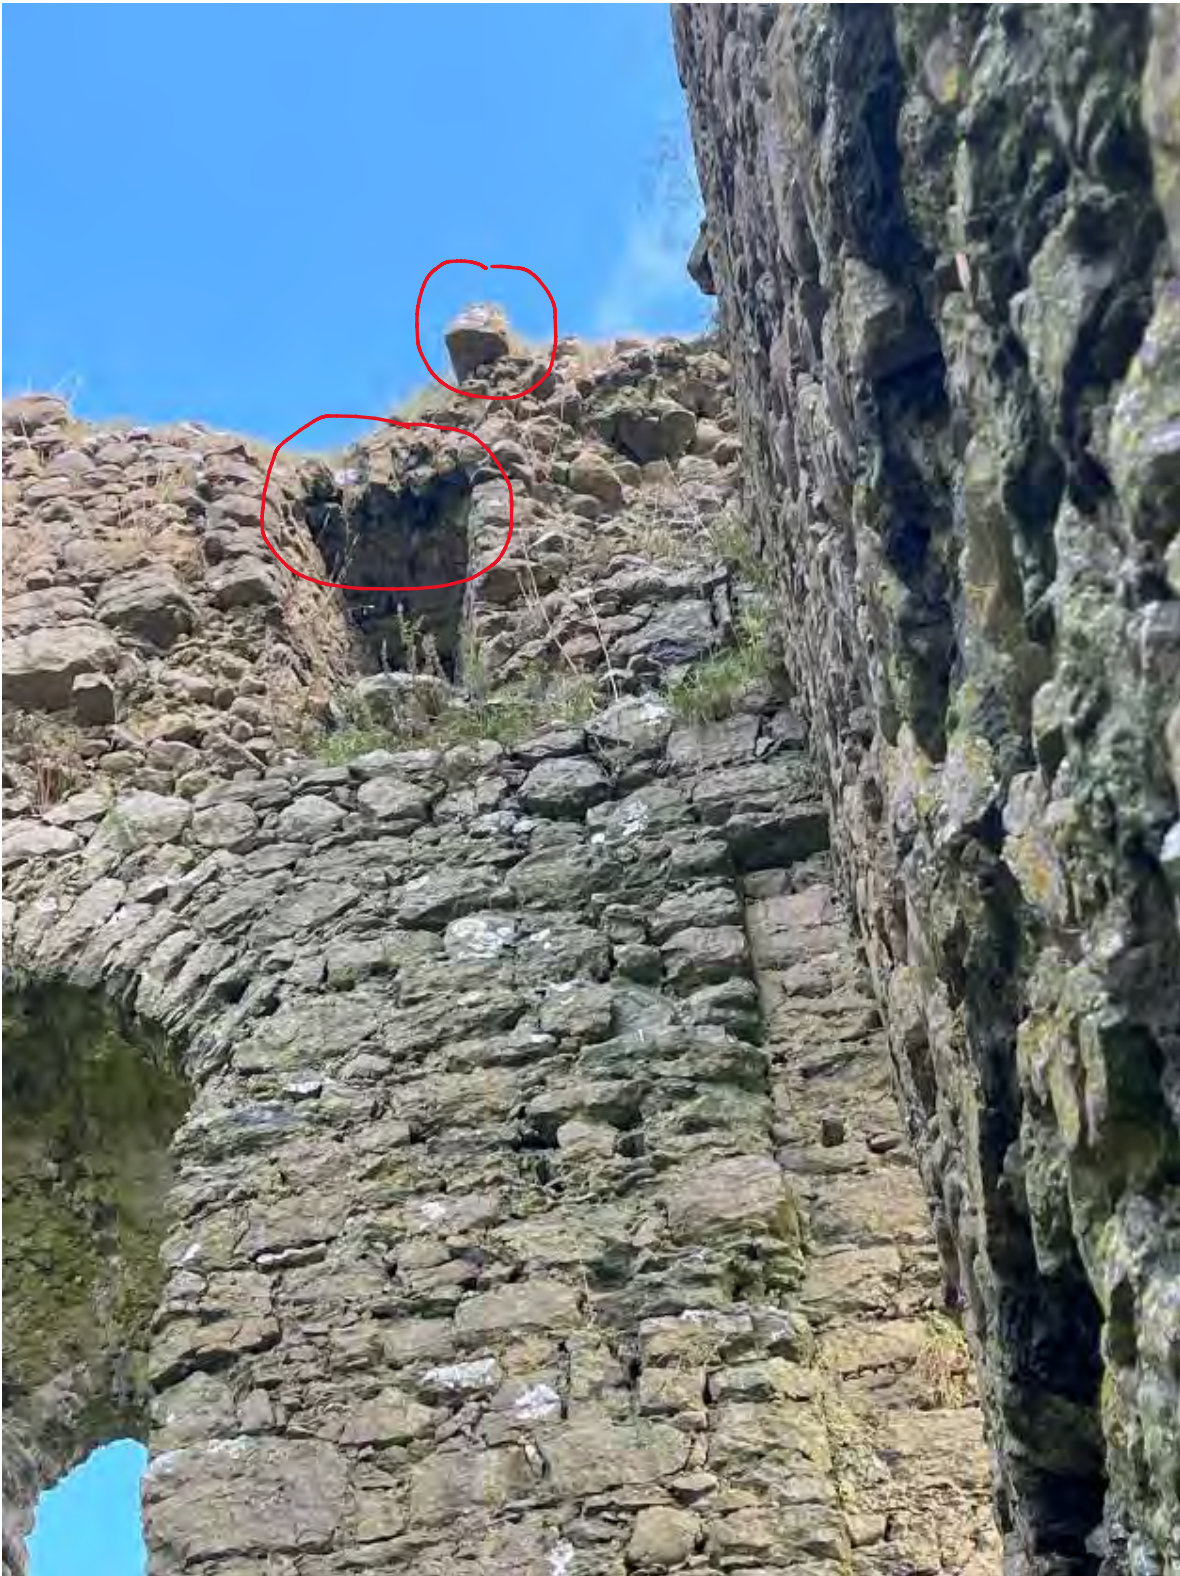
Photo No. 28 (1034)

The second-floor windows are narrow and generally have flat heads – see photo no.'s 28 (1034), 29 (1042), 30 (1053) and 31 (1011) with a single stone lintol.

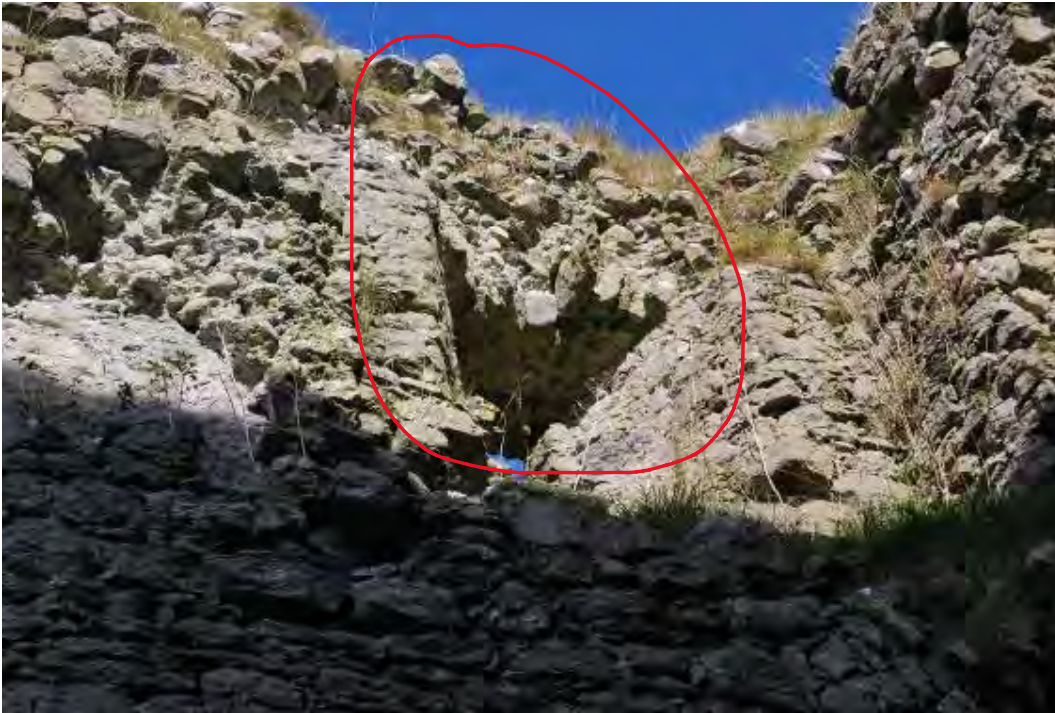
Photo No. 32 (0139)

Internally the heads of W9 – see photo no. 32 (0139) and W11 – see photo no. 33 (0138) are suspect and will need support lintols especially on the inner face where arching across the opening does not appear to be in place.

In the short term – no new work is proposed to any of the high level openings unless access is provided to the level of W9 and W11 for other works.

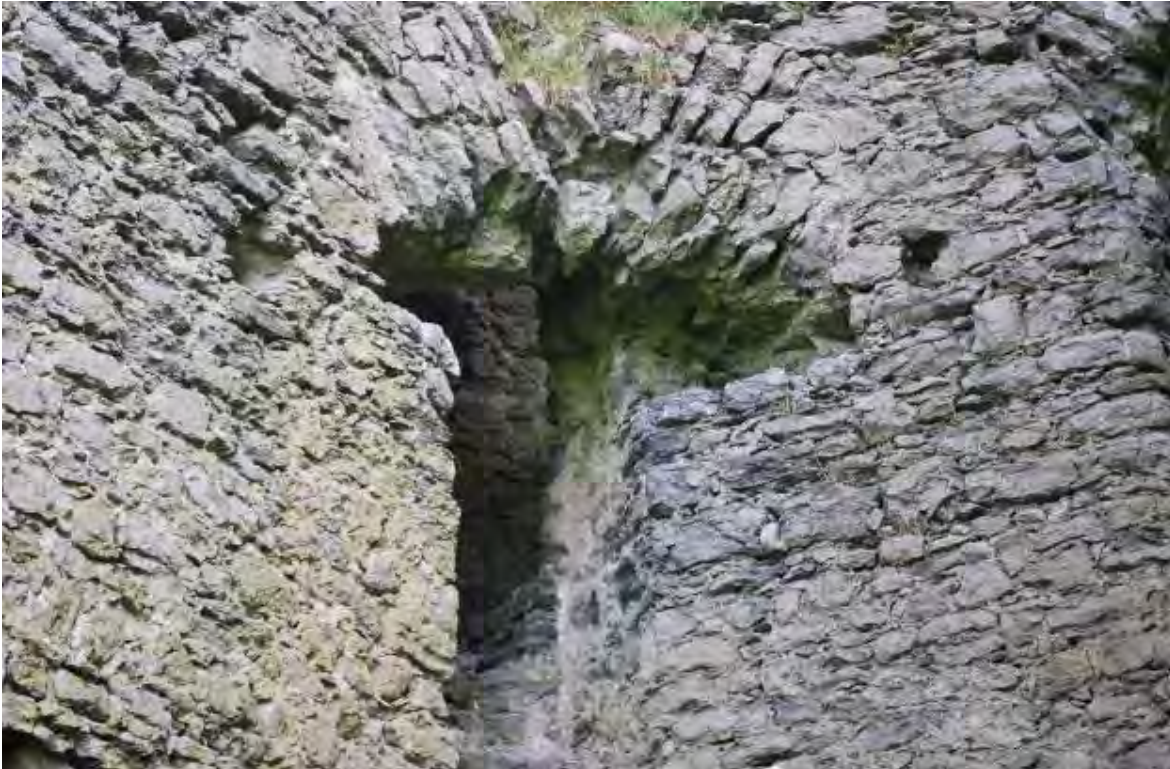
Photo No. 34 (0135)

This arched head – in the squinch - see photo no.'s 34 (0135) and no. 35 (1032) in the first floor has substantial bearing either side of the wall opening and bearing is available both sides for a further section or infill below the stone arch. This has been in this present condition for a long period. The existing upper section of the arch is adequately supporting the overhead masonry – the binding of the keystone would improve the integrity of the existing arch.

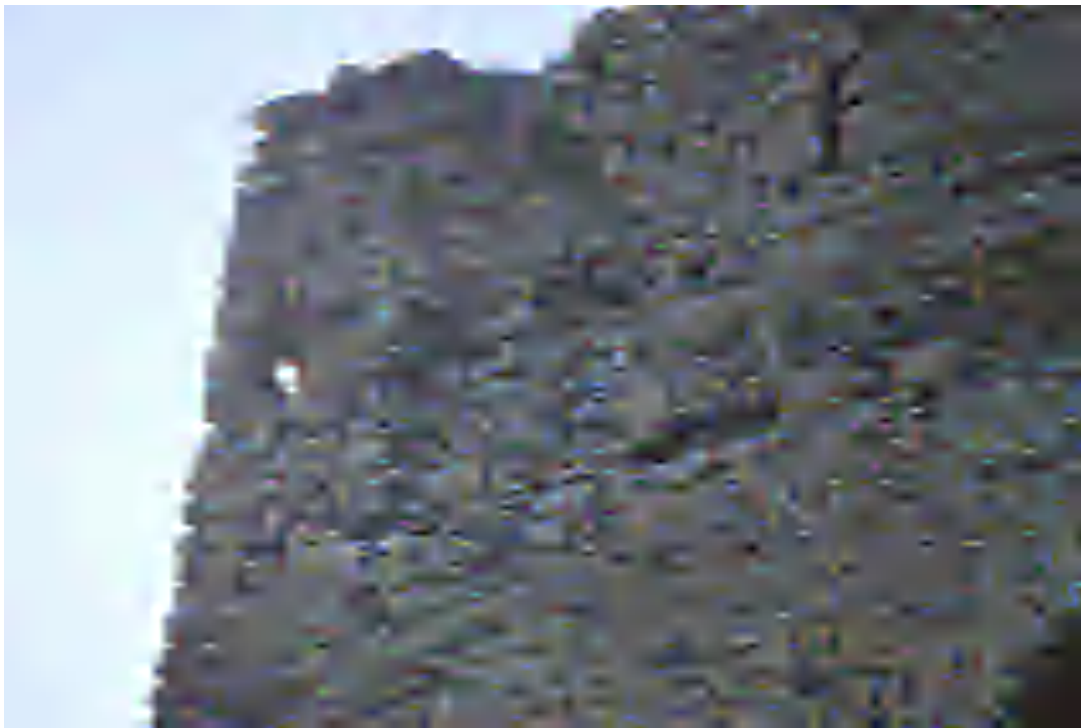
Photo No. 36 (0195)

1. There is a critical support issue at the rear right hand corner or North-East corner at high level where stone fall out has left a substantial height of wall supported on two corner stones – see photo no.'s 36 (0195), 37 (0196), 38 (0197), 39 (0198) and 40 (0201).

This is in critical structural condition and unless it is remedied, the top corner section of this corner will collapse. This has already happened at the North-West corners – see photo no.'s 41 (0173), 42 (0185) and 43 (0188).

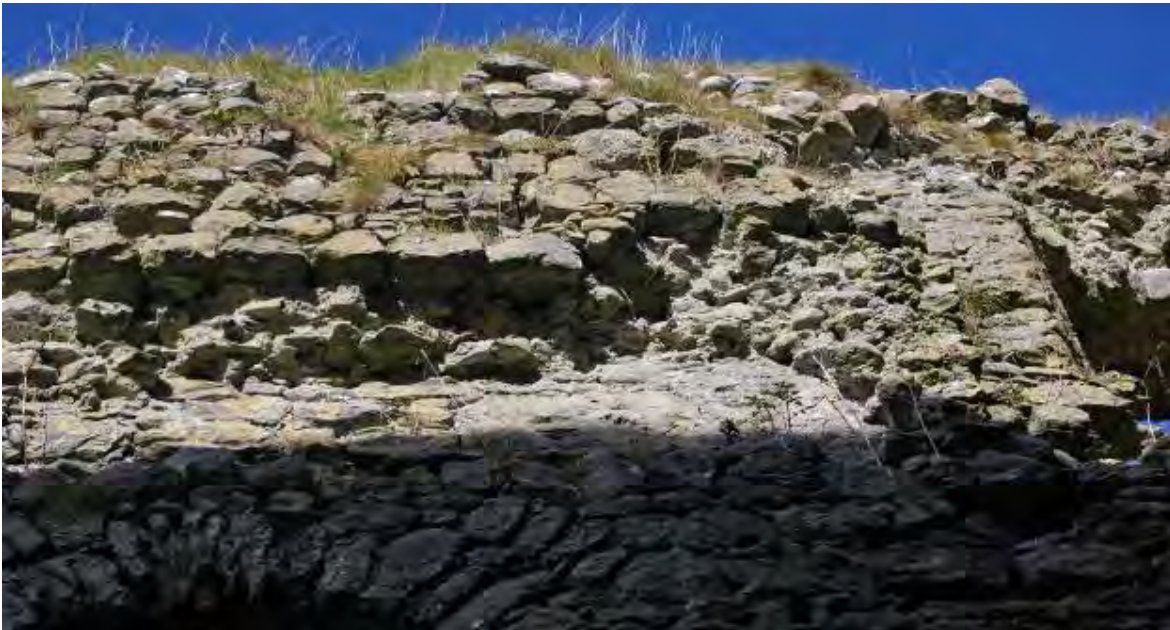
Photo No. 44 (0140)

2. Internally at 2nd. floor level on the left-hand wall or North-West wall, there are two areas where the inner skin of the stone masonry appears to have fallen away leaving overhead masonry unsupported except for the tying-in of the masonry at that level to the main body of the masonry wall – see photo no.'s 44 (0140) and 45 (0141).

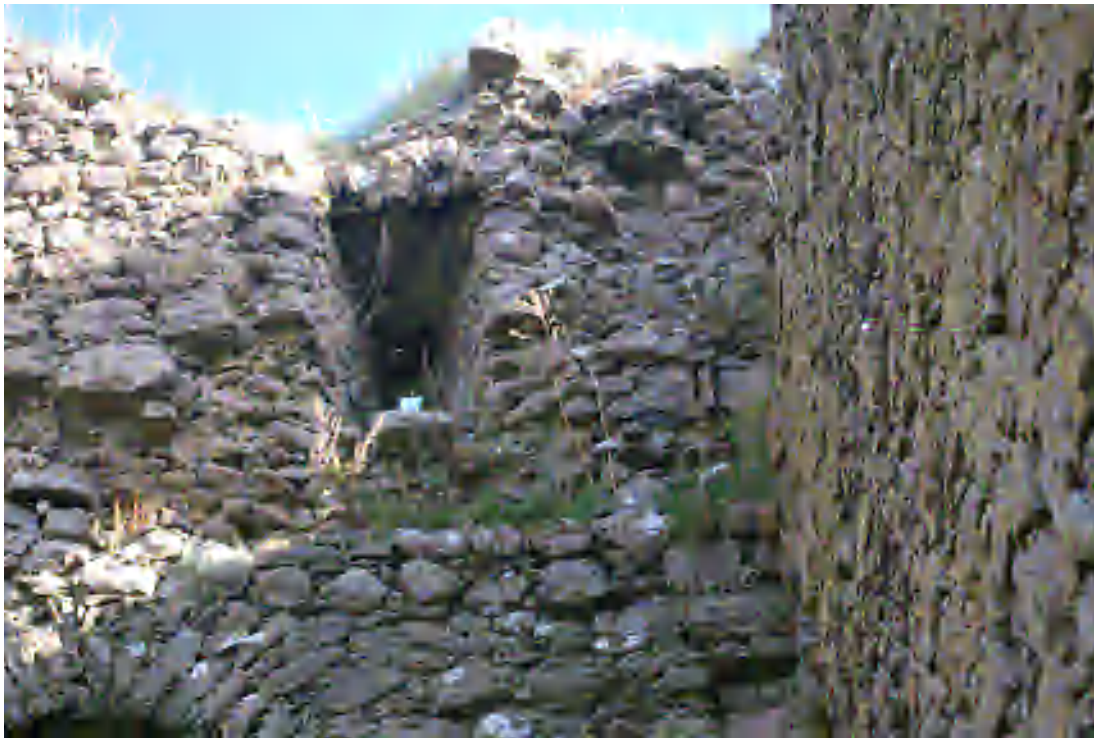
Photo No. 32 (0138)

3. There is an overhanging single large stone over window W11 – see photo no. 32 (0138) which looks unstable.

4. Growth of grass, weeds and shrubs in the upper levels needs to be killed off and not be allowed to develop with root stems extending into the masonry to cause future damage – see photo no. 32 (0138) above. No ivy was noted.

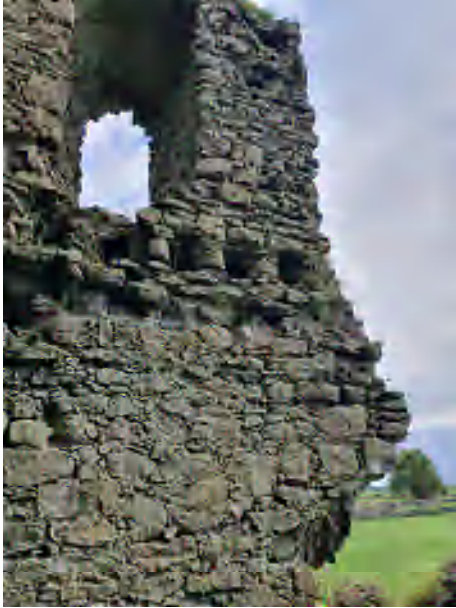
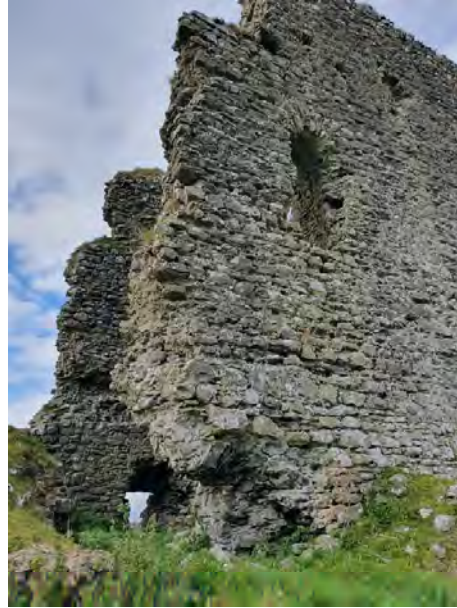
1. There was a masonry collapse in the south end of the south-eastern wall. The remaining wall end is precariously cantilevered and in danger of further collapse.

Masonry collapse at south end of the south-eastern wall. - It is anticipated that the wall should be built up underneath the cantilevered section. I assume that it would be built off the existing base wall without the need for the digging of foundations. The question therefore is "How can the works be designed to accord with best conservation practice?"

I recommend Option 2 therefore.

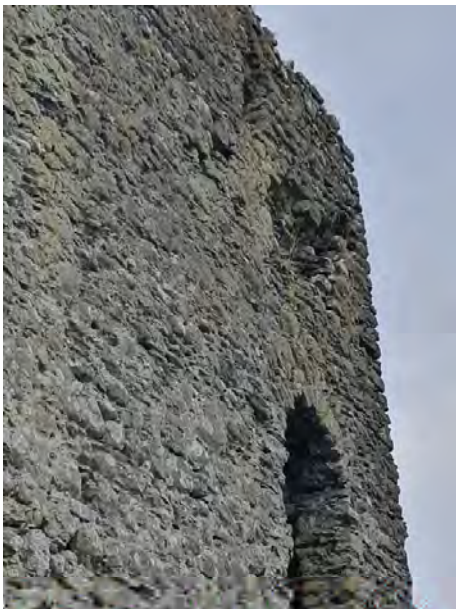
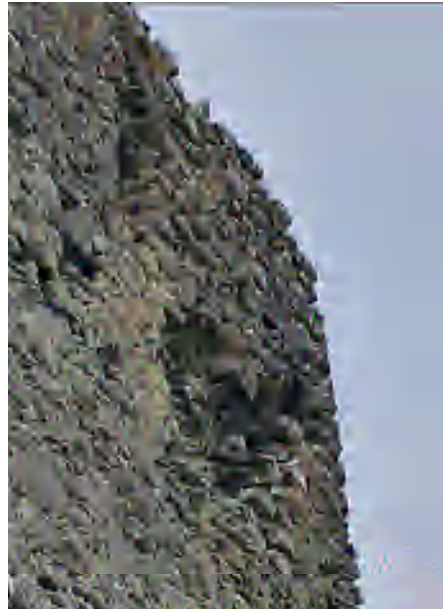
2. A section of masonry has fallen from the face of the south-eastern wall at second floor level at its northern end. There is a concern that there may be further falls. This will require access at height to be provided in order that a structural inspection be undertaken.

Masonry loss at northern end of south-eastern wall – In order to repair this it will be necessary to obtain access at height (scaffolding), firstly to determine the nature and extent of the defect and secondly to undertake a repair. I await engineer's proposals in this regard. I have been informed that the cost of scaffolding would be prohibitive and that funds may not be immediately available.

With regard to best conservation practice I see no reason why this area should not be repaired in the same masonry and coursing pattern as the existing.
